**Cripple Creek & Victor Gold Mining Company
Squaw Gulch VLF Phase 1 (9,450' to 9,550' Bench)
Final Report
Quality Assurance Monitoring & Test Results
October 2015**

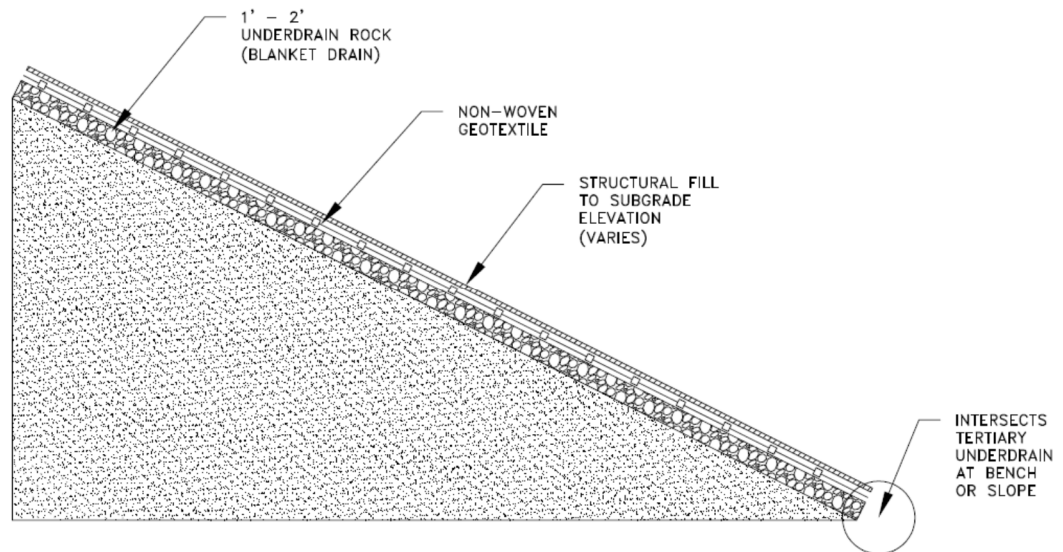
UNDERDRAIN PROFILE DETAIL

- On ROC Drawing 3 in Appendix A, there are three locations shown referred to as blanket drains, a profile and section of these drawings is shown in the figure below. The blanket drains were used to capture several natural ground water springs in close proximity to one another and direct the water to the tertiary underdrain piping system.
