**COLORADO DIVISION OF RECLAMATION, MINING AND SAFETY
MINERALS PROGRAM INSPECTION REPORT
PHONE: (303) 866-3567**

MINE NAME: Ignacio Pit	MINE/PROSPECTING ID#: M-1992-054	MINERAL: Sand and gravel	COUNTY: La Plata
INSPECTION TYPE: Monitoring	INSPECTOR(S): Lucas J. West	INSP. DATE: October 7, 2015	INSP. TIME: 14:45
OPERATOR: LBCR, LLC	OPERATOR REPRESENTATIVE: Jay Nielson, Crossfire Aggregate Services	TYPE OF OPERATION: 112c - Construction Regular Operation

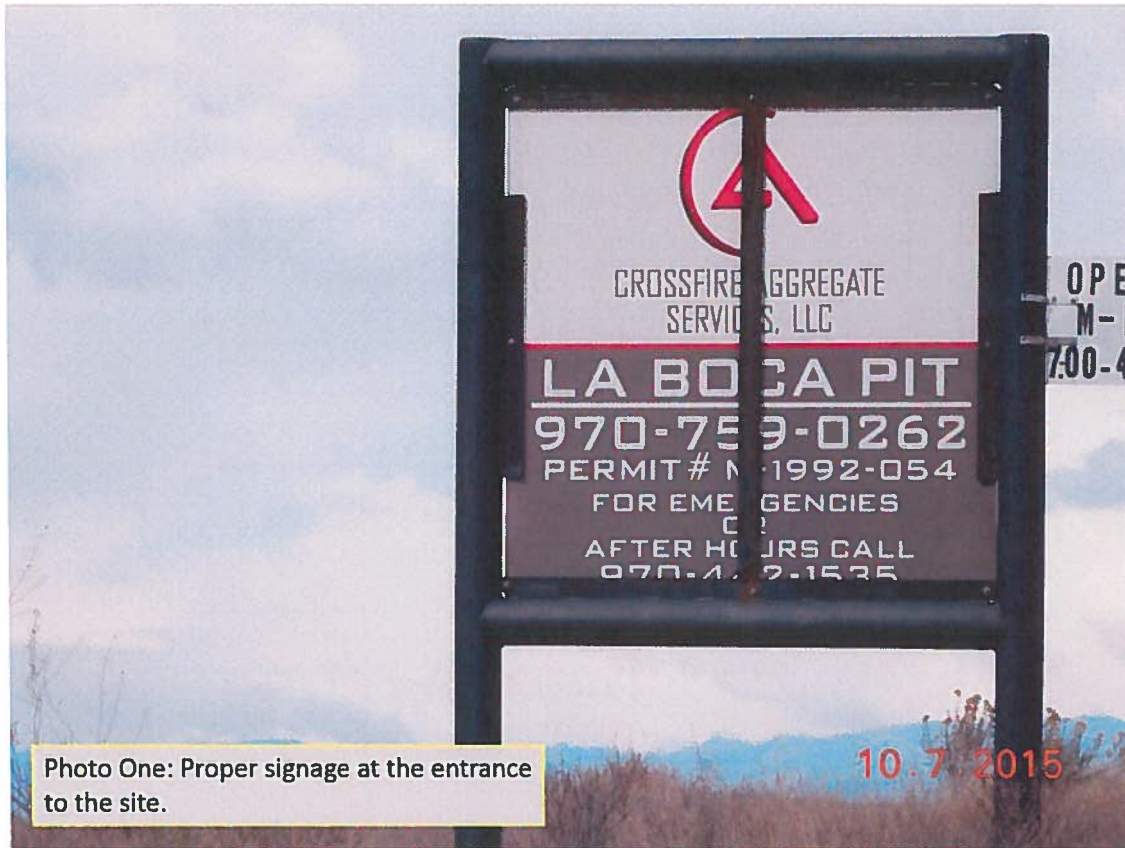
The Permit is located just west of County Road 172, South of Ignacio. The site is a phased mining operation currently being mined in Phase D. Proper signage was observed during the time of the inspection as seen in Photo One, as well as Permit Boundary Markers by way of earthen berms, fencing and T-posts. The site was not active during the time of the inspection, however equipment was observed on site. Several stockpiles were located on the pit floor of the active phase as seen in Photo Two. All slopes within the disturbed area, including the stockpiled material and mining highwalls are stable and show no signs of erosion. The Operator expressed that currently, and in future phases of mining, they would maintain an approximate 20 foot buffer from the East Permit Boundary as seen in Photo Three. The Fence delineating the Eastern Permit Boundary is part of an easement associated with the County Road. Standing water was observed in the pit floor due to recent precipitation events, the site does not encounter groundwater during their mining operations.

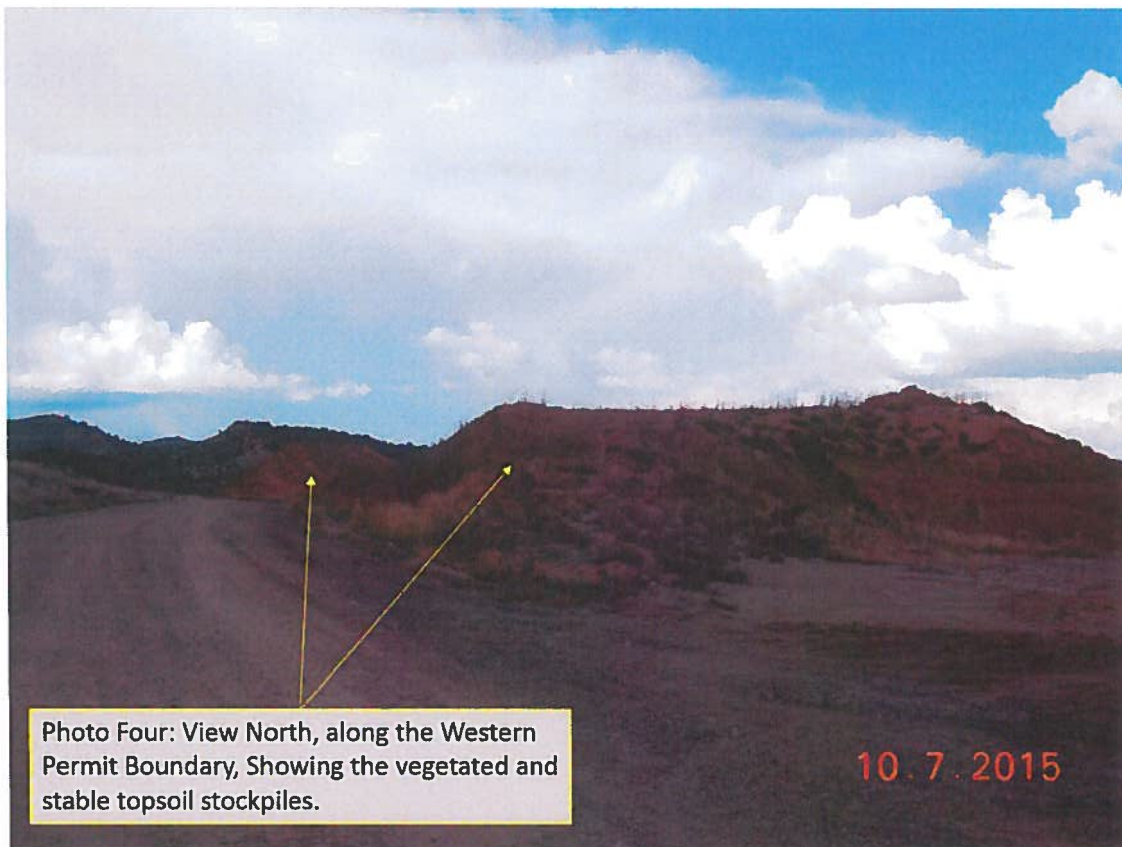
Topsoil and overburden stockpiles were observed on site. The top soil stockpiles were seeded and stable, shown in Photo Four, and the overburden stockpiles have grown volunteer species and are also stable. In one drainage on the West side of the haul road a small isolated population of Thistle was observed. It is recommended that the Operator employ a non-chemical treatment such as cut and bag method, for weed management in this area.
