COLORADO DIVISION OF RECLAMATION, MINING AND SAFETY MINERALS PROGRAM INSPECTION REPORT

MINE NAME:	MINE/PROSPECTING ID#:	MINERAL:	COUNTY:
Mineral Mountain Project	M-2014-045	Gold	Teller
INSPECTION TYPE:	INSPECTOR(S):	INSP. DATE:	INSP. TIME:
Surety-Related Inspection	Timothy A. Cazier	October 20, 2015	10:00
OPERATOR:	OPERATOR REPRESENTATIVE:	TYPE OF OPERATION:	
Mineral Mountain Gold, LLC	Lance Barker	110d - Designated Limited Impact

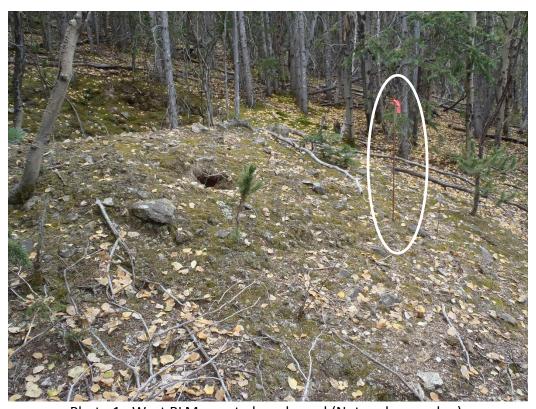
New permit boundary makers were placed to mark the corners of BLM land. The west area included roughly 6,000 sqft of undisturbed forested BLM land (see **Photo 1**). The southeast corner included approximately 600 sqft of likely pre-law disturbed area that is supporting new conifer growth (see **Photo 2**). Each area's corners were marked with rebar stakes marked with BLM tags (see **Photos 3** and **4**).

Photo 1. West BLM area to be released (Note rebar marker).

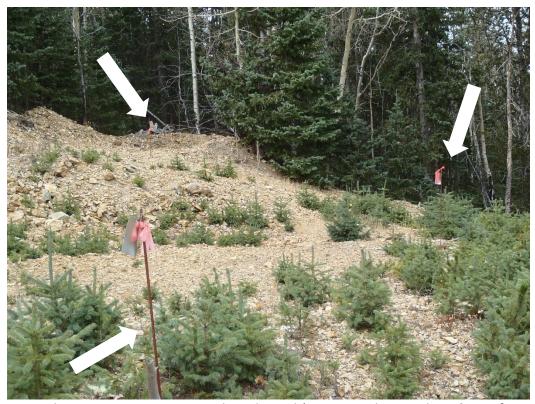
Photo 2. Southeast corner BLM area to be released (Note: 3 rebar markers & conifer growth).

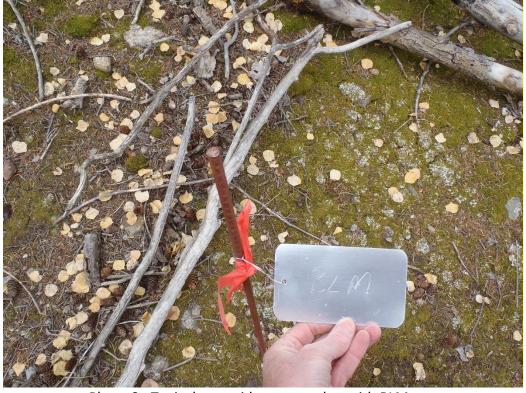
Photo 3. Typical west side area marker with BLM tag.

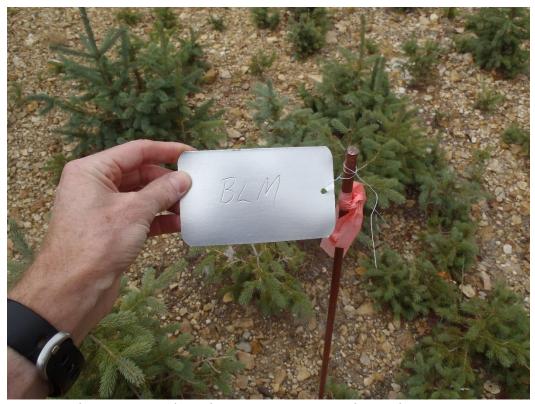
Photo 4. Typical southeast corner area marker with BLM tag.
