COLORADO DIVISION OF RECLAMATION, MINING AND SAFETY
MINERALS PROGRAM INSPECTION REPORT
PHONE: (303) 866-3567

MINE NAME: Spotted Burro Pit	MINE/PROSPECTING ID#: M-1979-192	MINERAL: Sand and gravel	COUNTY: Fremont
INSPECTION TYPE: Monitoring	INSPECTOR(S): Timothy A. Cazier	INSP. DATE: February 19, 2015	INSP. TIME: 11:30
OPERATOR: Rockbottom, LLC	OPERATOR REPRESENTATIVE: Andy Kagan	TYPE OF OPERATION: 112c - Construction Regular Operation

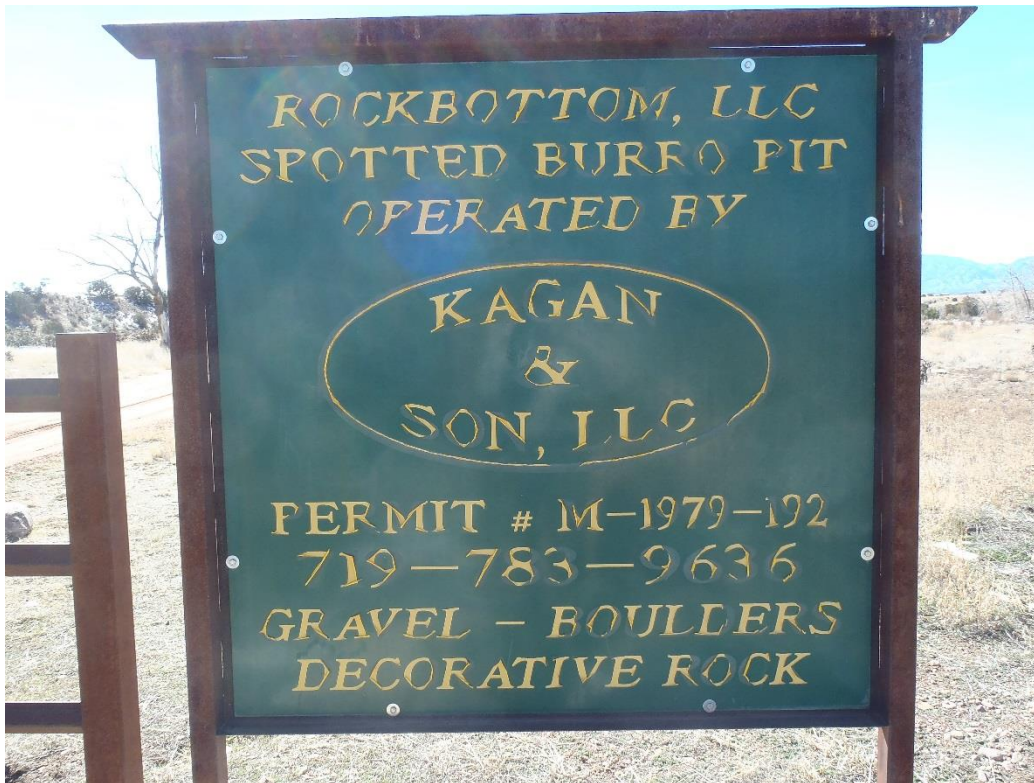
Markers & Boundary – A permit sign was displayed at the site entrance (see **Photo 1**). The Operator has marked the limits of mine excavation with permit boundary with T-posts (see **Photo 2**). The south and east permit boundaries were marked with fencing (see **Photos 3 and 4**).

Photo 1. Permit sign posted at entrance.

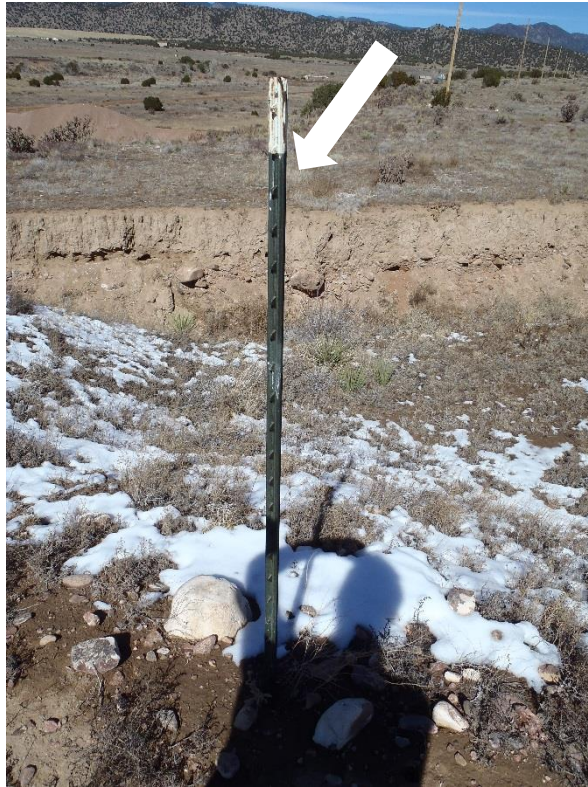
Photo 2. Limits of mine excavation T-post marker.

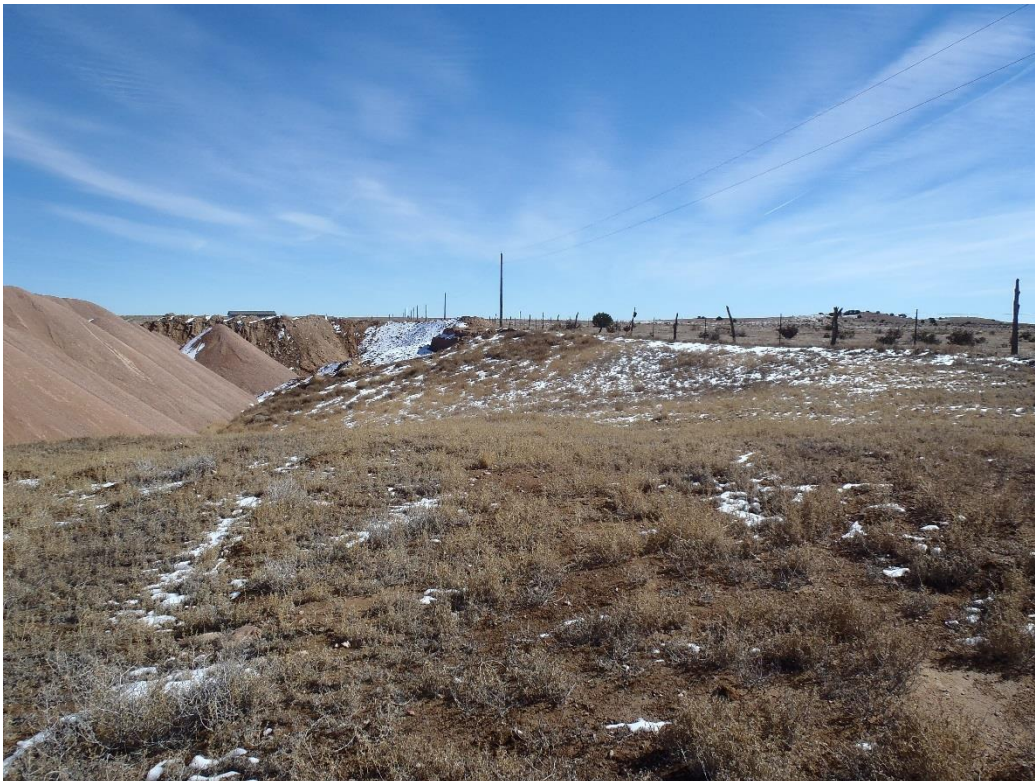
Mining Plan – Working highwalls were observed to be near vertical (see **Photo 5**), but finished area highwalls were flattened to at least 3H:1V and vegetated (see **Photo 3**). Several stockpiles of recently crushed material were observed on the pit floor. Mr. Kagan indicated he does not plan to mine the bottomlands in the west side of the permit area. That area is primarily used for material stockpiles.

Photo 3. South permit boundary fence and concurrent reclamation (looking east).

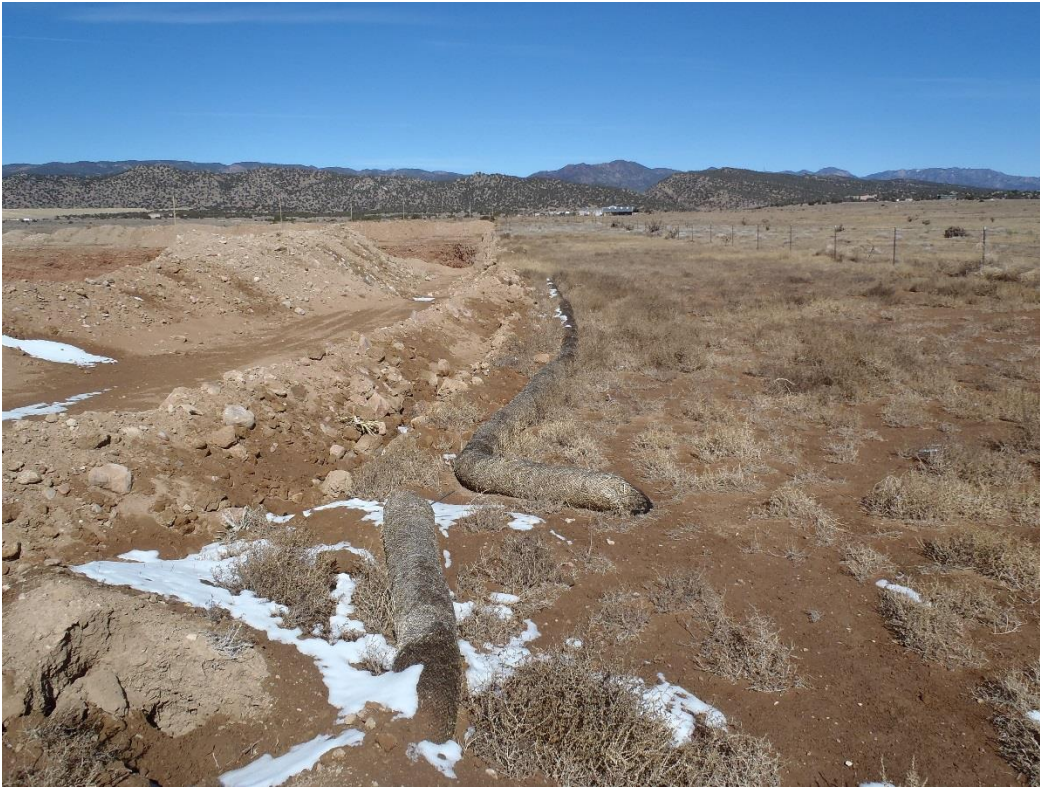
Photo 4. East permit boundary fence (looking north).

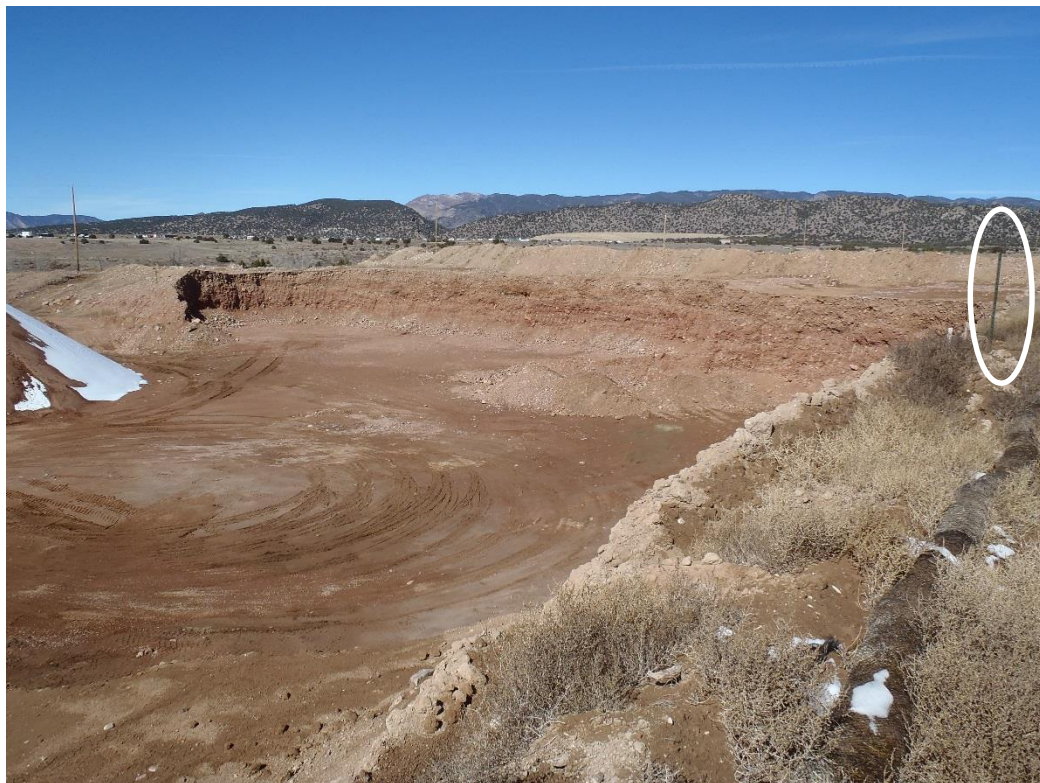
Photo 5. Working highwalls observed to be near vertical (looking NW, note excavation limit T-post).

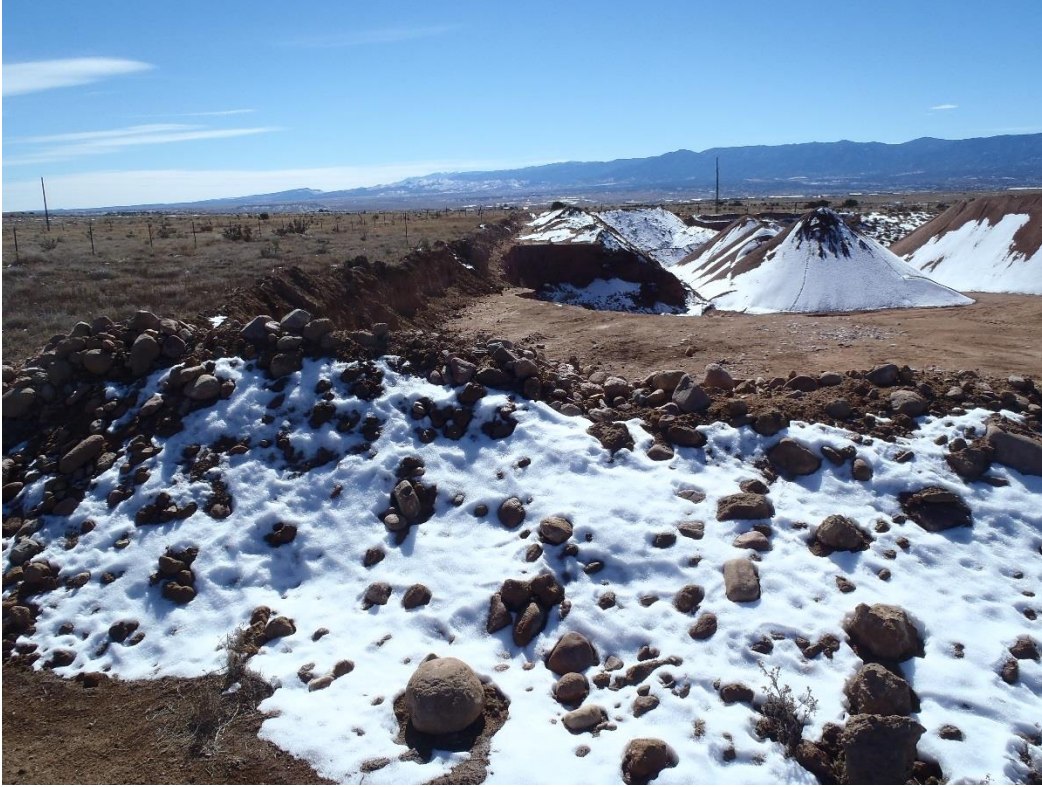
Reclamation – Some highwall reclamation had been completed as previously mentioned. Topsoil stockpiles were placed 30 to 50 feet beyond the working highwall (see **Photo 6**) to be used for concurrent reclamation.

Photo 6. Topsoil stockpiles 30 - 50 feet beyond the working highwall (looking south).
