COLORADO DIVISION OF RECLAMATION, MINING AND SAFETY
MINERALS PROGRAM INSPECTION REPORT
PHONE: (303) 866-3567

MINE NAME: Neglected Mine	MINE/PROSPECTING ID#: M-1981-165	MINERAL: Gold	COUNTY: La Plata
INSPECTION TYPE: Monitoring	INSPECTOR(S): Lucas J. West	INSP. DATE: October 8, 2015	INSP. TIME: 09:00
OPERATOR: Mine Development Inc	OPERATOR REPRESENTATIVE: Harold Luzar	TYPE OF OPERATION: 110(2) - Hard Rock Limited Impact

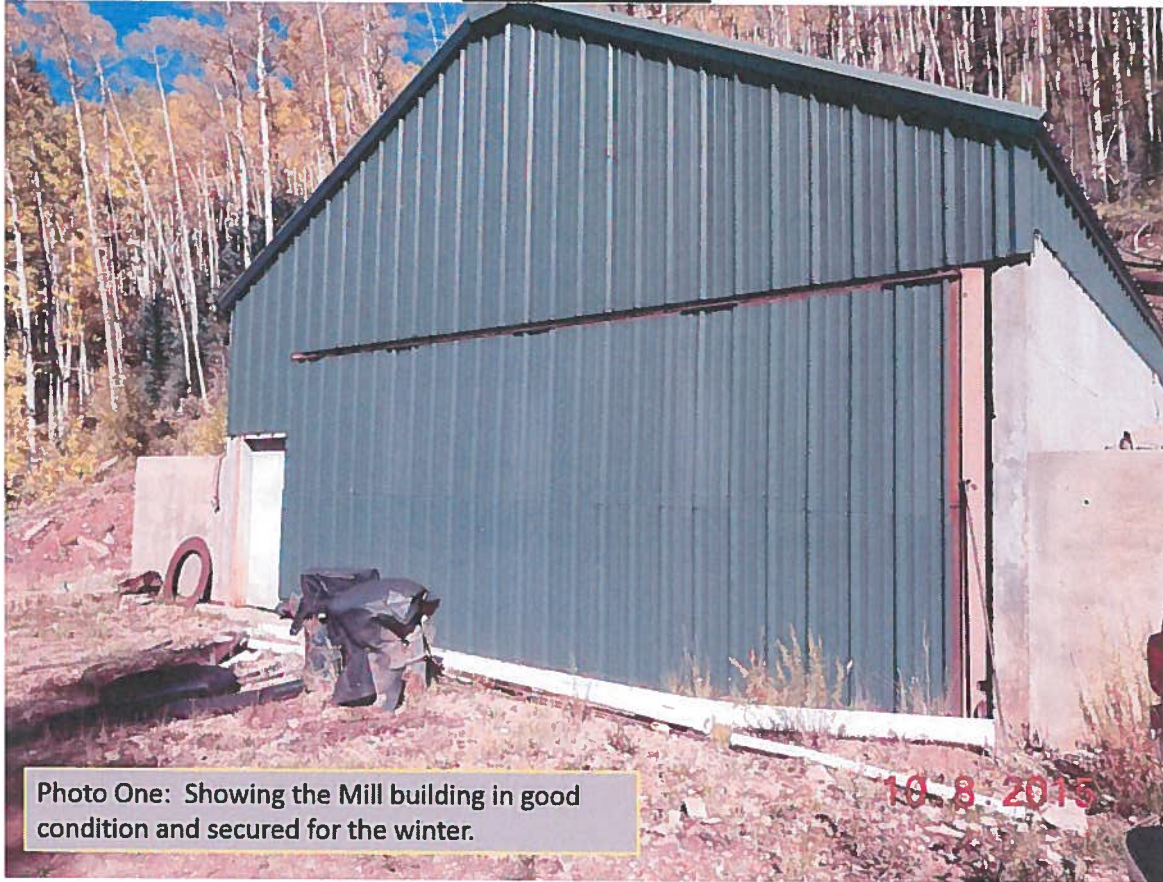
The interior of the Mill building was not inspected at this time, however the building was secure and in good condition. Photo One shows the mill building, which is built on a concrete pad with proper drainage structures to contain any processed water generated during operations. All other surface structures and facilities were inspected. The site is currently winterized after the conclusion of the intermittent operation during the summer months. As seen in Photos Two and Three, proper signage and Permit Boundary Markers were observed.

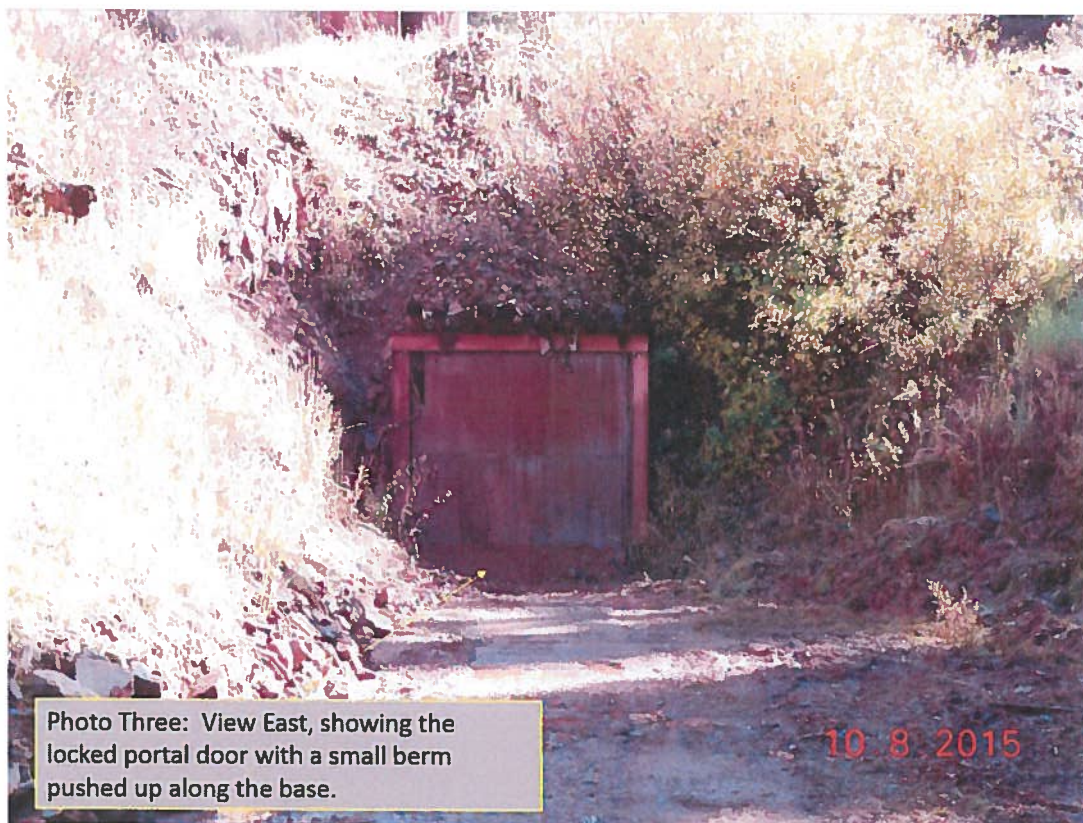
The portal was sealed with a locked steel door and small temporary berm pushed up to its base, shown in Photo Four. The portal was not draining water during the inspection and the Operator confirmed that it does not drain water at any time. The storage yard was in good condition, and well vegetated. Equipment stored includes a box truck, lumber, scrap iron and an explosives magazine. The Explosives magazine is locked but was not inspected because the Operator no longer has the keys. The Operator confirms it is empty and prior to the commencement of mining activities next season he will change the locks to allow for access and use.

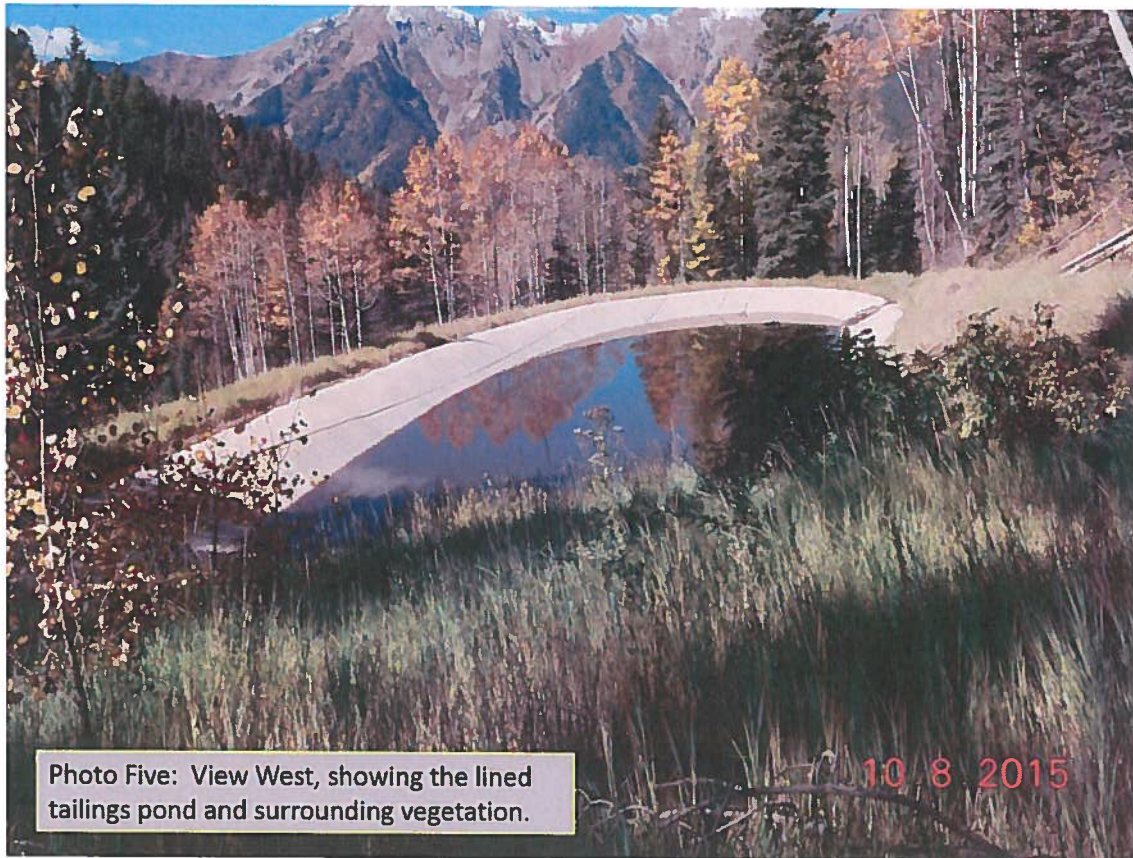
The lined tailings pond was in good condition, as seen in Photo Five. The area above the water line showed no signs of tearing or compromising of any kind. The pond level is lowered by the assisted evaporation process and is low enough to support the addition of any contributions from precipitation events. The Operator confirmed that he closely monitors the pond level to prevent any surface discharge into the adjacent drainage. The presence of vegetation and "water dogs" strongly suggest the lack of toxicity in the tailings pond as a result of the Operators use of non-hazardous chemicals in the milling process.

Photo Five: View West, showing the lined tailings pond and surrounding vegetation.
