COLORADO DIVISION OF RECLAMATION, MINING AND SAFETY
MINERALS PROGRAM INSPECTION REPORT
PHONE: (303) 866-3567

MINE NAME: Argo Gravel Pit	MINE/PROSPECTING ID#: M-1978-267	MINERAL: Sand and Gravel	COUNTY: Otero
INSPECTION TYPE: Monitoring	INSPECTOR(S): Amy Eschberger and Wally Erickson	INSP. DATE: September 29, 2015	INSP. TIME: 10:45
OPERATOR: Otero County	OPERATOR REPRESENTATIVE: Lex Nichols and Darren Garcia	TYPE OF OPERATION: 112c - Construction Regular Operation

M1978-267 / Argo Gravel Pit / Otero County

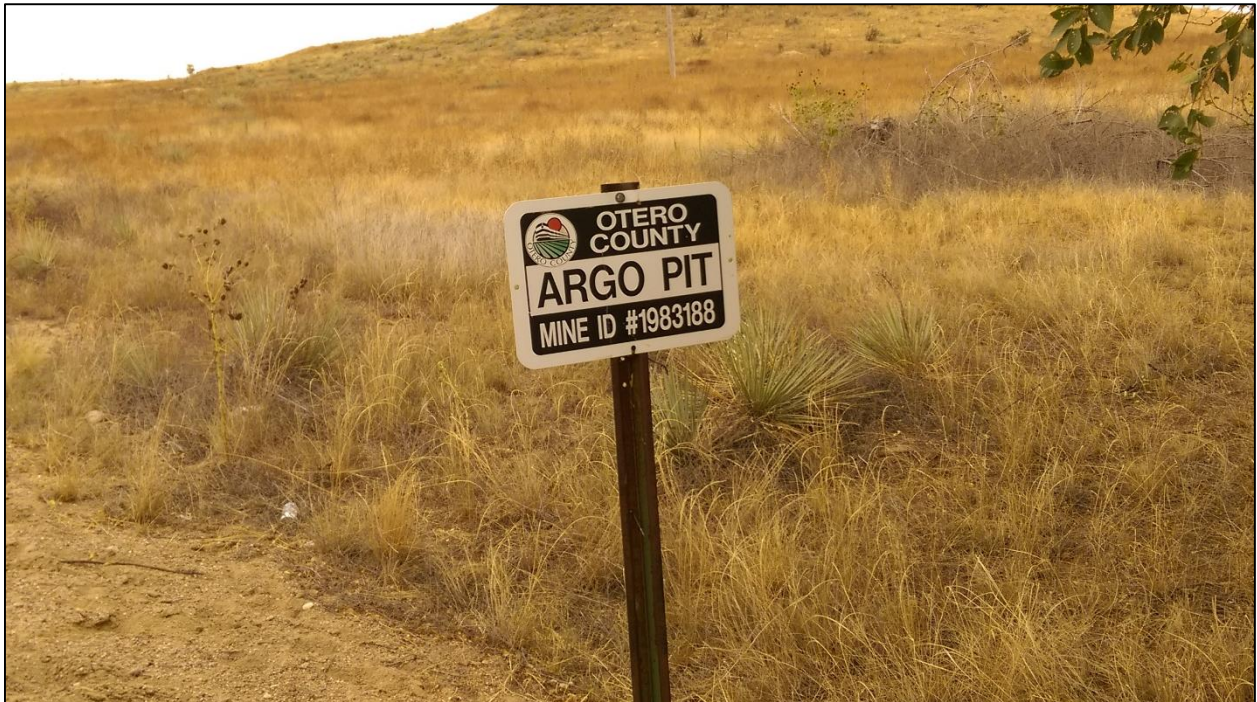
At the time of the inspection, the weather was partly cloudy and breezy. No standing water was observed on site. A permit sign was posted at the main site entrance off of Co Rd JJ.5 (**Photo 1**). This sign includes the operator name as required; however, the permit number (M-1983-188) is not correct. Per Rule 3.1.12(1), a permit sign should include the operator name, the permit number, and a statement that the permit was issued by the CO Mined Land Reclamation Board (which could be abbreviated on the sign as "issued by CO MLRB"). To be fully compliant, the Division recommends the operator replace the sign with one that includes these required items, at a minimum. The permit boundary was clearly delineated by fencelines and roads (for the eastern boundary and a portion of northern boundary). The site was not active during the inspection, and no equipment was stored on site. According to the operator, mining of Phase 1 was completed in 2004 or 2005. The county was only hauling off stockpiled material between 2005 and 2008 (which is considered mining activity by the Division). The Division estimates that approximately 42 acres have been disturbed by the operation, all of which have been in various stages of reclamation since mining was completed. This amount of disturbance is in compliance with the approved maximum allowed disturbed acreage at any time, which is 50 acres.

Photo 1. View of permit sign posted at main entrance to site off of Co Rd JJ.5. This sign includes the operator name as required. However, it has the wrong permit number, and no statement that the permit was “issued by the CO MLRB”.

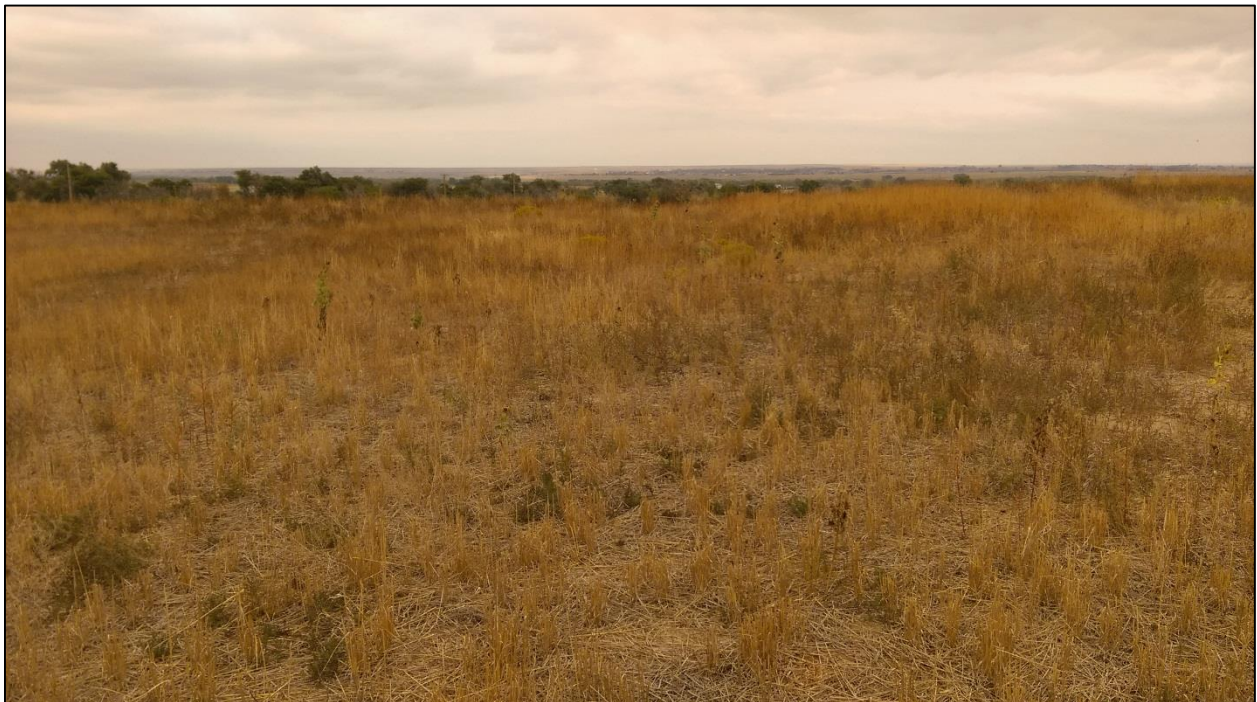
Photo 2. View looking northwest across ridge top in western portion of disturbed area, showing good vegetative cover.

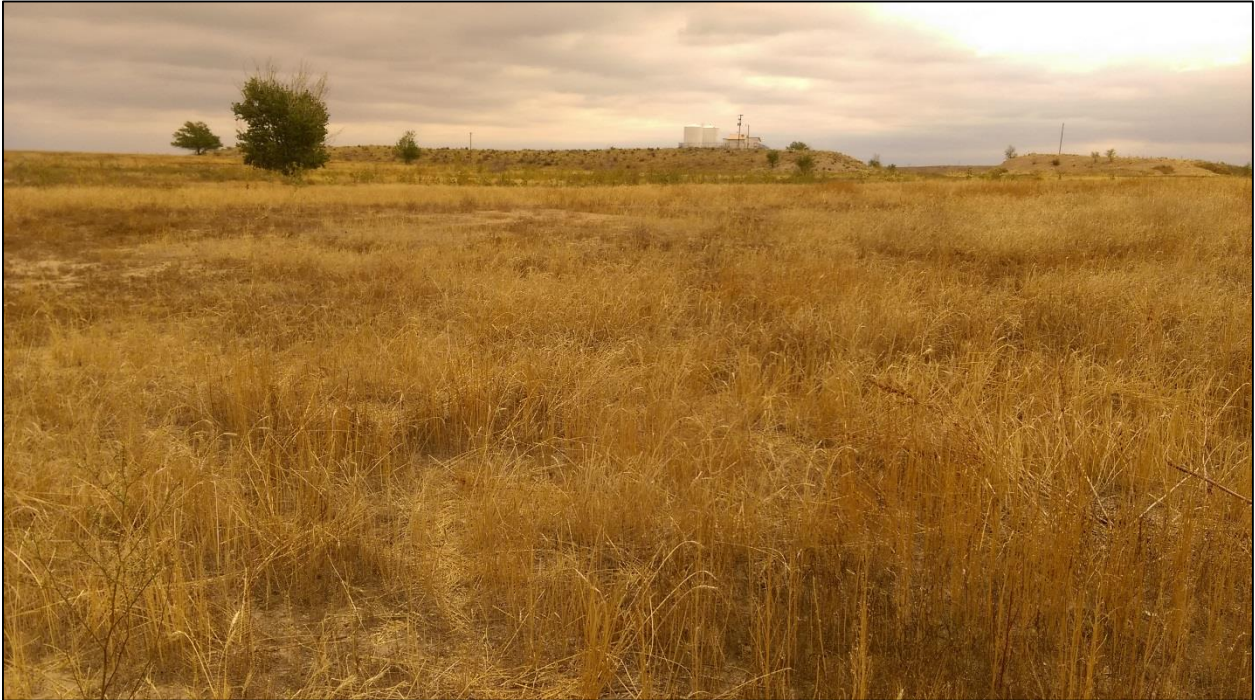
Photo 3. View looking east across ridge top in western portion of disturbed area, showing good vegetative cover.

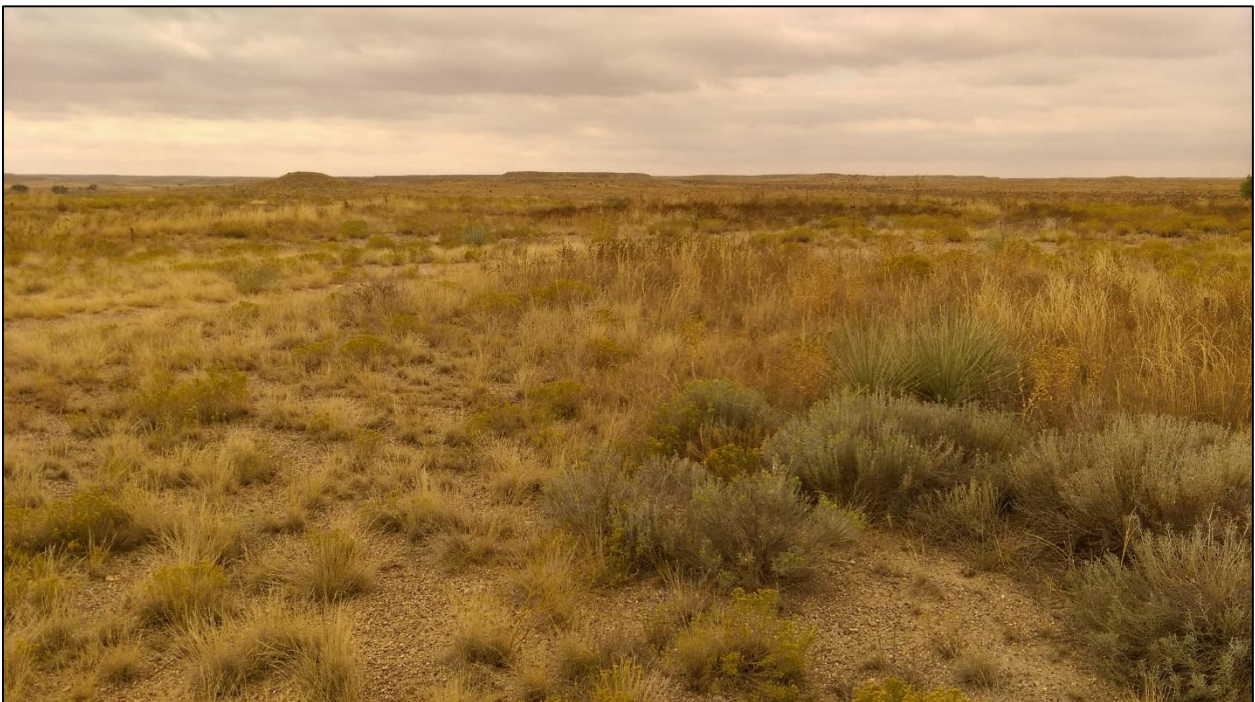
Photo 4. View looking southwest across western portion of disturbed area (south of radio tower), showing good vegetative cover.

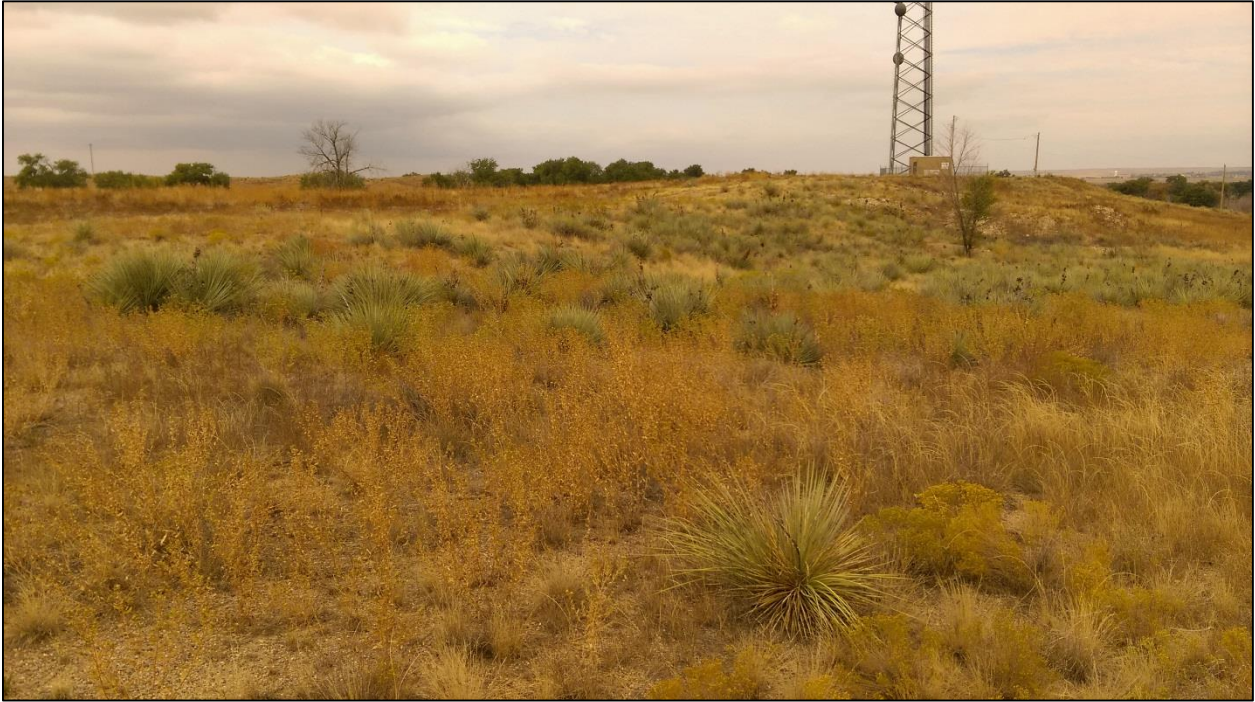
Photo 5. View looking west across western portion of disturbed area (south of radio tower), showing good vegetative cover.

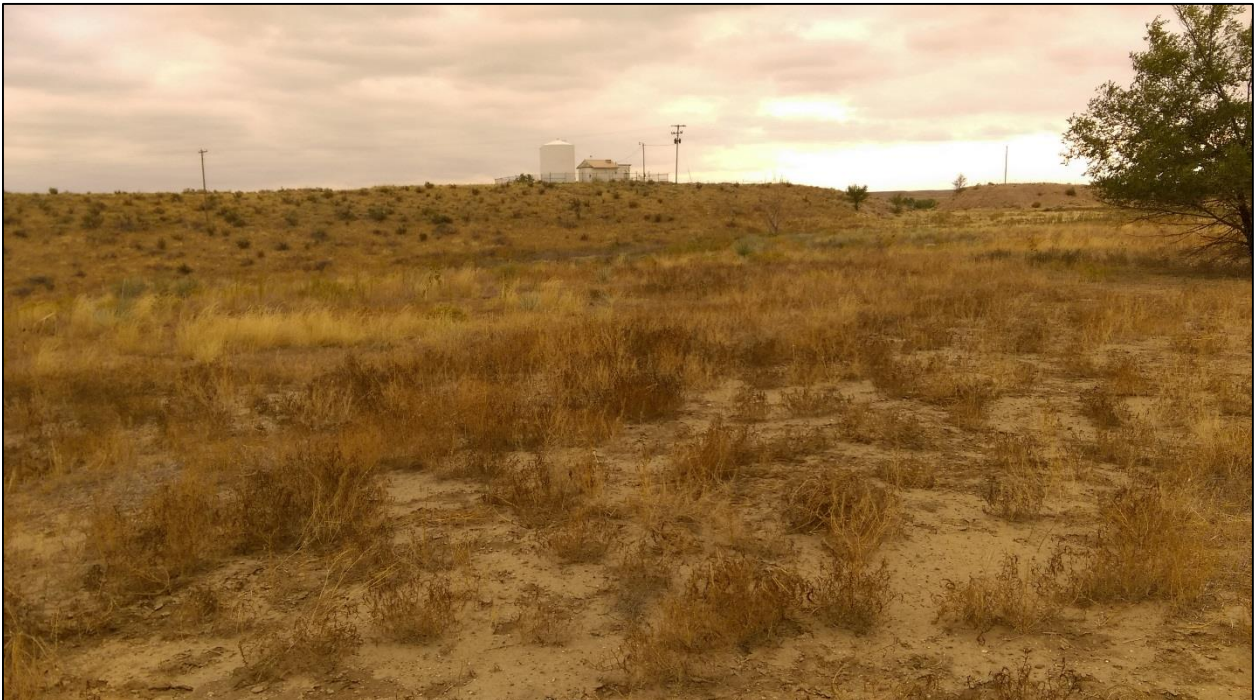
Photo 6. View looking east across portion of ridge (west of ridge with water tanks), showing some areas with sparse grass growth (in foreground) that may require interseeding.

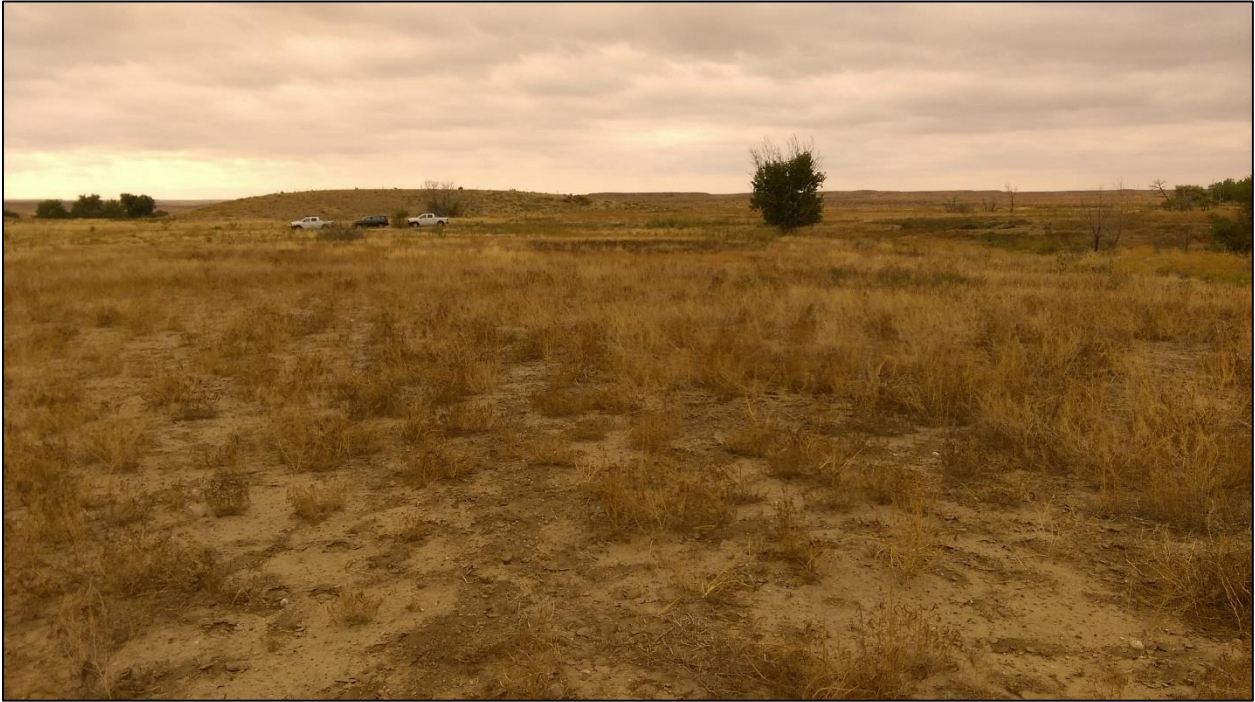
Photo 7. View looking south across portion of ridge (west of ridge with water tanks), showing some areas with sparse grass growth (in foreground) that may require interseeding.

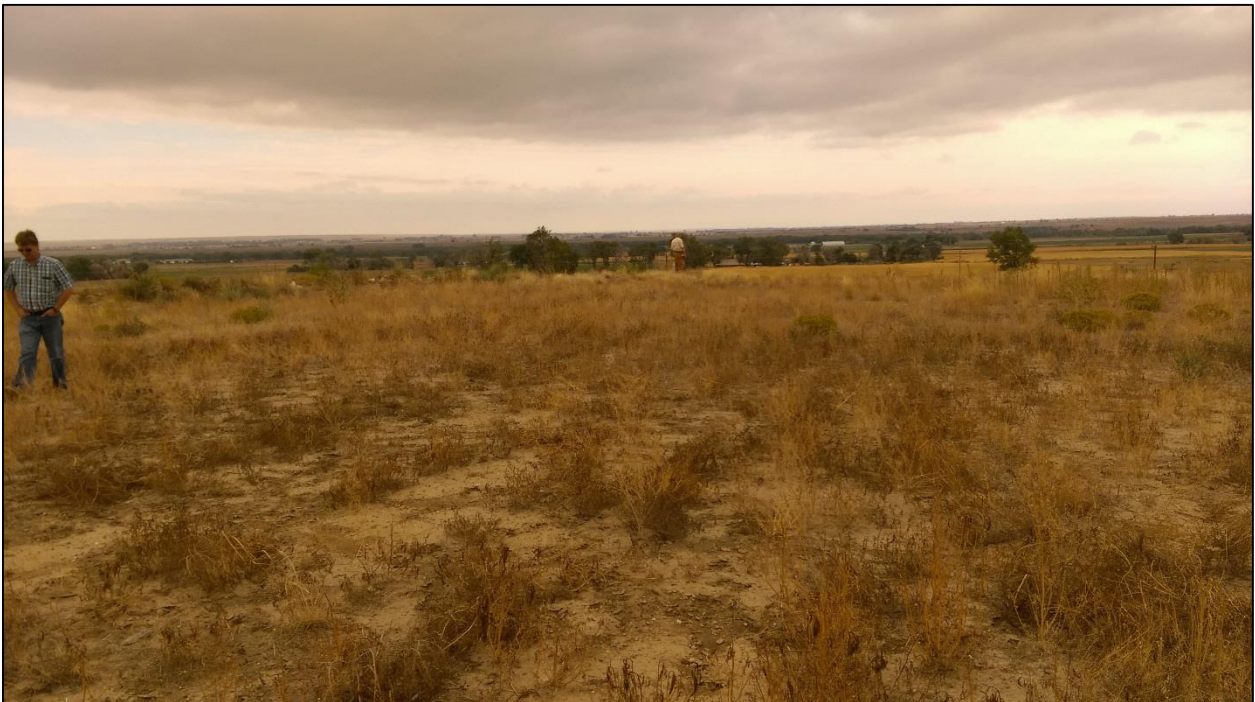
Photo 8. View looking north across portion of ridge (west of ridge with water tanks), showing some areas with sparse grass growth (in foreground) that may require interseeding.

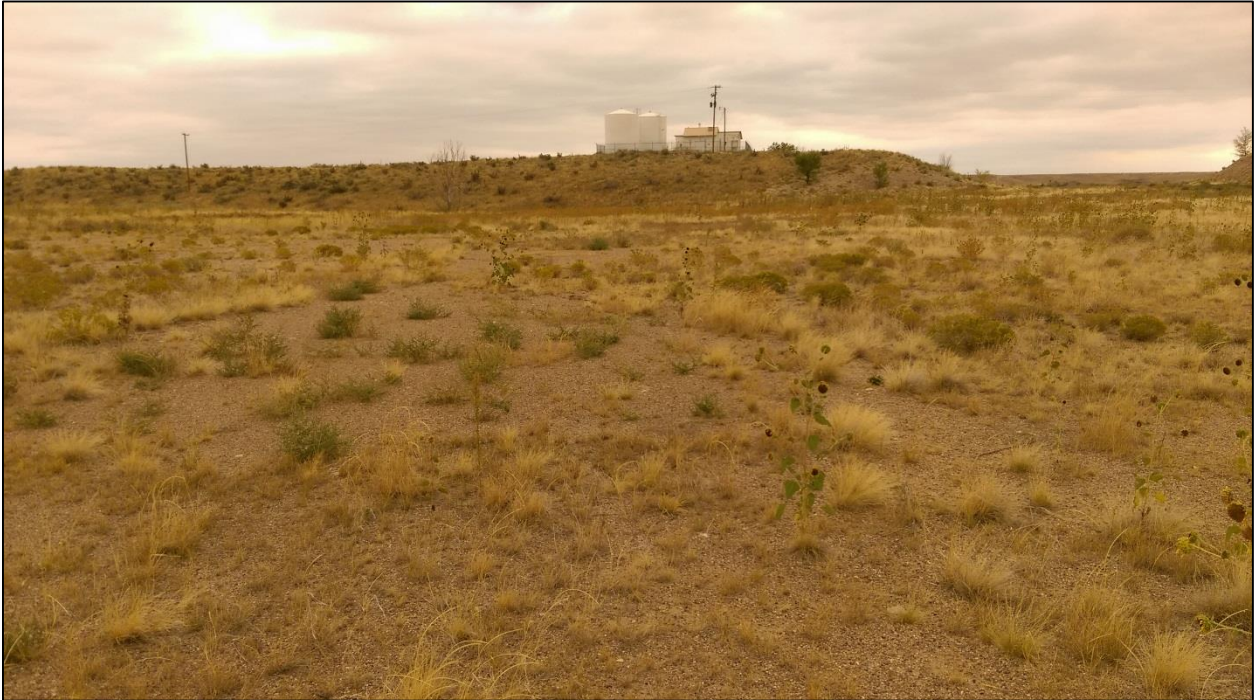
Photo 9. View looking east across portion of ridge (west of ridge with water tanks), showing some areas with sparse grass growth (in foreground) that may require interseeding. However, this particular area may only require another growing season, as grass growth is more prominent here than on other portions of the ridge.

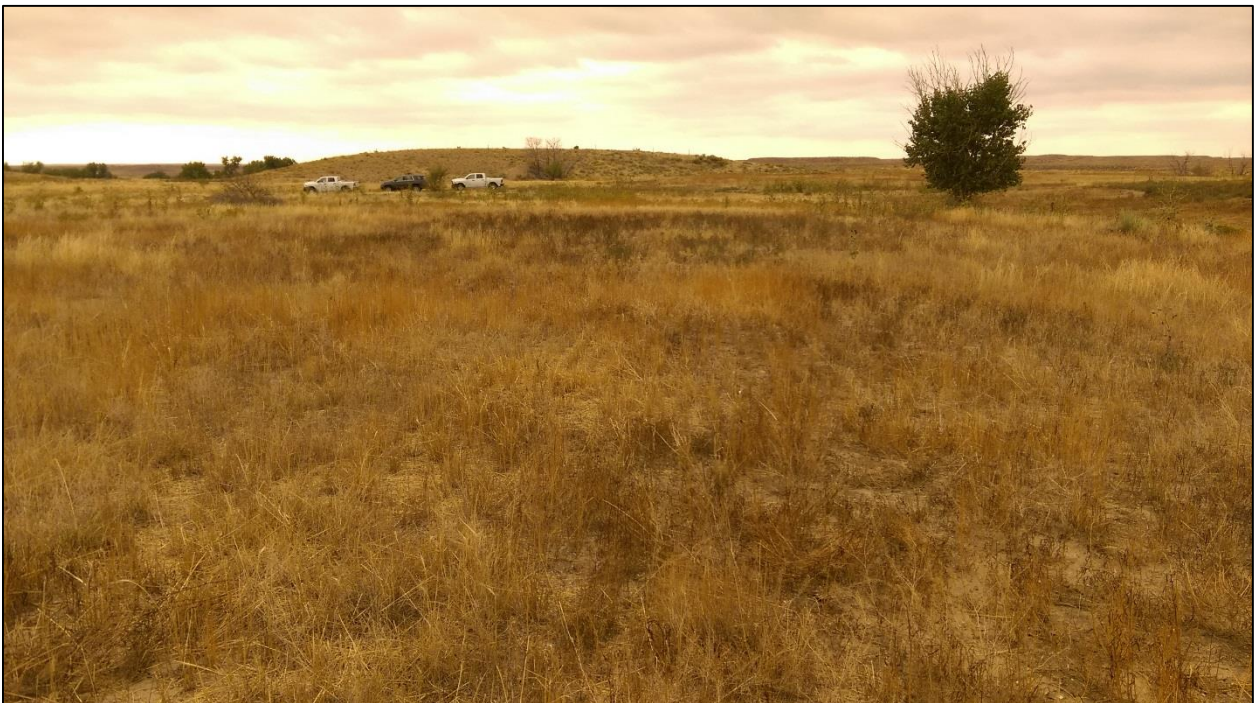
Photo 10. View looking south across southern portion of ridge (west of ridge with water tanks), showing good establishment of grasses.

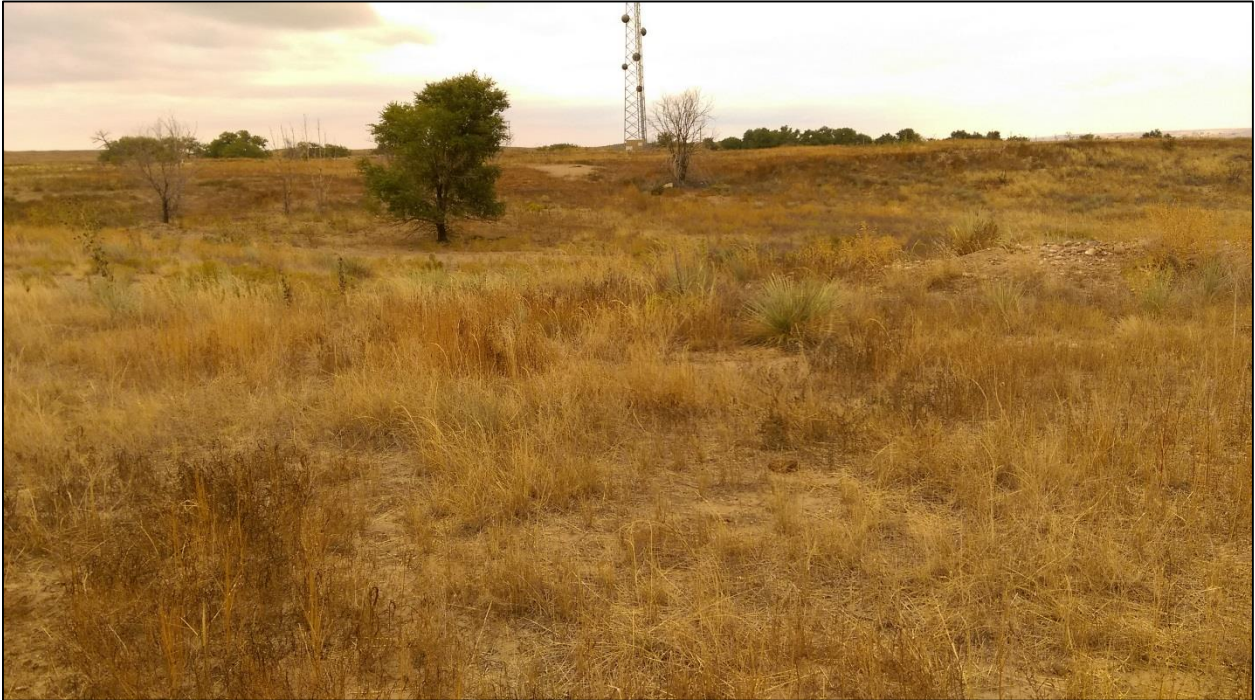
Photo 11. View looking west across southern portion of ridge (west of ridge with water tanks), showing good establishment of grasses.

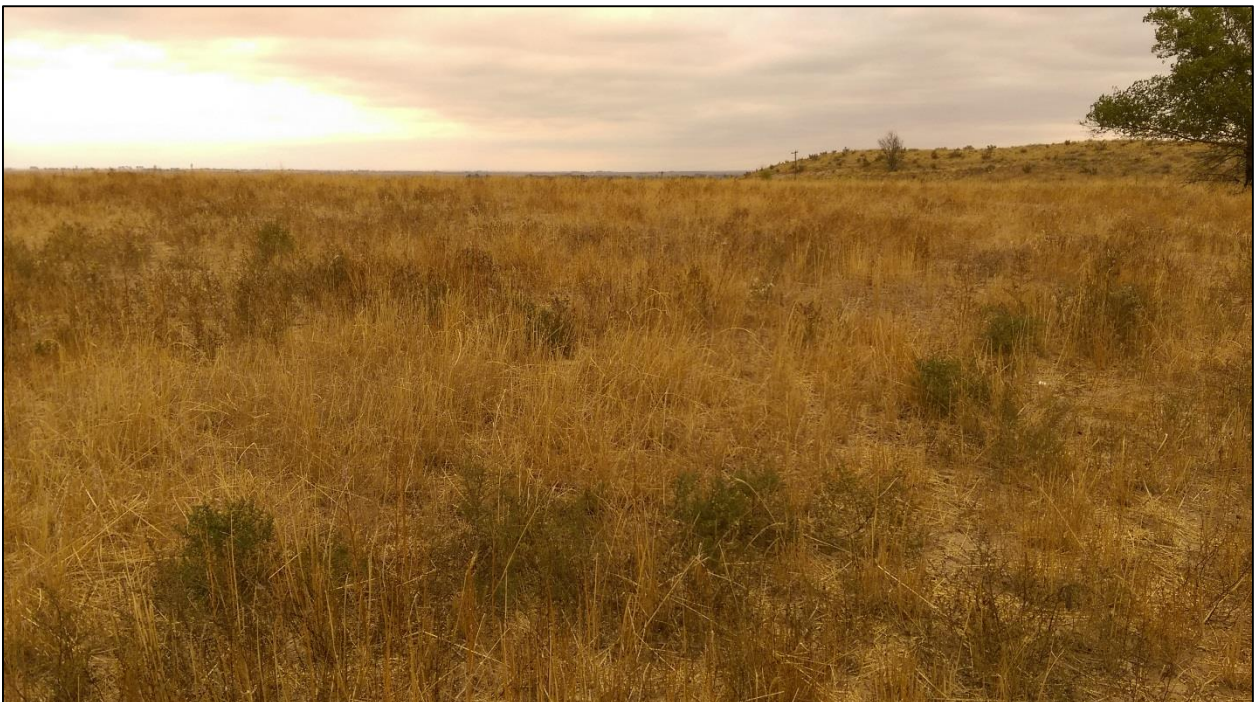
Photo 12. View looking northeast across southern portion of ridge (west of ridge with water tanks), showing good establishment of grasses.

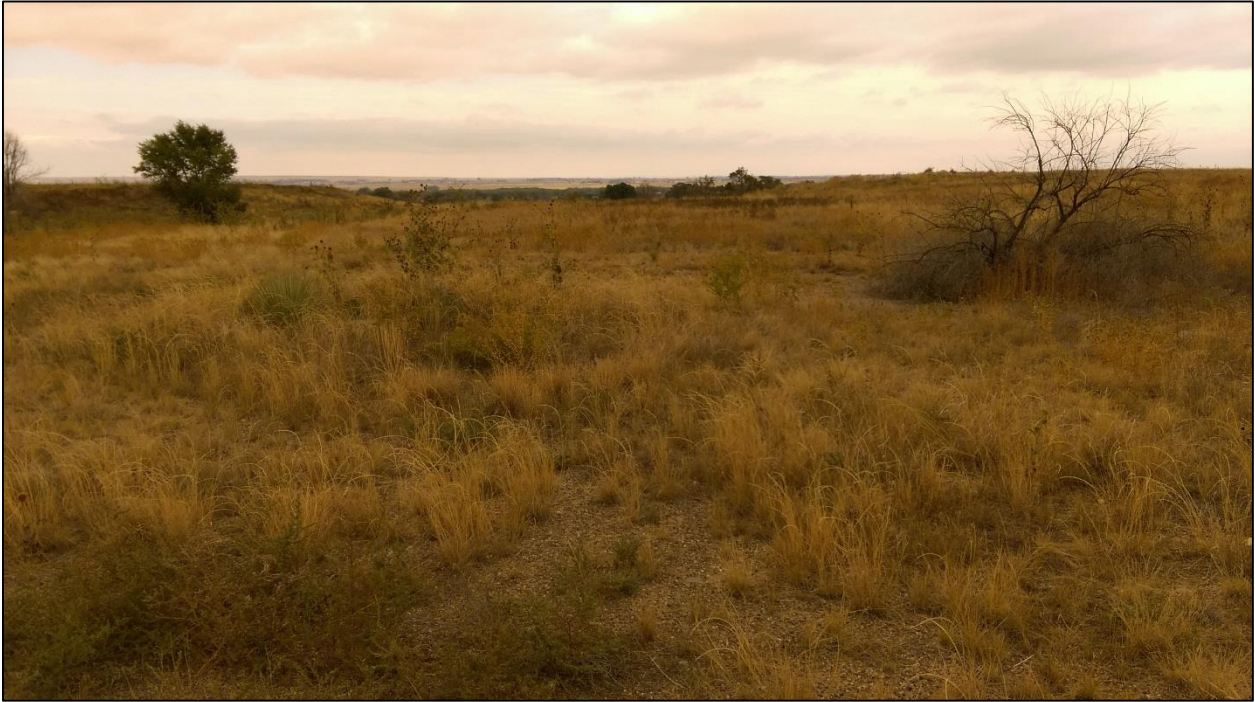
Photo 13. View looking southeast across southern portion of ridge (west of ridge with water tanks), showing good establishment of grasses.

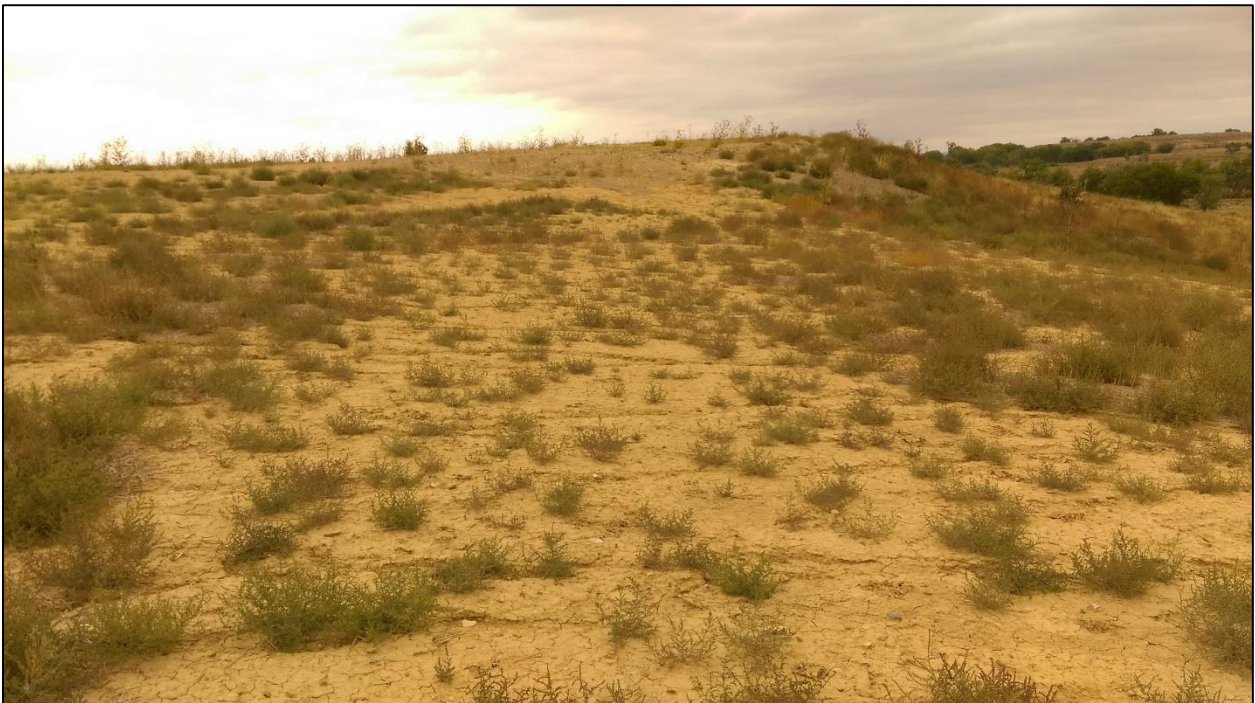
Photo 14. View looking east across eastern ridge (east of ridge with water tanks), showing sparse vegetative cover consisting primarily of weeds. This area may require reseeding.

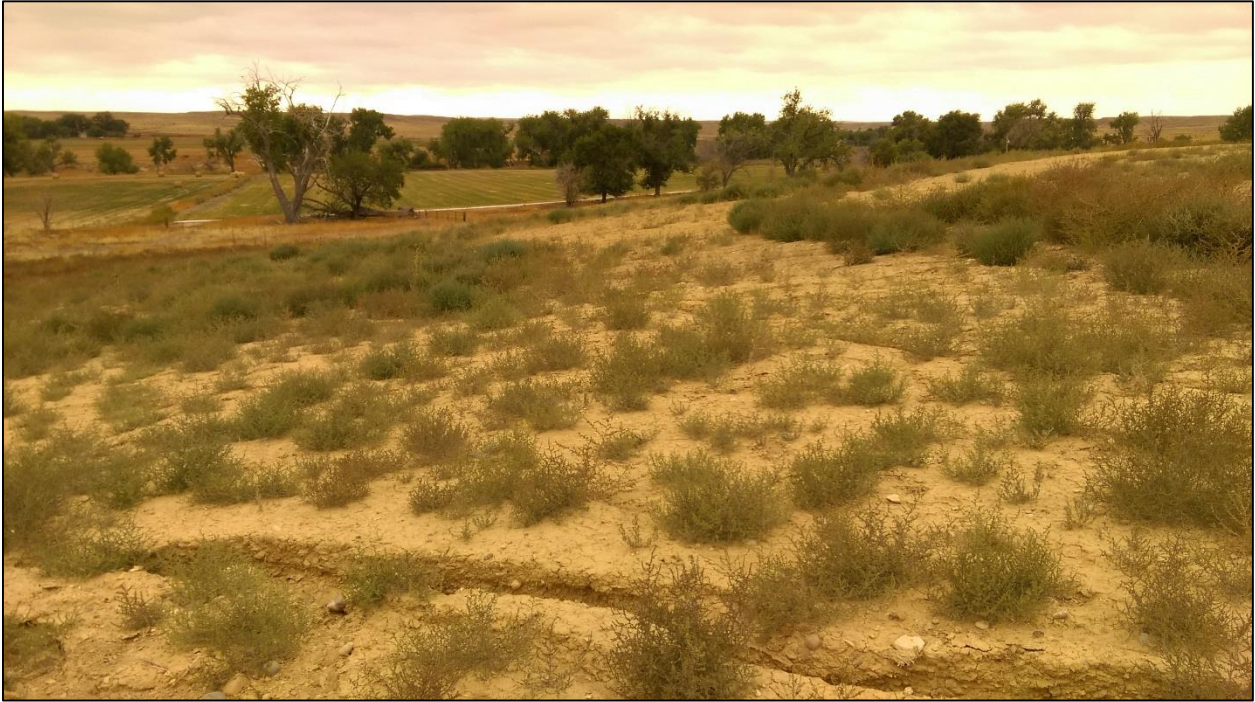
Photo 15. View looking south across eastern ridge (east of ridge with water tanks), showing sparse vegetative cover consisting primarily of weeds. This area may require reseeding.

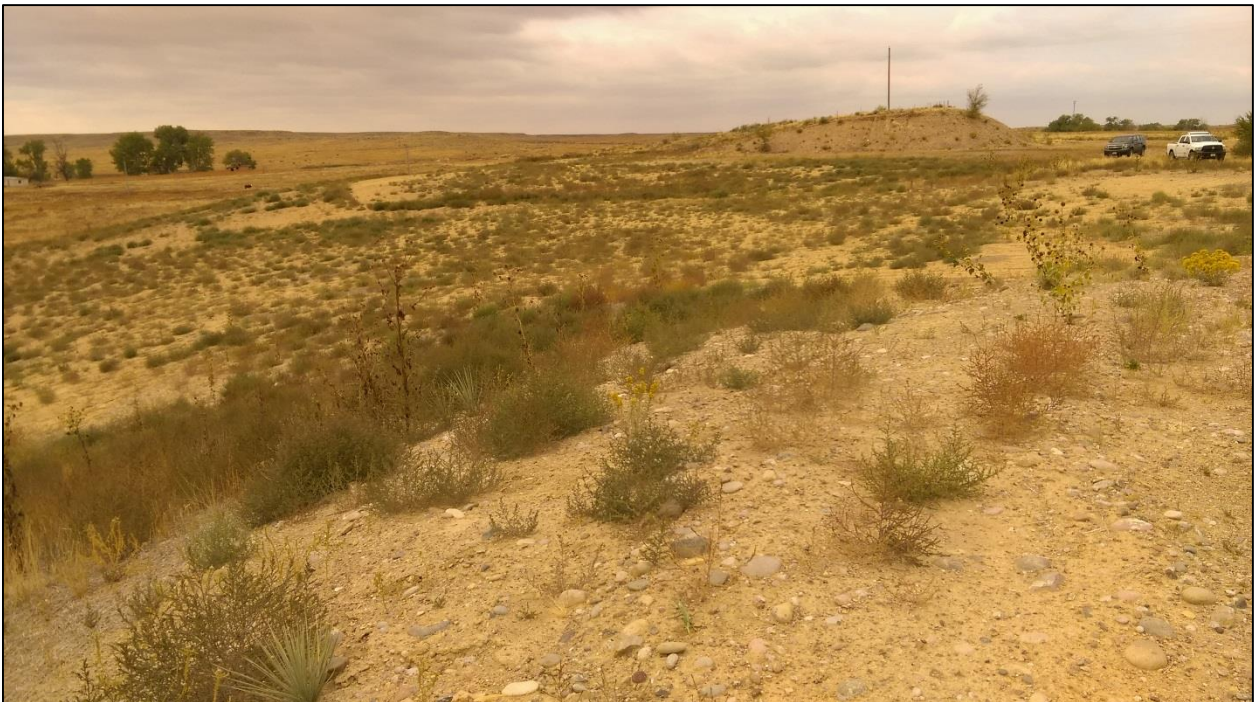
Photo 16. View looking west across eastern ridge (east of ridge with water tanks), showing sparse vegetative cover consisting primarily of weeds. This area may require reseeding.

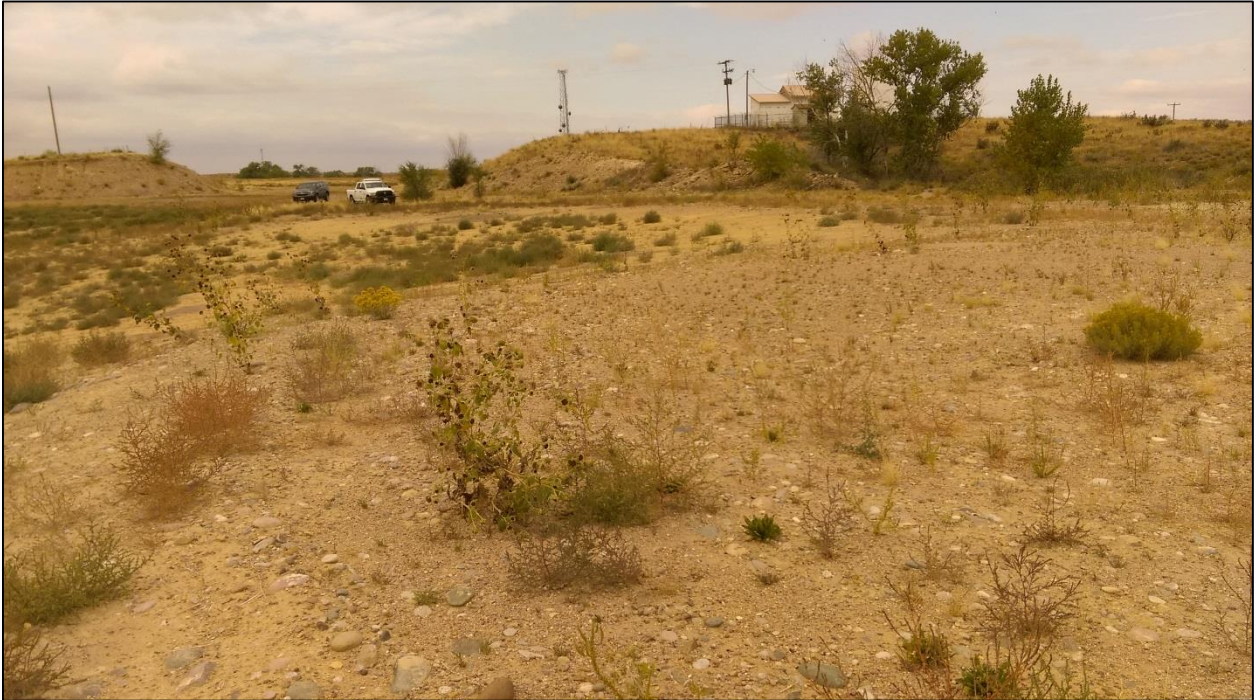
Photo 17. View looking northwest across eastern ridge (east of ridge with water tanks), showing sparse vegetative cover consisting primarily of weeds. This area may require reseeding.

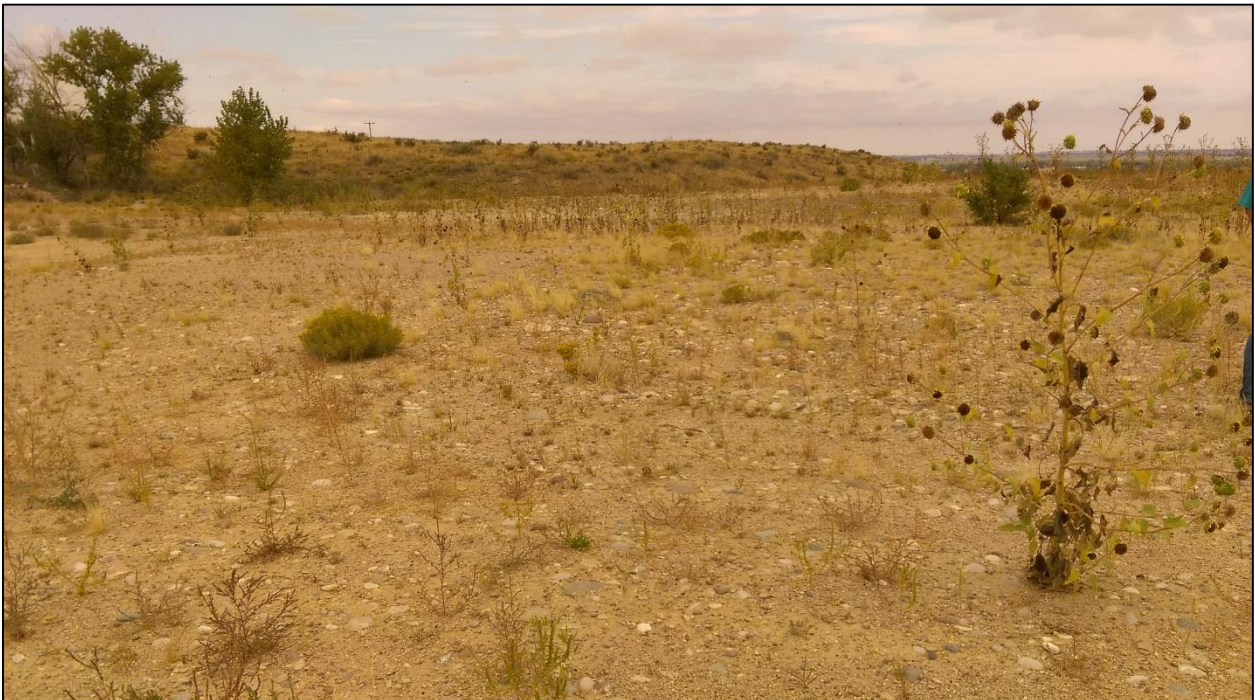
Photo 18. View looking north across eastern ridge (east of ridge with water tanks), showing sparse vegetative cover consisting primarily of weeds. This area may require reseeding.

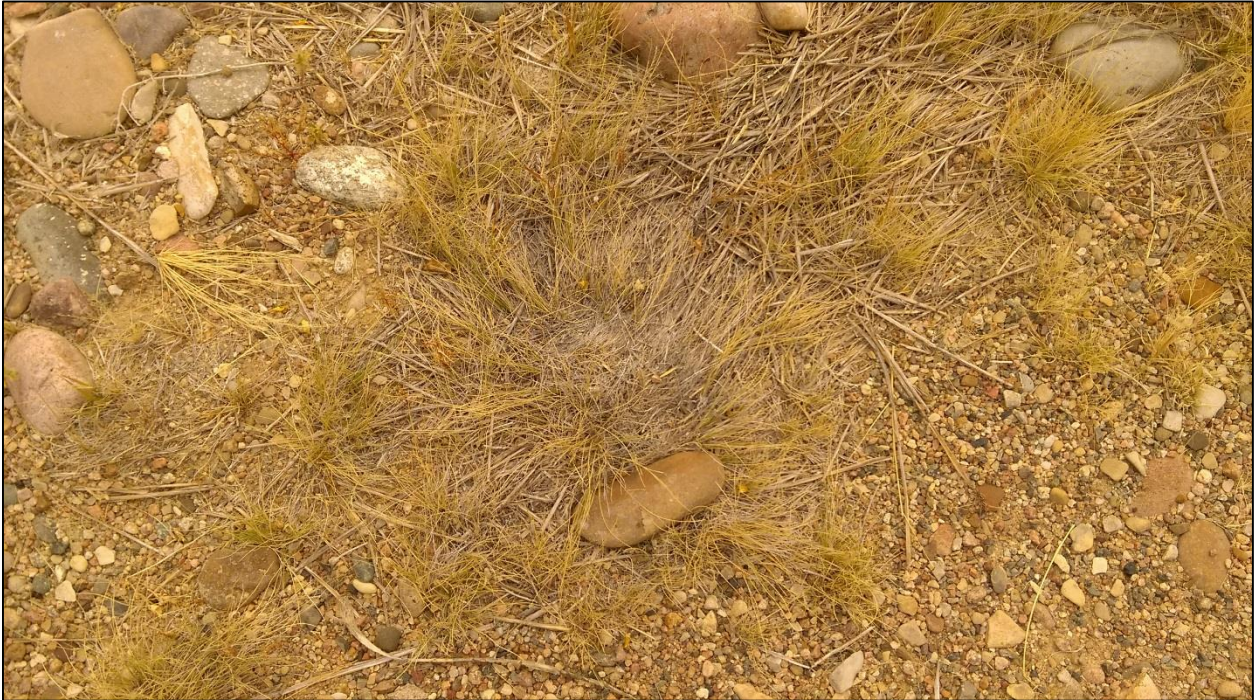
Photo 19. Close-up view of ground on eastern ridge (east of ridge with water tanks), showing some small patches of grass present in this area.

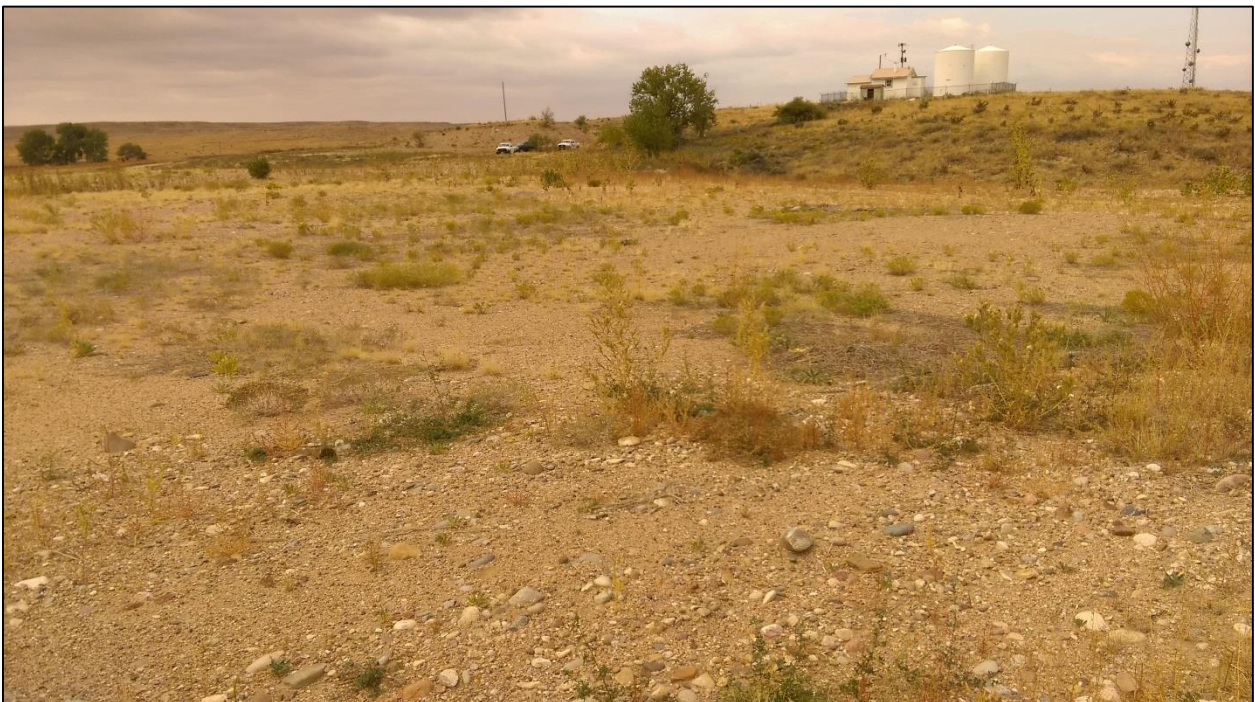
Photo 20. View looking west across eastern ridge (east of ridge with water tanks), showing sparse vegetative cover consisting primarily of weeds. This area may require reseeding.

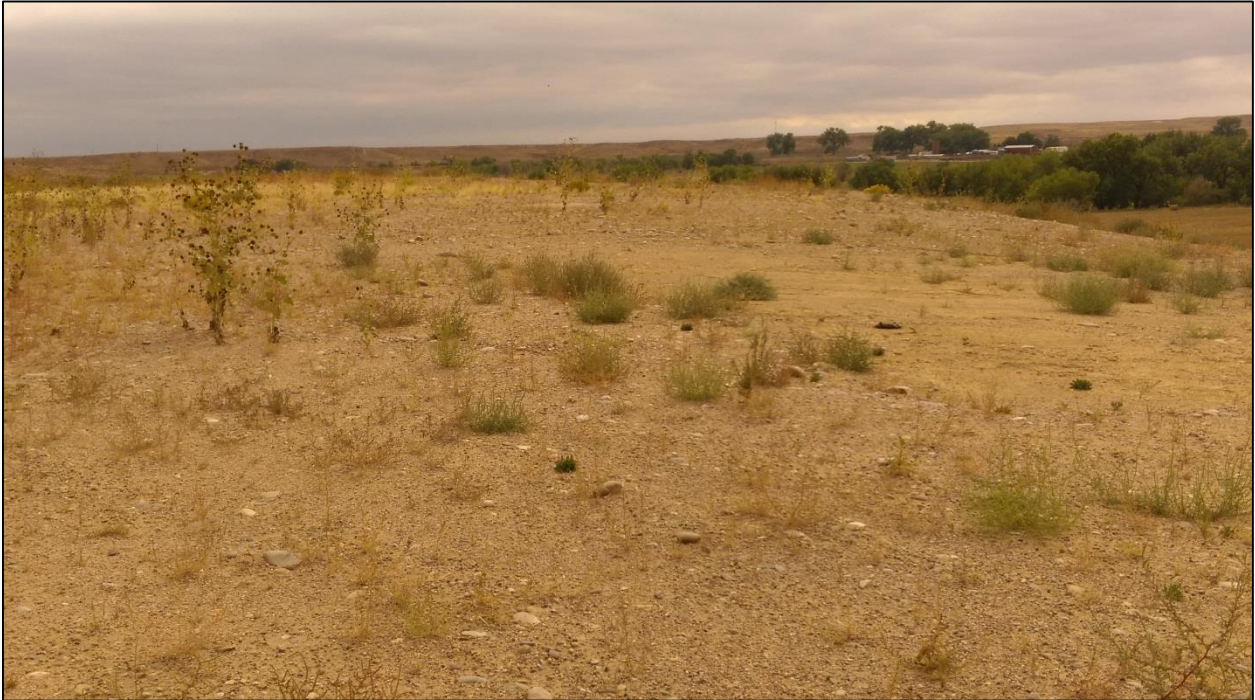
Photo 21. View looking east across eastern ridge (east of ridge with water tanks), showing sparse vegetative cover consisting primarily of weeds. This area may require reseeding.

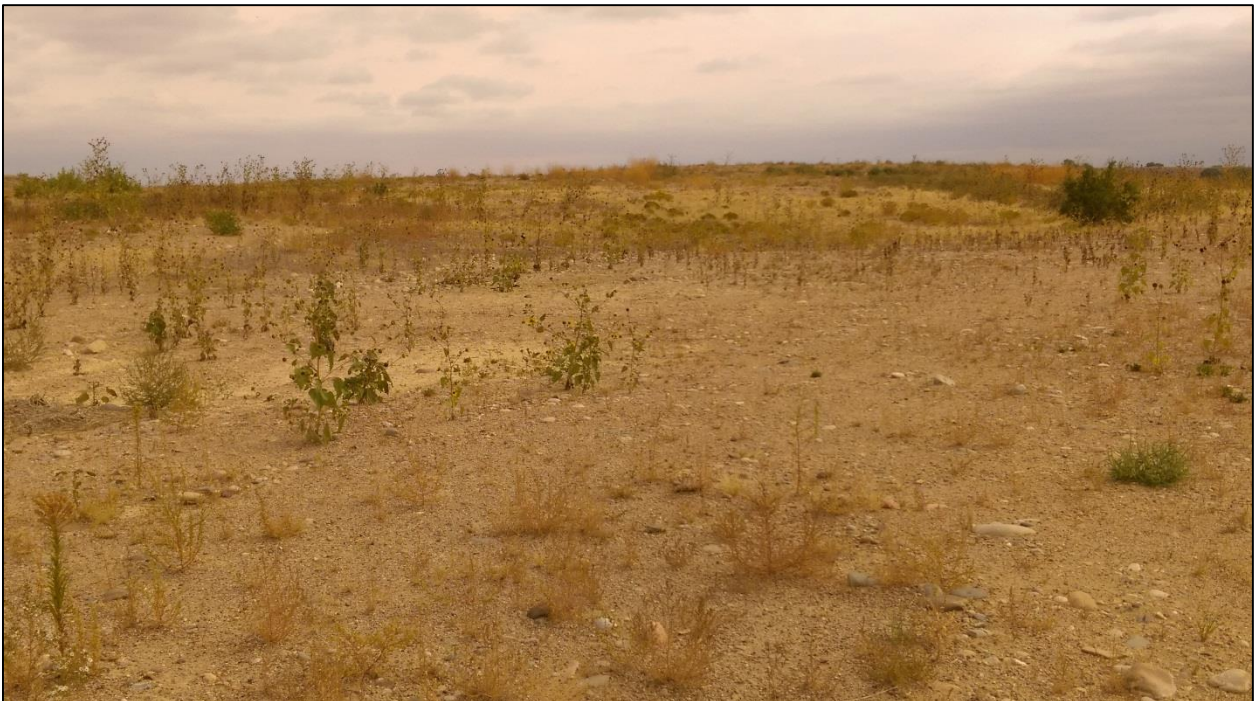
Photo 22. View looking northeast across eastern ridge (east of ridge with water tanks), showing sparse vegetative cover consisting primarily of weeds. This area may require reseeding.

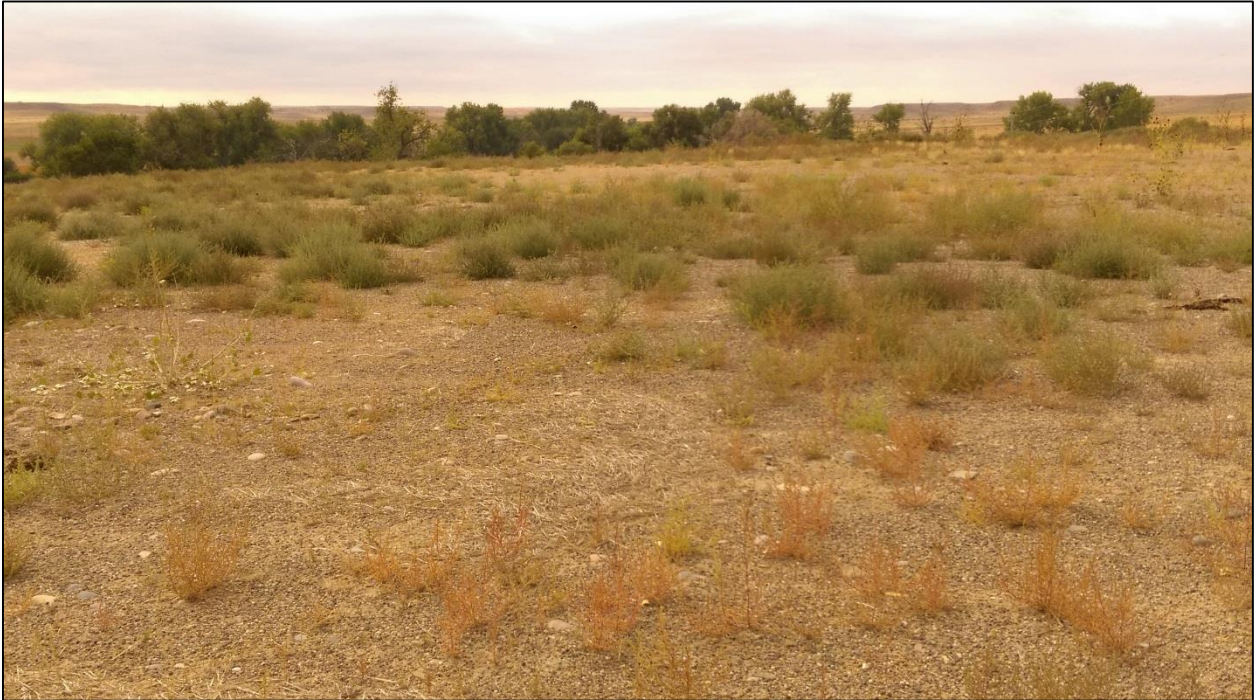
Photo 23. View looking south across eastern ridge (east of ridge with water tanks), showing sparse vegetative cover consisting primarily of weeds. This area may require reseeding.

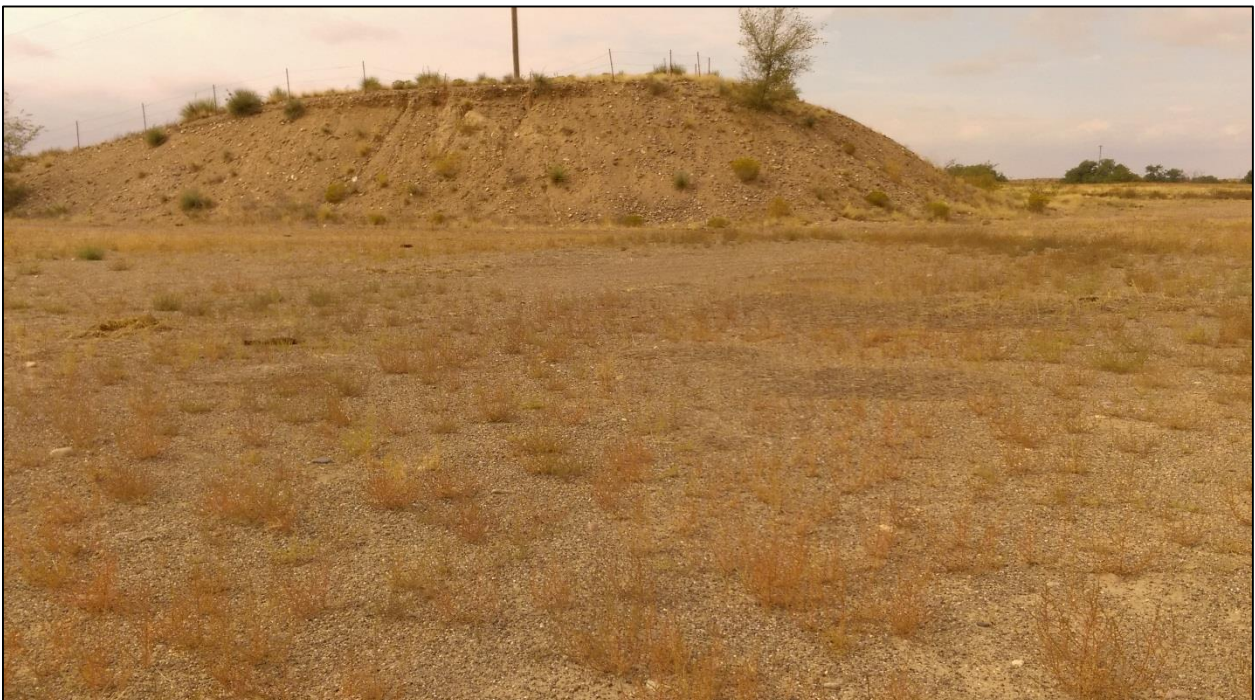
Photo 24. View looking west across eastern ridge (east of ridge with water tanks), showing sparse vegetative cover consisting primarily of weeds. This area may require reseeding.
