COLORADO DIVISION OF RECLAMATION, MINING AND SAFETY
MINERALS PROGRAM INSPECTION REPORT
PHONE: (303) 866-3567

MINE NAME: Argo Gravel Pit	MINE/PROSPECTING ID#: M-1978-267	MINERAL: Sand and Gravel	COUNTY: Otero
INSPECTION TYPE: Monitoring	INSPECTOR(S): Amy Eschberger and Wally Erickson	INSP. DATE: September 29, 2015	INSP. TIME: 10:45
OPERATOR: Otero County	OPERATOR REPRESENTATIVE: Lex Nichols and Darren Garcia	TYPE OF OPERATION: 112c - Construction Regular Operation

M1978-267 / Argo Gravel Pit / Otero County

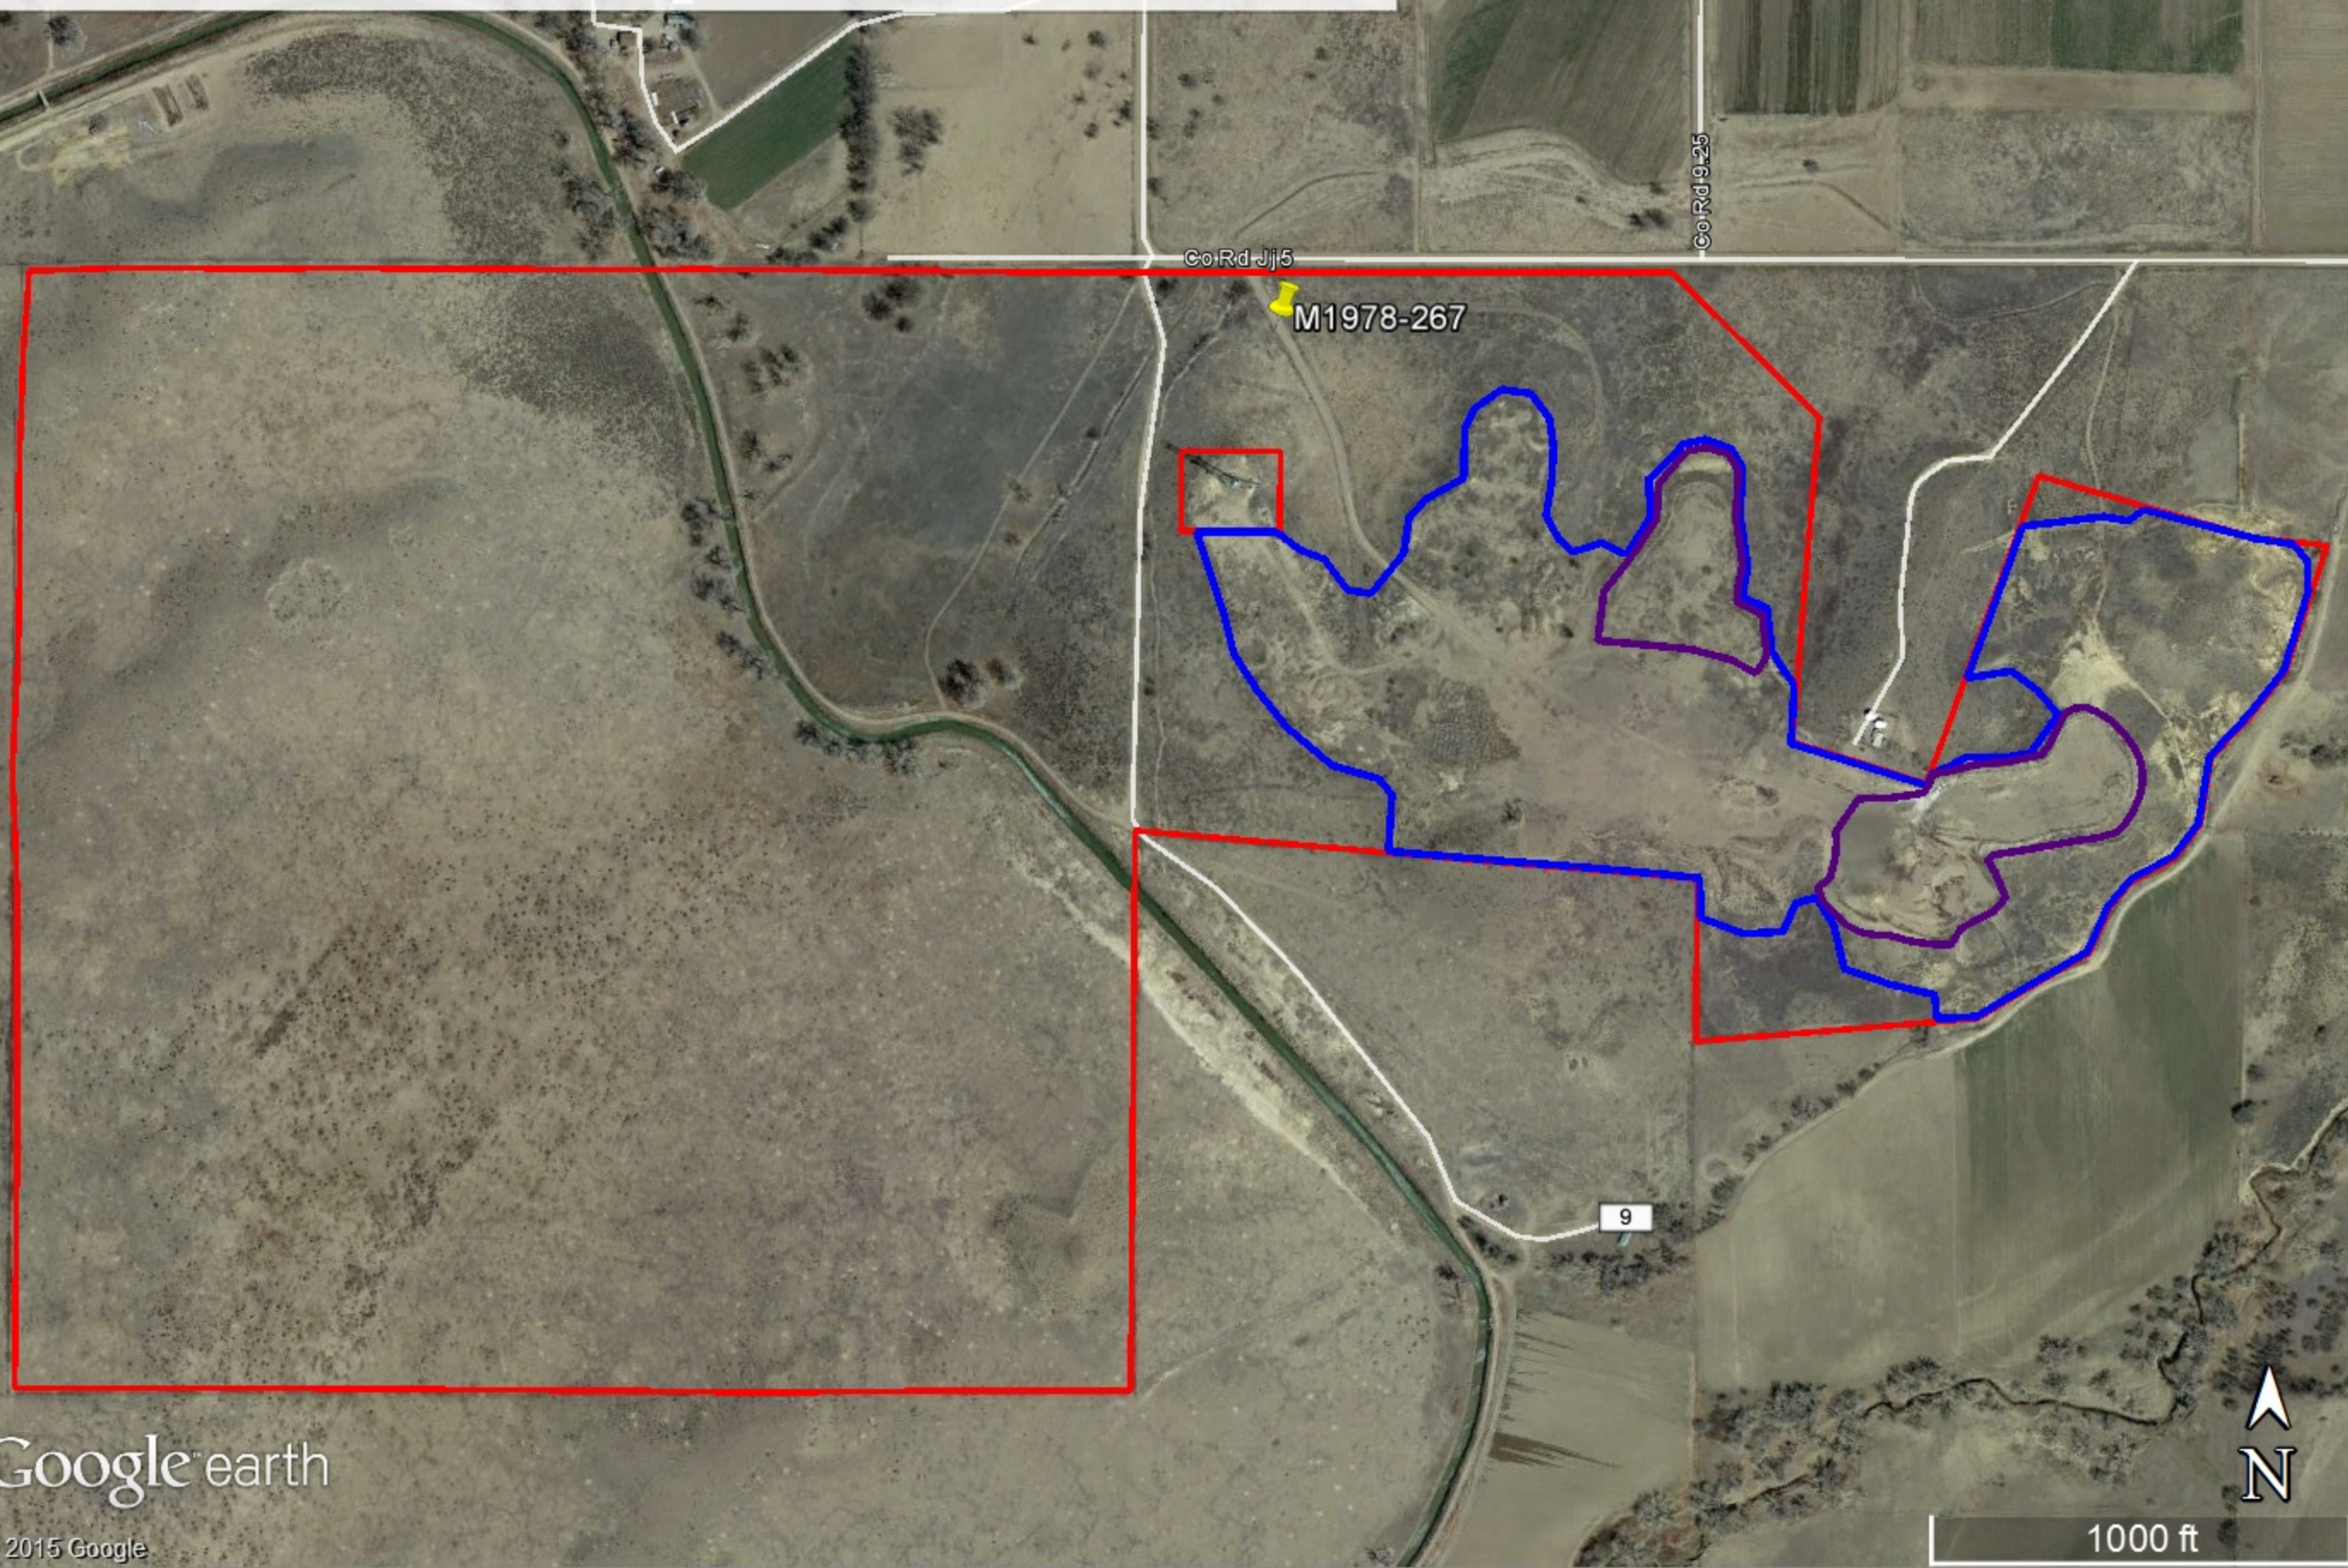
Blue Outline = 41.5 acres = Disturbed Area

Purple Areas = 7.8 acres = Approximate Total Area to be Interseeded (2.8 acres + 5 acres)

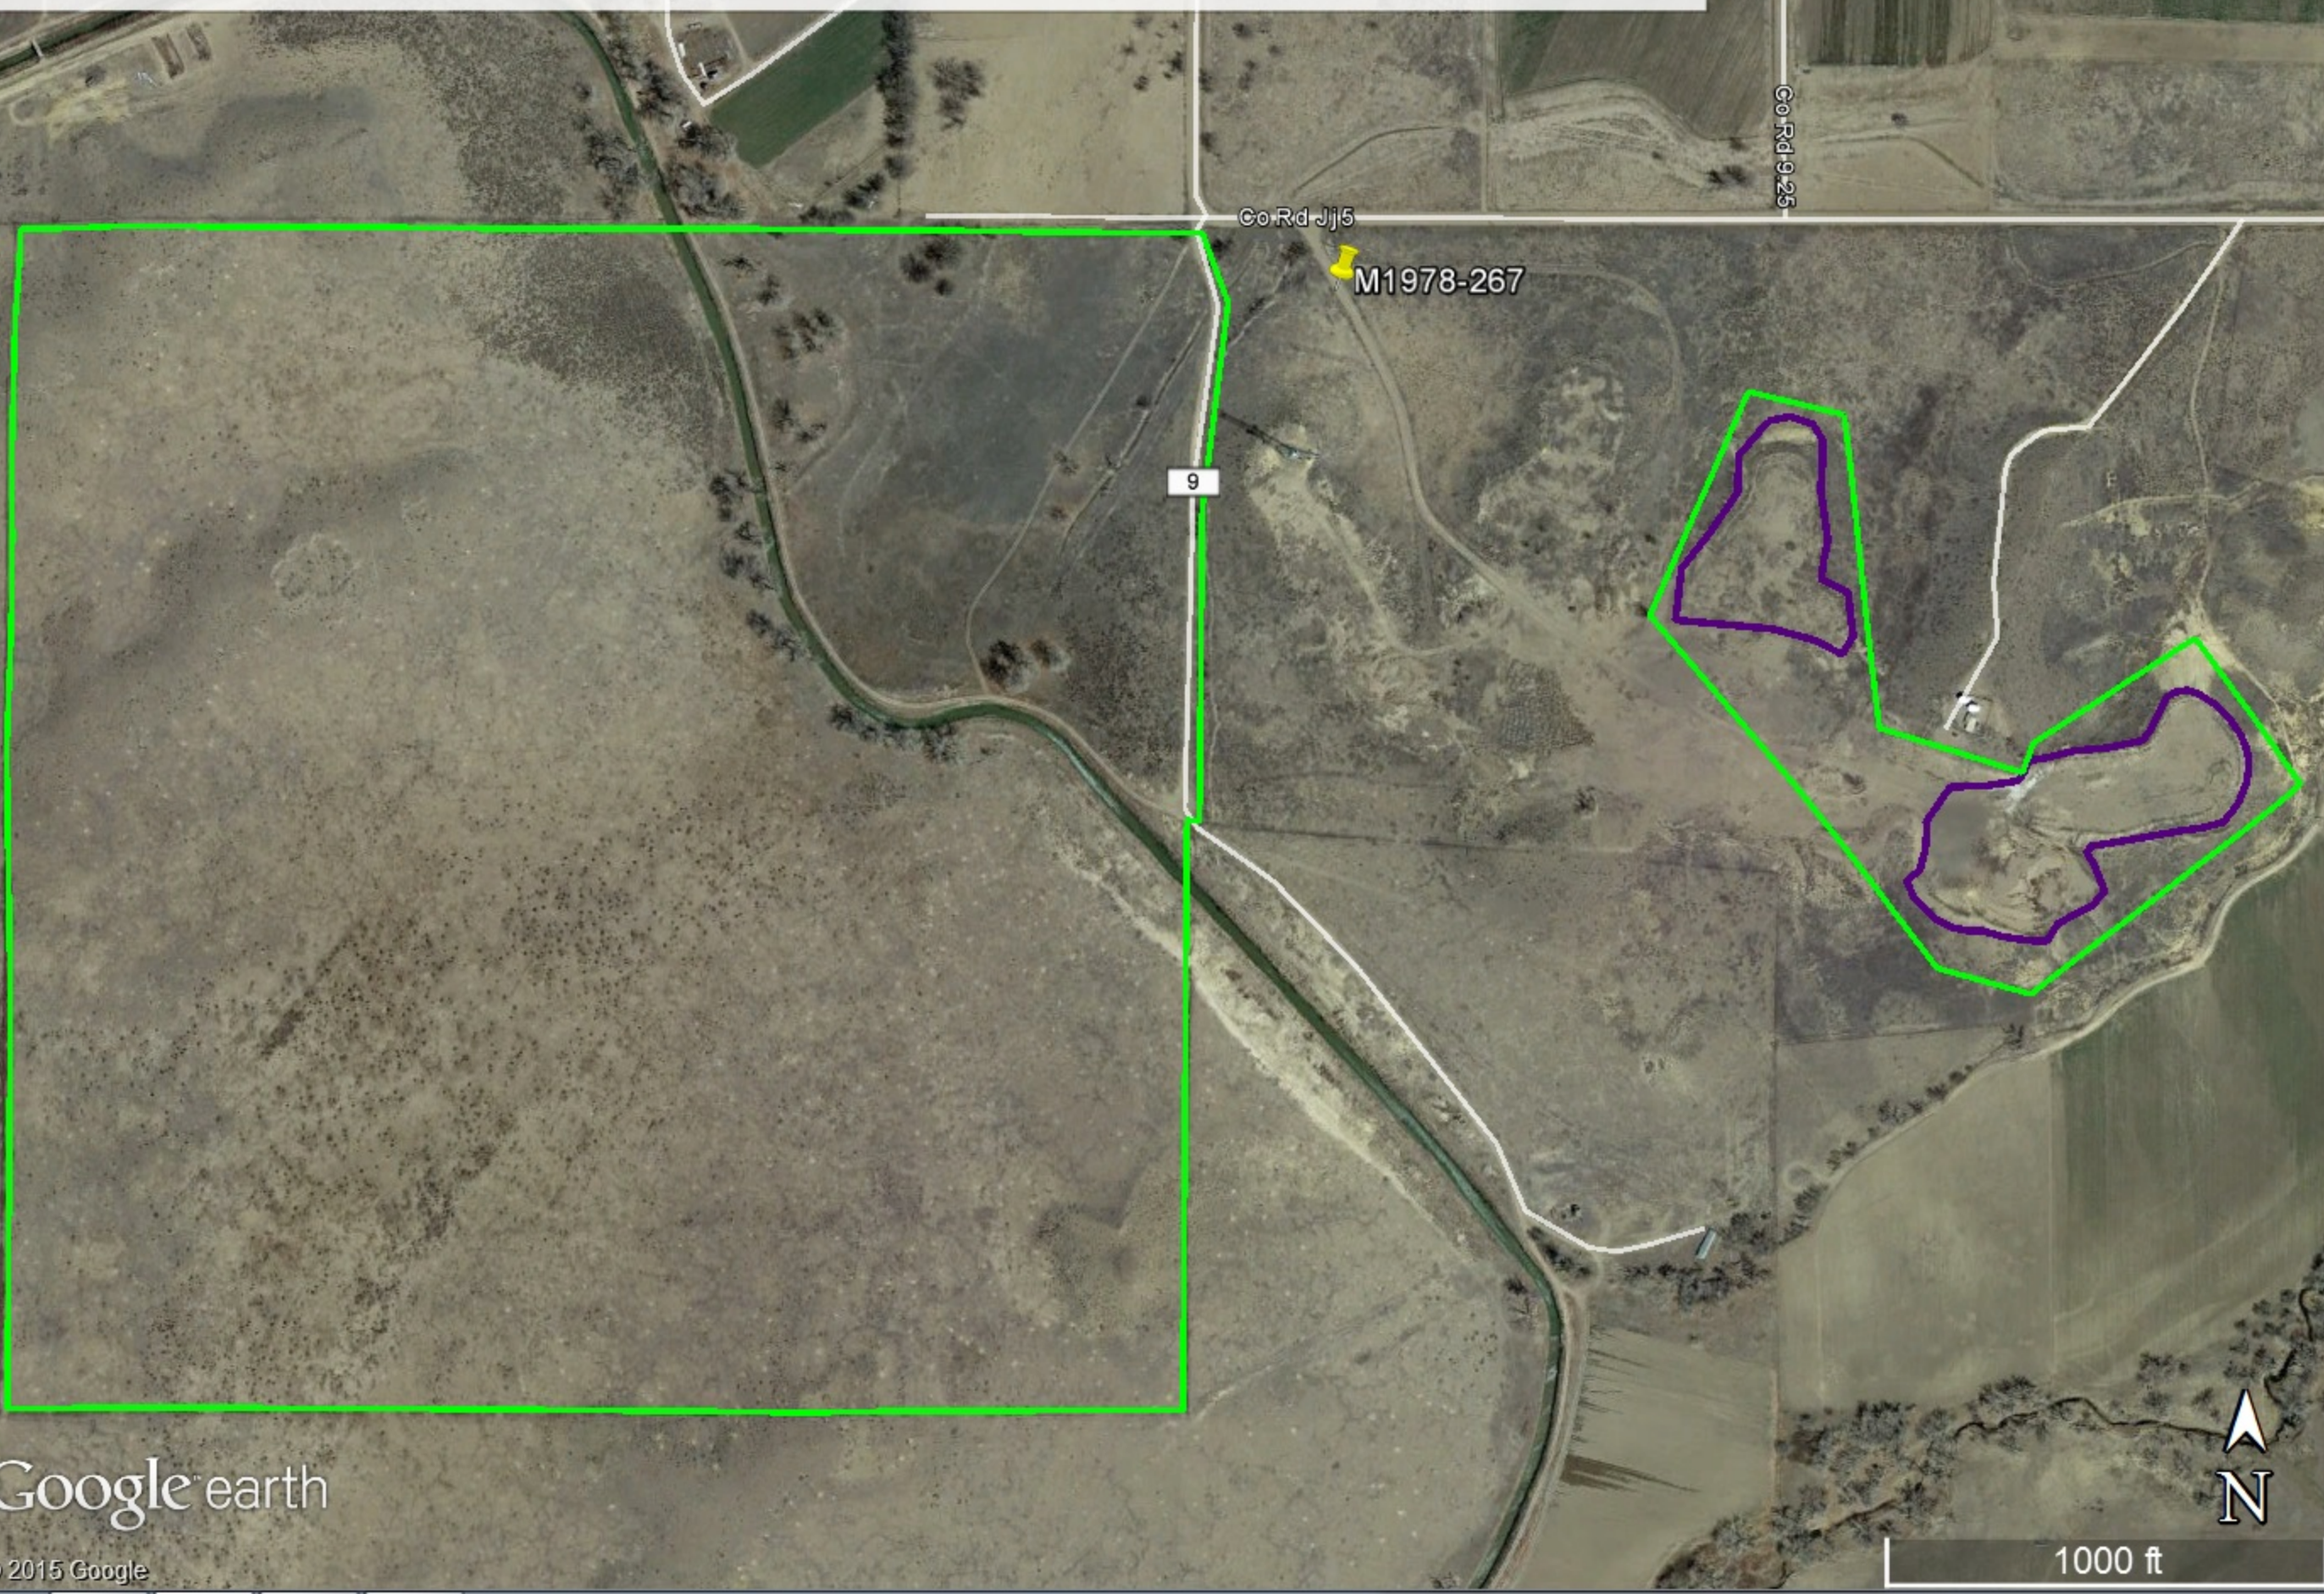
M1978-267 / Argo Gravel Pit / Otero County

Green Outline = 177 acres = Potential New Permit Area (160 acres + 17 acres) after Reclaimed Areas Released
Purple Outline = 7.8 acres = Approximate Total Area to be Interseeded (2.8 acres + 5 acres)
