COLORADO DIVISION OF RECLAMATION, MINING AND SAFETY
MINERALS PROGRAM INSPECTION REPORT
PHONE: (303) 866-3567

MINE NAME: Idarado Mining Co	MINE/PROSPECTING ID#: M-1977-403-HR	MINERAL: Lead, zinc, copper, cadmium and gold	COUNTY: San Miguel
INSPECTION TYPE: Monitoring	INSPECTOR(S): Lucas J. West, Russ Means	INSP. DATE: October 21, 2015	INSP. TIME: 09:30
OPERATOR: Idarado Mining Company	OPERATOR REPRESENTATIVE: Larry Fiske	TYPE OF OPERATION: 112d-3 - Designated Mining Operation

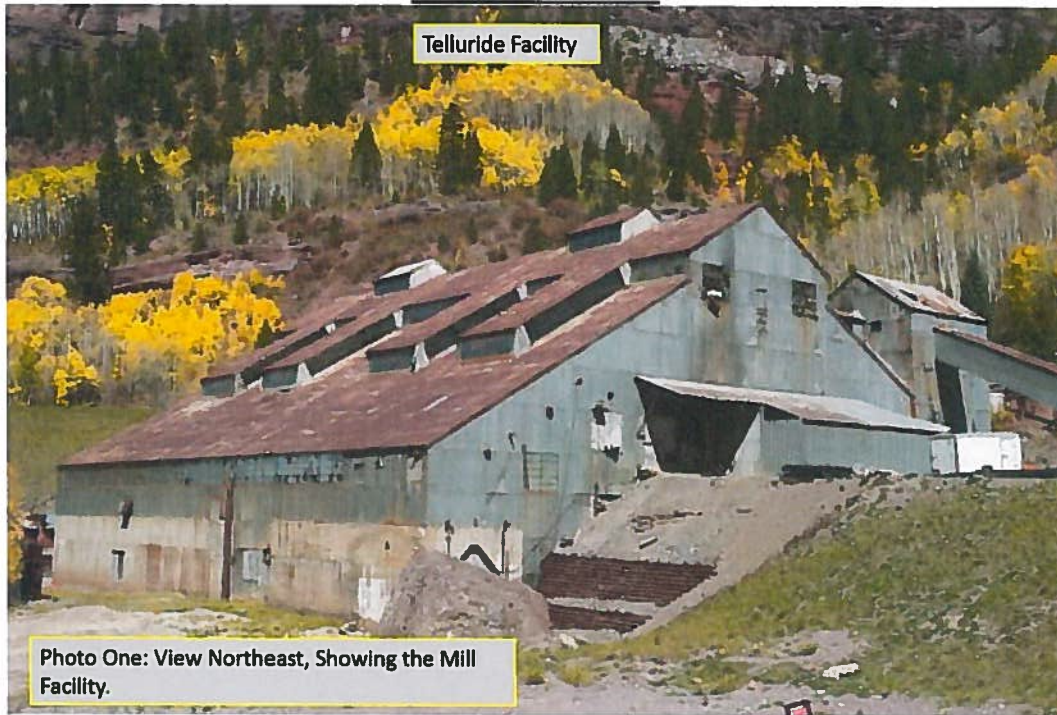
On site discussions were held at the Pandora Mill site regarding the future of the mill building as seen in Photo One. The current reclamation plan calls for the demolition and removal of the historic structure, However the Operator and representatives from San Miguel County have been in contact about the preservation of the facility for its historic and aesthetic value. The Operator completed all environmental hazard mitigation of the facility in 2014 including all asbestos removal, and also continues to carry out regular maintenance on the facility. The mill building has been evaluated for its structural integrity. A primary issue has been identified is that the facility will require a new roof among other maintenance activities to ensure the preservation of the building.

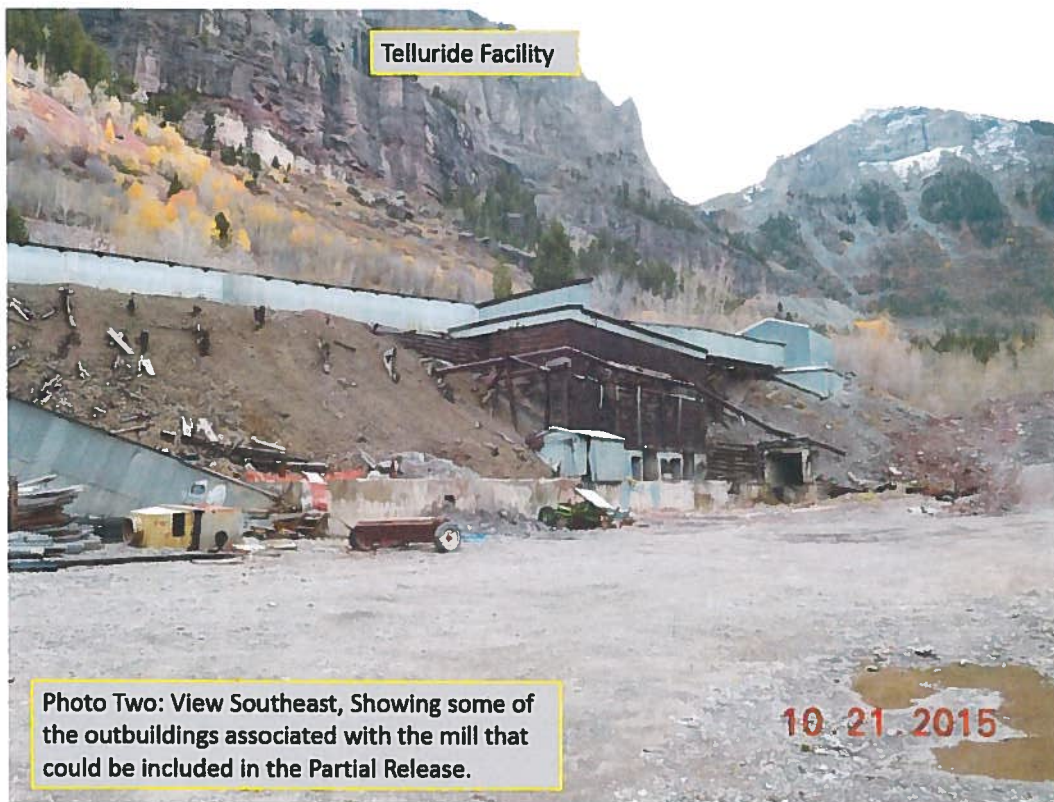
Discussions included the possibility of releasing the mill facility and some of the surrounding structures, shown in Photo Two to be entrusted to the care of a third party entity consisting of representatives from Nemont Mining Company, San Miguel County and the Historical Preservation society. The Division concluded that a Partial Release would be considered providing the proper documentation. The Division may require the following to evaluate the proposal being considered;

1. A written plan of any further repairs and or stabilization work to be completed for the preservation of the facility as it stands
2. A detailed list of the facilities to be removed and reclaimed or left on site in any Partial Release
3. A map showing the area of the existing permit that is to be released
4. Written documentation clearly identifying the third party entity accepting liabilities and ongoing maintenance requirements for the mill facility in perpetuity

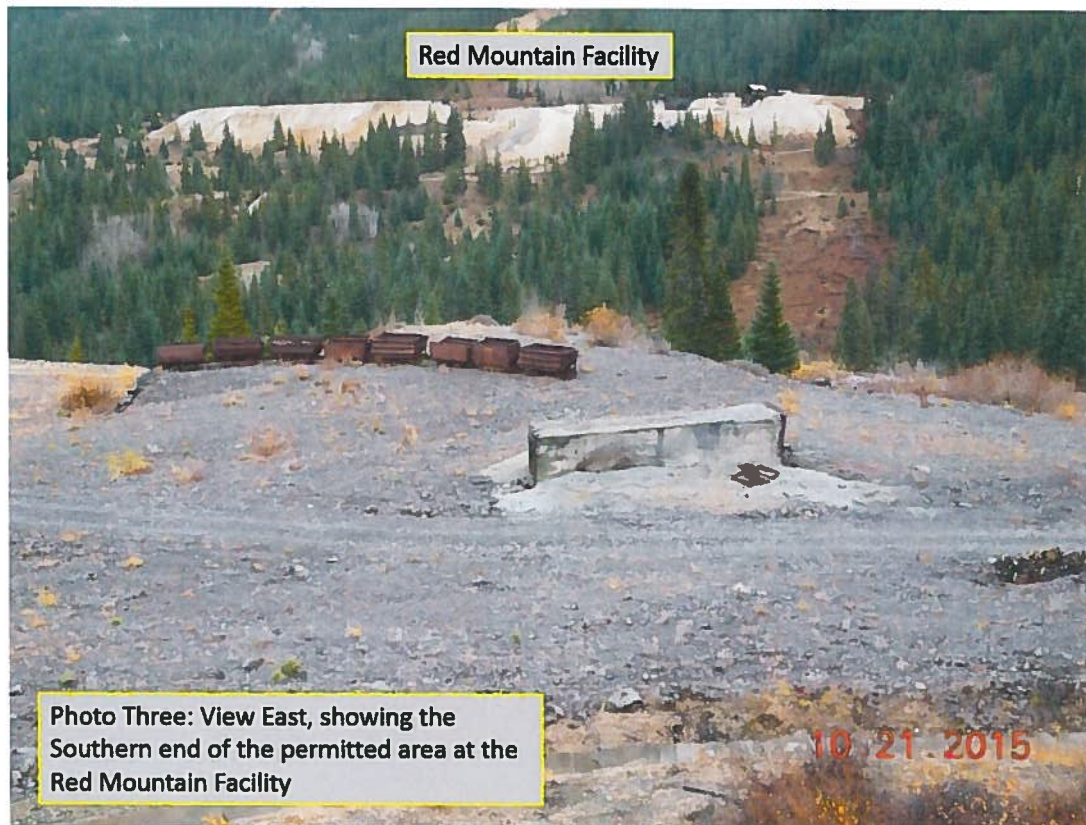
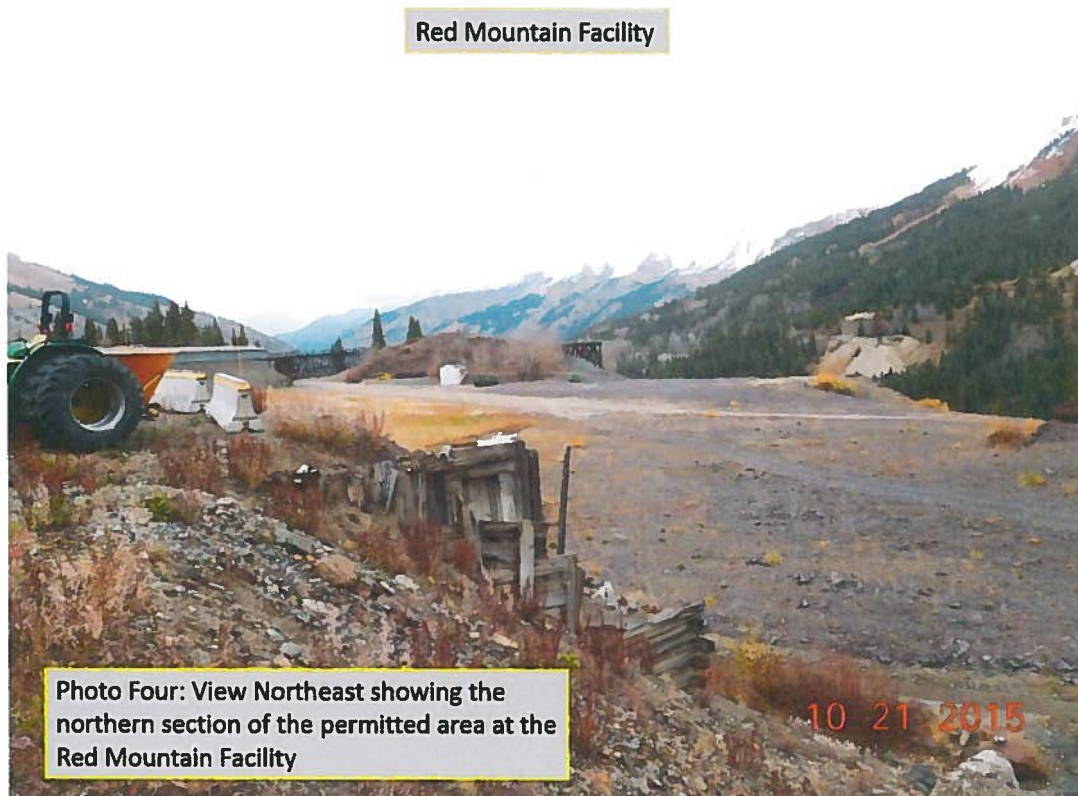
The Red Mountain facility Shown in Photos Three and Four consists of a smaller permitted area on the East and West sides of Highway 550 approximately 11 Miles South of Ouray. The Red Mountain facility is also included in the Consent Decree and Remedial Action Plan. It is also simultaneously regulated by CDPHE and WQCD.

The overall footprint of the Red Mountain Facility was in good condition, with no excess trash or debris. No noxious weeds were observed, and the site exhibited positive drainage with no erosional issues observed. No problems or possible violations were observed at this time.

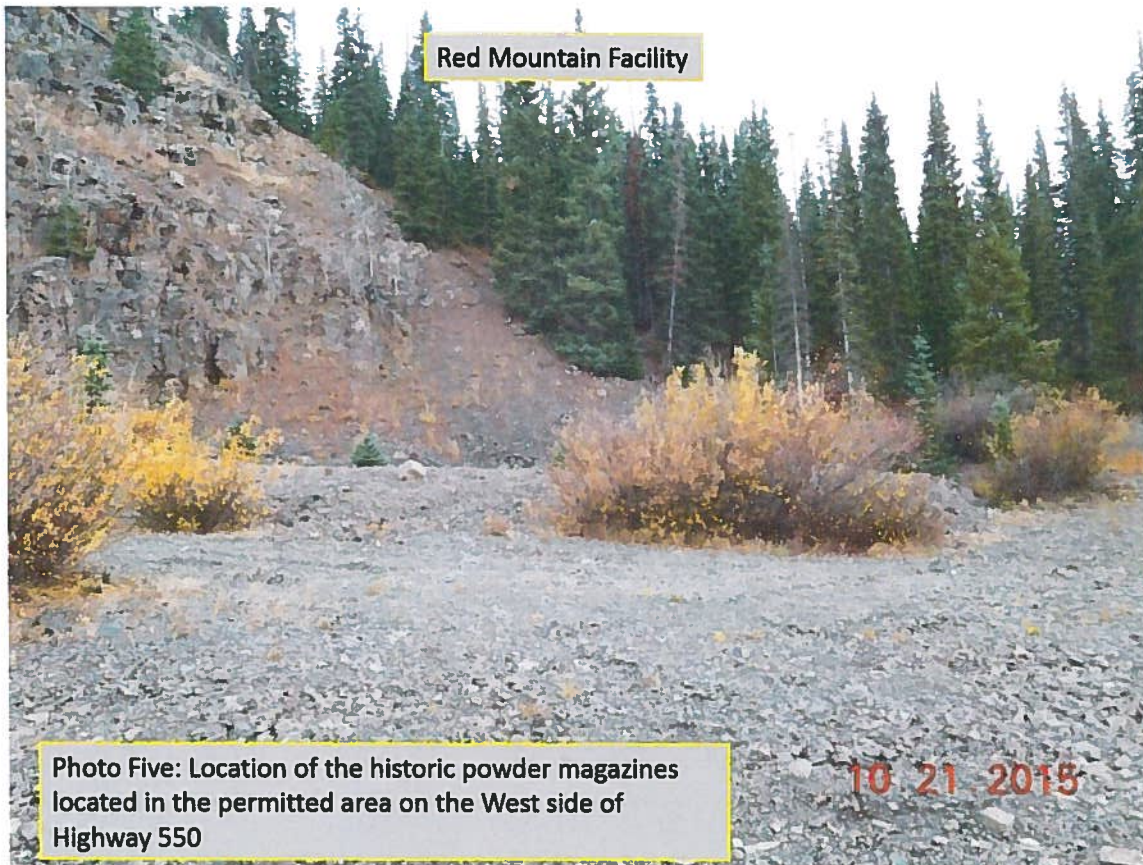
The site has experienced ongoing maintenance and reclamation activities in the form of the demolition and removal of several structures within the permit area. Such structures include historic powder magazines, location shown in Photo Five, the Transformer building, the geology building as well as the overhead power lines and their associated poles that are no longer in service. The Operator has also continued work on the foundation of the mill facility to prevent the structure from impounding water. Discussions took place regarding the construction of a new shop facility to better house the necessary staff and equipment on site.
