COLORADO DIVISION OF RECLAMATION, MINING AND SAFETY MINERALS PROGRAM INSPECTION REPORT

MINE NAME: King Mountain Sand & Gravel Mine	MINE/PROSPECTING ID#: M-1978-314	MINERAL: Sand and gravel	COUNTY: Routt
INSPECTION TYPE: Surety Release Inspection	INSPECTOR(S): Amy C. Yeldell	INSP. DATE: October 28, 2015	INSP. TIME: 14:30
OPERATOR: King Mountain Gravel, LLC	OPERATOR REPRESENTATIVE: Theresa Cain	TYPE OF OPERATION: 112c - Construction Regular Operation

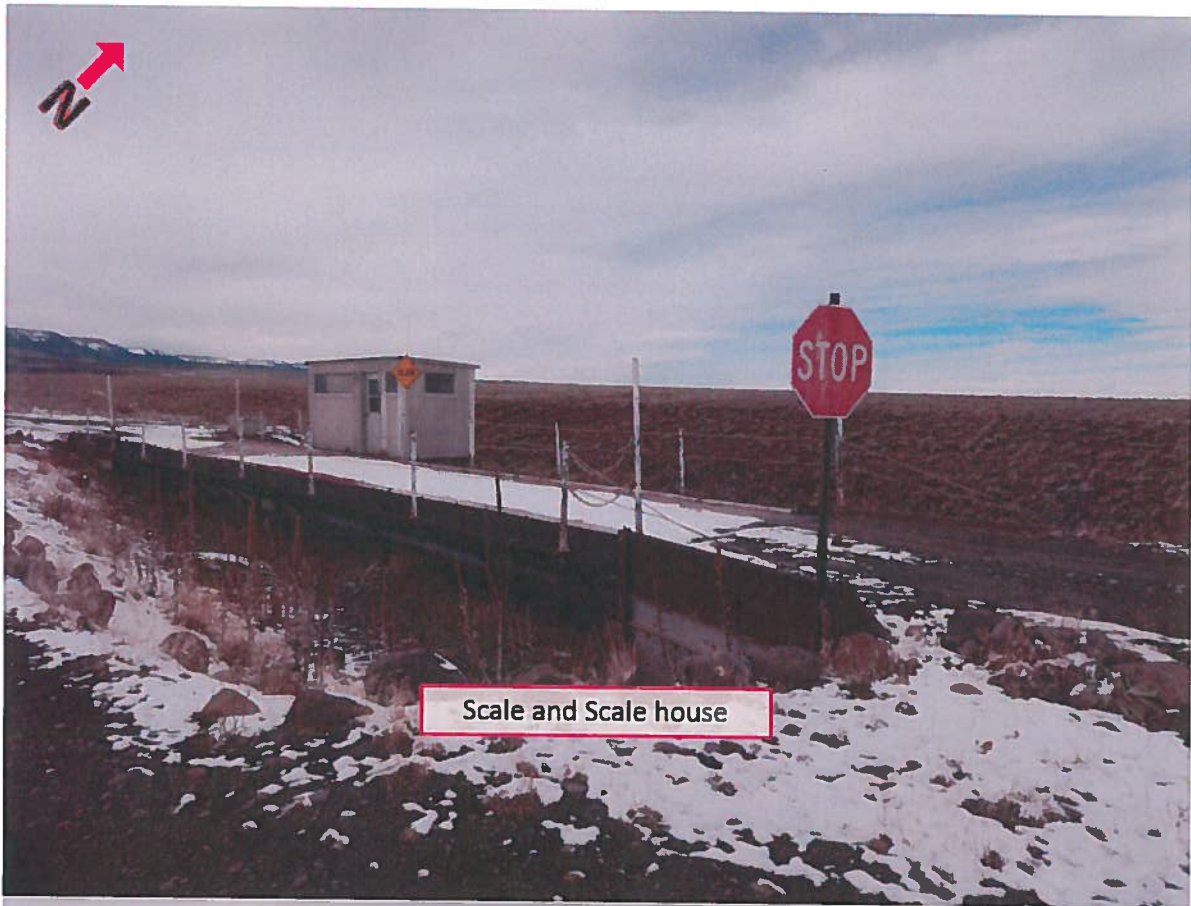
A permanent load scale and scale house on a cement foundation are located near the pit entrance.

Scale and Scale house

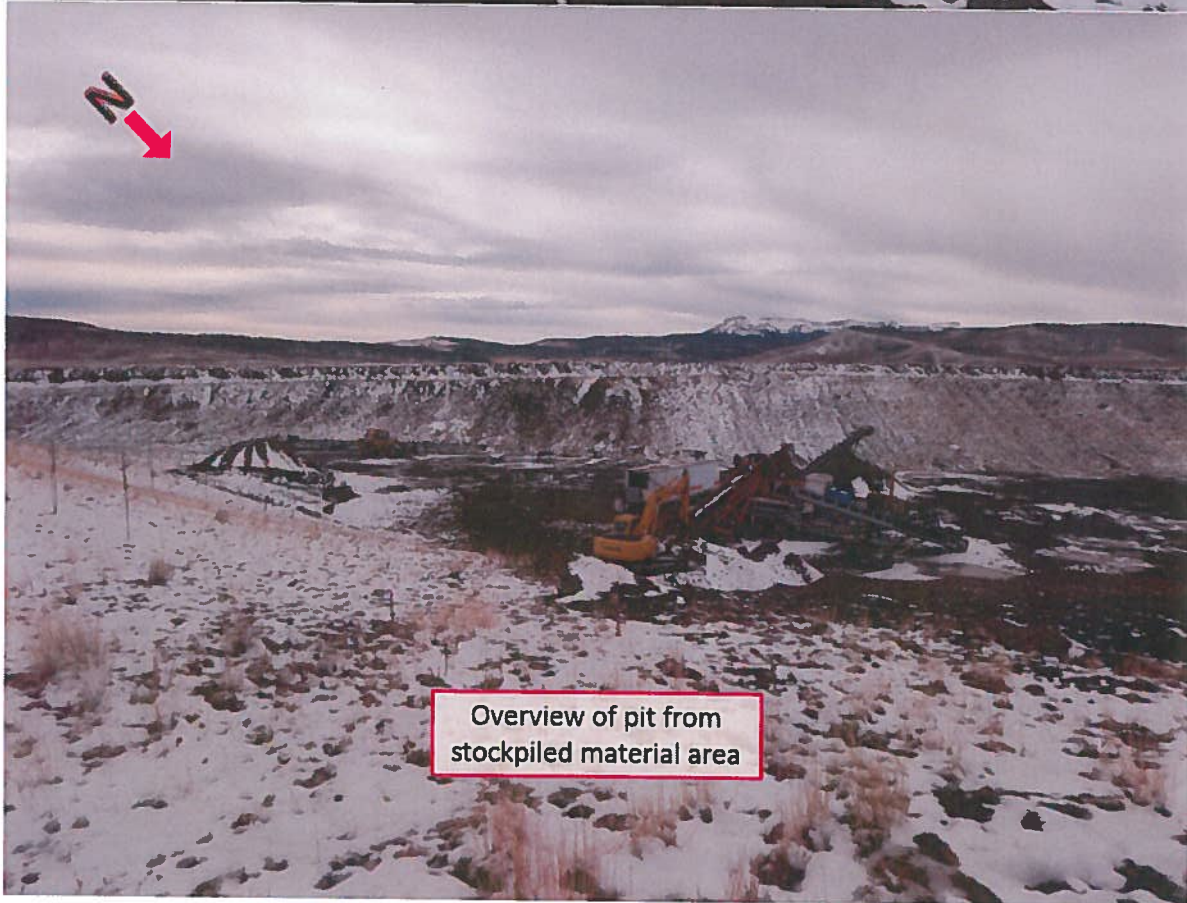
Most slopes appeared to be stable however there was some snow cover and staff could not fully evaluate stability at this time. Several stockpiles of material and topsoil were observed. All of which are stable and well organized.

Overview of pit from
stockpiled material area

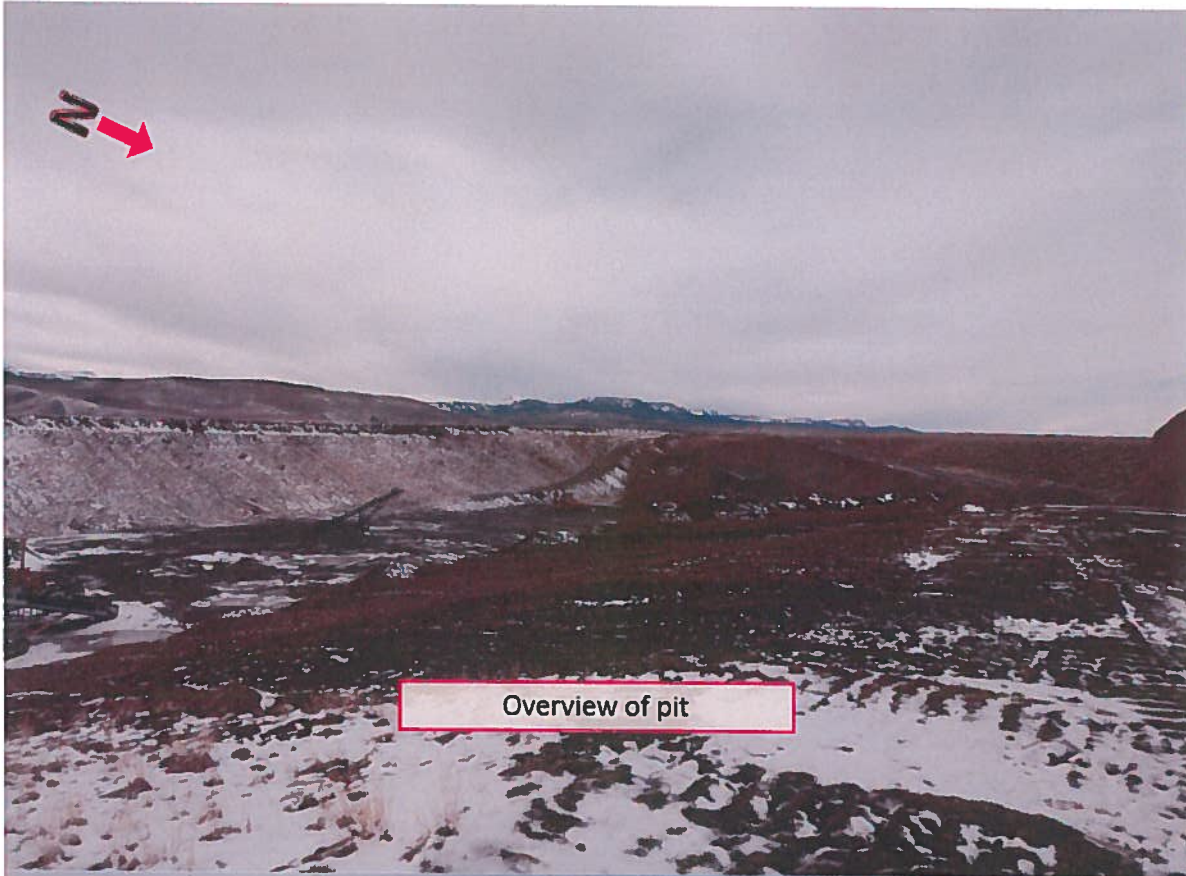
Overview of pit

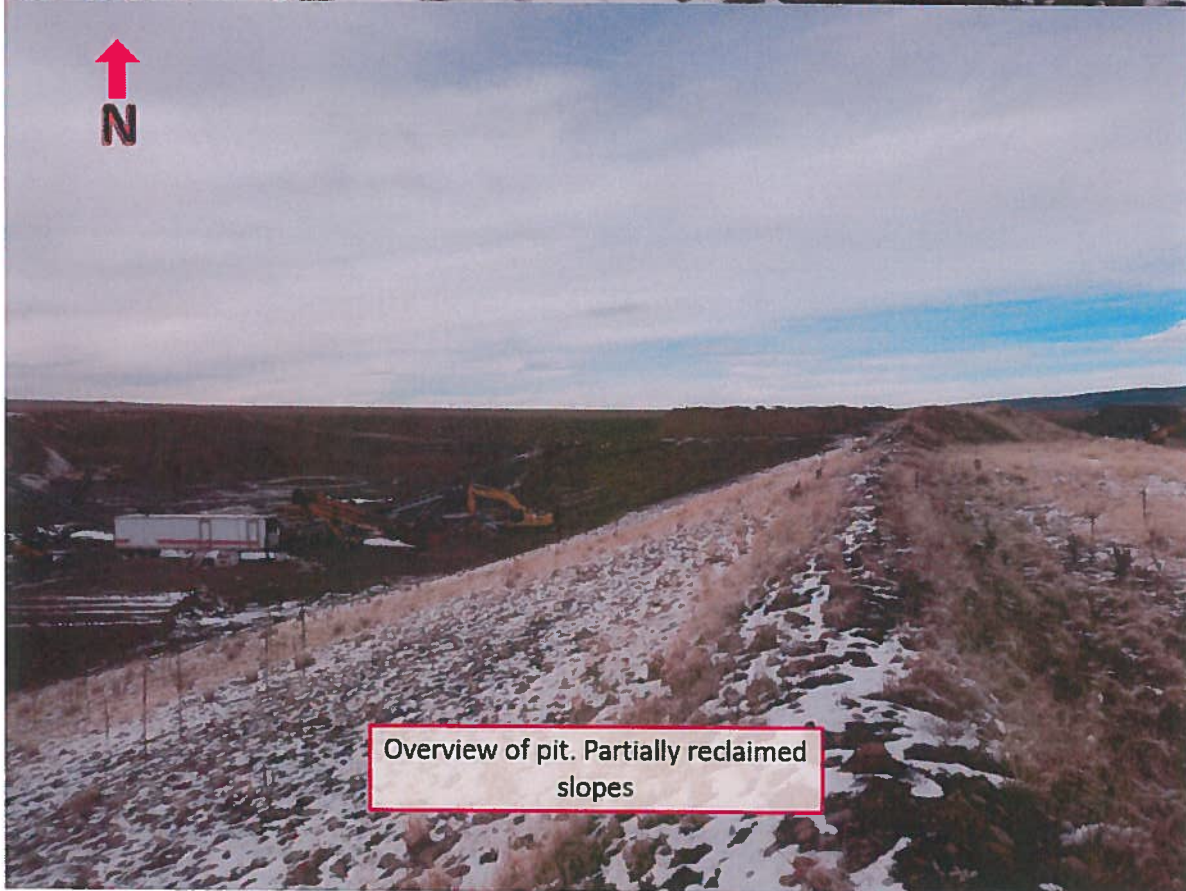
Pit wall slopes vary from 1:1 to 3:1 depending on location and mining progress. The pit currently has approximately 2,300 lft of walls, where nearly all of the south west side meets final reclamation specifications. The bond calculations must take into account the worst case scenario under the approved permit so 3,000 lft which is the perimeter of 15 acres, the max disturbance, is the estimate used.

Overview of pit. Partially reclaimed slopes

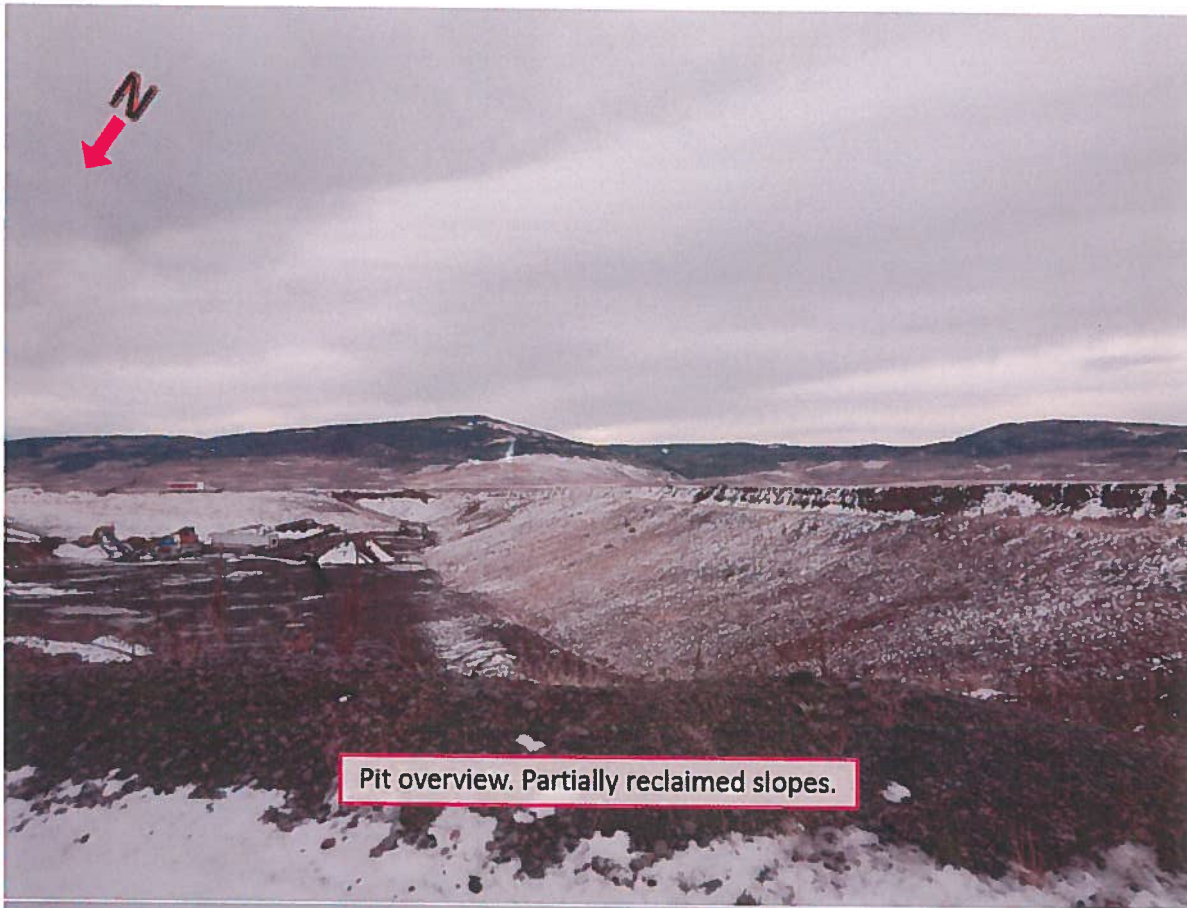
Pit overview. Partially reclaimed slopes.

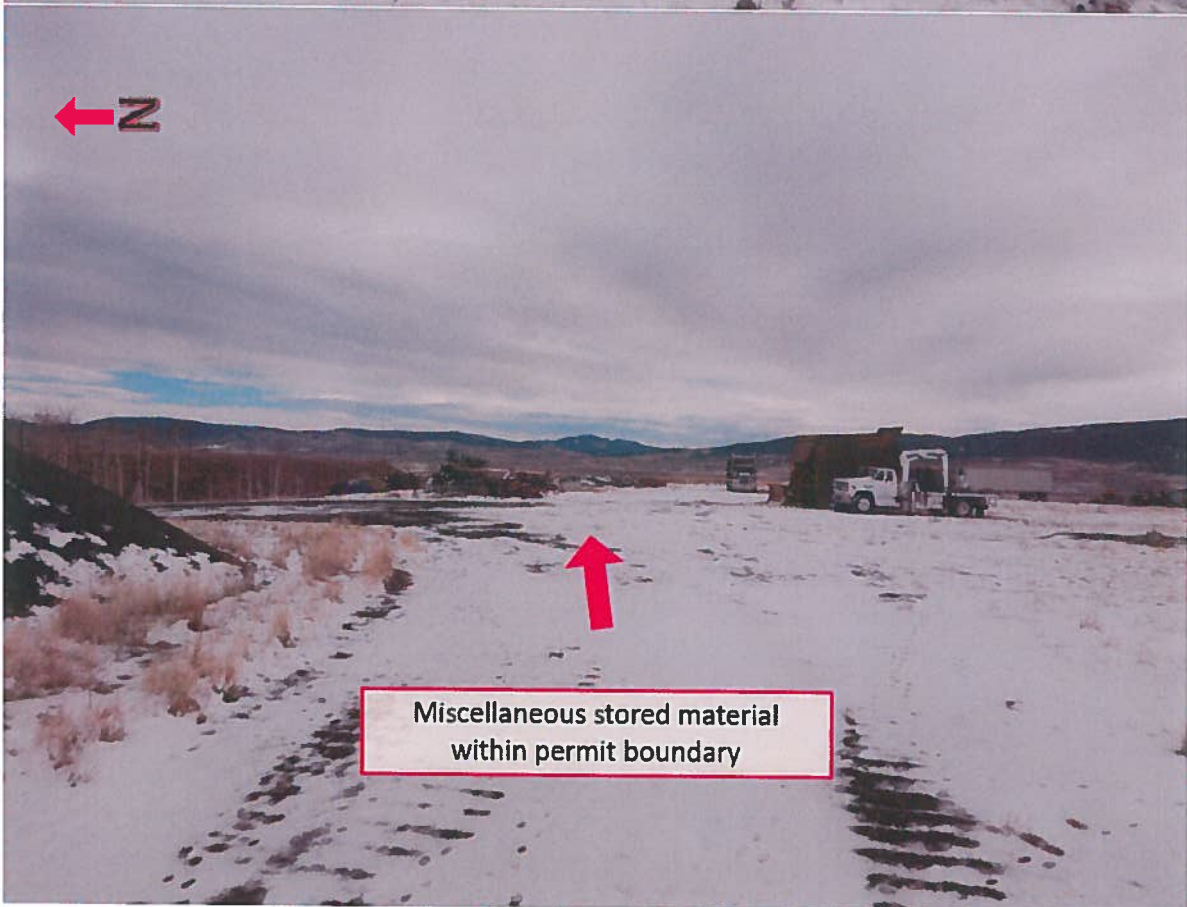
No fuel or other hazardous materials are store onsite. No powerlines or other utilities run through the permit boundary. All fuel for equipment is provided via transfer tank. To the west of the pit several piles of debris are being stored within the permit boundary. However according to the landowner the material is for personal use not related to the mining operation.

Miscellaneous stored material
within permit boundary
