COLORADO DIVISION OF RECLAMATION, MINING AND SAFETY
MINERALS PROGRAM INSPECTION REPORT
PHONE: (303) 866-3567

MINE NAME: Deep Creek Placer	MINE/PROSPECTING ID#: M-1986-102	MINERAL: Limestone (general)	COUNTY: San Miguel
INSPECTION TYPE: Monitoring	INSPECTOR(S): Lucas J. West	INSP. DATE: October 30, 2015	INSP. TIME: 09:00
OPERATOR: Collins Morehead, LLC	OPERATOR REPRESENTATIVE: Dan Collins	TYPE OF OPERATION: 110c - Construction Limited Impact

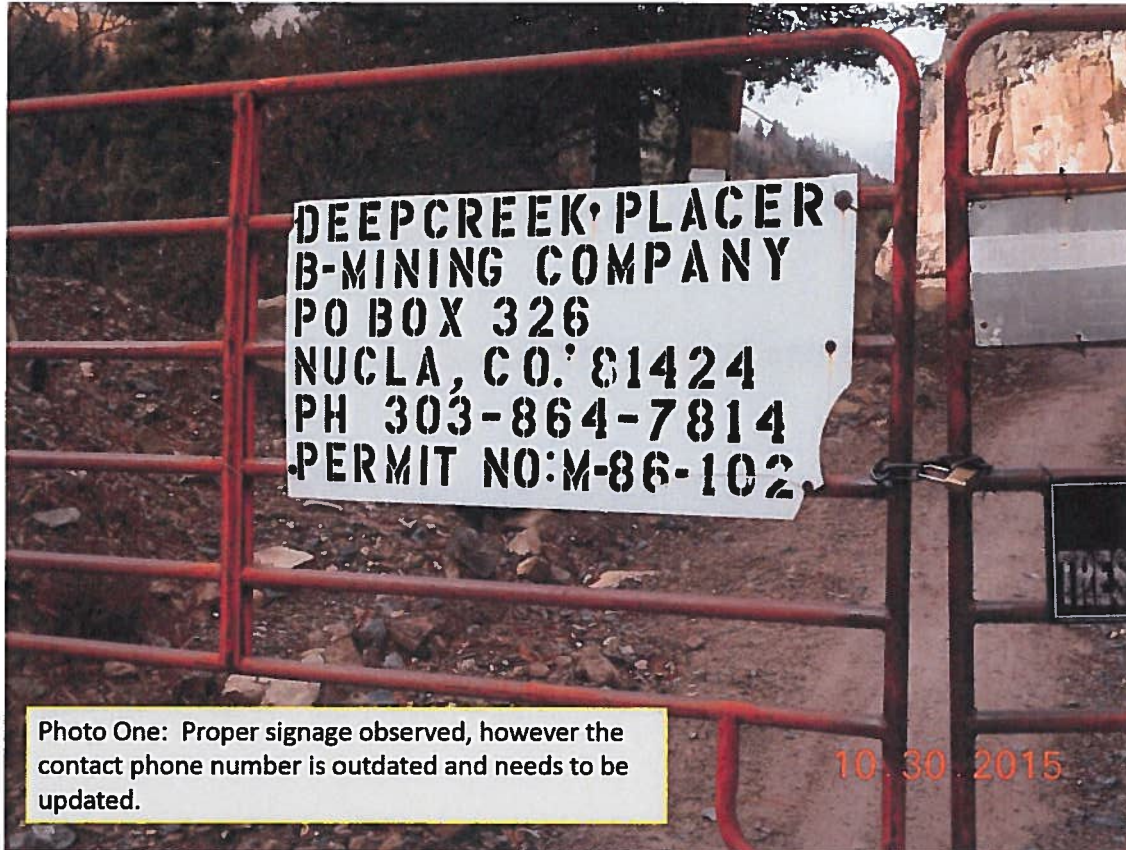
Photo One shows the proper mine identification sign posted on the gate at the bottom of the access road. It is noted however that the Operator's contact number on the sign is out of date and the Division requests that the Operator update the sign with the appropriate contact information. The permit boundaries are delineated by a storm water containment berm that encompasses the work/ storage area just outside of the portals. Proper storm water control features were observed and were stable. The site exhibits positive drainage and no erosional features were observed. Small amounts of stockpiled material was observed outside of the portals. No topsoil or overburden stockpiles were observed on site. No Noxious weeds were observed.

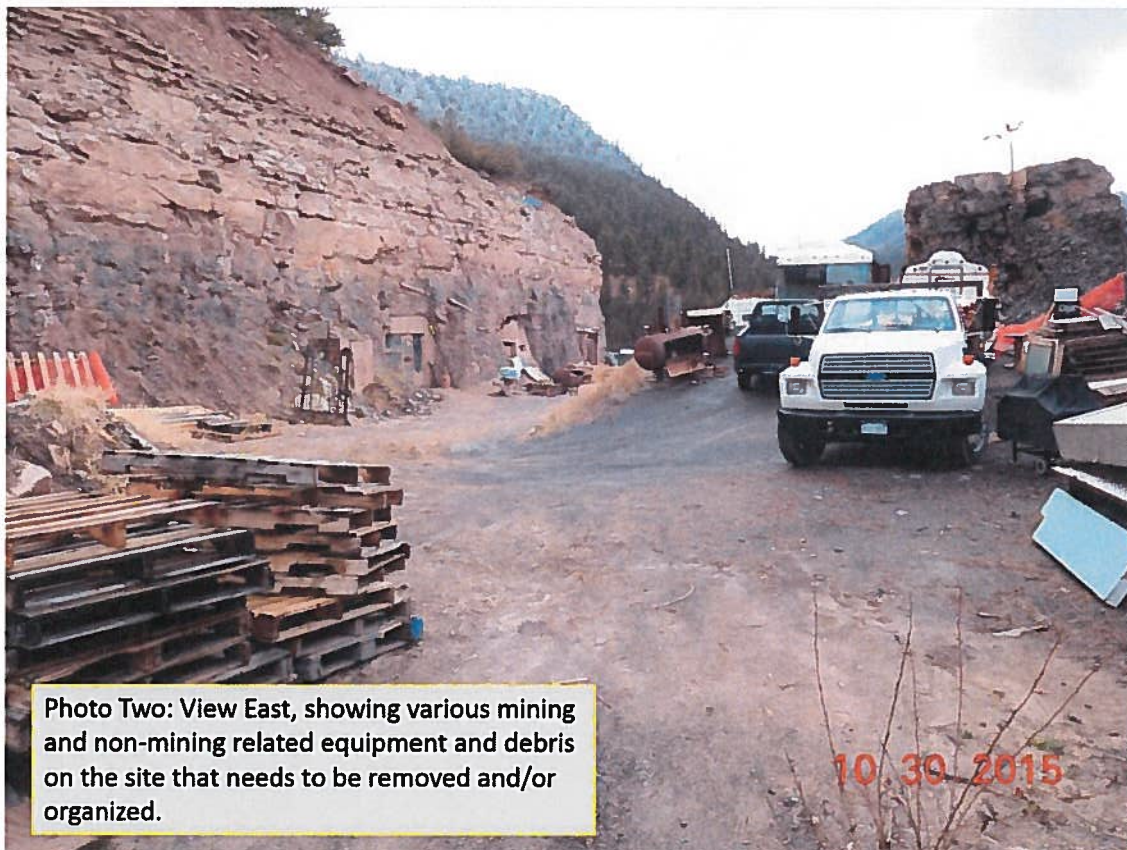
The site has not been active for several years. Due to the recent inactivity the work and storage area that is just outside of the portals has become cluttered with both mining and non-mining related equipment, and debris as seen in Photos Two and Three. The Division also requests, that the Operator clean up the site of the trash and debris, and store the equipment whether mining or non-mining related in a neat and orderly fashion.

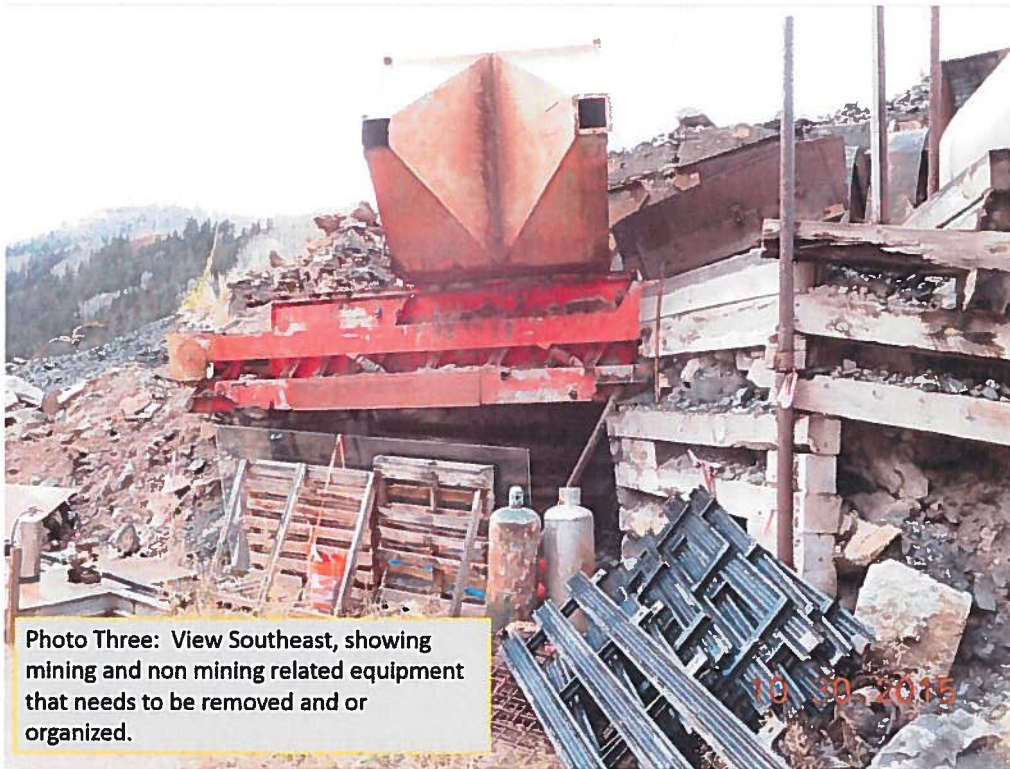
Photo Three: View Southeast, showing mining and non mining related equipment that needs to be removed and or organized.

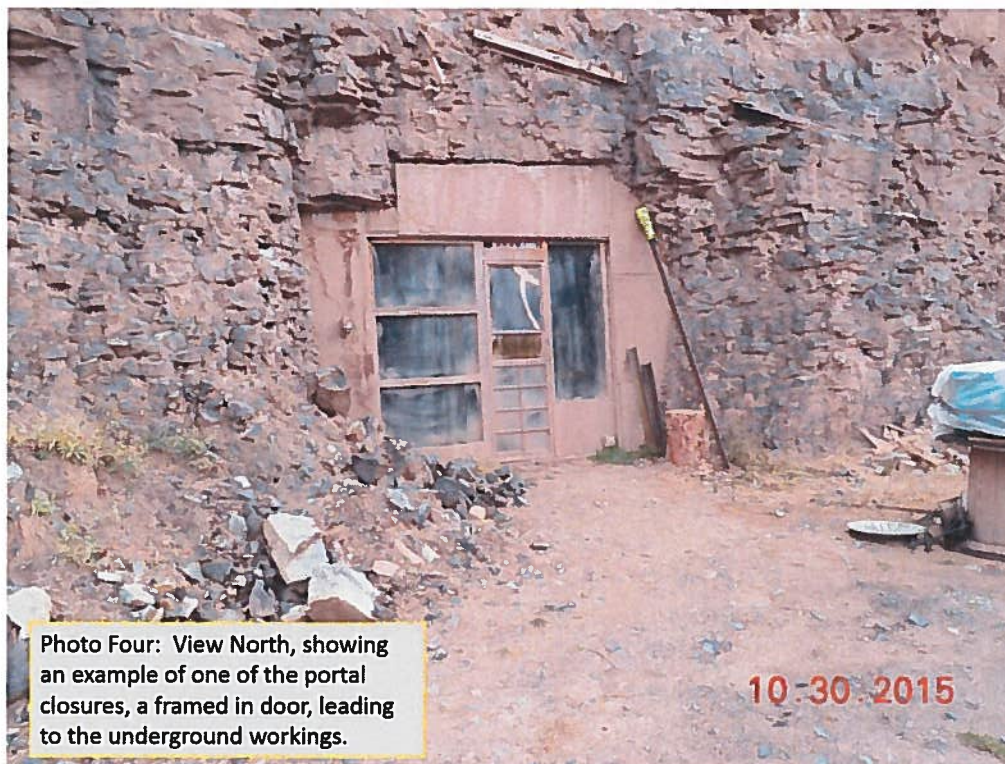
The site consists of six portals leading into large extensive workings, and include an underground metal working and maintenance shop. Despite the recent inactivity the underground workings are in very good condition and are well kept. All portals were sealed and locked with various types of closures, shown in Photo Four including framed in doors, as well as metal grate doors used for equipment access. A historic explosives magazine is located on site, however the Operator verified it was empty, and as seen in Photo Five, the door is blocked by vegetated rock and soil berms, suggesting the magazine has not been used for some time.

Photo Four: View North, showing an example of one of the portal closures, a framed in door, leading to the underground workings.
