COLORADO DIVISION OF RECLAMATION, MINING AND SAFETY
MINERALS PROGRAM INSPECTION REPORT
PHONE: (303) 866-3567

MINE NAME: Cresson Project	MINE/PROSPECTING ID#: M-1980-244	MINERAL: Gold	COUNTY: Teller
INSPECTION TYPE: Monitoring	INSPECTOR(S): Timothy A. Cazier	INSP. DATE: September 16, 2015	INSP. TIME: 07:15
OPERATOR: Cripple Creek & Victor Gold Mining Company	OPERATOR REPRESENTATIVE: Chris Hanks & Meg Burt	TYPE OF OPERATION: 112d-3 - Designated Mining Operation	
REASON FOR INSPECTION: Normal I&E Program	BOND CALCULATION TYPE: None	BOND AMOUNT: \$173,434,420.00	
DATE OF COMPLAINT: NA	POST INSP. CONTACTS: None	JOINT INSP. AGENCY: None	
WEATHER: Clear	INSPECTOR'S SIGNATURE:

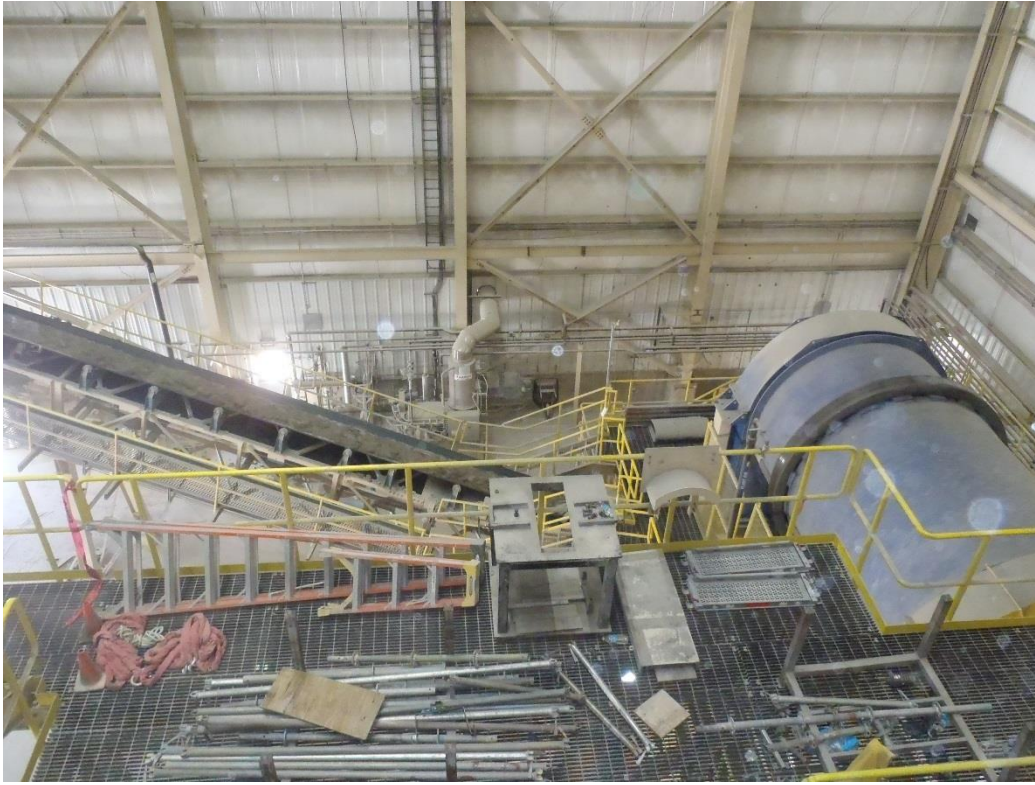
PROBLEM/POSSIBLE VIOLATION: Problem: Excessive vibration caused by the drum agglomerator was observed in the high grade mill. The Division is concerned with potential impacts to the mill foundation, underlying liner, and VLF slope stability.

Meeting II: Mr. Don Rodabough (CC&V) provided an overview of the high grade mill to the Division representatives. Mr. Rodabough noted the mine was experiencing excessive vibration from the drum

agglomerator (see **Photo 1**) and that they are evaluating options. The Division representatives toured the mill following the overview presentation. The Division experienced the excessive vibration during the mill tour and has concerns related to the long term impact to the mill and the platform and liner on which it has been constructed as it is an environmental protection facility (EPF). The Division pointed out concerns related to the vibration and its potential impact on the 100 plus feet of structural backfill as part of the adequacy review process during Amendment 10. The Division's concerns are summarized as follows:

- 1) What is the potential for and impact on the mill (primarily with respect to impacted water containment and foundation cracking) from the excessive vibration?
- 2) What is the potential impact on the underlying liner with respect to rubbing caused by the excessive vibration?
- 3) What is the potential impact of the excessive vibration on the slope stability of the adjacent VLFs (primarily the Arequa VLF at this time)?
- 4) How does the mine intend to monitor potential impacts and assess the severity of the potential impact(s) on the aforementioned facilities?

Photo 1. High grade mill drum agglomerator.

CORRECTIVE ACTIONS: Provide a report addressing the following: 1) What is the potential for and impact on the mill (primarily with respect to impacted water containment and foundation cracking) from the excessive vibration? 2) What is the potential impact on the underlying liner with respect to rubbing caused by the excessive vibration? 3) What is the potential impact of the excessive vibration on the slope stability of the adjacent VLFs (primarily the Arequa VLF at this time)? 4) How does the mine intend to monitor potential impacts and assess the severity of the potential impact(s) on the aforementioned facilities?

CORRECTIVE ACTION DUE DATE: 1/19/16

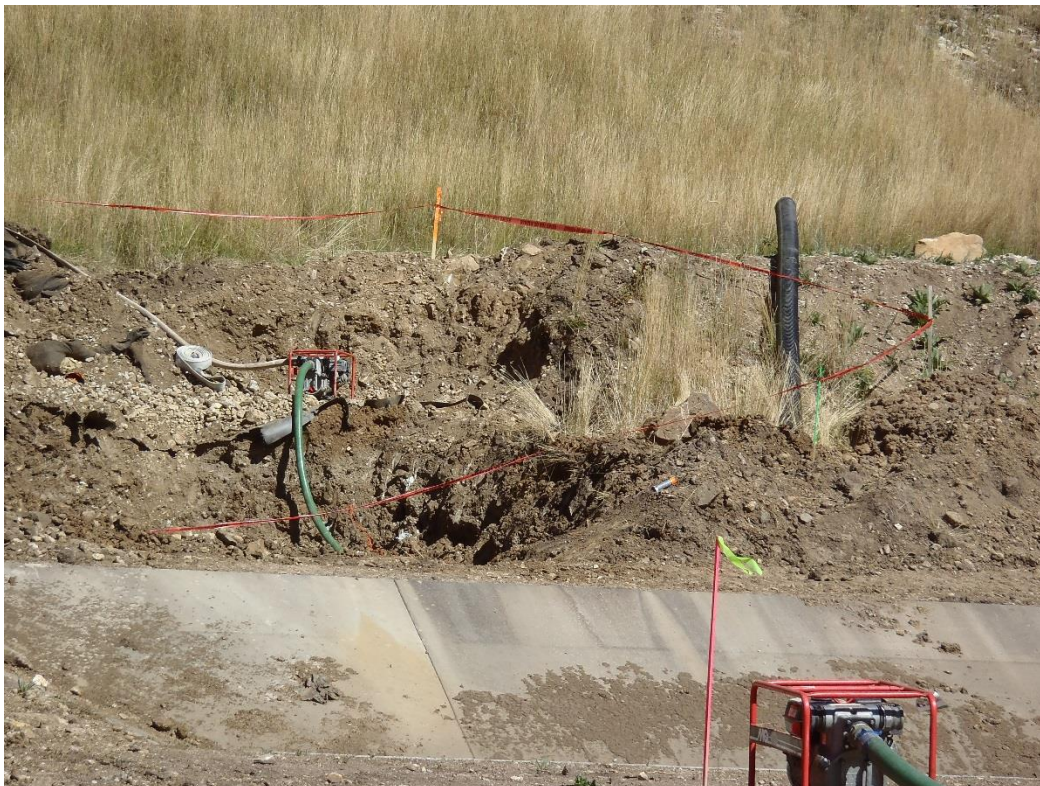
Mr. Hanks pointed out the mine is beginning to excavate the area for the proposed sump at the toe of the SGVLF toe berm (see **Photo 2**). The liner was expected to be installed prior to the next inspection. The proposed substation location was visited. It is at the bottom of Squaw Gulch where it intersects Shelf Road. It was undisturbed at the time of the inspection (see **Photo 3**).

Photo 2. Proposed underdrain sump at the toe of the SGVLF toe berm (looking east).

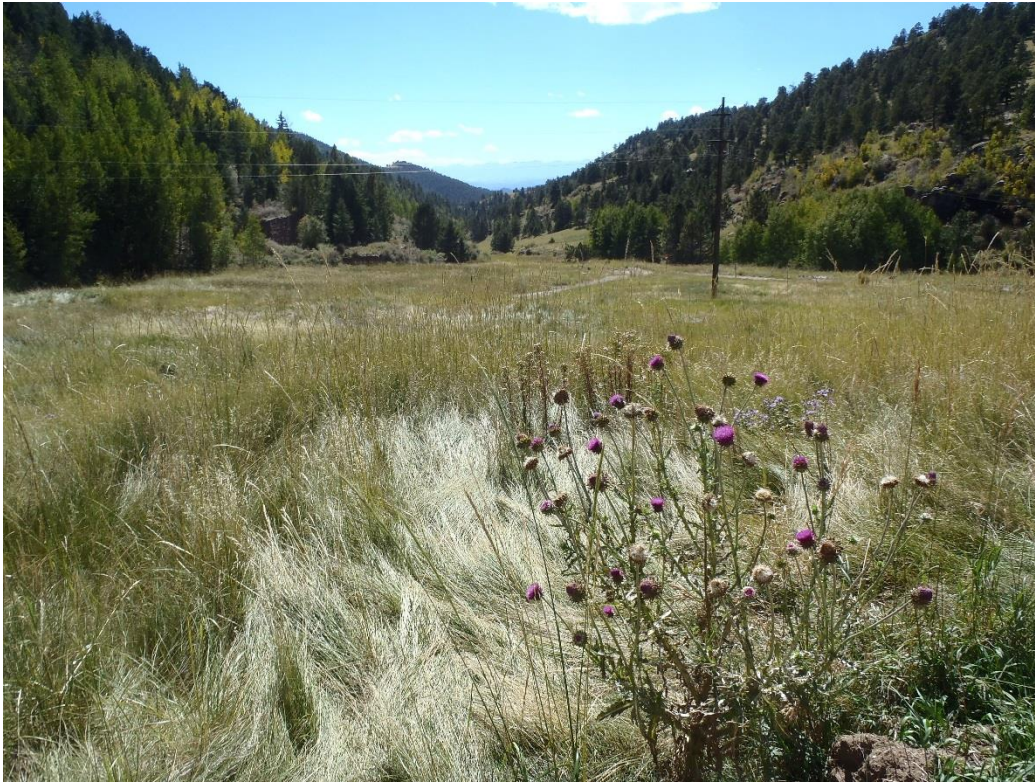
Photo 3. Currently undisturbed proposed substation location (looking SW towards Shelf Road).

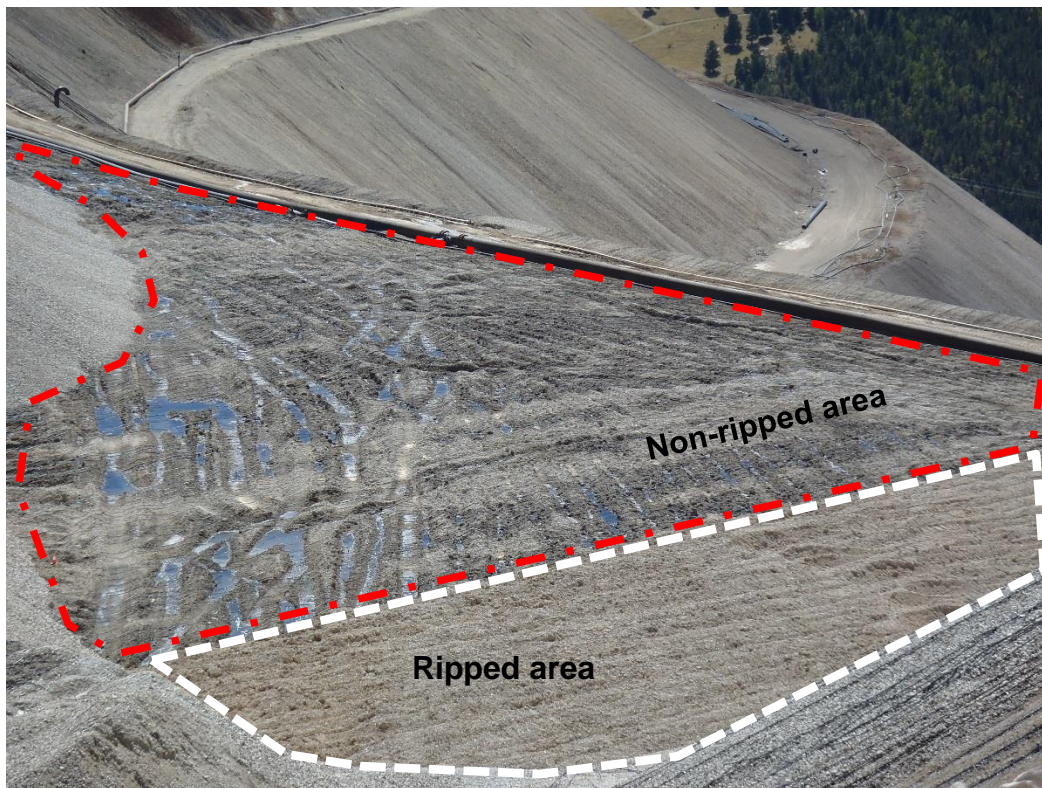
This specialist was taken to the top of the AGVLF pad to observe the mitigation efforts in progress to re-establish infiltration of applied barren solution on the pad. **Photo 4** shows where the pad had been ripped to break up the precipitate "seal" (foreground) in contrast to the area beyond that had not yet been ripped and where ponded water was observed.

Photo 4. AGVLF pad infiltration mitigation – ripped vs non-ripped (looking east).

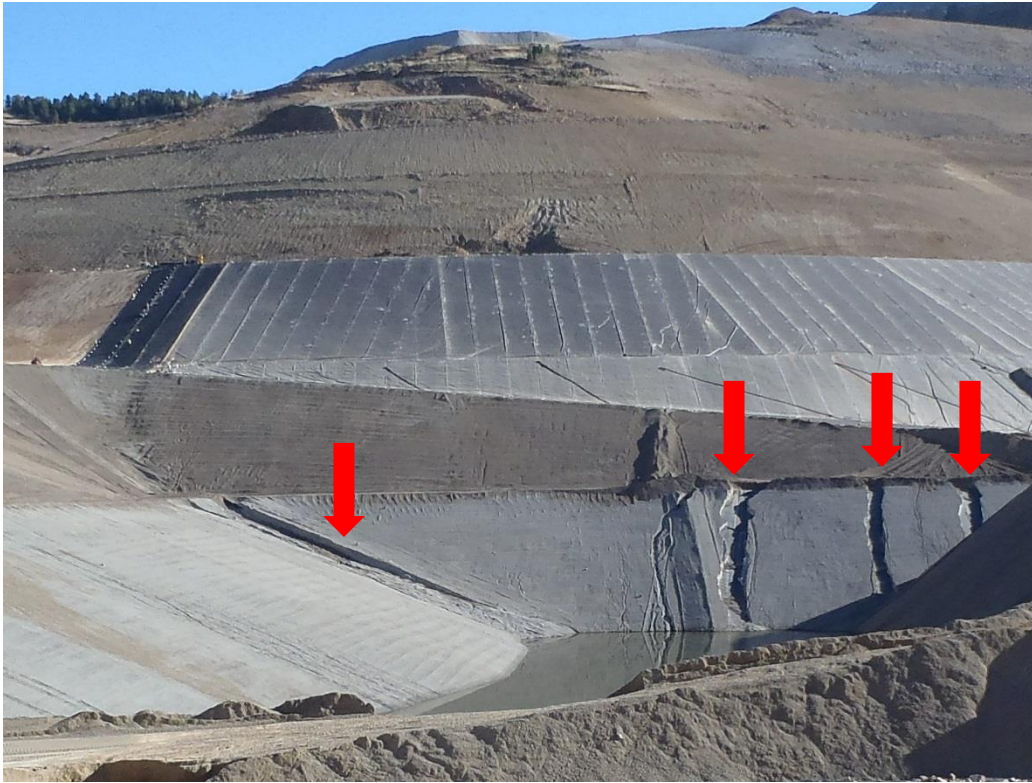
This specialist was taken to the top of the southeast end of the PSSA to observe the eroded DCF on the northeast end of the certified PSSA. **Photo 5** shows the eroded DCF. The ponded water in the bottom of the PSSA is visible in the foreground of **Photo 5**.

Photo 5. Eroded DCF and ponded water in SGVLF PSSA (looking NE).
