**COLORADO DIVISION OF RECLAMATION, MINING AND SAFETY
MINERALS PROGRAM INSPECTION REPORT
PHONE: (303) 866-3567**

MINE NAME: Shavano Pit	MINE/PROSPECTING ID#: M-1983-208	MINERAL: Sand and gravel	COUNTY: Montrose
INSPECTION TYPE: Monitoring	INSPECTOR(S): Dustin M. Czapla	INSP. DATE: November 3, 2015	INSP. TIME: 09:30
OPERATOR: Montrose County	OPERATOR REPRESENTATIVE: Norm David	TYPE OF OPERATION: 112c - Construction Regular Operation

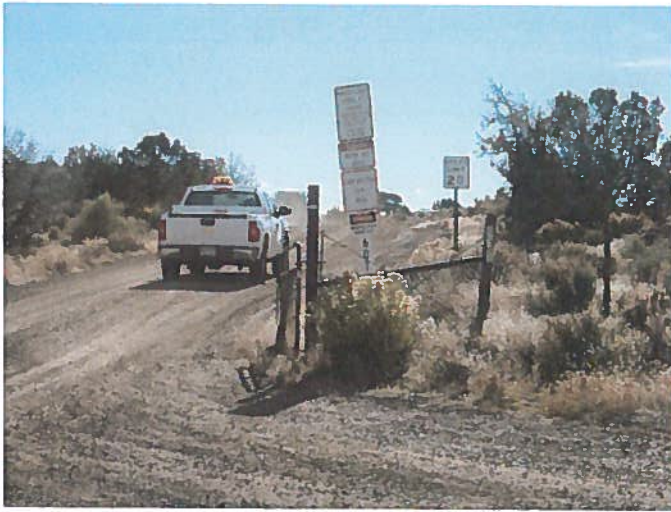
Adequate mine identification signage was noted at the entrance to the site.

Figure 1: Adequate sign at entrance

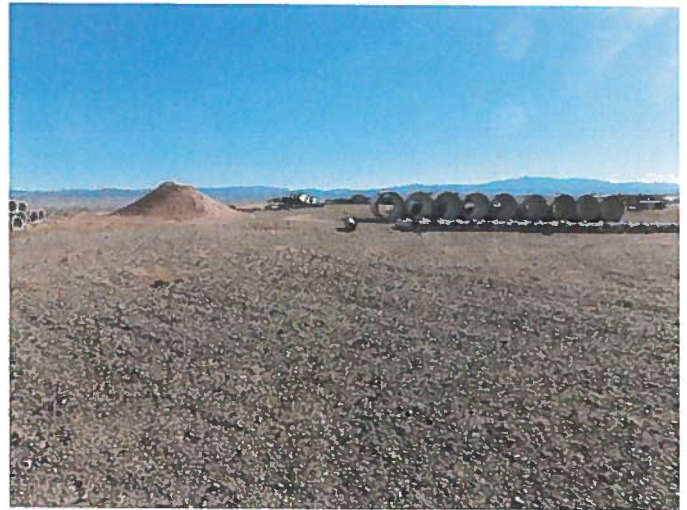
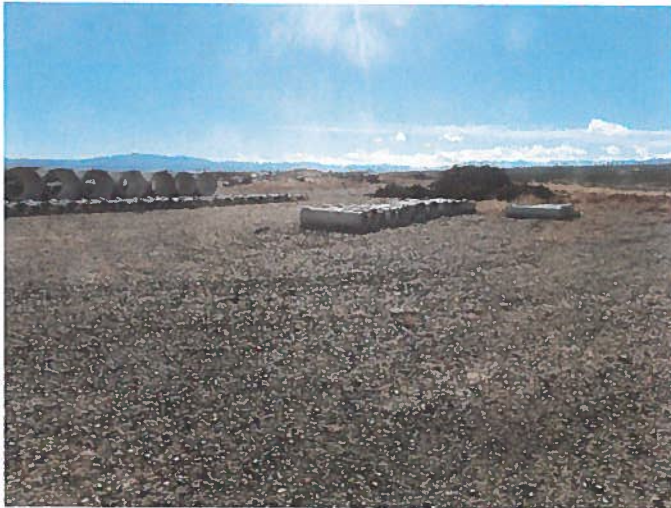
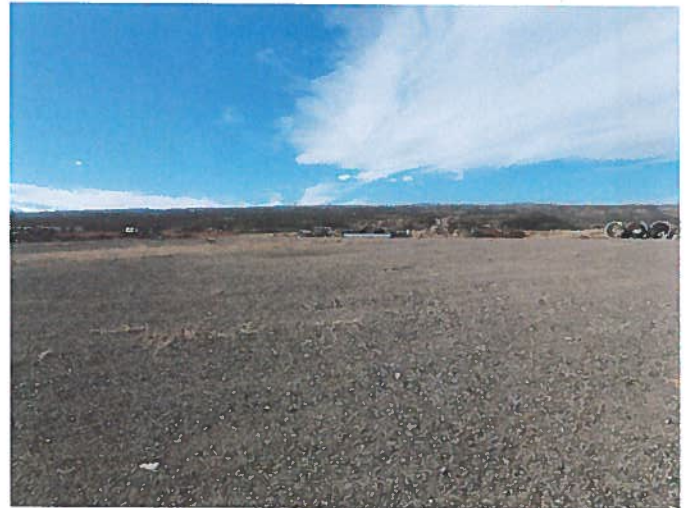
The operator is planning to request release of the equipment and material storage area located at the north end of the permit area, as well as an undisturbed area adjacent to the cemetery. Release of the area near the cemetery will create additional buffer between the mine and the cemetery. The Division would be supportive of removal of this area from the permit. The removal of the equipment and storage area from the permit would be consistent with the approved end land use of industrial/commercial. This end land use was approved through AM-1 in 2002. The area is currently graded flat with a gravel surface. Noxious weed infestations were not noted in this area. Various equipment is stored in this area. No problems regarding future release of this area were noted.

Figure 2: Equipment storage area

Figure 3: Equipment storage area

Figure 4: Equipment storage area

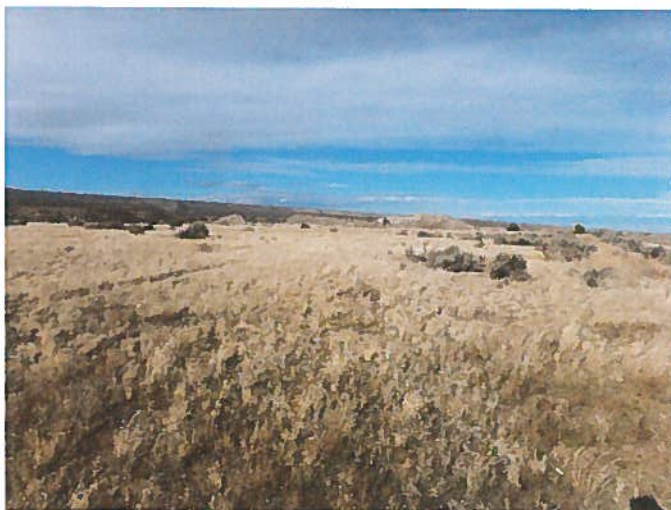
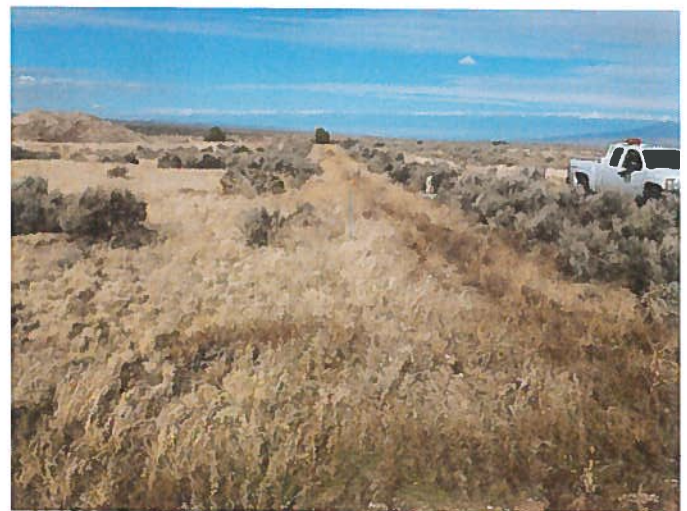
Figure 5: Proposed area for release on south side of cemetery

Figure 6: Proposed area for release on south side of cemetery

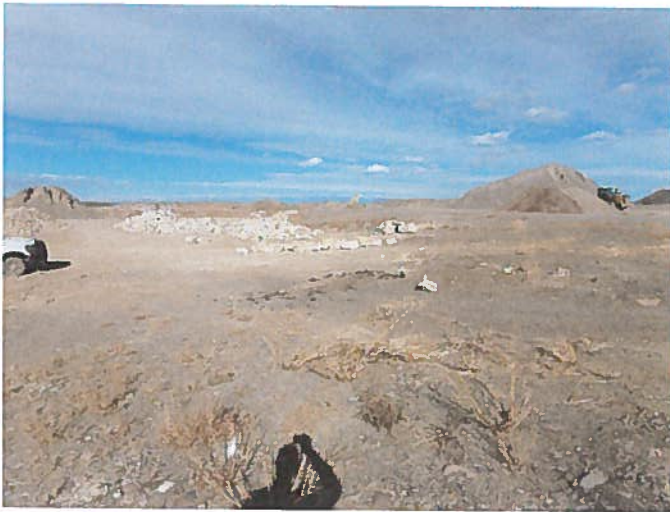
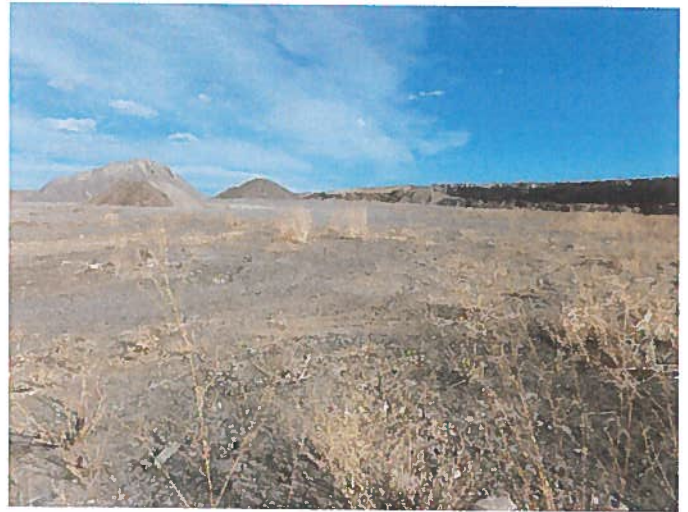
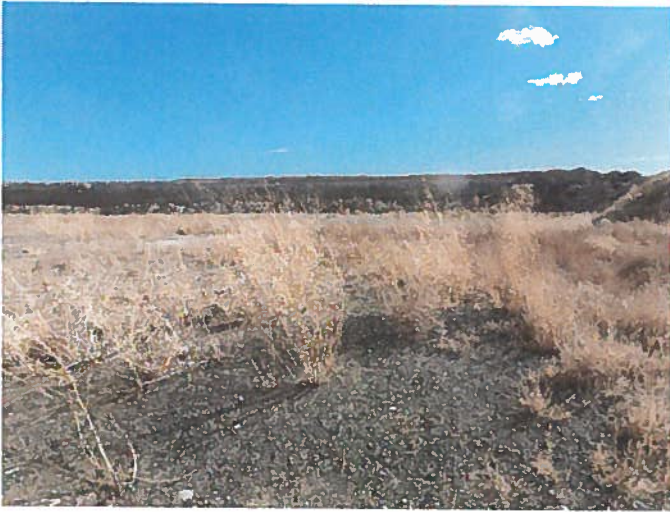
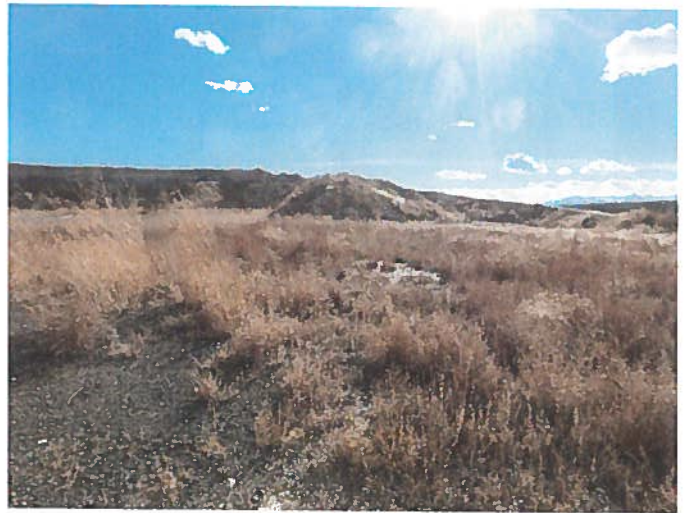
The mined area contains sand and gravel, recycled asphalt and rip rap stockpiles. The pit is advancing from west to east and currently includes approximately 11.5 acres. The highwall is approximately 20 feet high and near vertical, and spans approximately 500 lineal feet.

Figure 7: Active pit area

Figure 8: Active pit area

Figure 9: Active pit area

Figure 10: Active pit area

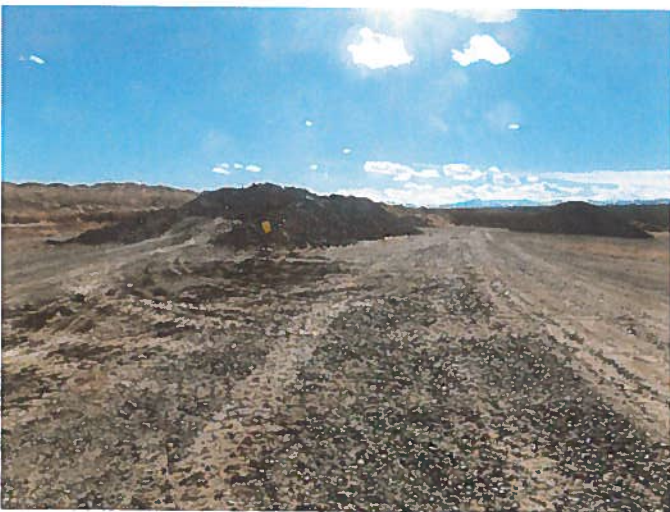
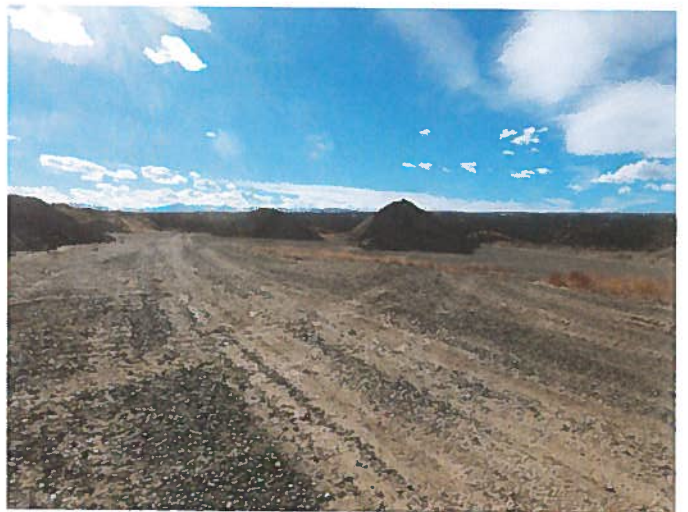
Figure 11: Active pit area recycled asphalt piles

Figure 12: Active pit area recycled asphalt piles
