COLORADO DIVISION OF RECLAMATION, MINING AND SAFETY
MINERALS PROGRAM INSPECTION REPORT
PHONE: (303) 866-3567

MINE NAME: Donley Rock Quarry	MINE/PROSPECTING ID#: M-2011-005	MINERAL: Sand and gravel	COUNTY: Montrose
INSPECTION TYPE: Monitoring	INSPECTOR(S): Dustin M. Czaplá	INSP. DATE: November 3, 2015	INSP. TIME: 10:00
OPERATOR: Montrose County	OPERATOR REPRESENTATIVE: Norm David	TYPE OF OPERATION: 112c - Construction Regular Operation

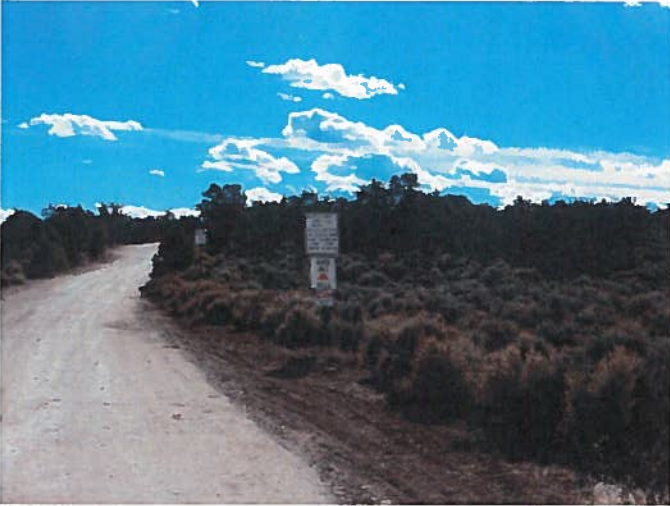
Adequate mine identification signage was noted at the entrance to the site.

Figure 1: Adequate mine identification sign

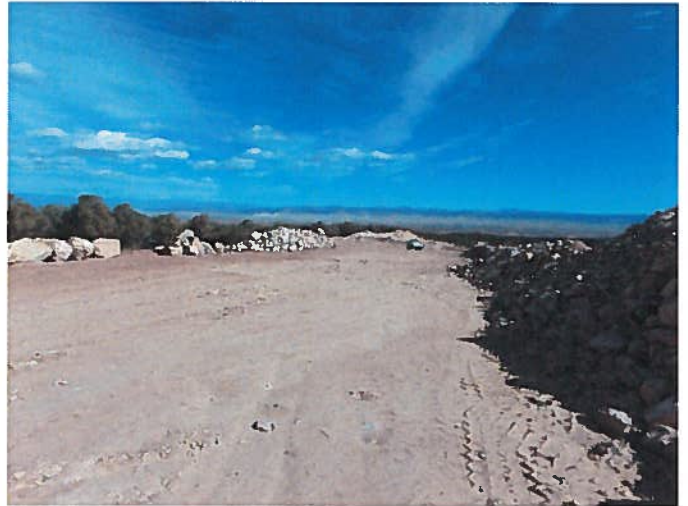
The operation has stripped approximately three acres. The active pit, which is approximately ten feet deep with near vertical sides, covers approximately 0.6 acres. The active pit is located at the east end of the stripped area and is advancing toward the southwest.

Figure 2: Stripped area viewed from southwest end

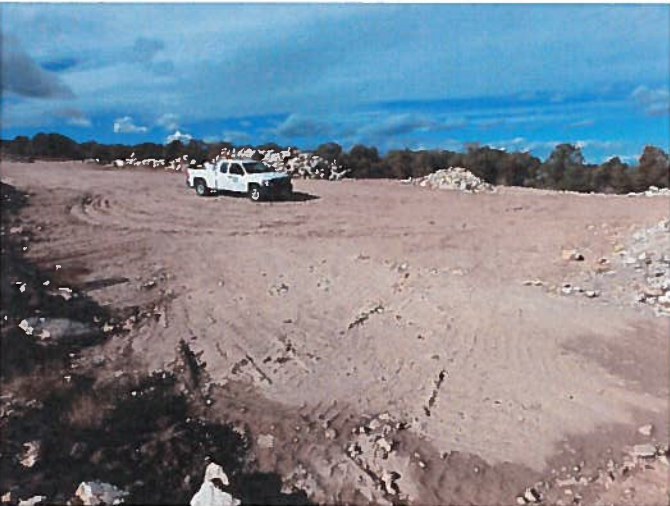
Figure 3: North part of stripped area

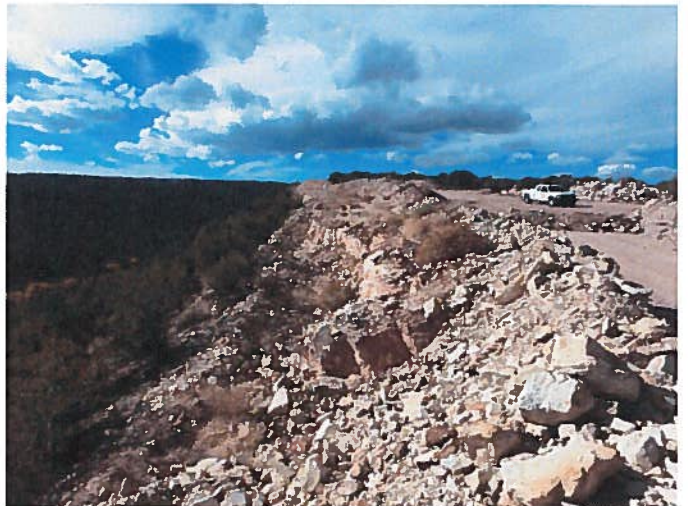
Rip rap stockpiles are stored on the stripped area on the west side of the mined pit. A berm has been constructed along the south side of the mine area in order to retain runoff and sediment. Erosion or stability concerns were not noted.

Figure 4: Berm placed along south side of stripped area

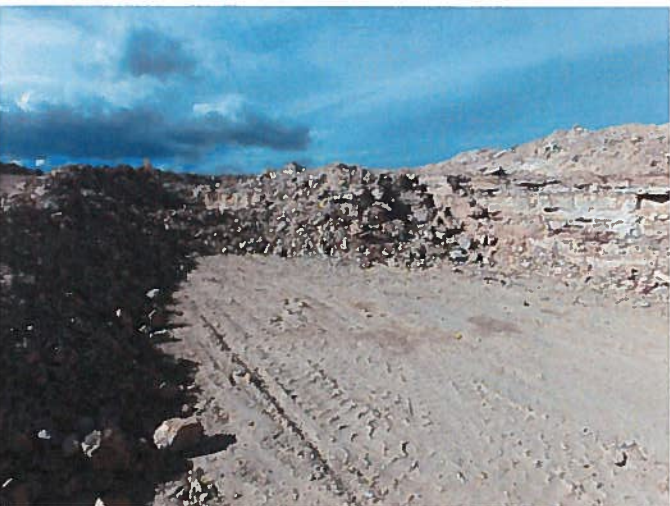
Figure 5: Active pit area

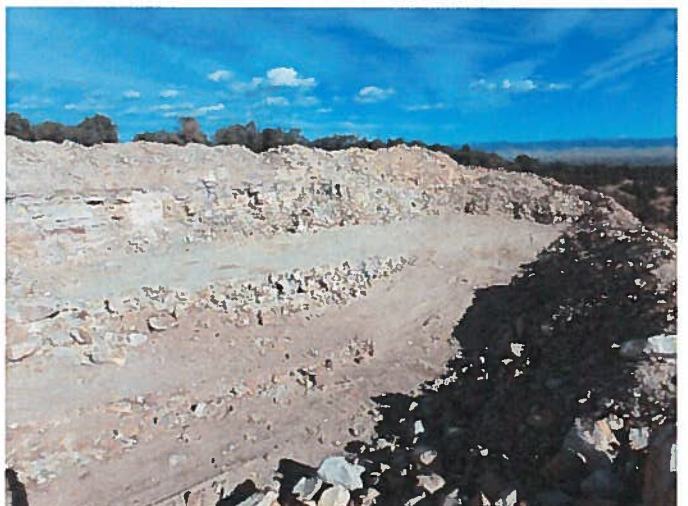
Figure 6: Active pit area
