COLORADO DIVISION OF RECLAMATION, MINING AND SAFETY
MINERALS PROGRAM INSPECTION REPORT
PHONE: (303) 866-3567

MINE NAME: Lindsey Canyon LLC	MINE/PROSPECTING ID#: M-2000-072	MINERAL: Borrow material	COUNTY: Montrose
INSPECTION TYPE: Monitoring	INSPECTOR(S): Dustin M. Czapla	INSP. DATE: November 3, 2015	INSP. TIME: 11:00
OPERATOR: Lindsey Canyon, LLC	OPERATOR REPRESENTATIVE: None	TYPE OF OPERATION: 110c - Construction Limited Impact

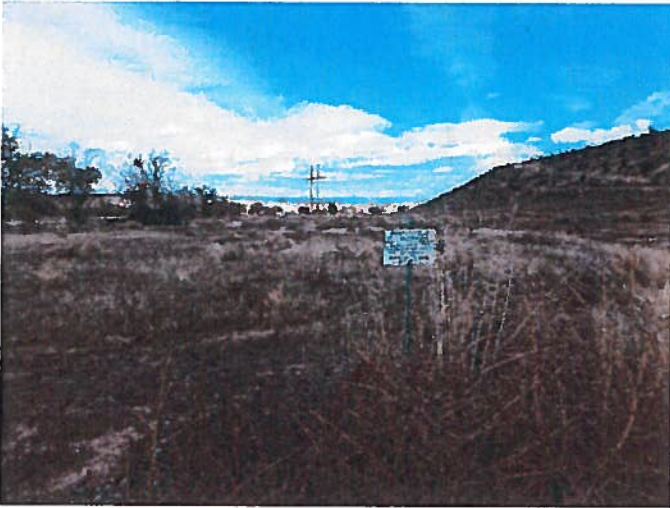
Adequate mine identification signage was noted at the entrance to the site.

Figure 1: Adequate mine sign at entrance

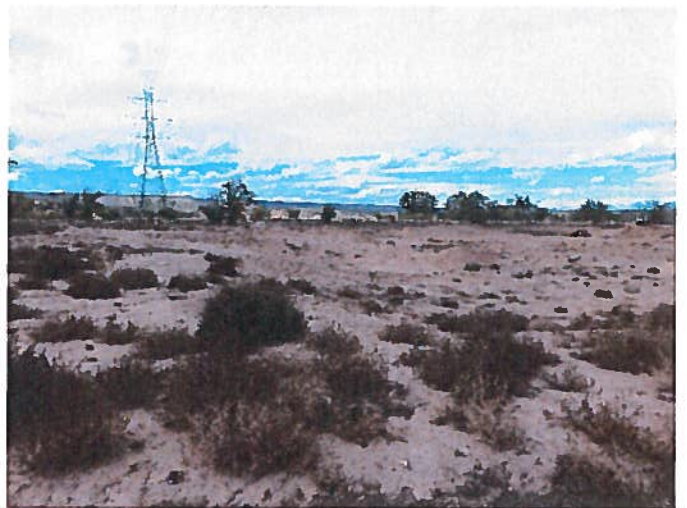
Figure 2: Pit area

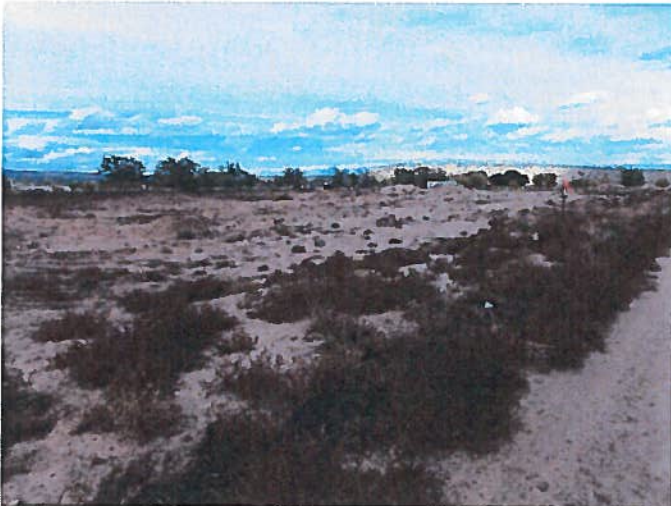
Figure 3: Pit area

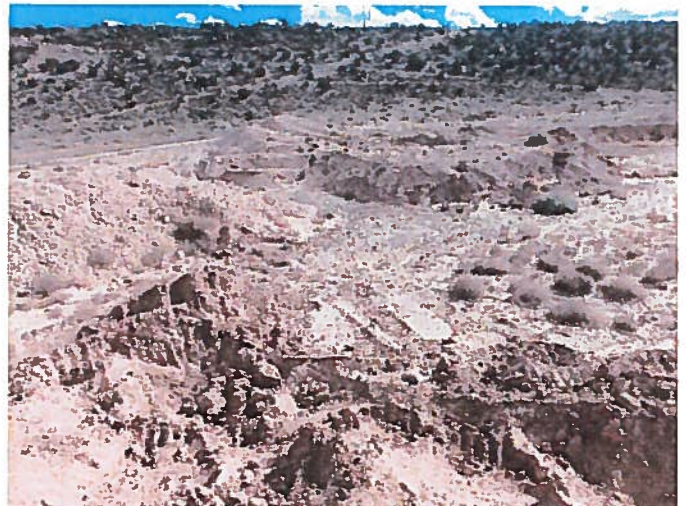
The pit has been excavated to a depth of approximately fifteen feet. Groundwater has not been exposed. Most of the slopes around the pit perimeter are at 3H:1V or gentler. There are slopes and dirt piles in the northeast part of the pit that will require additional grading.

Figure 4: North pit slope and dirt piles

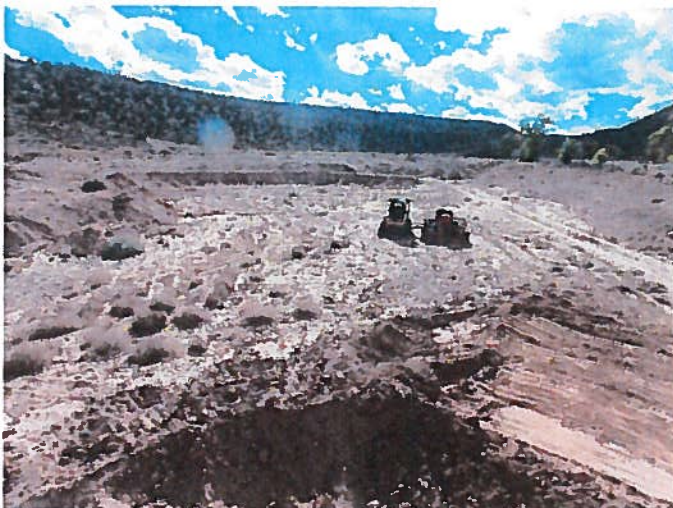
Figure 5: Pit area viewed from north end

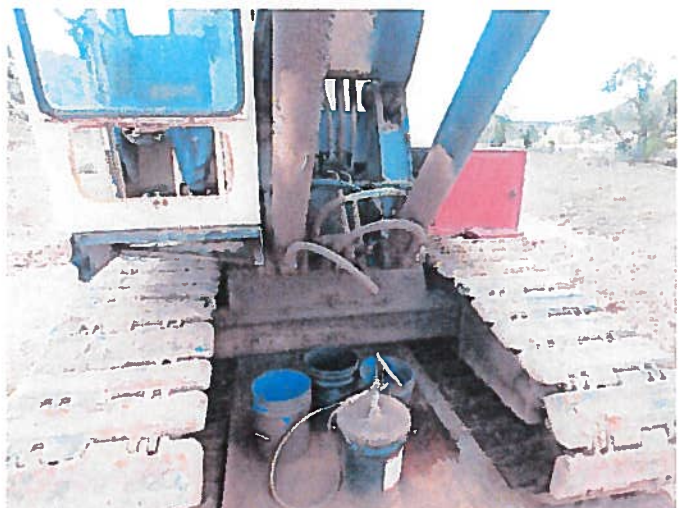
An old excavator, dozer and skid-steer were located on site. The excavator appears to have several minor fluid leaks. Buckets and plywood have been placed beneath the excavator to contain leaks. There was no sign of contaminated soil noted.

Figure 6: Old excavator on site
