# COLORADO DIVISION OF RECLAMATION, MINING AND SAFETY MINERALS PROGRAM INSPECTION REPORT

<b>MINE NAME:</b> Triple R Gravel Pit	<b>MINE/PROSPECTING ID#:</b> M-1991-097	<b>MINERAL:</b> Sand and gravel	<b>COUNTY:</b> Montrose
<b>INSPECTION TYPE:</b> Monitoring	<b>INSPECTOR(S):</b> Dustin M. Czapla	<b>INSP. DATE:</b> November 3, 2015	<b>INSP. TIME:</b> 12:00
<b>OPERATOR:</b> Ouray County	<b>OPERATOR REPRESENTATIVE:</b> None	<b>TYPE OF OPERATION:</b> 112c - Construction Regular Operation

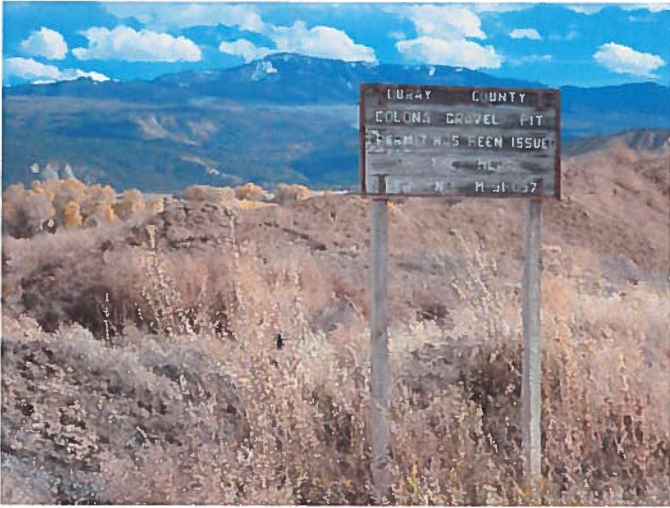
Adequate mine identification signage was noted at the entrance to the site.

Figure 1: Entrance to mine site from Hwy 550

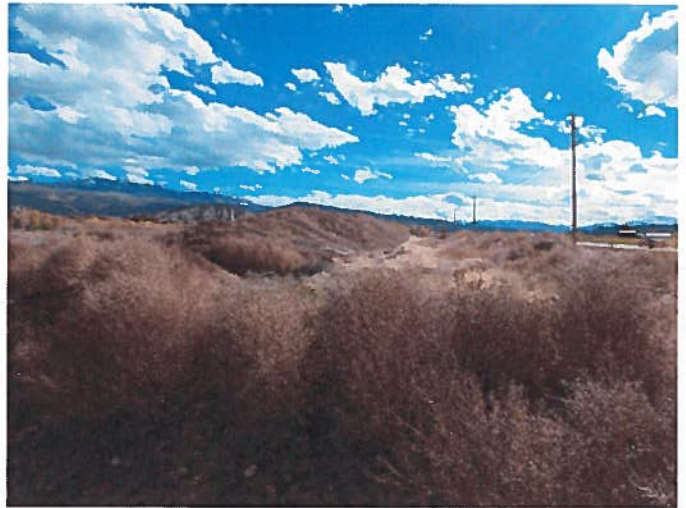
Figure 2: Topsoil berm located along west boundary

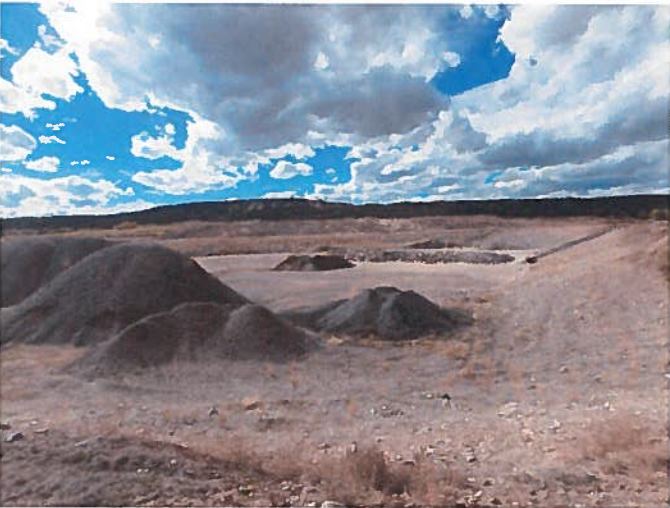
Figure 3: Pit area viewed from the northeast side

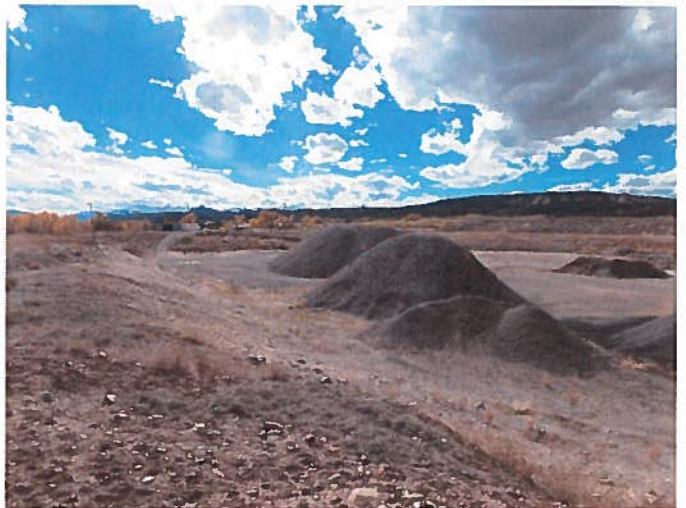
Figure 4: Pit area viewed from the northeast side

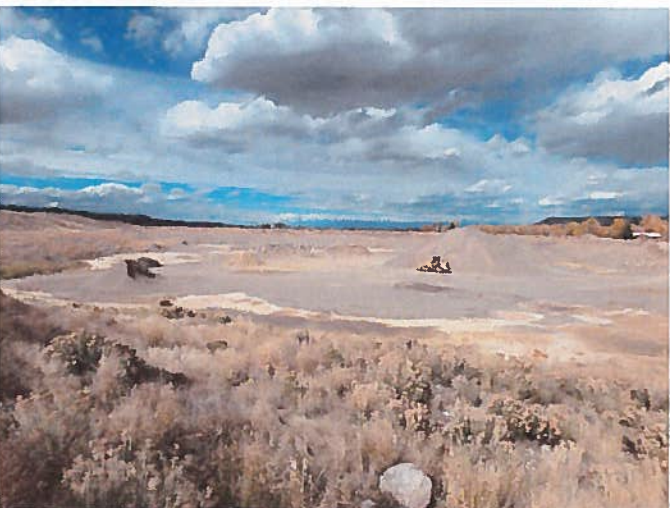
Figure 5: Pit area viewed from the southeast side

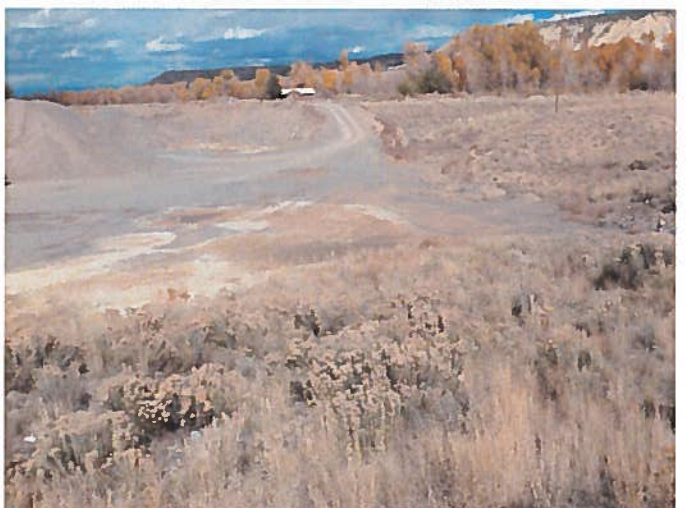
Figure 6: Pit area viewed from the southeast side
