COLORADO DIVISION OF RECLAMATION, MINING AND SAFETY
MINERALS PROGRAM INSPECTION REPORT
PHONE: (303) 866-3567

MINE NAME: Jesse Lee	MINE/PROSPECTING ID#: M-1984-043	MINERAL: Sand and gravel and	COUNTY: Chaffee
INSPECTION TYPE: Monitoring	INSPECTOR(S): Dustin M. Czapla	INSP. DATE: November 4, 2015	INSP. TIME: 08:00
OPERATOR: Pelino, Inc.	OPERATOR REPRESENTATIVE: Scott Pelino	TYPE OF OPERATION: 112c - Construction Regular Operation

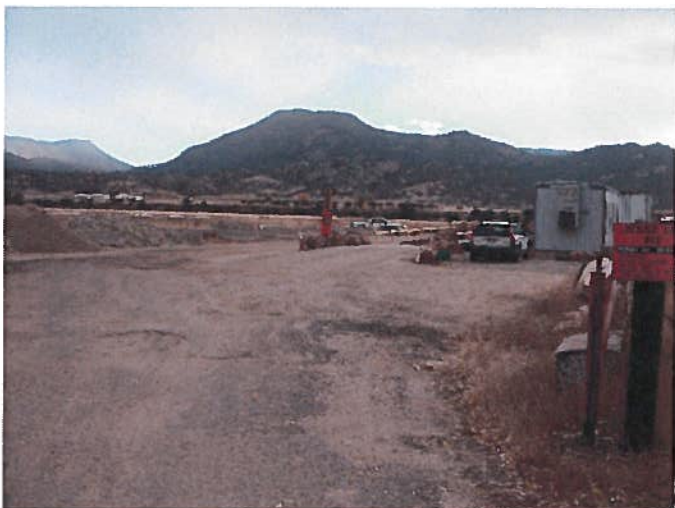
Figure 1: Upper bench area

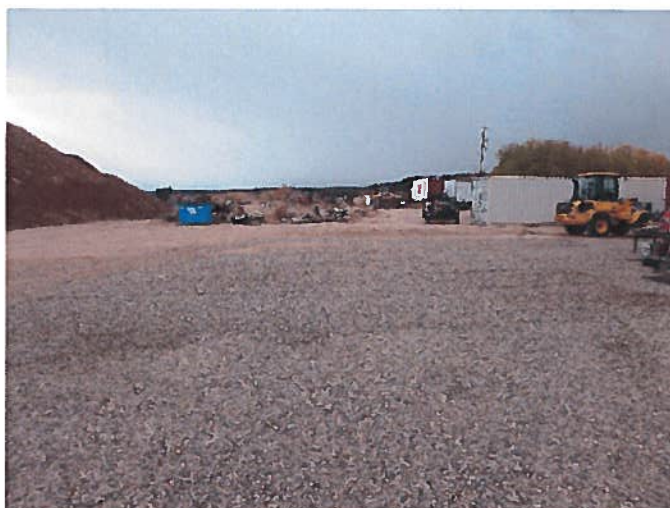
Figure 2: Upper bench area

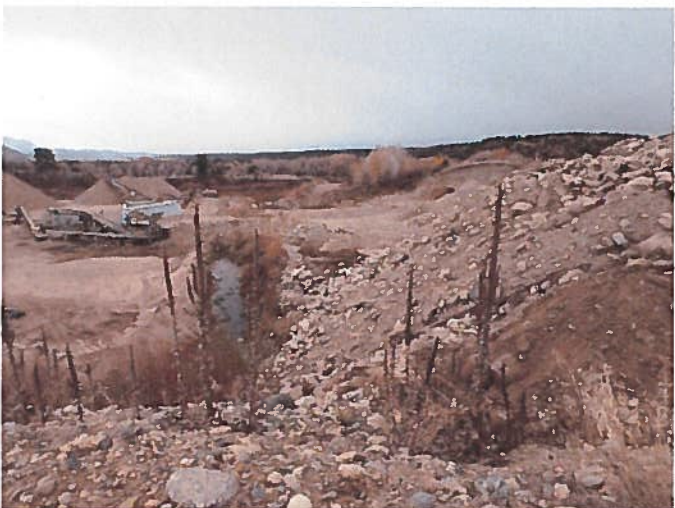
Figure 3: View of the pit from the access road

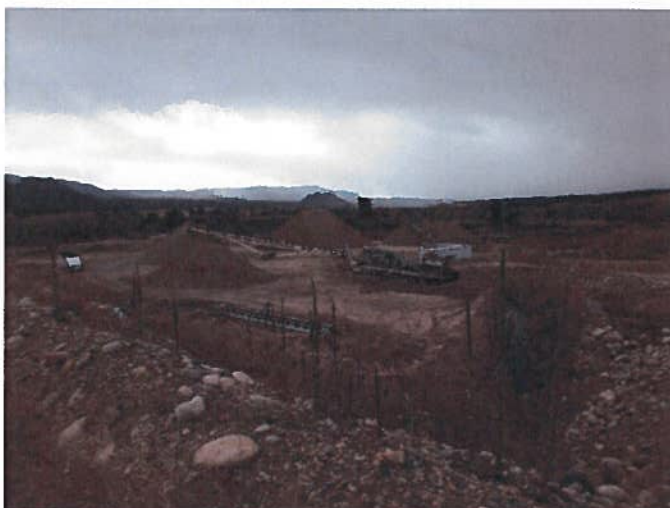
Figure 4: View of the pit from the access road

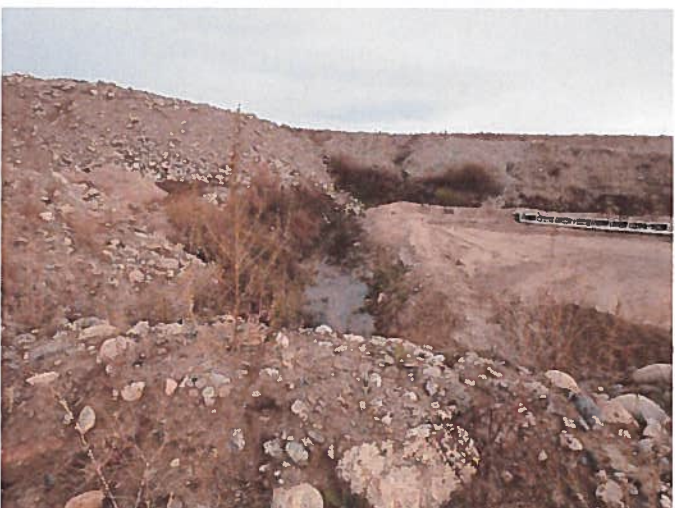
Figure 5: Diversion ditch placed at the base of the highwall

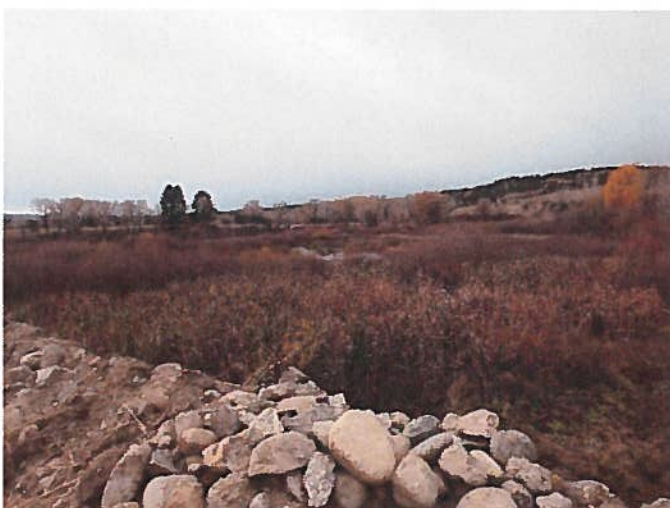
Figure 6: Reclamation area and sediment ponds.
