**COLORADO DIVISION OF RECLAMATION, MINING AND SAFETY**  
**MINERALS PROGRAM INSPECTION REPORT**  
**PHONE: (303) 866-3567**

<b>MINE NAME:</b> Arnold Gulch	<b>MINE/PROSPECTING ID#:</b> M-1998-091	<b>MINERAL:</b> Sand and gravel	<b>COUNTY:</b> Chaffee
<b>INSPECTION TYPE:</b> Monitoring	<b>INSPECTOR(S):</b> Dustin M. Czapla	<b>INSP. DATE:</b> November 4, 2015	<b>INSP. TIME:</b> 09:00
<b>OPERATOR:</b> Joseph L and Arlene Cogan dba B.B.L. COGAN, L.L.C.	<b>OPERATOR REPRESENTATIVE:</b> Joseph Cogan	<b>TYPE OF OPERATION:</b> 110c - Construction Limited Impact

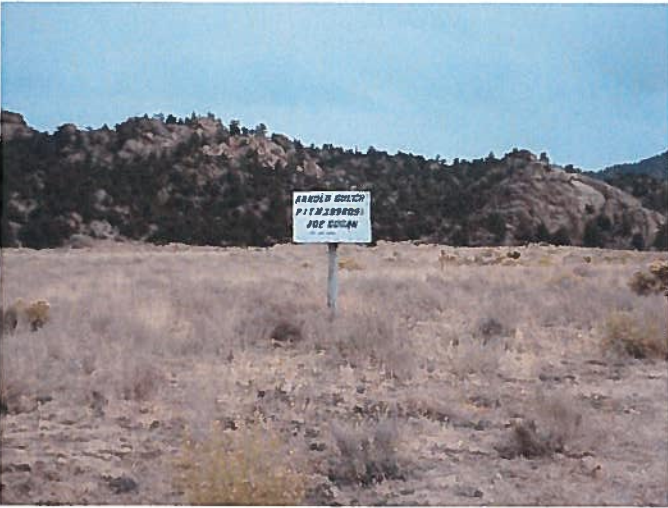
Adequate mine identification signage was noted at the entrance to the site.

Figure 1: Mine site entrance

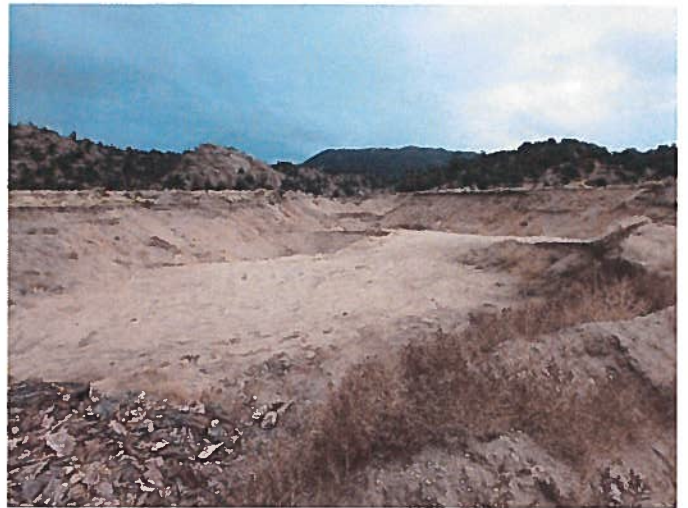
Figure 2: View towards the east end of the pit

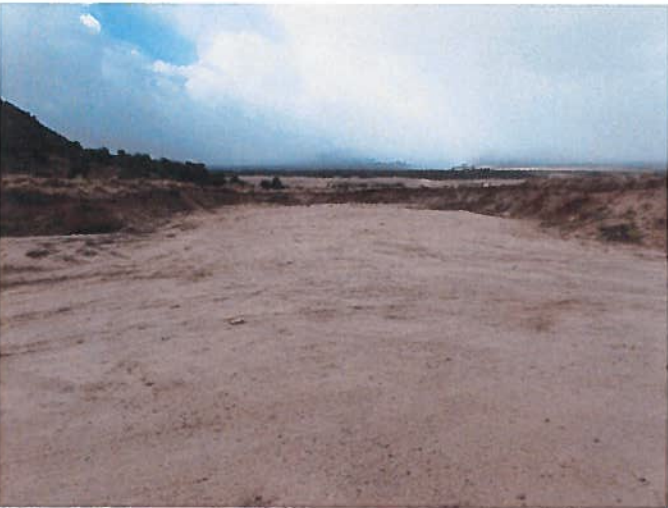
Figure 3: View towards the west end of the pit
