**COLORADO DIVISION OF RECLAMATION, MINING AND SAFETY**  
**MINERALS PROGRAM INSPECTION REPORT**  
**PHONE: (303) 866-3567**

<b>MINE NAME:</b> Topsoil Pit	<b>MINE/PROSPECTING ID#:</b> M-2012-027	<b>MINERAL:</b> Overburden	<b>COUNTY:</b> Chaffee
<b>INSPECTION TYPE:</b> Monitoring	<b>INSPECTOR(S):</b> Dustin M. Czapla	<b>INSP. DATE:</b> November 4, 2015	<b>INSP. TIME:</b> 09:30
<b>OPERATOR:</b> B & L Cogan, L.L.C.	<b>OPERATOR REPRESENTATIVE:</b> Joseph Cogan	<b>TYPE OF OPERATION:</b> 112c - Construction Regular Operation

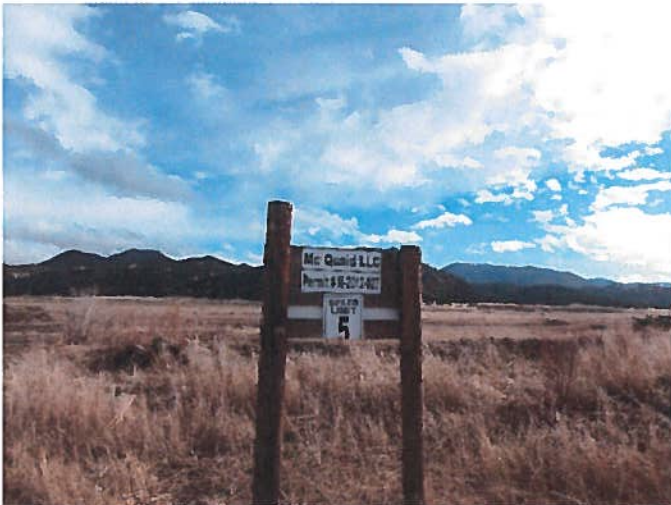
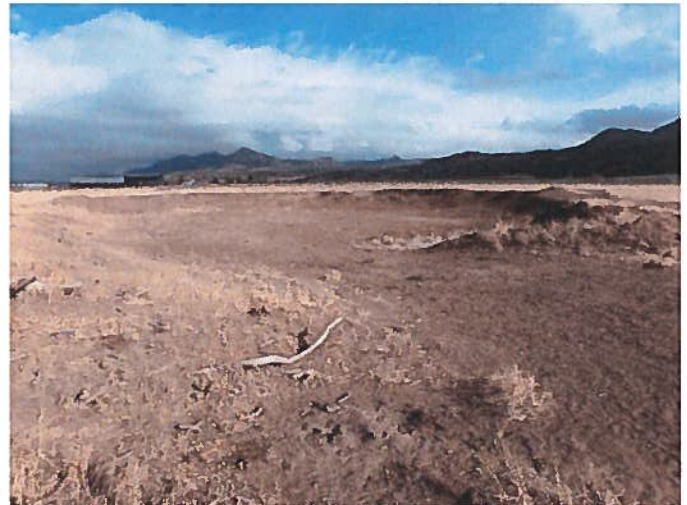
Adequate mine identification signage was noted at the entrance to the site.

The affected area was marked by fencing that was clearly visible and adequate to delineate the affected area boundary.

There is currently less than one acre disturbed by the operation. The pit has been excavated to a depth of approximately five feet. The slopes on the east and north sides of the pit are approximately 1H:1V. The slope on the west side of the pit is approximately 2H:1V.
