COLORADO DIVISION OF RECLAMATION, MINING AND SAFETY
MINERALS PROGRAM INSPECTION REPORT
PHONE: (303) 866-3567

MINE NAME: Bromley Lakes	MINE/PROSPECTING ID#: M-1987-049	MINERAL: Sand and gravel	COUNTY: Adams
INSPECTION TYPE: Monitoring	INSPECTOR(S): Tyler V. O'Donnell	INSP. DATE: April 14, 2015	INSP. TIME: 13:00
OPERATOR: Ready Mixed Concrete Company	OPERATOR REPRESENTATIVE: Bill Timmons	TYPE OF OPERATION: 112c - Construction Regular Operation

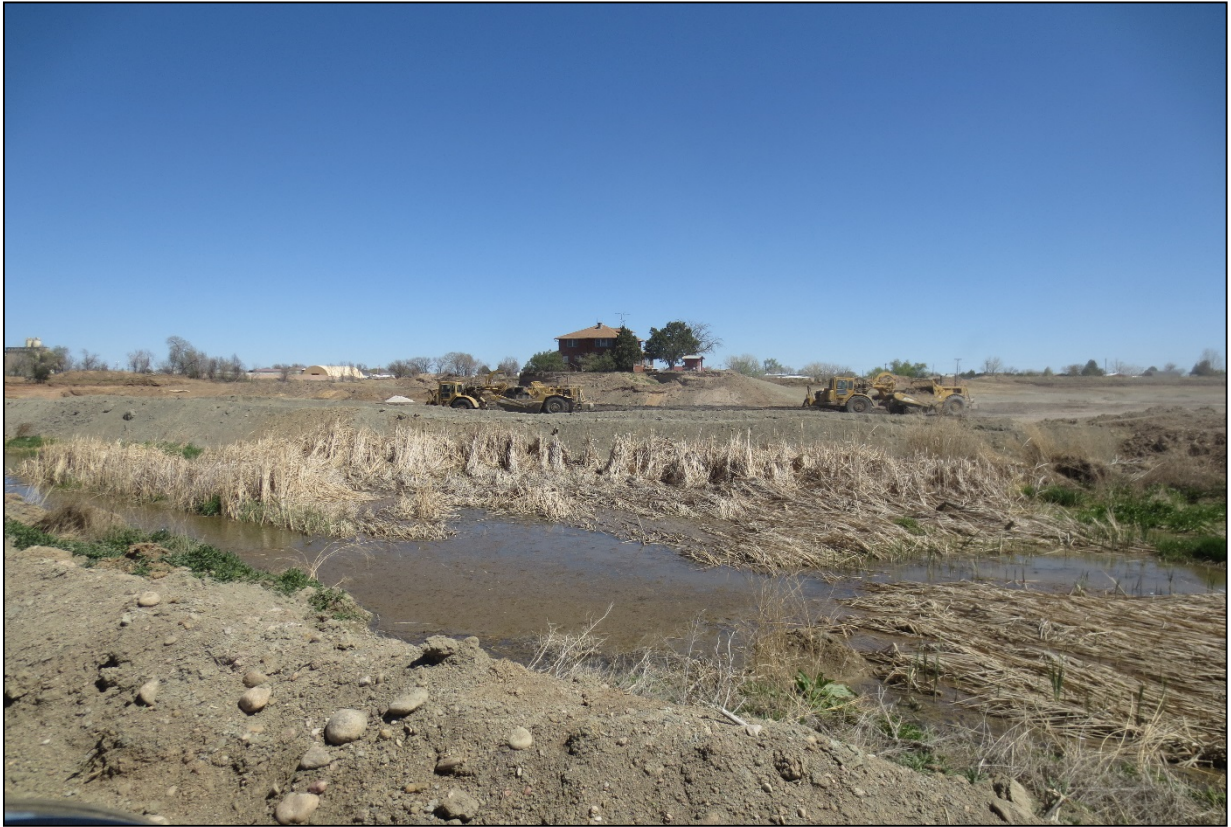
Photo 1: Backfilling and grading in Phase 16.

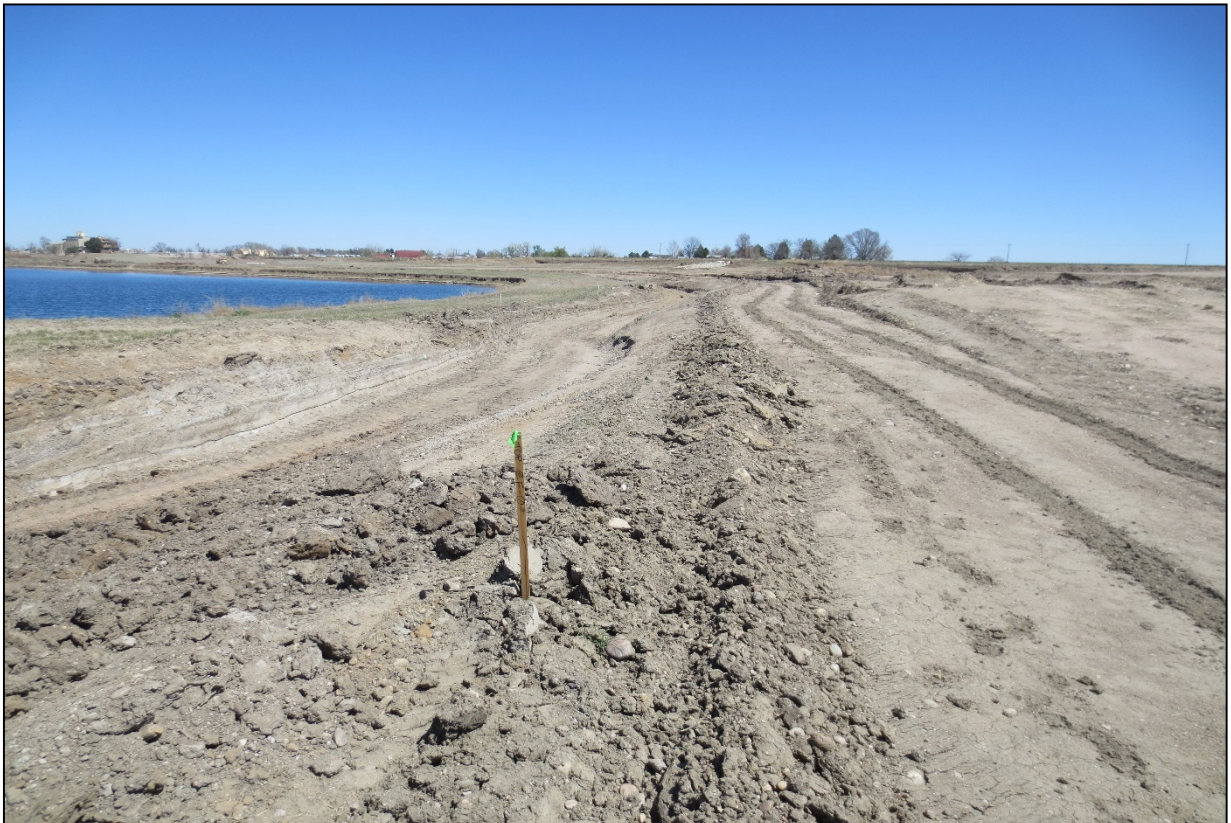
Photo 2: Re-construct/restore the McCanne Ditch

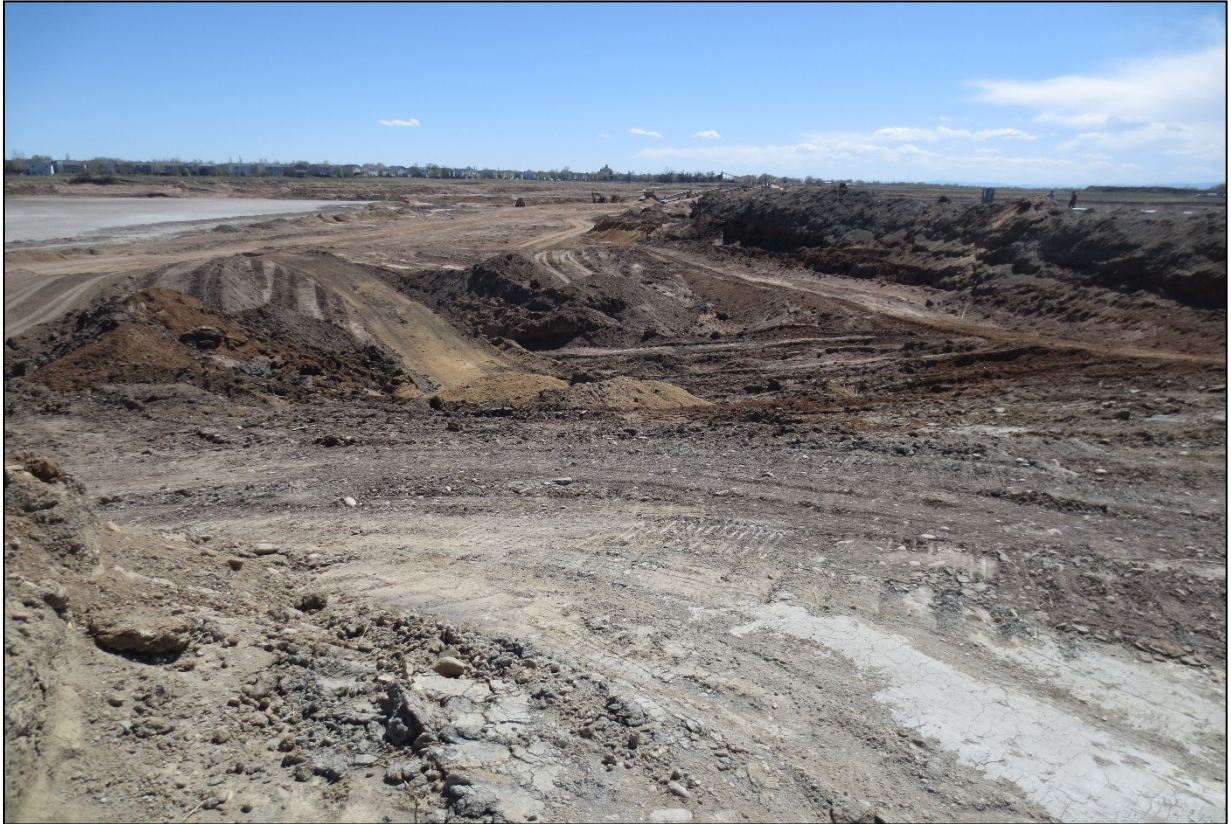
Photo 3: Retreat mining of phase 11 (land bridge). Sections of the conveyor belt have been removed as mining is completed.

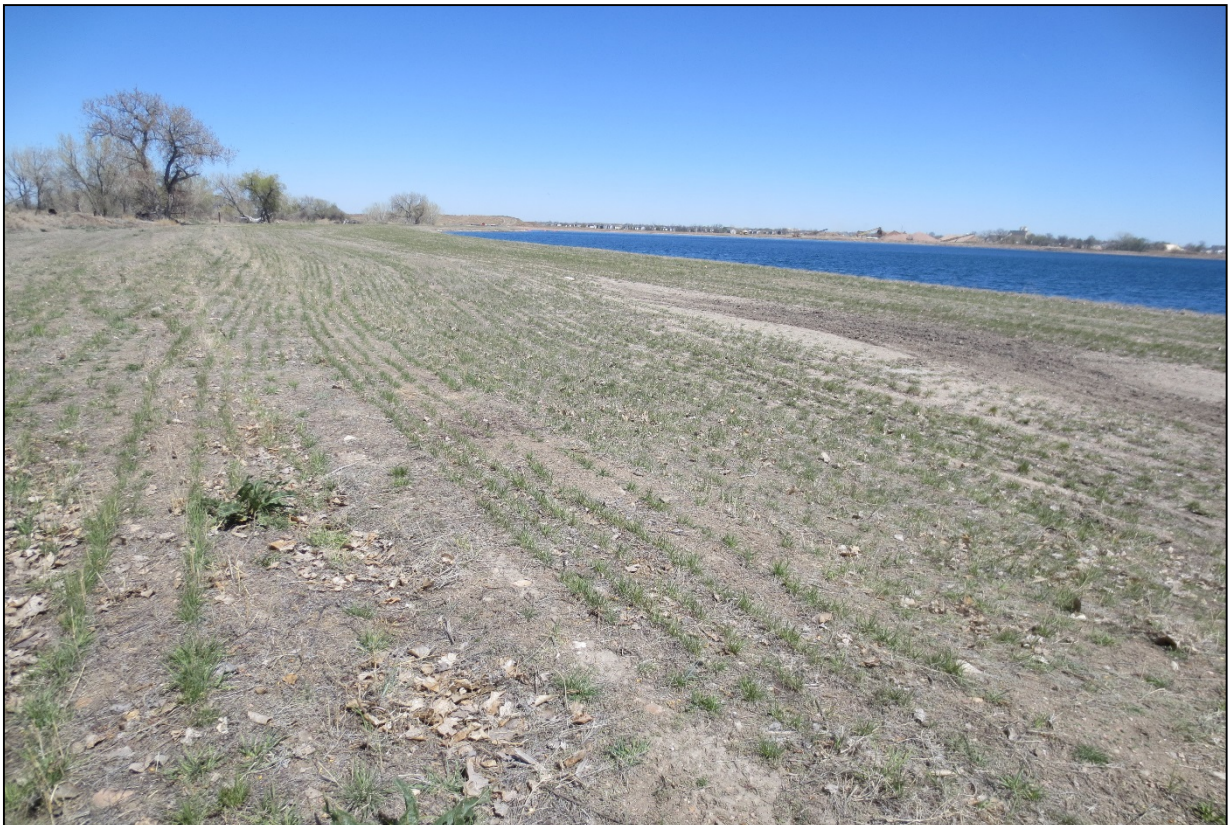
have been backfilled and graded. The Operator has seeded the portion of the site located west of Cell No. 3 (Photo 4).

There was 22 acres of recently seeded land just west of Cell No. 3. The area west of Cell No. 3 has been revegetated and has a strong mix of grasses beginning to establish.

Photo 4: Seeded portions along the west side of Cell No. 3
