COLORADO DIVISION OF RECLAMATION, MINING AND SAFETY
MINERALS PROGRAM INSPECTION REPORT
PHONE: (303) 866-3567

MINE NAME: Cresson Project	MINE/PROSPECTING ID#: M-1980-244	MINERAL: Gold	COUNTY: Teller
INSPECTION TYPE: Aerial Inspection	INSPECTOR(S): Timothy A. Cazier	INSP. DATE: September 30, 2015	INSP. TIME: 09:10
OPERATOR: Cripple Creek & Victor Gold Mining Company	OPERATOR REPRESENTATIVE: None	TYPE OF OPERATION: 112d-3 - Designated Mining Operation

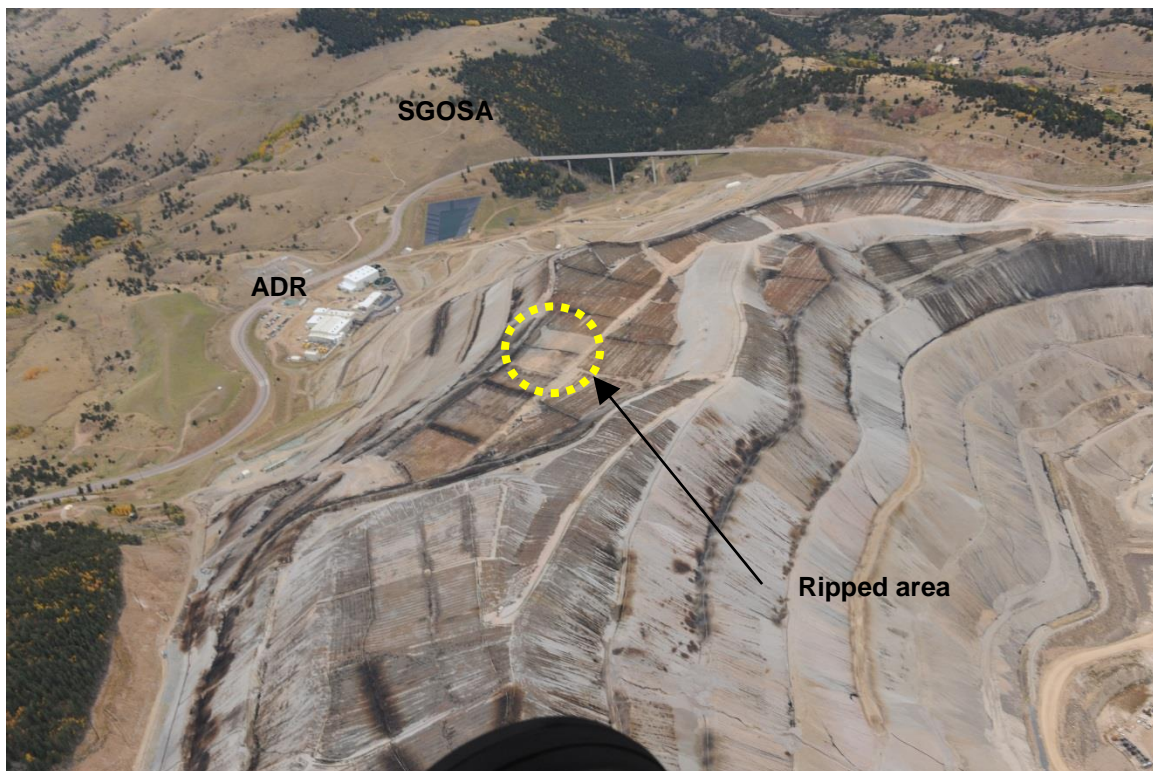
Photo 2. Arequa Gulch VLF (Looking west).

Some AGVLF areas show sign of the re-ripping mitigation effort (see **Photo 2**). The Division will inspect the AGVLF during the next inspection.
