**COLORADO DIVISION OF RECLAMATION, MINING AND SAFETY**  
**MINERALS PROGRAM INSPECTION REPORT**  
**PHONE: (303) 866-3567**

| <b>MINE NAME:</b><br>Vick Borrow Pit | <b>MINE/PROSPECTING ID#:</b><br>M-2010-048 | <b>MINERAL:</b><br>Borrow material | <b>COUNTY:</b><br>Lincoln |
| <b>INSPECTION TYPE:</b><br>Monitoring | <b>INSPECTOR(S):</b><br>Amy Eschberger | <b>INSP. DATE:</b><br>November 19, 2015 | <b>INSP. TIME:</b><br>13:40 |

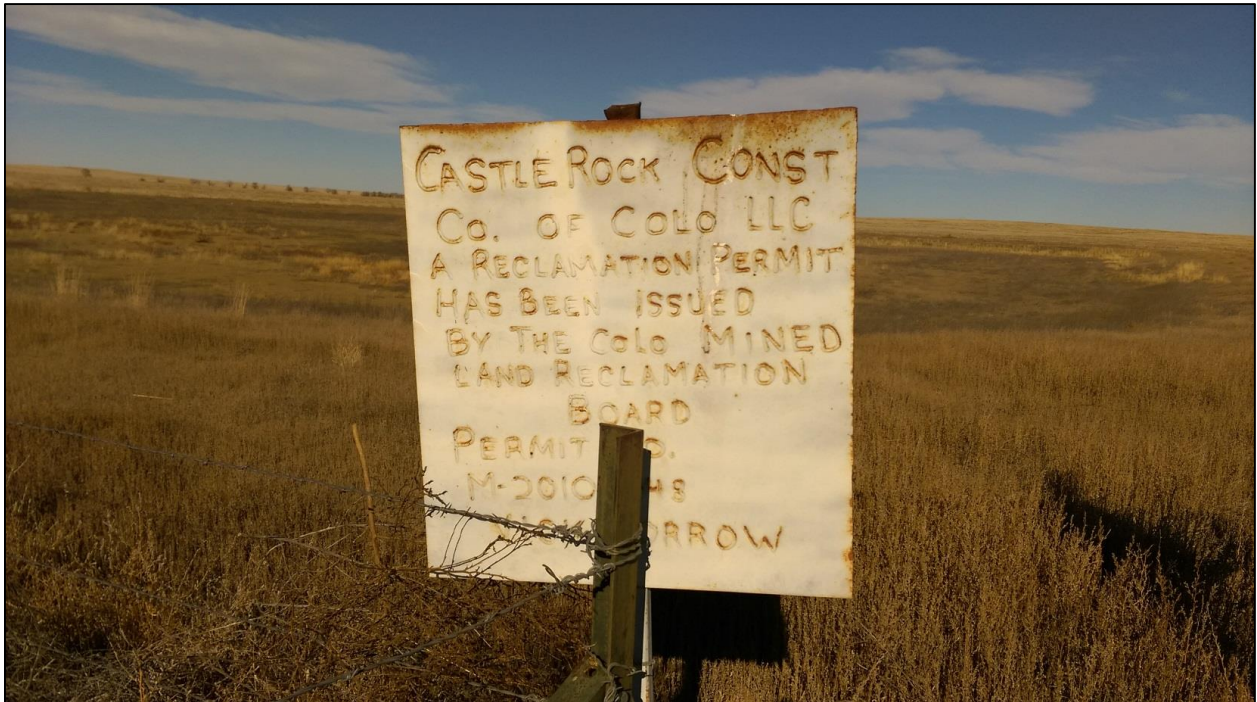
At the time of the inspection, the weather was clear, cold, and sunny, and the ground was dry. A permit sign was posted at the main entrance to the site (**Photo 1**). The permit boundary was completely enclosed by a barbed wire fence for protection from grazing during grass establishment. The mined pit is a shallow rectangular-shaped depression with the side slopes graded to a 5H:1V gradient (**Photos 2-4**). The disturbed land has some vegetative cover including a mixture of native grasses, forbs, and annual weeds (**Photos 5-7; also see Photos 2-4**). However, at this time, the grasses are concentrated primarily along the edges of the pit, with mainly weeds growing on the pit floor (**Photos 8-11**). In the inspection report for 04/04/2013, the Division noted that no vegetation was growing on the side slopes and no germination of the planted grass species was observed. Since that time, the site has clearly shown some success with vegetative growth. The Division recommends the operator continue to closely monitor the site for establishment of vegetation. It may be necessary to reseed the pit floor next spring. Additionally, the Division recommends the operator closely monitor the growth of state-listed noxious weed species in the permit area, and implement the approved weed control and management plan as needed to keep these weeds from establishing at the site. In particular, the Division observed some Canada thistle growing in the southwestern portion of the permit area.

**Photo 1.** View of permit identification sign posted at main entrance to site.

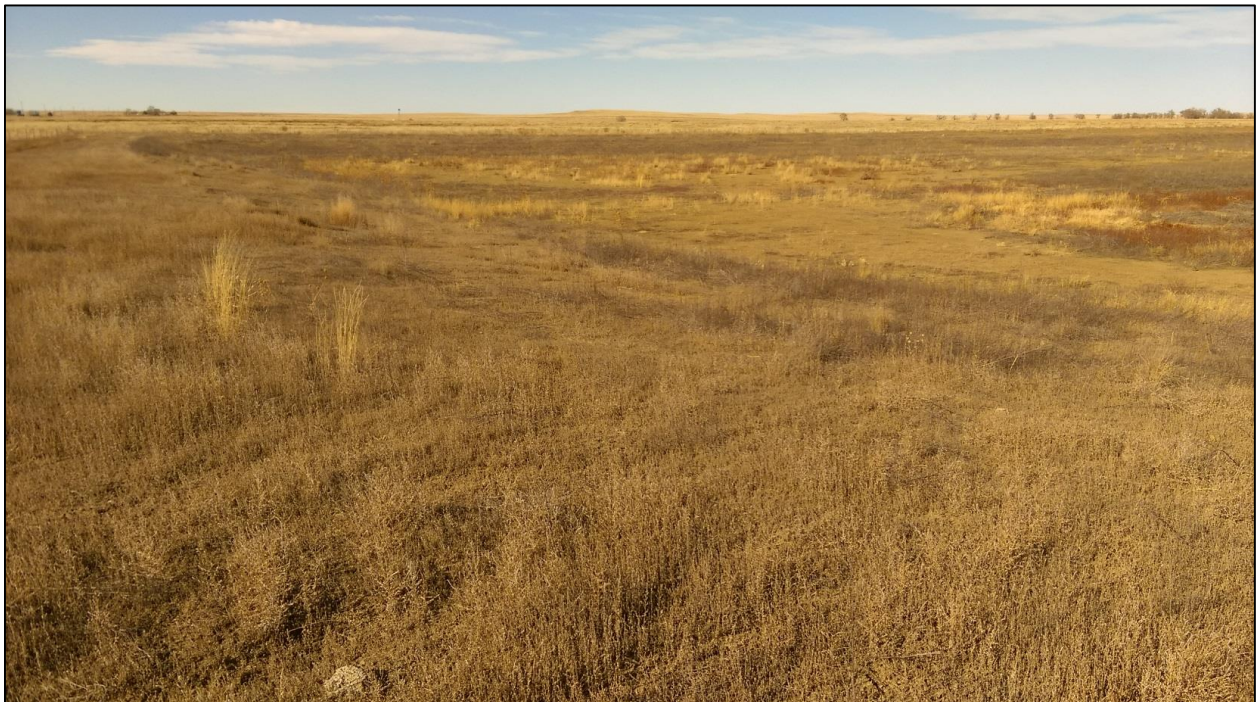
**Photo 2.** View looking northwest across southwestern mined slope graded to 5H:1V, stable with vegetative cover.

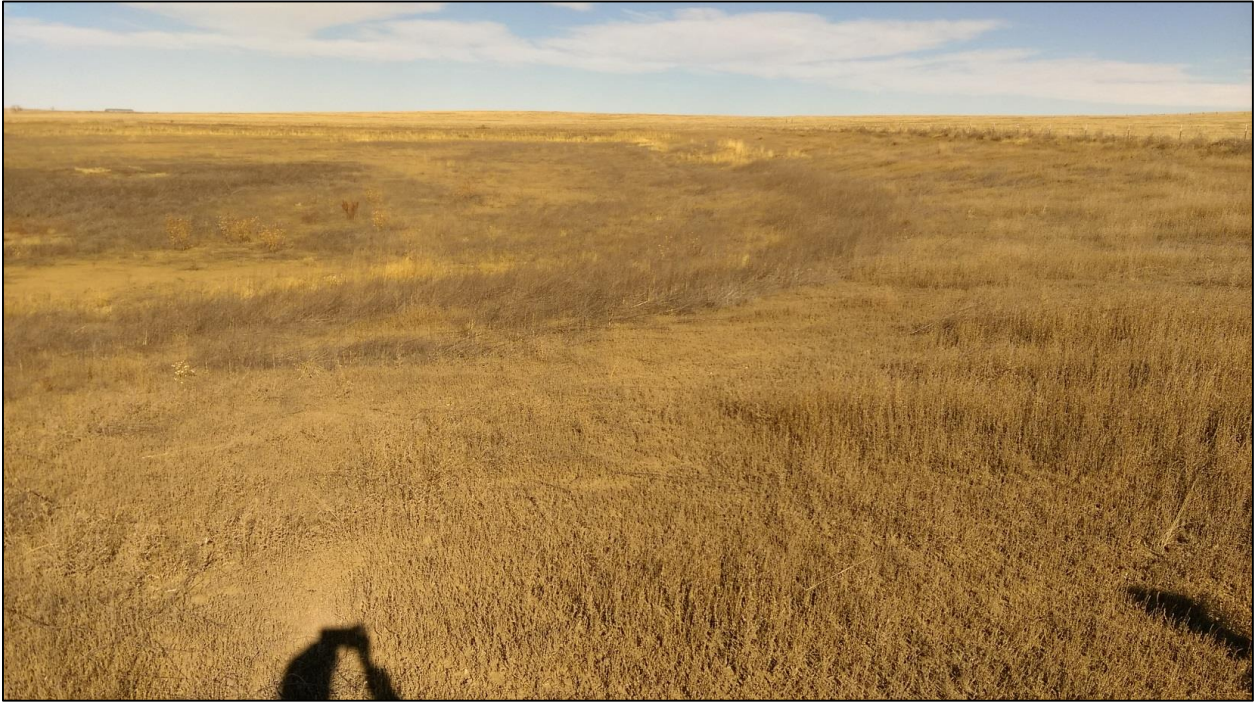
**Photo 3.** View looking northeast across southeastern mined slope graded to 5H:1V, stable with vegetative cover.

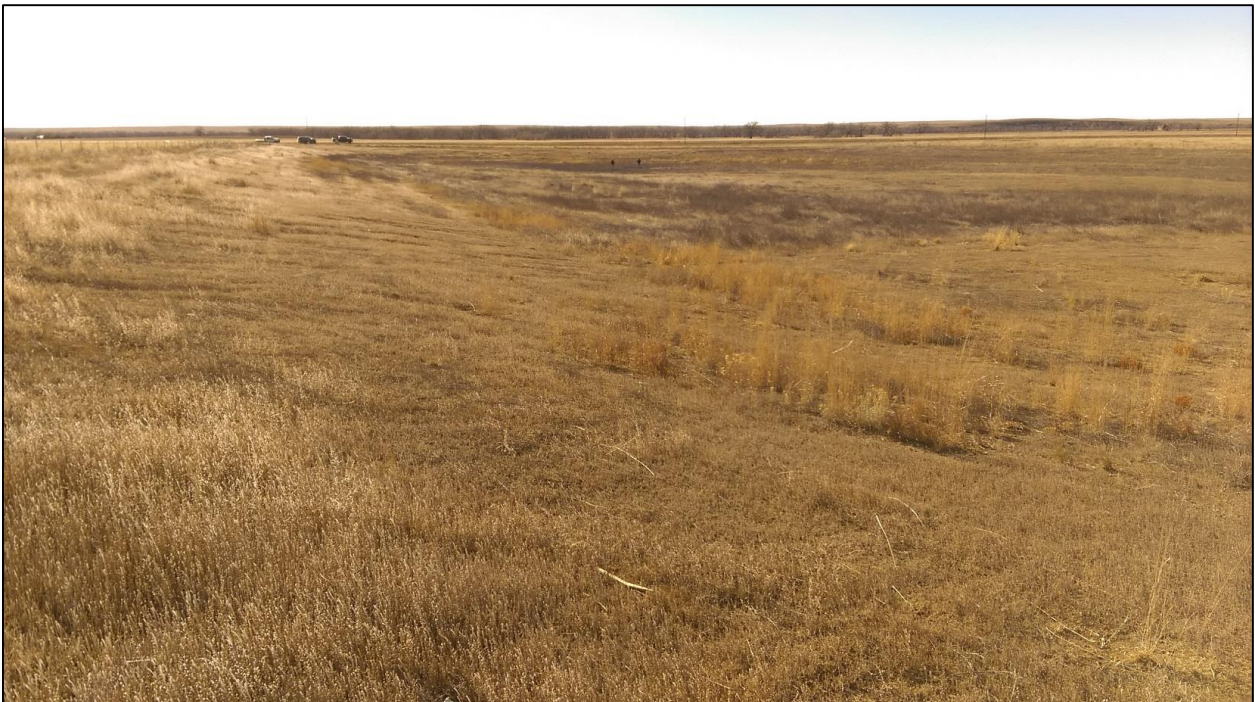
**Photo 4.** View looking southwest across southeastern mined slope graded to 5H:1V, stable with vegetative cover.

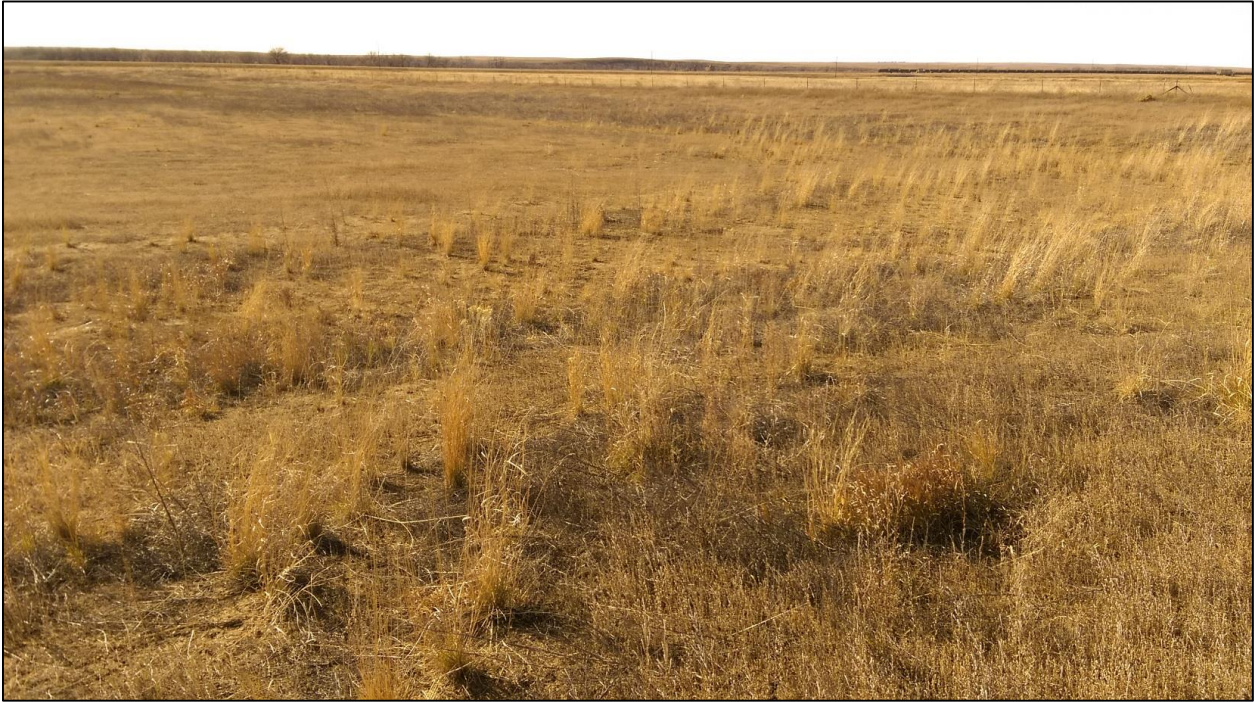
**Photo 5.** View looking northwest across northeastern edge of pit, showing vegetative cover consisting of native grasses, forbs, and annual weeds. Note grasses primarily concentrated at edge of pit.

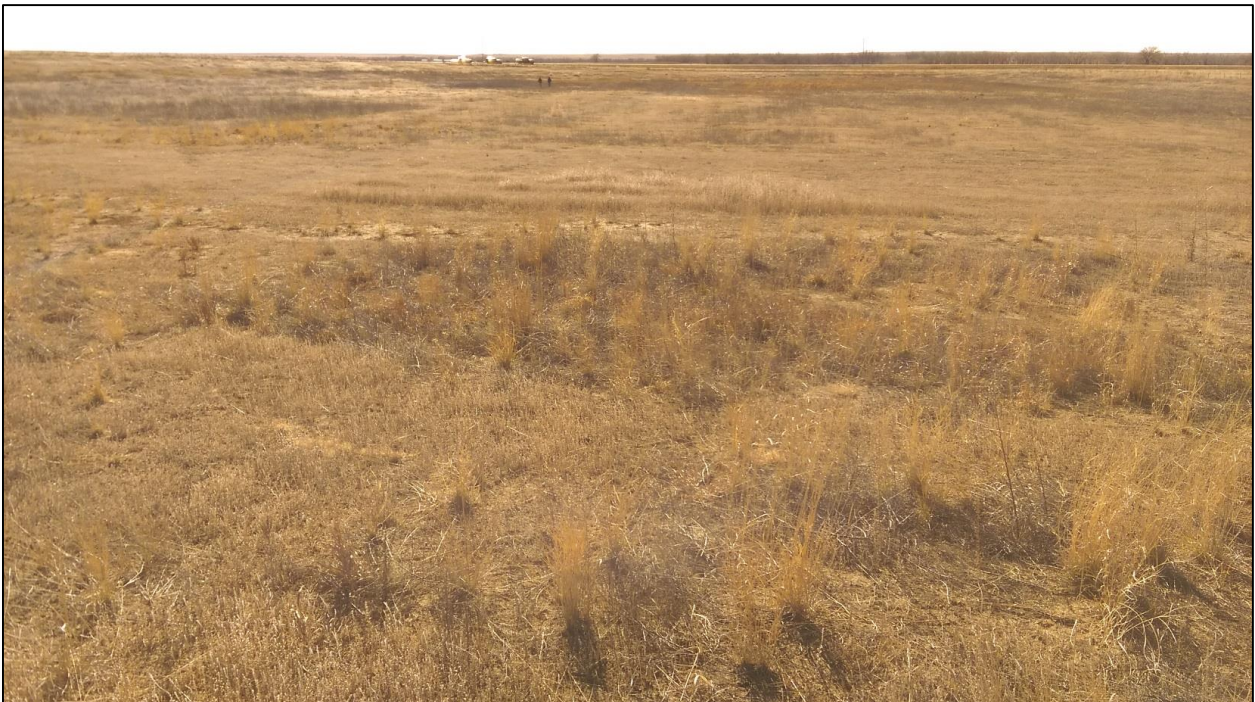
**Photo 6.** View looking south across pit from northeastern edge, showing vegetative cover consisting of native grasses, forbs, and annual weeds mainly along edge of pit (shown in foreground).

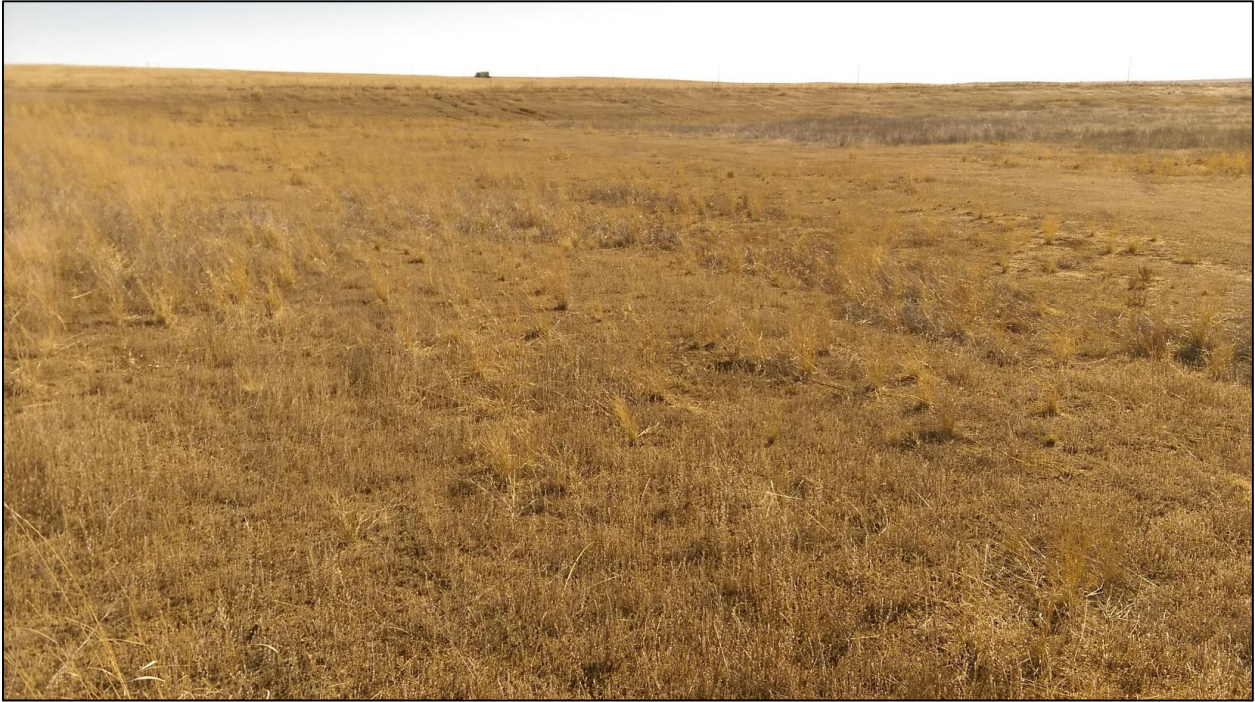
**Photo 7.** View looking southeast across northeastern edge of pit, showing vegetative cover consisting of native grasses, forbs, and annual weeds.

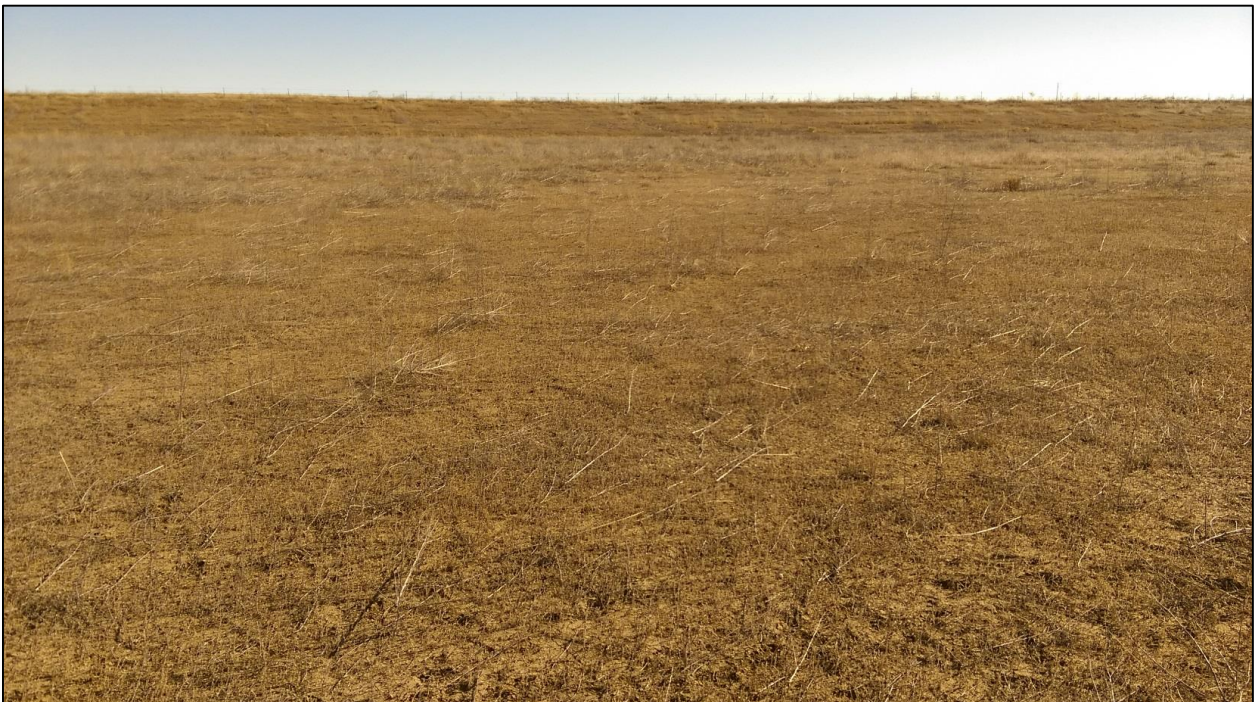
**Photo 8.** View looking southeast from center of pit floor, showing less grass establishment on pit floor than observed along edges of pit.

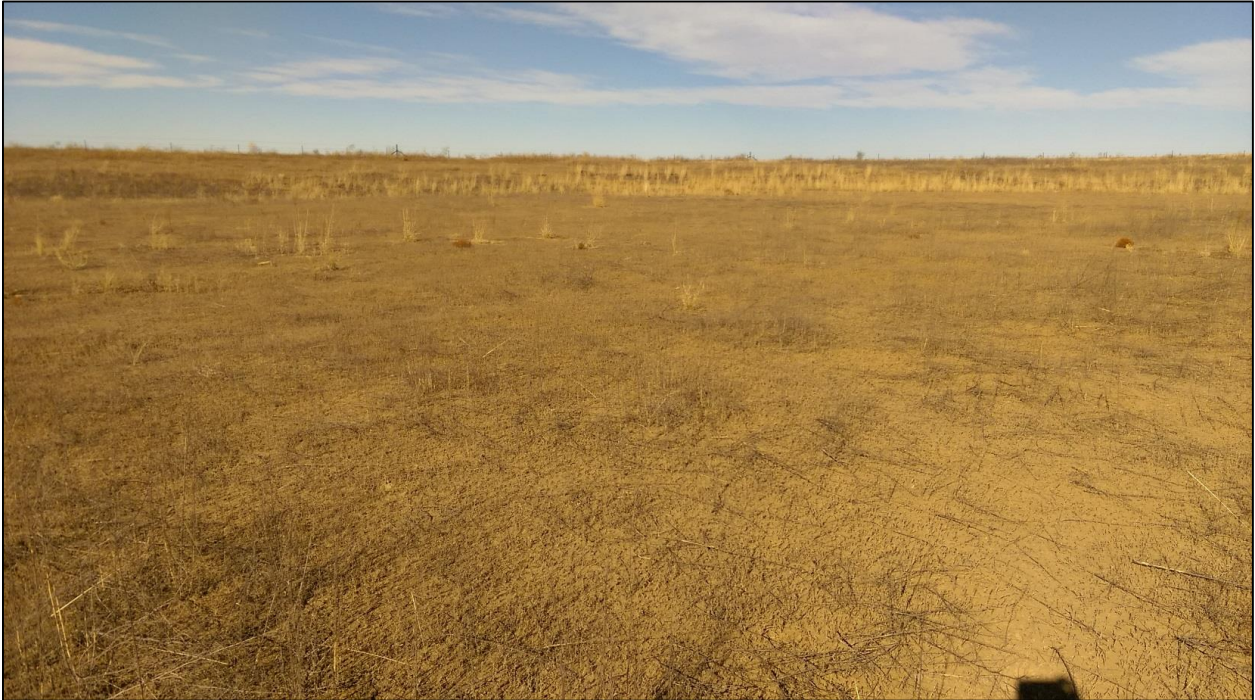
**Photo 9.** View looking north from center of pit floor, showing less grass establishment on pit floor than observed along edges of pit (shown in background).

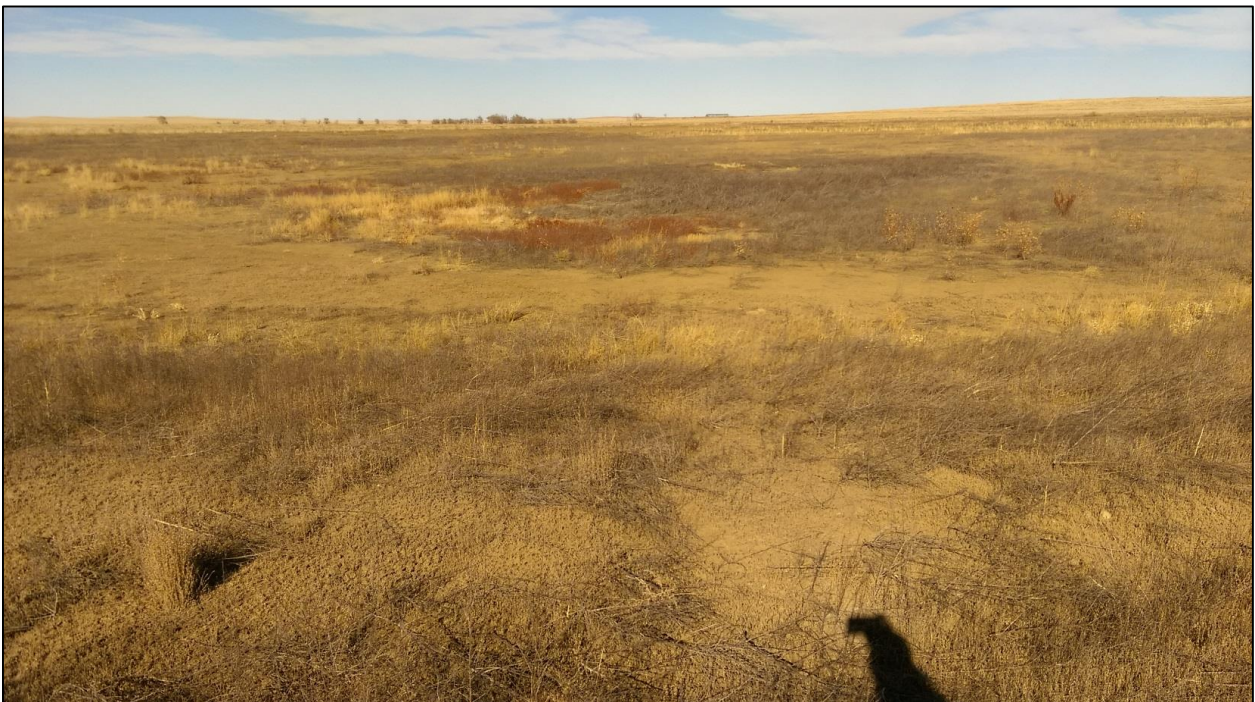
**Photo 10.** View looking northwest from southeastern corner of pit, showing less grass establishment on pit floor than observed along edges of pit.

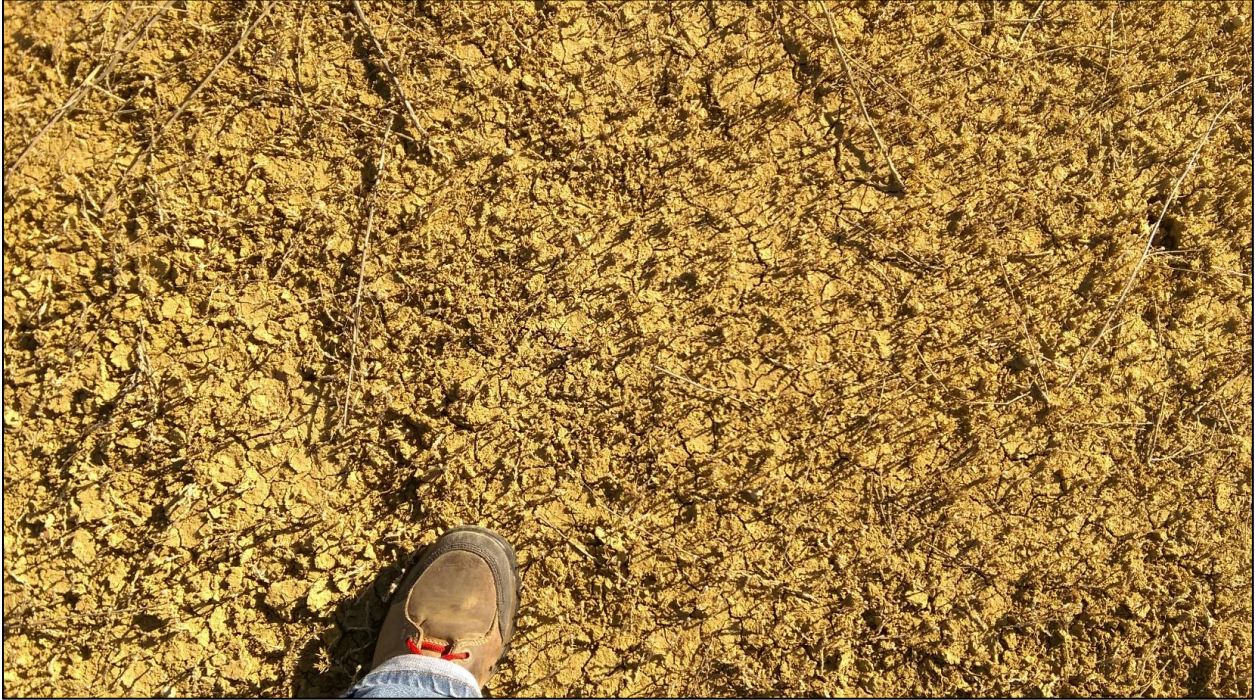
**Photo 11.** Representative close-up view of pit floor, showing vegetation currently present across much of pit floor
