COLORADO DIVISION OF RECLAMATION, MINING AND SAFETY
MINERALS PROGRAM INSPECTION REPORT
PHONE: (303) 866-3567

MINE NAME: Debeque Sand and Gravel Resource	MINE/PROSPECTING ID#: M-2011-054	MINERAL: Gravel and sand	COUNTY: Mesa
INSPECTION TYPE: Monitoring	INSPECTOR(S): Stephanie J. Mitchell	INSP. DATE: October 28, 2015	INSP. TIME: 10:30
OPERATOR: Oldcastle Southwest Group, Inc. dba United C	OPERATOR REPRESENTATIVE: Jason Burkey	TYPE OF OPERATION: 112c - Construction Regular Operation

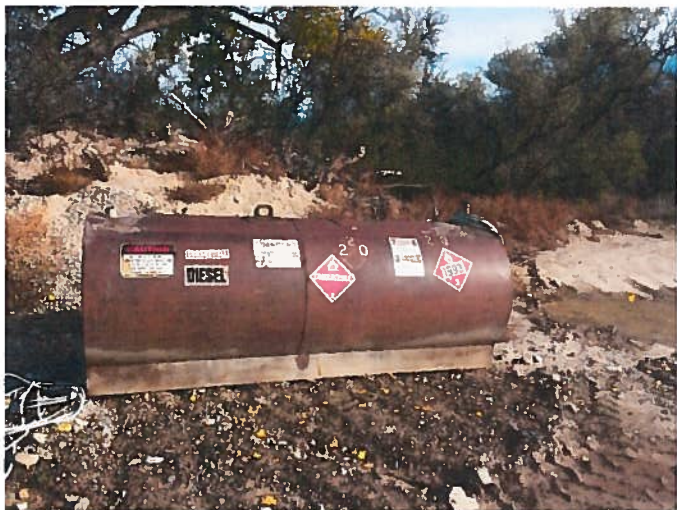
There were two fuel tanks on site. One tank was empty and did not have secondary containment. The other contained fuel and did have secondary containment.

Empty Fuel Tank

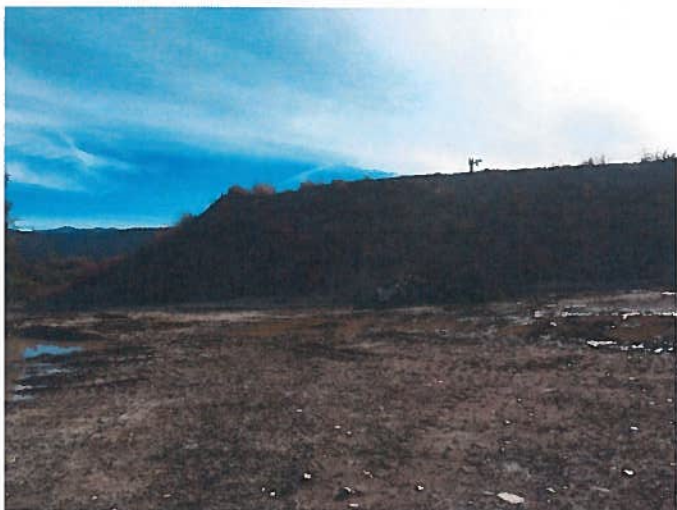
A haul road runs from the southern entrance of the mine site to the northeast corner of the permit area. Mined material is stockpiled in the Phase 1 area. Topsoil has been salvaged in advance of the excavation and placed in various berms adjacent to the pit slopes on the north and east sides of the permit area. The topsoil berms appear stable with vegetative cover.

TopSoil Stockpile

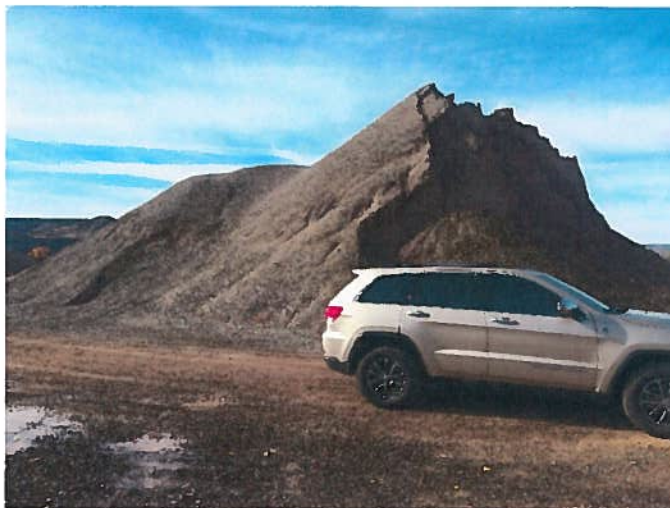
Material Stockpile

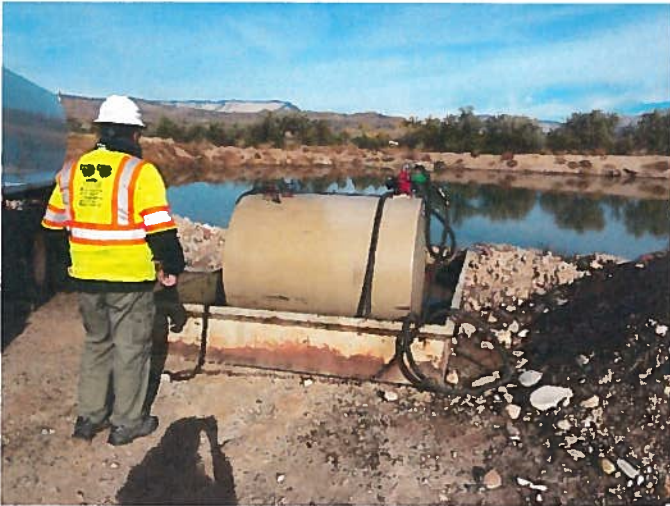
Fuel Tank with adequate secondary containment

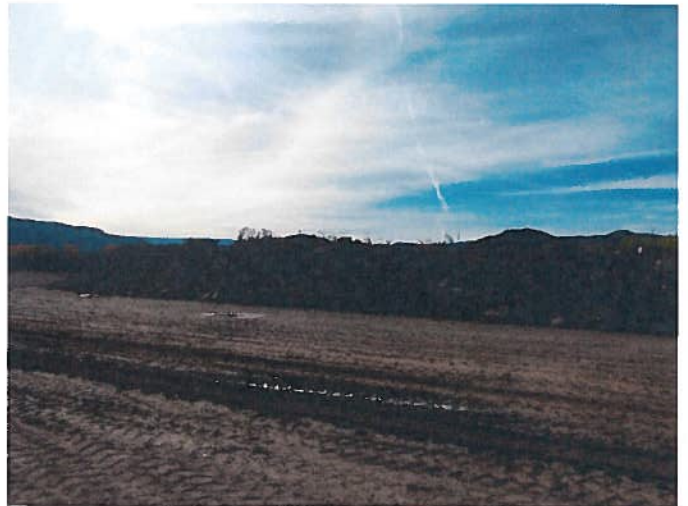
PROBLEM/POSSIBLE VIOLATION: Problem: The site is utilizing off-site fill without prior approval by the Division per 3.1.5(9) of the Rule.

There was a large pile of concrete slabs on site. This is offsite material and is considered a problem at this time. Details for compliance are noted at the beginning of this inspection report.

Offsite Material

CORRECTIVE ACTIONS: The operator shall provide a notarized affidavit, stating that the fill is, in fact, inert and addressing all requirements pursuant to Rule 3.1.5(9), which describes the intended use of inert/off-site fill by the corrective action date.

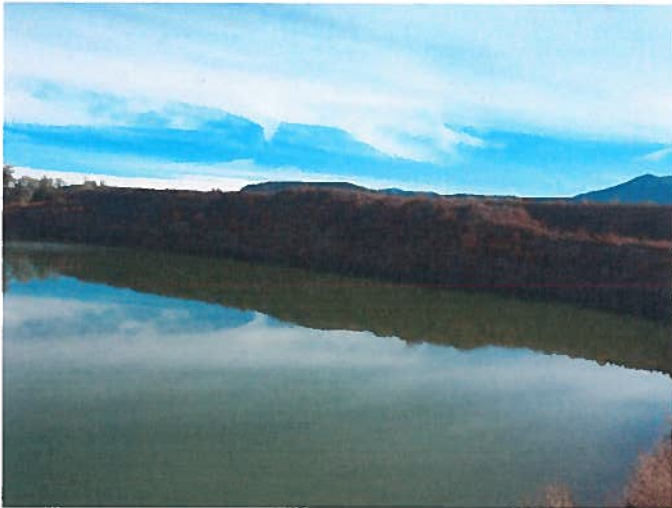
The pit excavation is about 20 to 25 feet deep. The pond pit slopes are at a 1:1 slope, but according to the mining plan, the final pit slopes will be at 3:1 per Rule 3.1.5(7). The Division recommends dewatering the pond before sloping pit slopes to conform to this rule.

Pond with too steep of slopes – 3:1 required

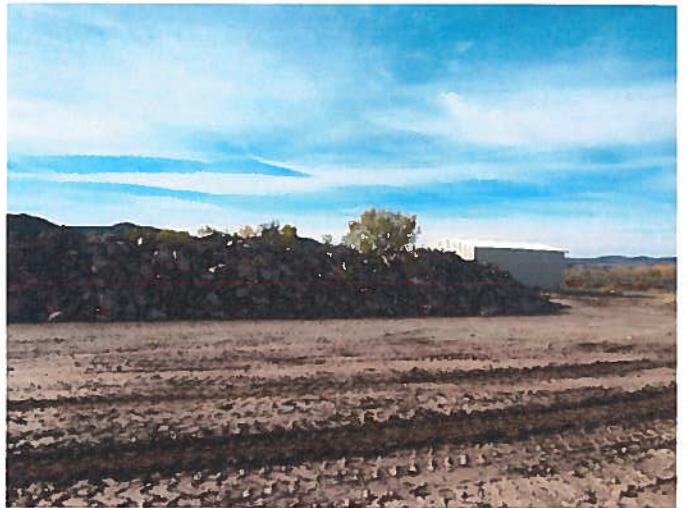
Offsite Material

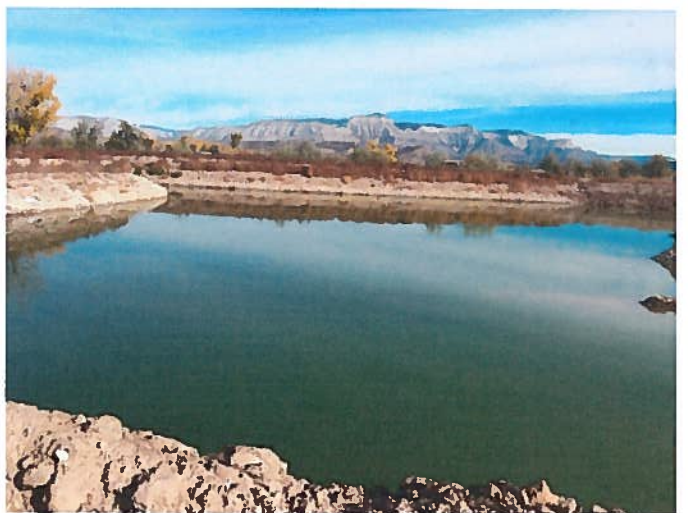
Some water retainage- should be less than 72 hours
