COLORADO DIVISION OF RECLAMATION, MINING AND SAFETY
MINERALS PROGRAM INSPECTION REPORT
PHONE: (303) 866-3567

MINE NAME: Moon Pit No 2	MINE/PROSPECTING ID#: M-1977-443	MINERAL: Sand and gravel	COUNTY: Moffat
INSPECTION TYPE: Surety-Related Inspection	INSPECTOR(S): Amy C. Yeldell	INSP. DATE: December 24, 2015	INSP. TIME: 13:30
OPERATOR: Northwest Aggregates, Inc.	OPERATOR REPRESENTATIVE: Jack Paulson & Penny Lewis	TYPE OF OPERATION: 110c - Construction Limited Impact	
REASON FOR INSPECTION: Surety Related	BOND CALCULATION TYPE: Complete Bond	BOND AMOUNT: \$16,500.00	
DATE OF COMPLAINT: NA	POST INSP. CONTACTS: None	JOINT INSP. AGENCY: None	
WEATHER: Cloudy	INSPECTOR'S SIGNATURE:

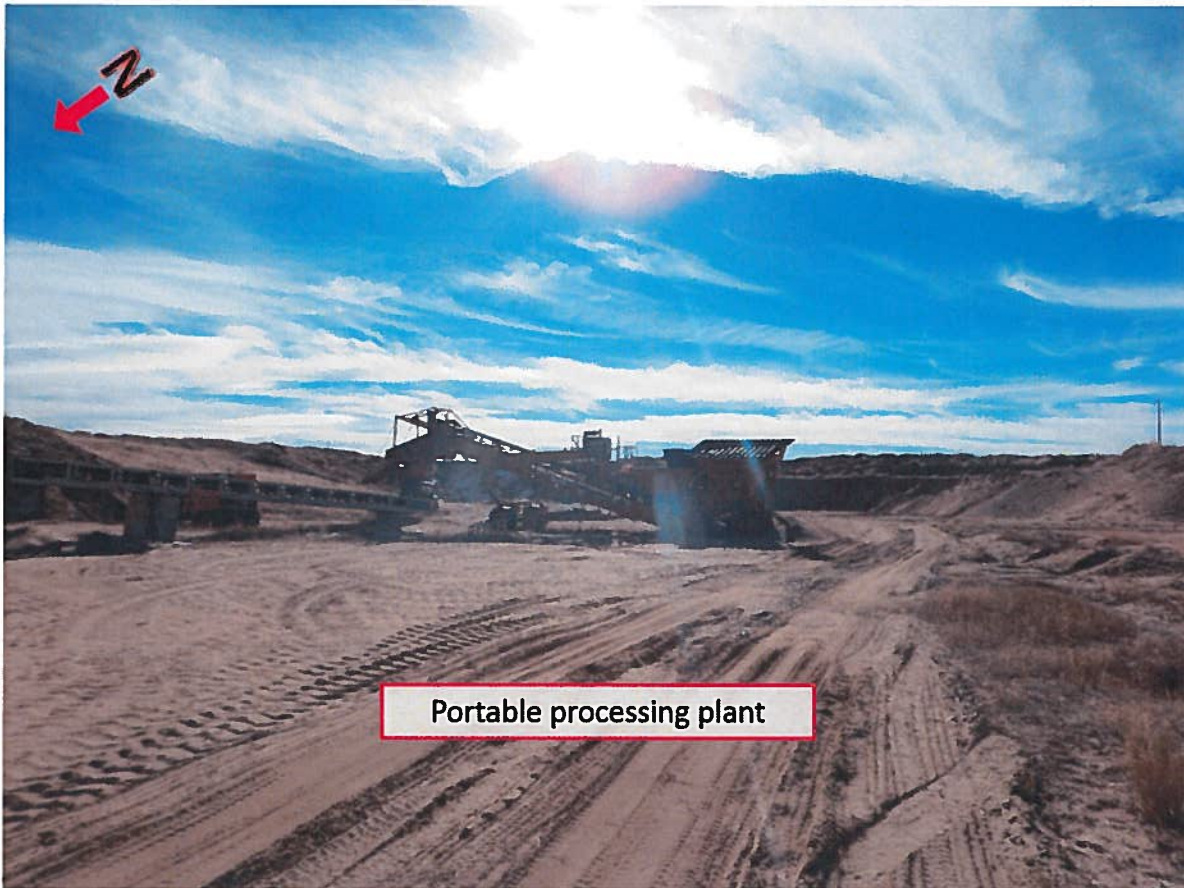
A portable screen/sifter was observed but not in operation at the time of the inspection. No fuel, trash or other hazardous material is stored at this site.

Portable processing plant

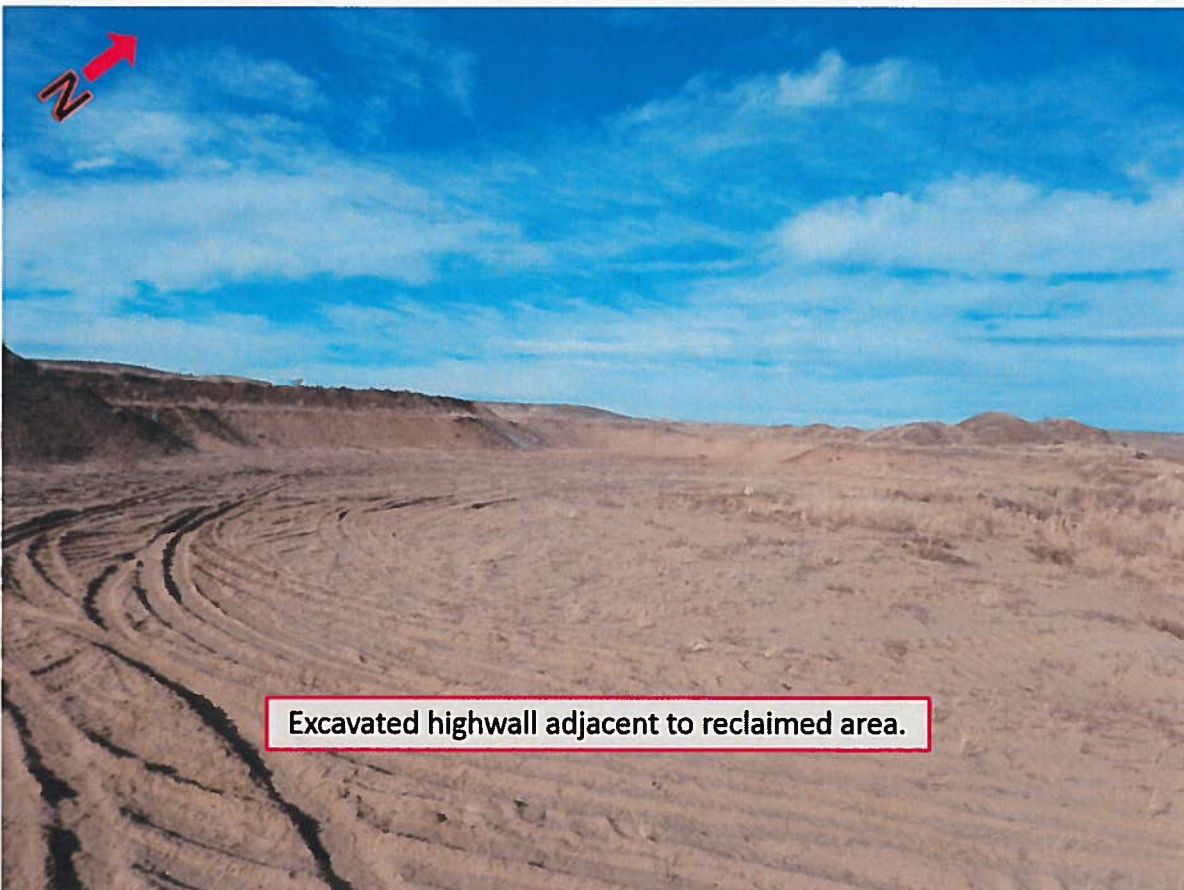
Slopes are mostly 1.5:1 to 2:1in areas where mining is actively occurring. All slopes are stable with no erosion. In an effort to ensure the Financial Warranty adequately, reflects the actual current cost of fulfilling the requirements of the approved reclamation plan the Division will be updating the reclamation cost estimate. The bond currently held in the amount \$16,357 is adequate to compete the approved reclamation plan.

Excavated highwall adjacent to reclaimed area.
