COLORADO DIVISION OF RECLAMATION, MINING AND SAFETY
MINERALS PROGRAM INSPECTION REPORT
PHONE: (303) 866-3567

MINE NAME: Sunday Mine	MINE/PROSPECTING ID#: M-1977-285	MINERAL: Uranium and vanadium	COUNTY: San Miguel
INSPECTION TYPE: Multi Person Inspection	INSPECTOR(S): Lucas J. West, Russ Means	INSP. DATE: November 23, 2015	INSP. TIME: 11:00
OPERATOR: Pinon Ridge Mining LLC	OPERATOR REPRESENTATIVE: None	TYPE OF OPERATION: 112d-2 - Designated Mining Operation	
REASON FOR INSPECTION: Normal I&E Program	BOND CALCULATION TYPE: None	BOND AMOUNT: \$297,926.00	
DATE OF COMPLAINT: NA	POST INSP. CONTACTS: None	JOINT INSP. AGENCY: None	
WEATHER: Clear	INSPECTOR'S SIGNATURE:

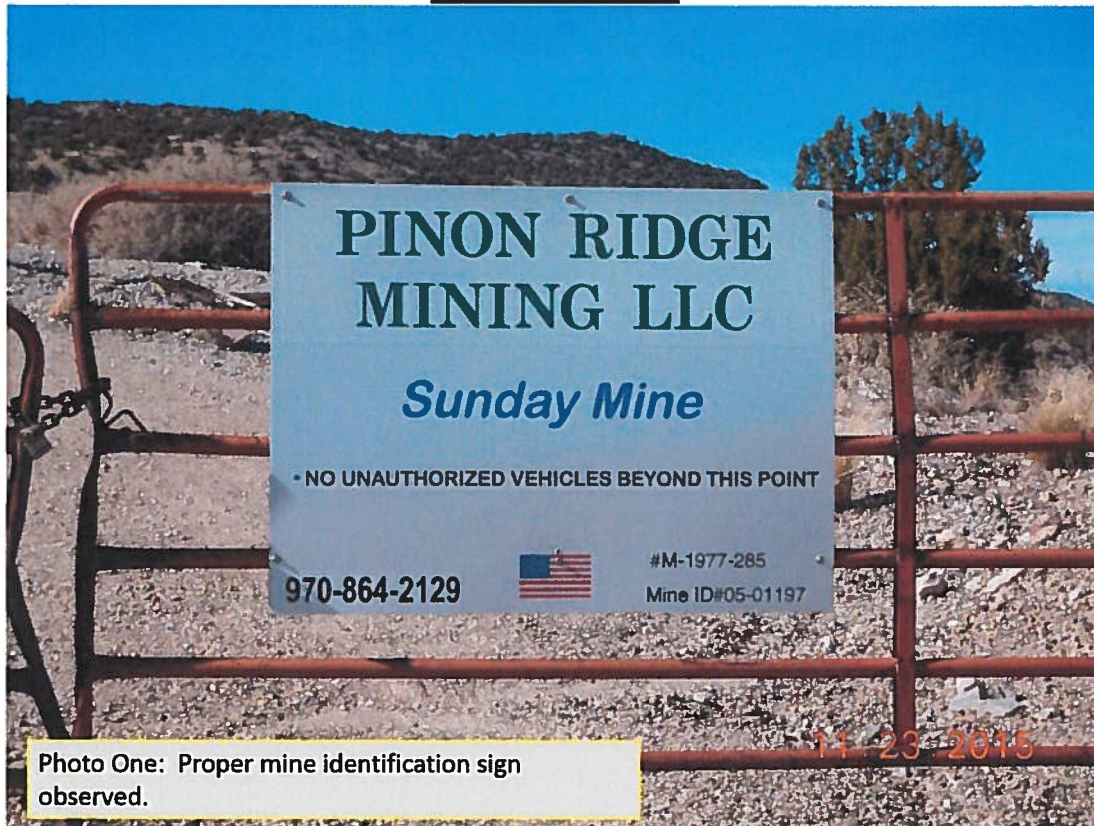
As seen in Photo One, the permit ID sign was observed at the entrance to the site. The permit boundary markers were also observed. The remote vent shaft sites were not inspected at this time. Photos Two and Three show the Sediment catchments functioning properly in response to a recent precipitation event. All diversion ditches appear to be functioning as designed and no significant erosion was observed throughout most of the site. One sediment catchment pond however, located just down gradient from the entrance gate shown in Photos Four and Five, has suffered significant erosion. The catchment has sufficient freeboard to not pose an imminent threat to offsite damages however this is cited as a problem with a corrective action date of January 25, 2016. The Operator shall submit photo documentation that the necessary repairs have been completed to prevent possible impacts to areas outside the affected lands. **Documentation demonstrating compliance must be received by the Division's Denver Office no later than January 25, 2016.**

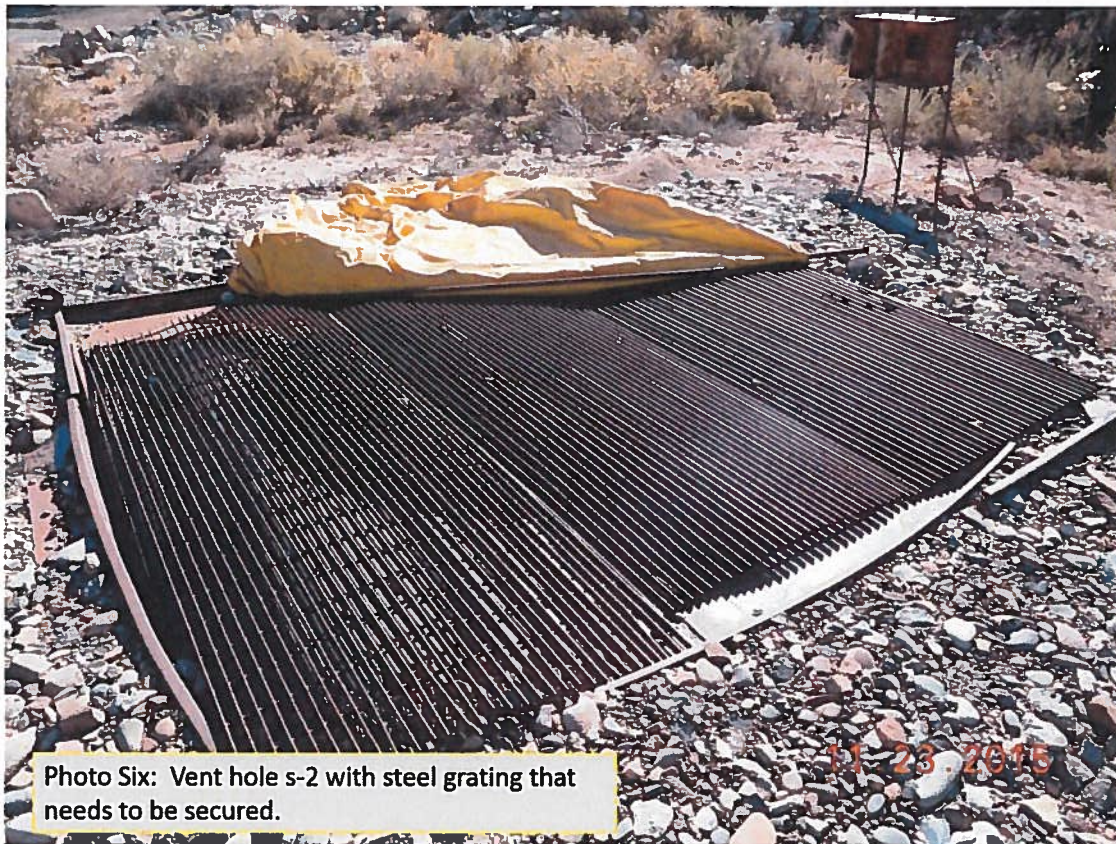
PROBLEM/POSSIBLE VIOLATION: Problem: One of the vent shaft closures located to the Northwest of the shop facilities is not secured posing a threat to public health pursuant to C.R.S. 34-32-124.5 (b) (III).

All work facilities were secure and seemed to be in good condition during the time of the inspection. The portal located on site was also secured, it has been backfilled and closed off with steel grates that are in good condition as seen in Photo Six. Vent shaft S-2, located to the Northwest of the shop facilities is covered with a steel grate, but is not secured. This is being cited as a problem with a compliance date of January 25, 2016. The Operator shall submit photo documentation of either the grate being TAC welded down, a locking mechanism be installed or some other form of securing the vent to prevent any unauthorized access. **Documentation demonstrating compliance must be received by the Division's Denver Office no later than January 25, 2016.**

Photo Six: Vent hole s-2 with steel grating that needs to be secured.

CORRECTIVE ACTIONS: The Operator shall submit photo documentation of the grating being secured by welding, lock installation or method of the Operators choosing by the compliance date of January 25, 2016.
