**COLORADO DIVISION OF RECLAMATION, MINING AND SAFETY**  
**MINERALS PROGRAM INSPECTION REPORT**  
**PHONE: (303) 866-3567**

<b>MINE NAME:</b> Ute Trail	<b>MINE/PROSPECTING ID#:</b> M-2015-044	<b>MINERAL:</b> Sand & Gravel	<b>COUNTY:</b> Delta
<b>INSPECTION TYPE:</b> Illegal(Unpermitted Operation)	<b>INSPECTOR(S):</b> Stephanie J. Mitchell	<b>INSP. DATE:</b> November 12, 2015	<b>INSP. TIME:</b> 11:00
<b>OPERATOR:</b>	<b>OPERATOR REPRESENTATIVE:</b>	<b>TYPE OF OPERATION:</b> ILL - Illegal

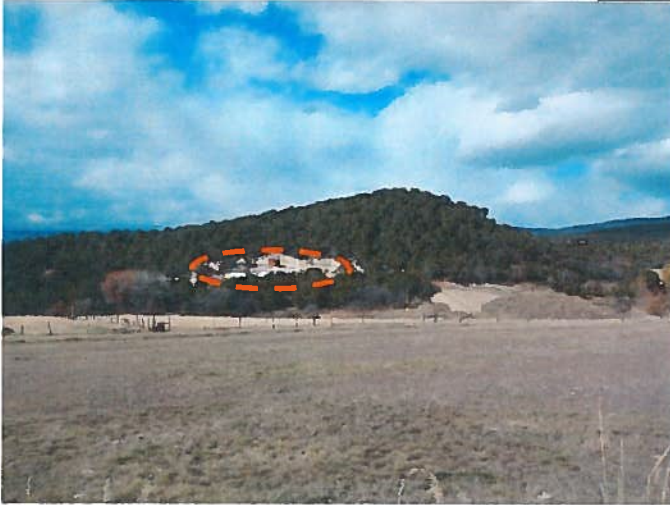
The disturbed area is estimated at about 10 acres. The landowner is encouraged to utilize proper erosion control methods surrounding the site to decrease siltation and disturbance to adjacent areas including Ute Trail Road.

Disturbed Area in Orange Dashed

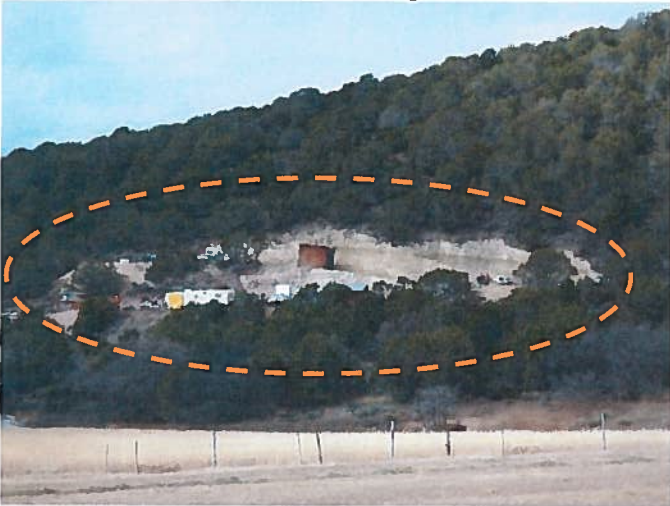
Area used for storage

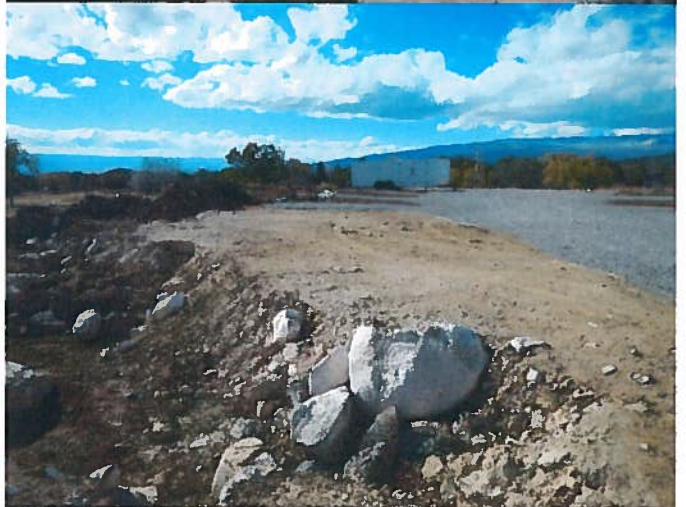
Material used for fill at Aspen Trails Campground
