**COLORADO DIVISION OF RECLAMATION, MINING AND SAFETY**  
**MINERALS PROGRAM INSPECTION REPORT**  
**PHONE: (303) 866-3567**

<b>MINE NAME:</b> Worthing Pit	<b>MINE/PROSPECTING ID#:</b> M-1977-526	<b>MINERAL:</b> Sand and gravel	<b>COUNTY:</b> Adams
<b>INSPECTION TYPE:</b> Monitoring	<b>INSPECTOR(S):</b> Tyler V. O'Donnell	<b>INSP. DATE:</b> May 19, 2015	<b>INSP. TIME:</b> 09:00
<b>OPERATOR:</b> Albert Frei & Sons Inc.	<b>OPERATOR REPRESENTATIVE:</b> Ben Frei	<b>TYPE OF OPERATION:</b> 112c - Construction Regular Operation

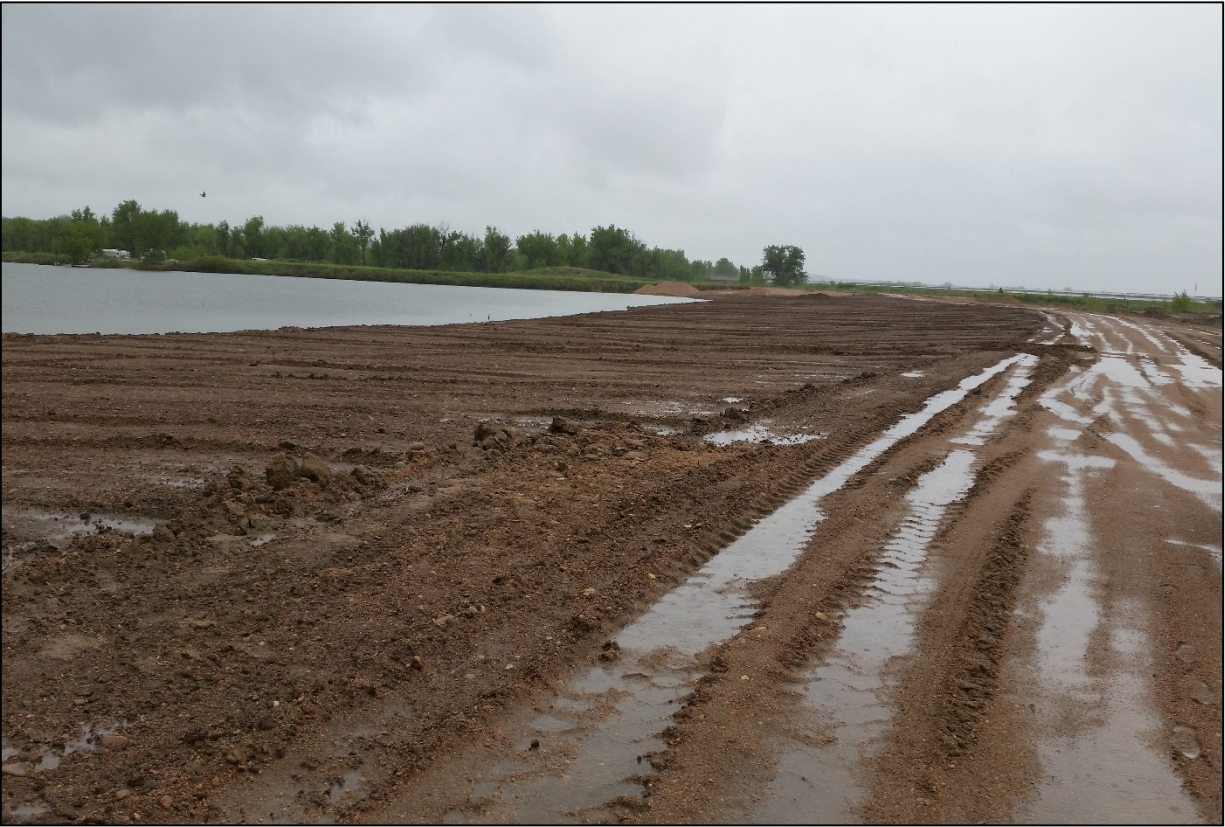
**Photo 1:** Backfilled exposed groundwater in the northwestern portion of the site.

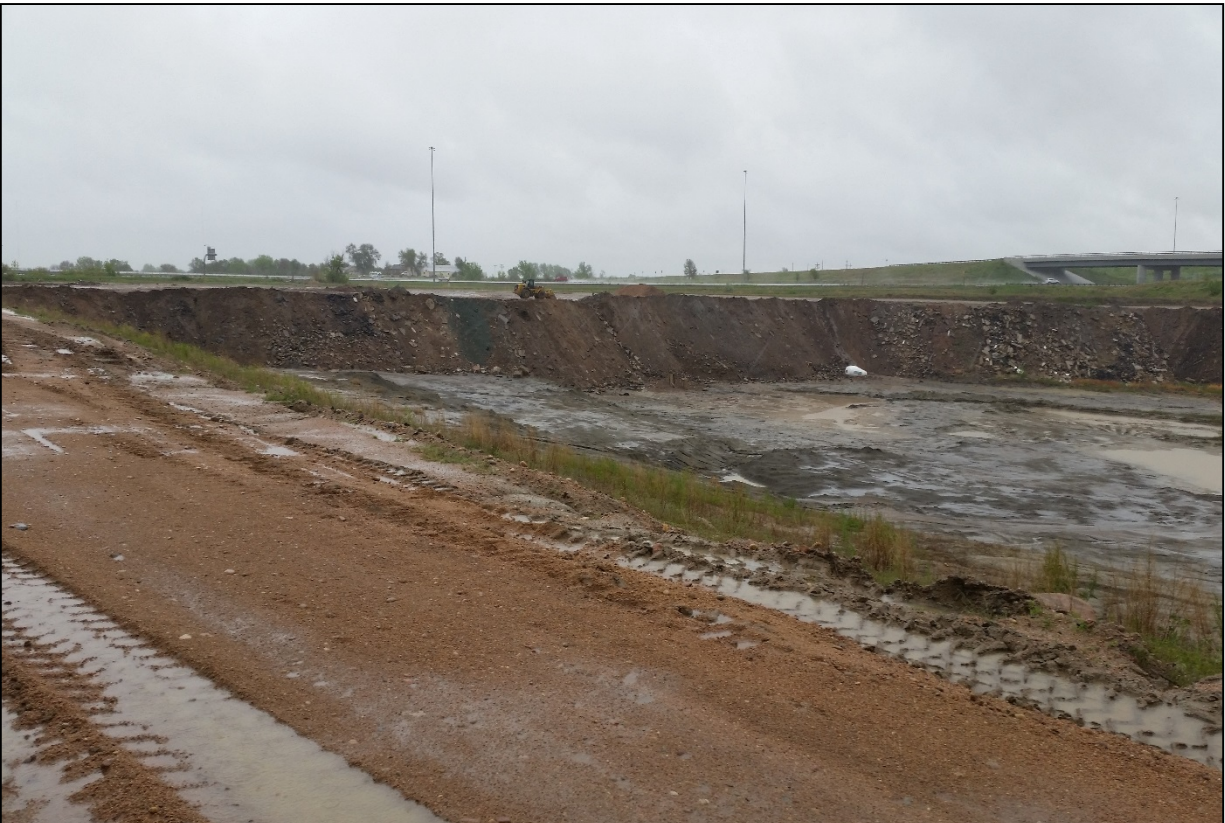
**Photo 2:** On going backfilling of the northeastern lined pit.

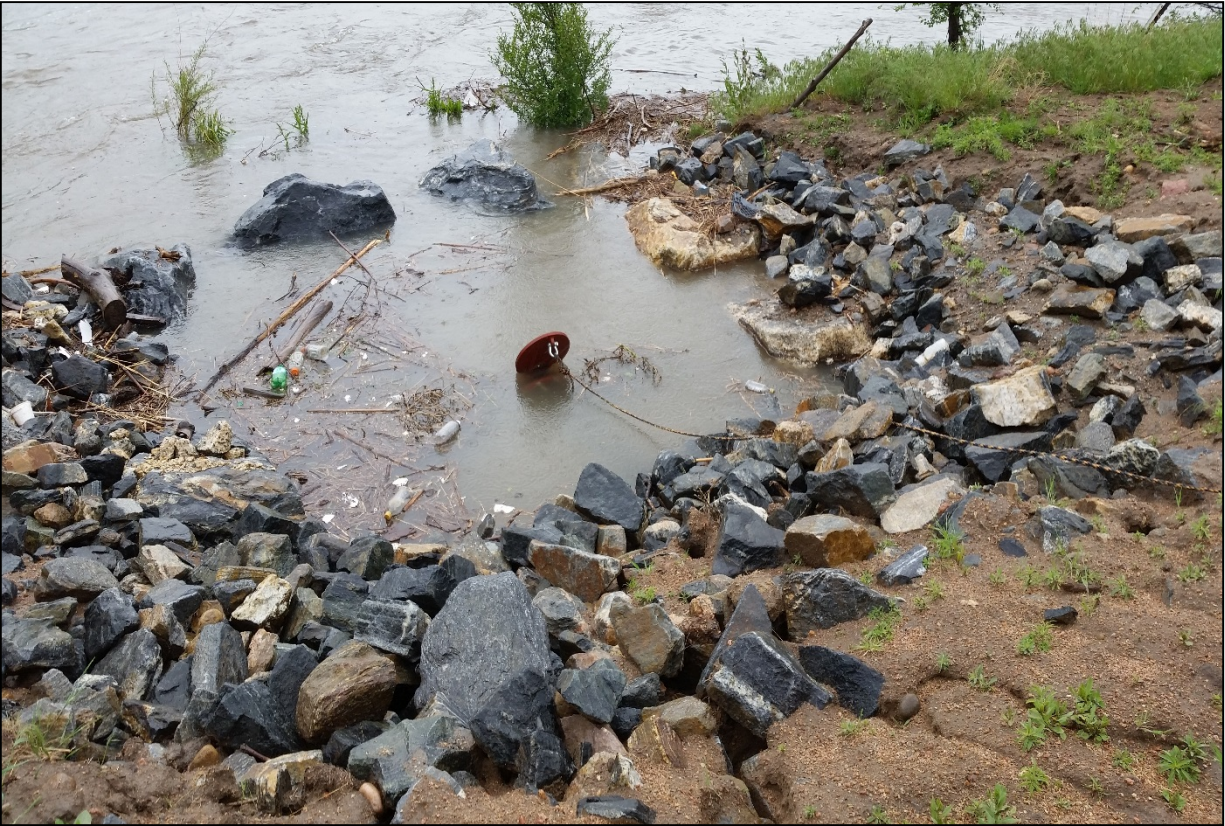
During the inspection the South Platte River was at a flood stage. The river was at a level such that the water from the river was backing up into the groundwater mounding mitigation ditch. The current flood stage of the river made it hard to evaluate the effectiveness of the groundwater mounding mitigation ditch.

**Photo 3:** Discharge side of the groundwater mounding mitigation system, the river is at a flood stage level were the pipe is completely submerged.

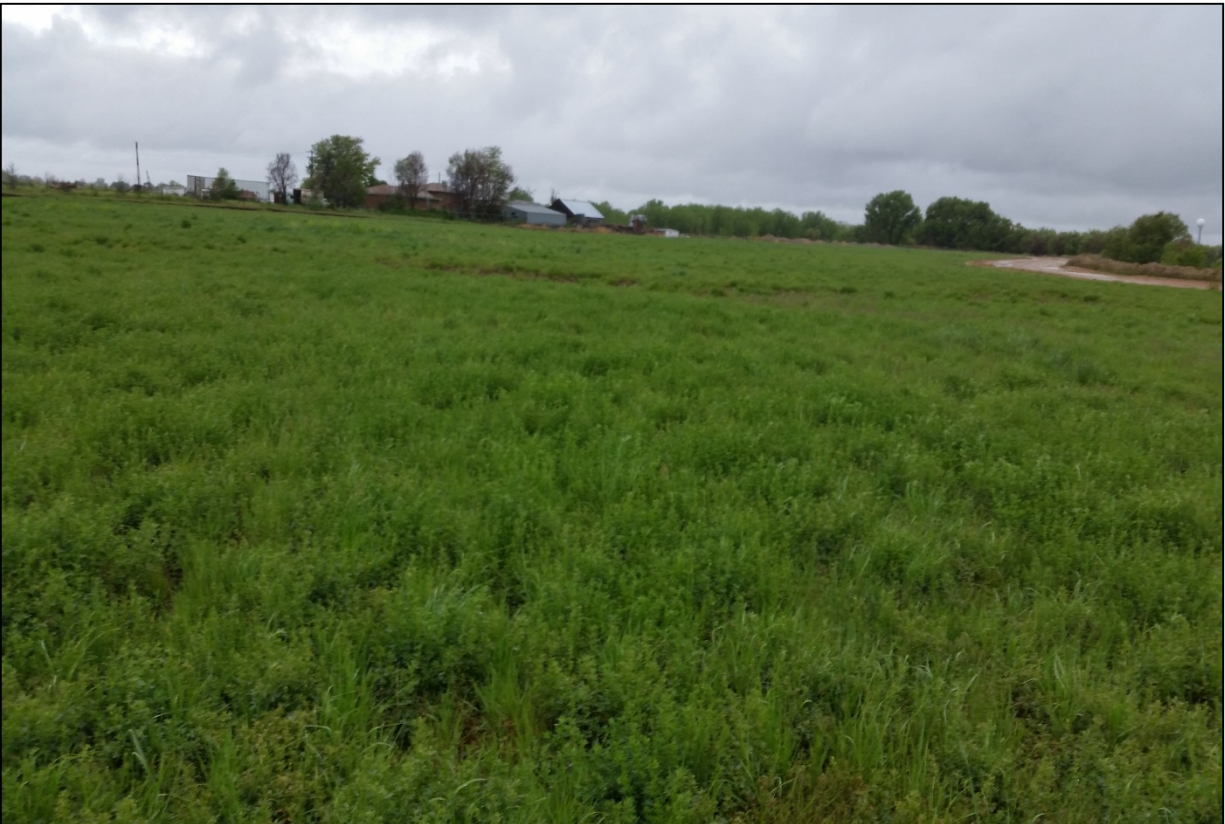
**Photo 4:** well established vegetative cover in the southern expansion area.
