COLORADO DIVISION OF RECLAMATION, MINING AND SAFETY
MINERALS PROGRAM INSPECTION REPORT
PHONE: (303) 866-3567

MINE NAME: King Pit	MINE/PROSPECTING ID#: M-1987-012	MINERAL: Sand and gravel	COUNTY: Alamosa
INSPECTION TYPE: Monitoring	INSPECTOR(S): Stephanie J. Mitchell	INSP. DATE: November 17, 2015	INSP. TIME: 15:30
OPERATOR: Southway Construction Company, Inc.	OPERATOR REPRESENTATIVE:	TYPE OF OPERATION: 112c - Construction Regular Operation

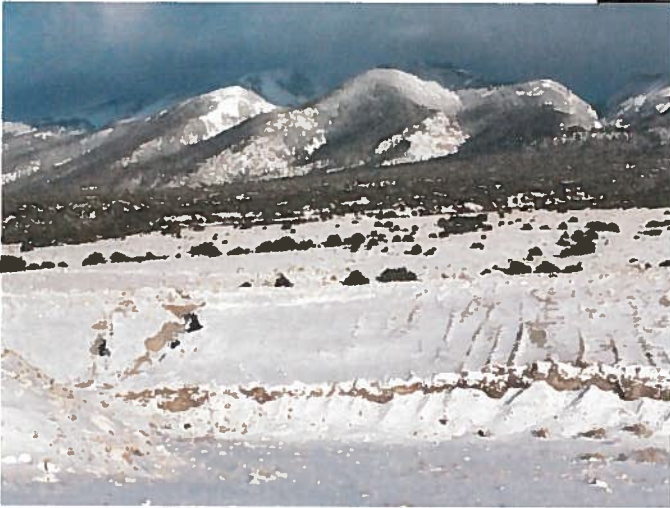
Slopes along the south and east pit perimeter had been graded to 3H:1V or less. There are some large gully's forming on the southeastern corner that appears to be from upland drainage. The active highwall, approximately 20 feet high or less, was located at the north and south sides of the pit.

Upland erosion into the pit

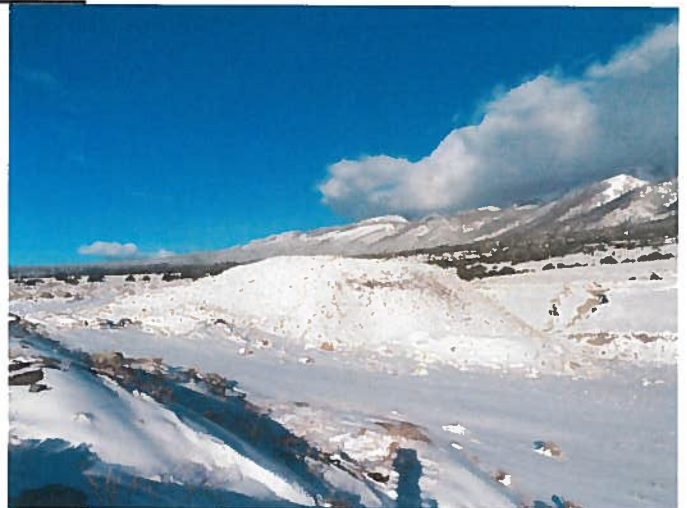
Stockpiles

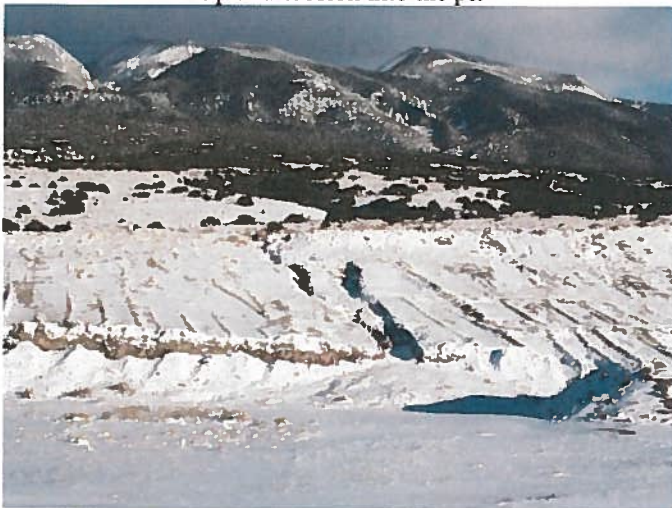
Upland erosion into the pit from the east

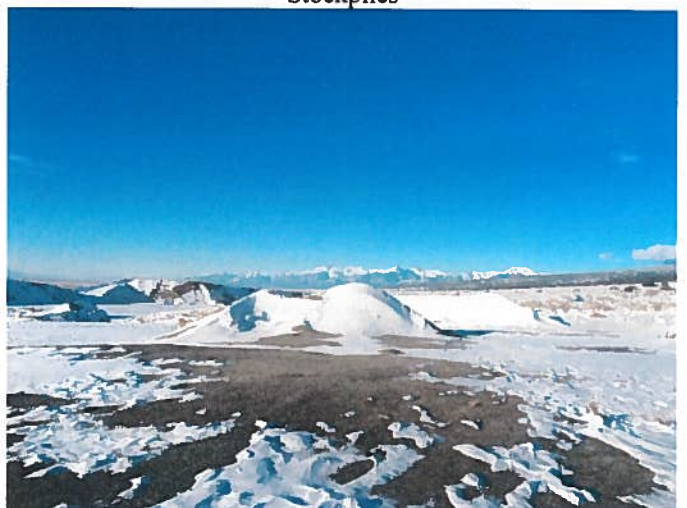
Stockpiles

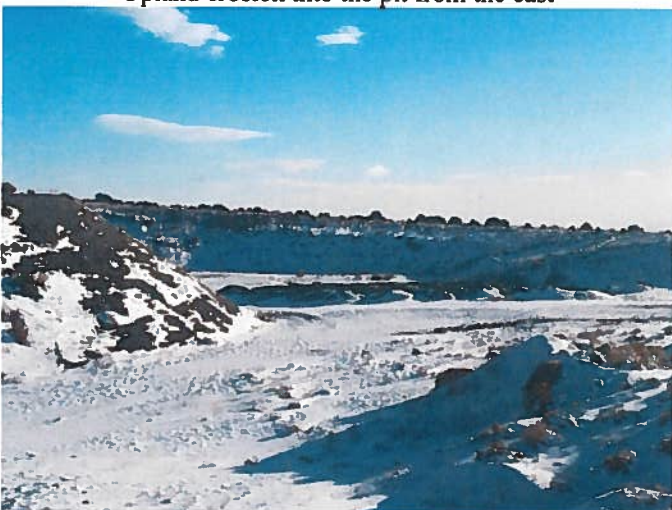
Looking South

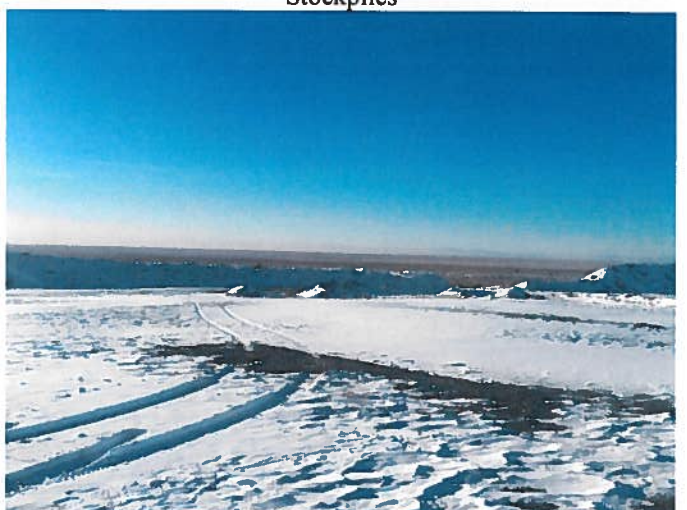
Looking North

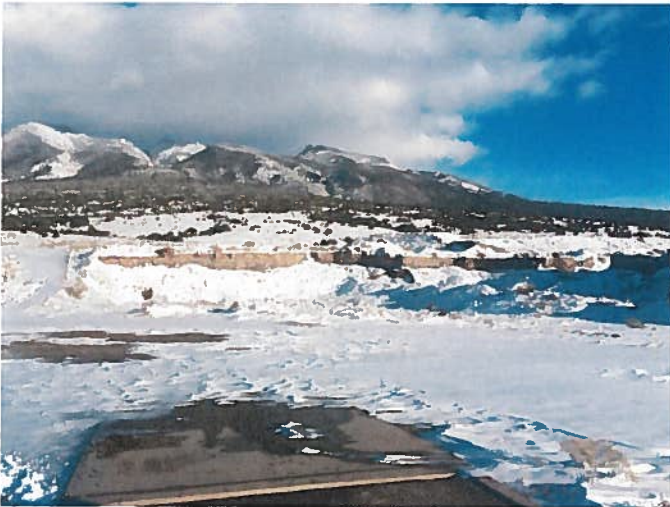
Scale pad

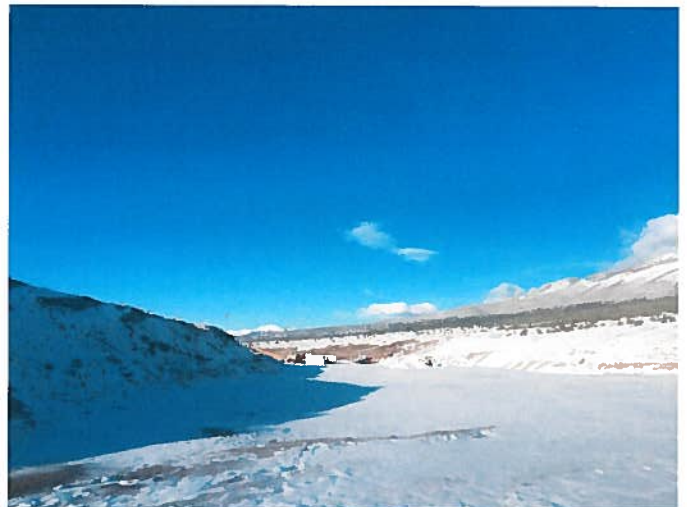
Looking North

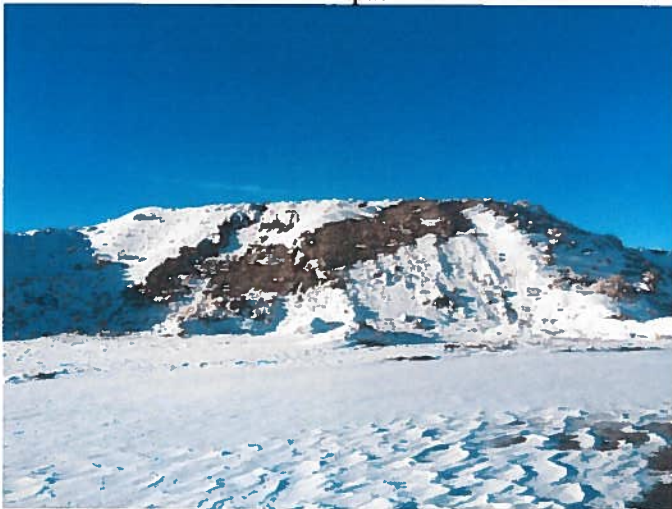
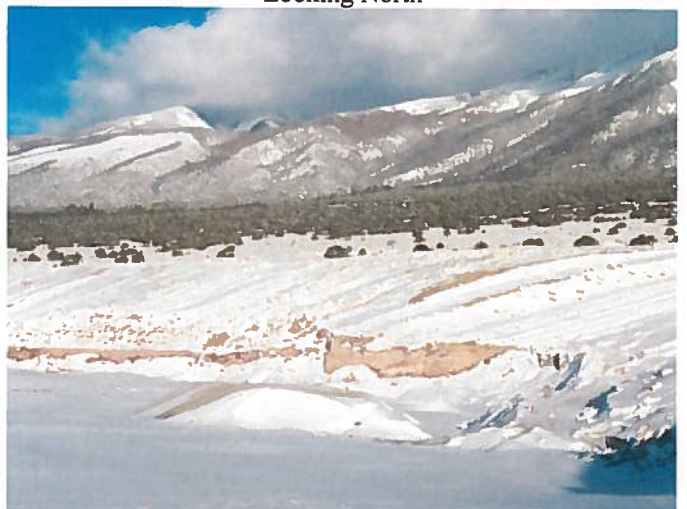
Northern part of pit- toe of slope cut out on east side

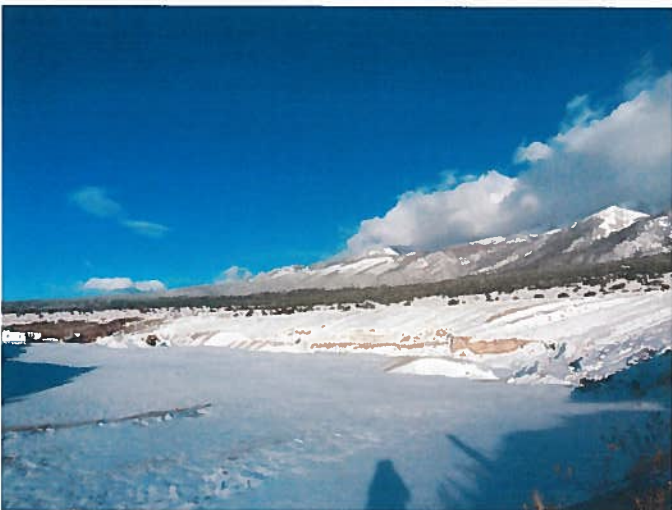
Northern part of pit- toe of slope cut out on east side

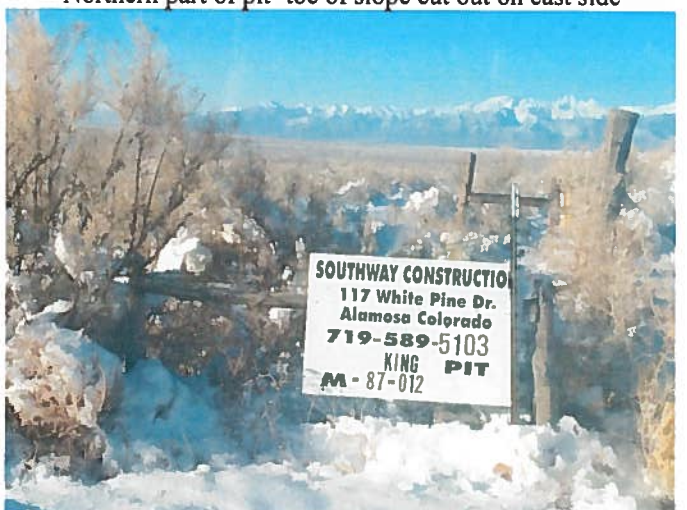
Mine ID sign
