COLORADO DIVISION OF RECLAMATION, MINING AND SAFETY
MINERALS PROGRAM INSPECTION REPORT
PHONE: (303) 866-3567

MINE NAME: Butcher Pit	MINE/PROSPECTING ID#: M-1995-060	MINERAL: Sand	COUNTY: Alamosa
INSPECTION TYPE: Monitoring	INSPECTOR(S): Stephanie J. Mitchell	INSP. DATE: November 17, 2015	INSP. TIME: 13:50
OPERATOR: Southway Construction Company, Inc.	OPERATOR REPRESENTATIVE:	TYPE OF OPERATION: 112c - Construction Regular Operation

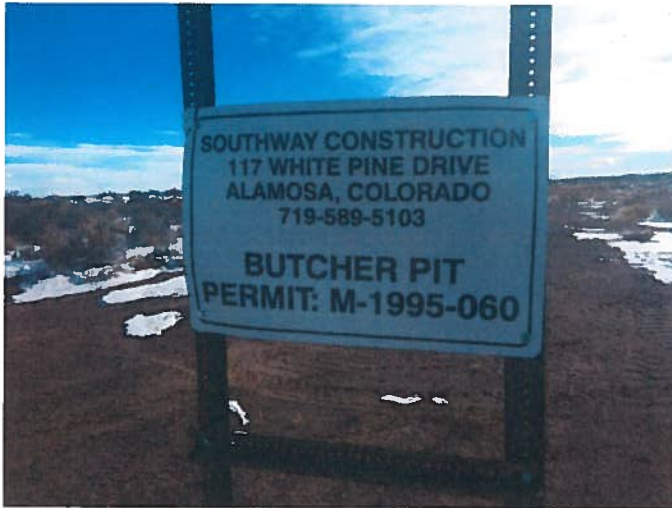
The Mine Identification sign was located at the entrance to the mine site. The affected area boundary markers were missing at the time of inspection. This is a problem for failure to maintain boundary markers around the affected area as required by Section 3.1.12(2) of the rule. The operator shall conduct a survey and replace the boundary markers in the correct location(s). The operator shall provide proof to the Division that this has been done by the corrective action date. **This is cited as a problem at the beginning of the inspection report.**

Mine ID Sign

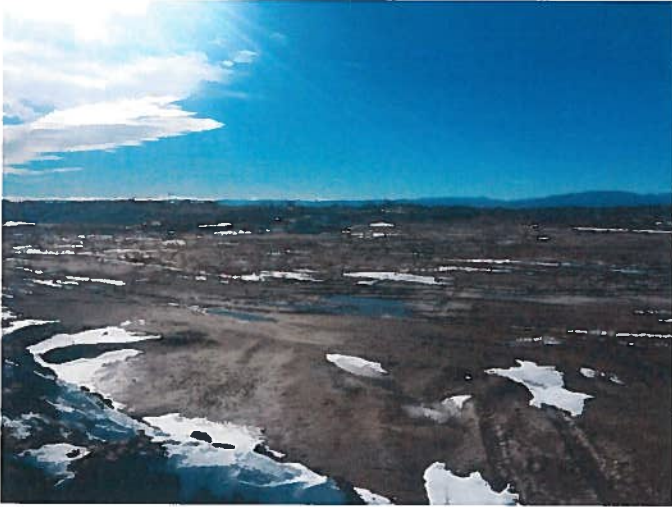
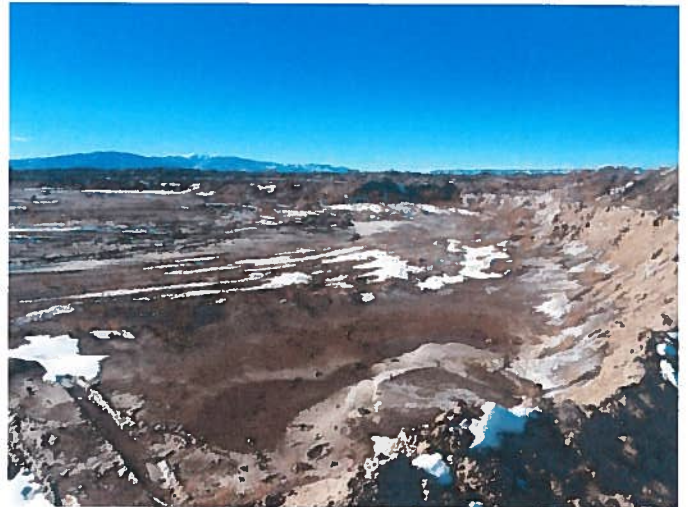
The current disturbance is located in the eastern portion of the permit area and is approximately 9 acres in size, and moving to the west. The excavation is about 10-15 feet deep with a vertical highwall. The highwall appears to be in the center of the permit area. Topsoil has been stripped and is stockpiled as a berm along the southern part of the permit boundary of the site and is stabilized with vegetative cover. No erosion or sedimentation issues were observed.

Current Disturbance ~9 acres
