COLORADO DIVISION OF RECLAMATION, MINING AND SAFETY
MINERALS PROGRAM INSPECTION REPORT
PHONE: (303) 866-3567

MINE NAME: Hawkeye Mine	MINE/PROSPECTING ID#: M-1978-311	MINERAL: Uranium and vanadium	COUNTY: San Miguel
INSPECTION TYPE: Multi Person Inspection	INSPECTOR(S): Lucas J. West, Russ Means	INSP. DATE: November 23, 2015	INSP. TIME: 15:00
OPERATOR: Gold Eagle Mining, Inc.	OPERATOR REPRESENTATIVE: Don Coram	TYPE OF OPERATION: 110d - Designated Limited Impact

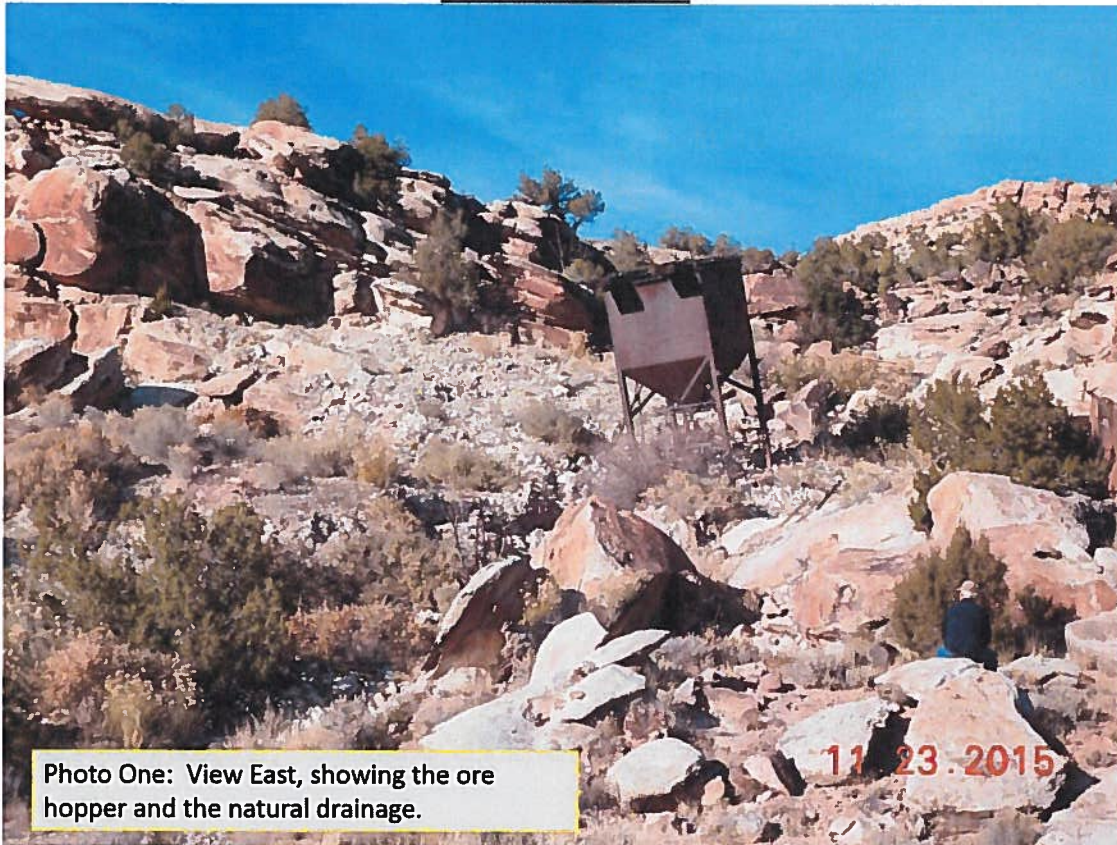
The site includes a steel ore hopper, as seen in Photo One. The hopper is empty and free standing in a natural drainage located on the site. Discussions with the Operator indicate they would like to do some stabilization work to ensure it does not fall over, however due to the injunction, the work cannot commence. Also located on site is the historic waste rock pile that had been recontoured and topsoiled some time ago. Photo Two shows the waste rock pile that is well vegetated and stable. Also located onsite is the portal to the underground workings that is sealed and closed with a welded steel closure. The portal was not inspected at this time, but was observed and was deemed stable during a previous site visit.

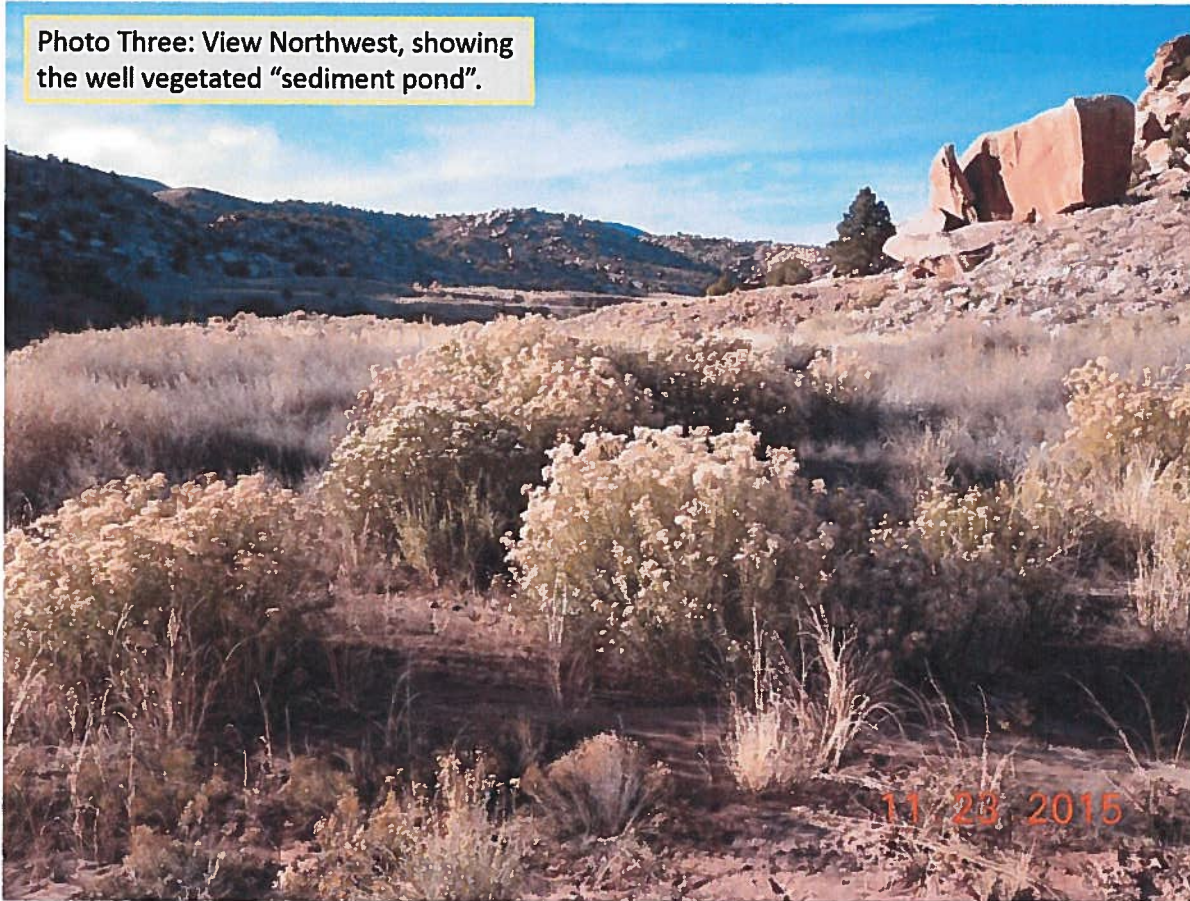
The site contains a natural drainage and the storm water controls lead to this natural drainage. The Operator was approved by the DOE to access the site to perform maintenance on the storm water control measures. The maintenance work was being conducted at the time of the inspection. Contractors for the DOE were present and supervising the activity. The storm water controls lead through the site, down the natural drainage to a small "sediment pond" near the County Road. The sediment pond shown in Photo Three, is well vegetated to dissipate flows and was in good condition.

Photo Three: View Northwest, showing the well vegetated "sediment pond".
