**COLORADO DIVISION OF RECLAMATION, MINING AND SAFETY
MINERALS PROGRAM INSPECTION REPORT
PHONE: (303) 866-3567**

MINE NAME: Burros Mine	MINE/PROSPECTING ID#: M-1977-297	MINERAL: Uranium and vanadium	COUNTY: San Miguel
INSPECTION TYPE: Multi Person Inspection	INSPECTOR(S): Lucas J. West	INSP. DATE: November 23, 2015	INSP. TIME: 14:10
OPERATOR: Gold Eagle Mining, Inc.	OPERATOR REPRESENTATIVE: Don Coram	TYPE OF OPERATION: 110d - Designated Limited Impact

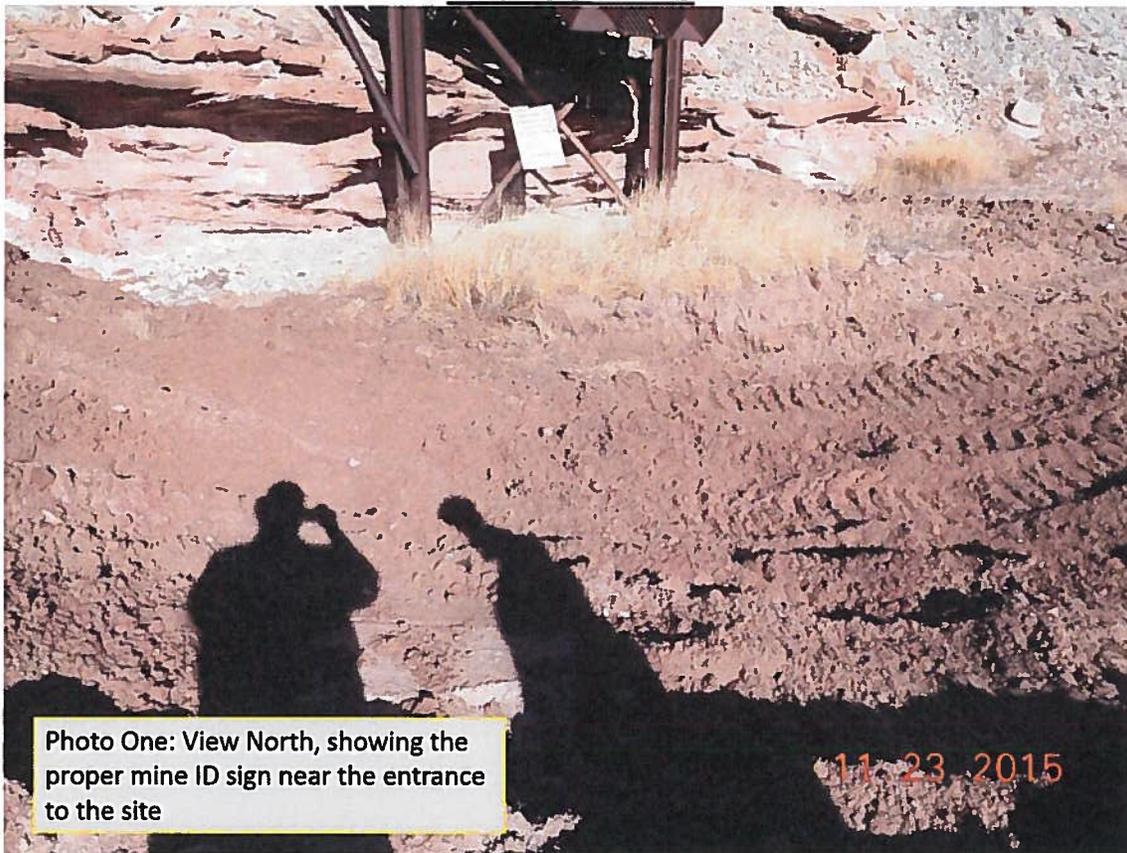
Photo One: View North, showing the proper mine ID sign near the entrance to the site

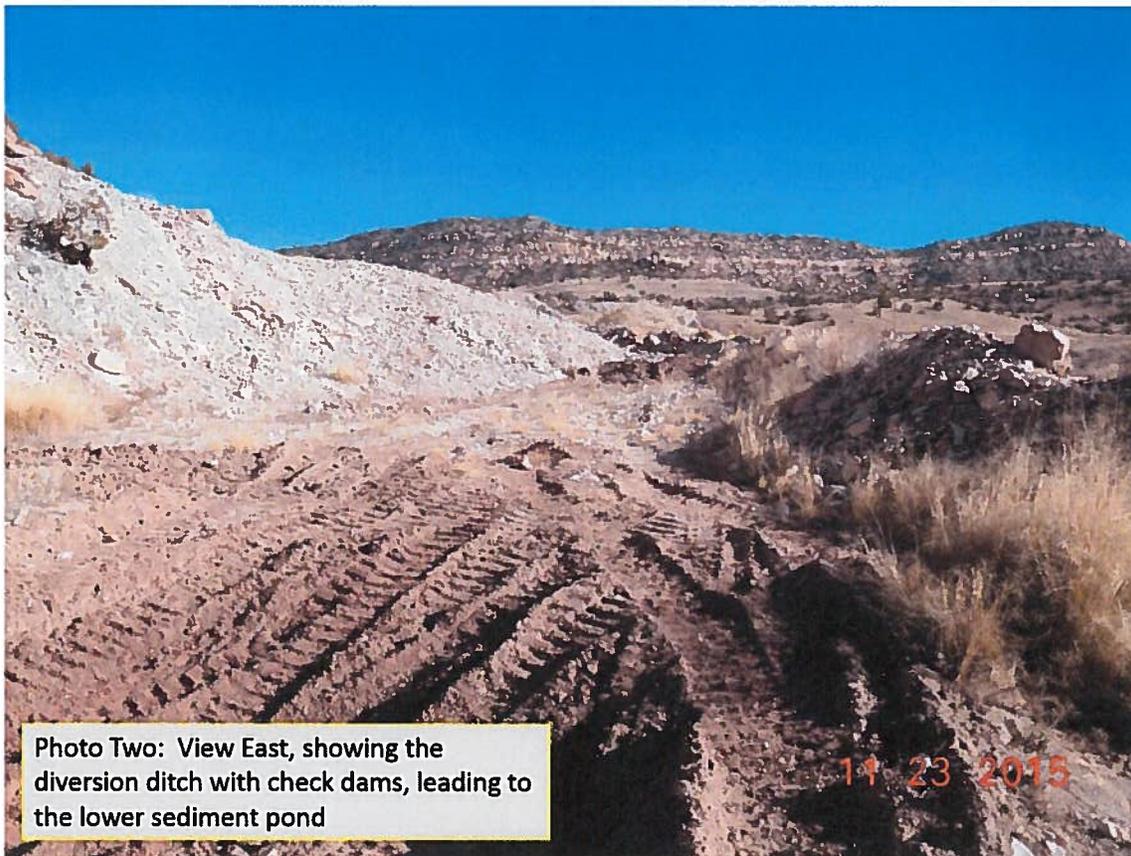
This site is part of the Injunction filed with the DOE and no mining was taking place during this inspection. The Operator was however, approved to access the site to perform maintenance on the storm water control measures that are located within the permitted area. The maintenance work was being conducted at the time of the inspection. Contractors for the DOE were present supervising the activity. The work consisted of clearing and reinforcing the storm water diversion ditch and sediment pond located near the County Road on the west side of the permitted area, as well as cleaning out the upper sediment pond and installing a culvert across the mine access road to prevent further erosional issues. Photo One shows the lower sediment pond near the road, and Photo Two shows the diversion ditch leading to the pond.

Photo Two: View East, showing the diversion ditch with check dams, leading to the lower sediment pond

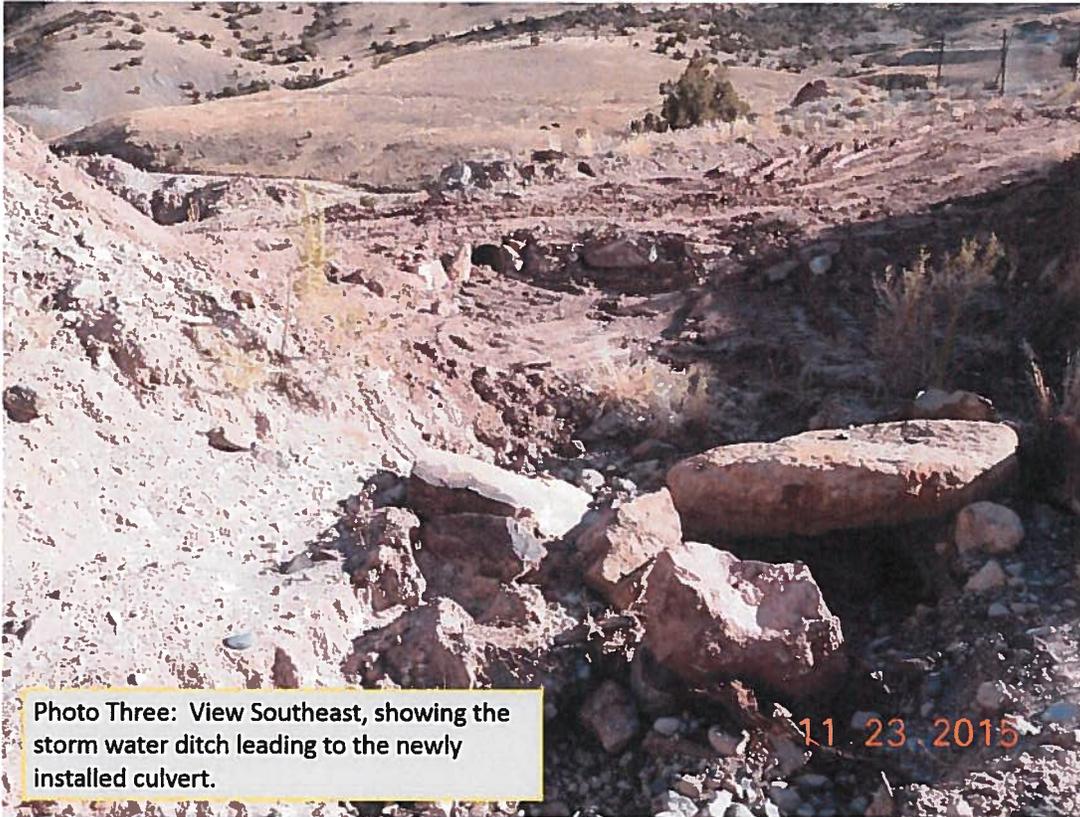
The culvert was installed across the road, above the locked access gate, to control erosional issues following recent precipitation events. Photo three shows culvert going under the road. The upper sediment pond shown in Photo Four was observed with some residual storm water from those recent precipitation events.

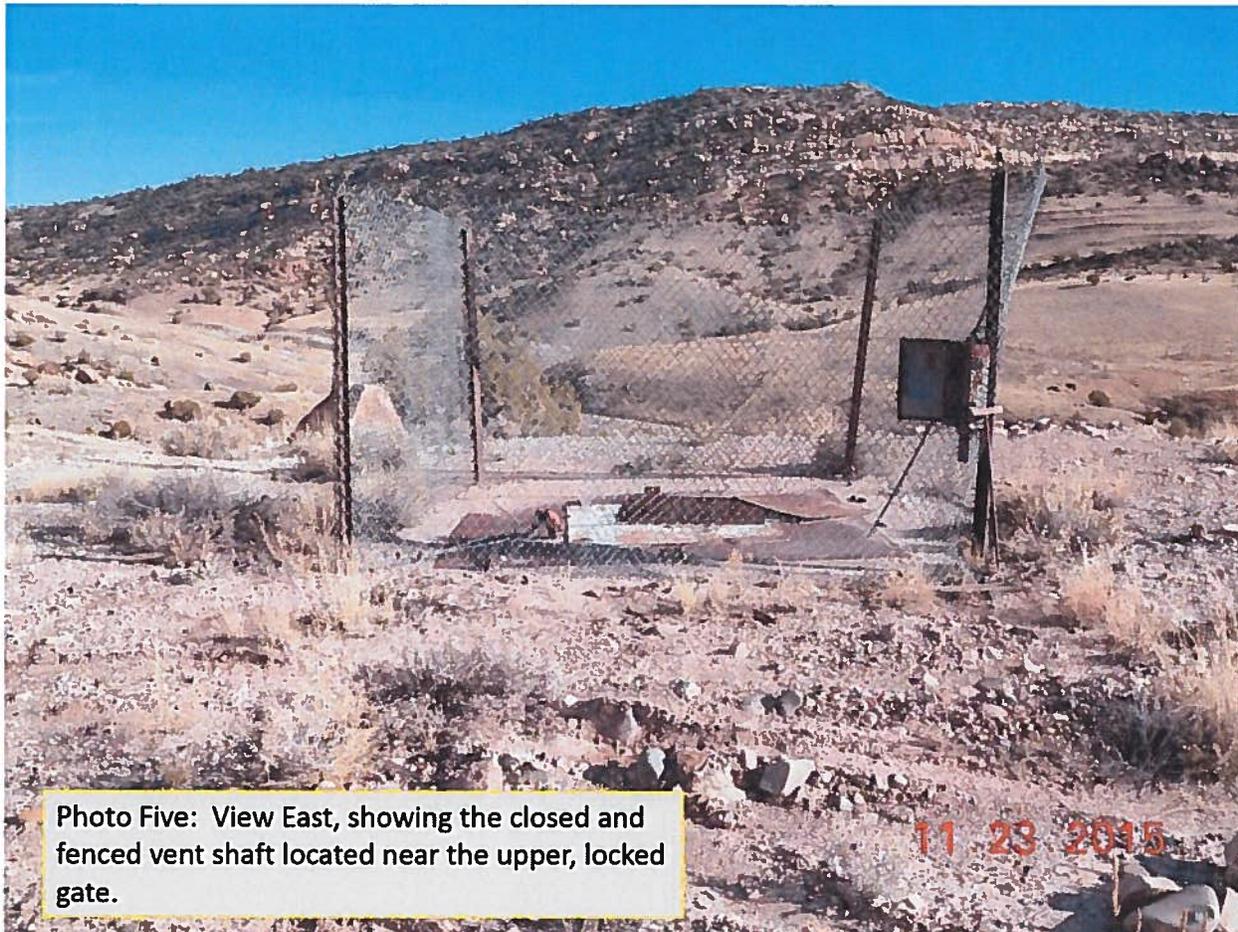
The historical loadout on the west end of the permitted area was observed and appeared to be stable. The portal was also observed and remains closed and unchanged since the previous inspection. Photo Five shows the vent shaft located within the permitted area. It is covered and sealed as well as surrounded by a safety fence.

Photo Five: View East, showing the closed and fenced vent shaft located near the upper, locked gate.
