COLORADO DIVISION OF RECLAMATION, MINING AND SAFETY
MINERALS PROGRAM INSPECTION REPORT
PHONE: (303) 866-3567

MINE NAME: Juniper Quarry	MINE/PROSPECTING ID#: M-1982-141	MINERAL: Limestone (general)	COUNTY: Moffat
INSPECTION TYPE: Monitoring	INSPECTOR(S): Amy C. Yeldell	INSP. DATE: November 24, 2015	INSP. TIME: 10:00
OPERATOR: Moffat Limestone Company	OPERATOR REPRESENTATIVE: Mike and Mardi Anson	TYPE OF OPERATION: 112c - Construction Regular Operation	
REASON FOR INSPECTION: Normal I&E Program	BOND CALCULATION TYPE: Complete Bond	BOND AMOUNT: \$154,405.00	
DATE OF COMPLAINT: NA	POST INSP. CONTACTS: None	JOINT INSP. AGENCY: None	
WEATHER: Clear	INSPECTOR'S SIGNATURE:

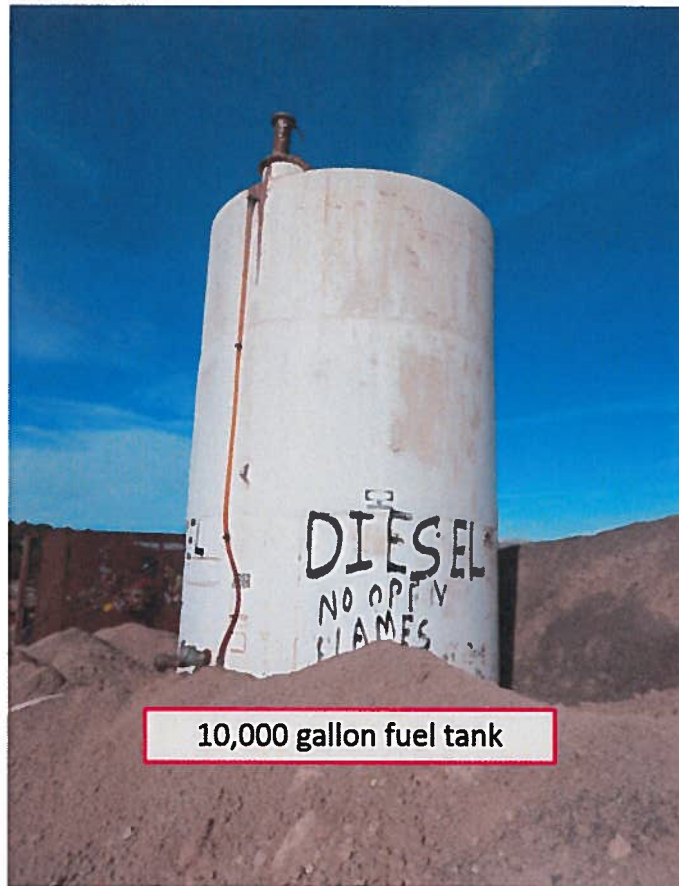
A 10,100 gallon fuel tank in earthen secondary containment was observed. It was recommended to the operators to use a lined containment to better protect against a spill. They were reminded that a proper containment is 110% of the largest tank volume stored in that containment. No other hazardous materials

were observed onsite.

10,000 gallon fuel tank

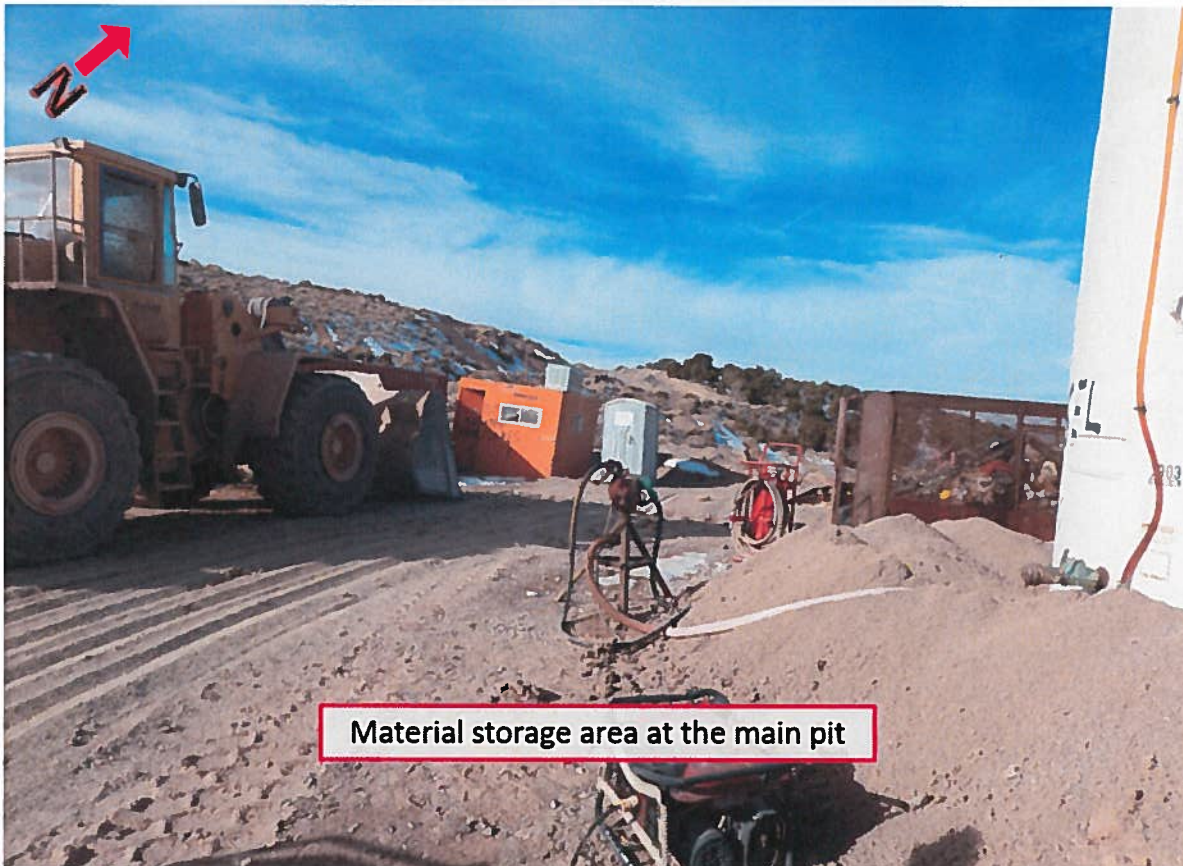
In the southwest corner of the main pit various piles of scrap material and two trailers still remain and will need to be removed prior to reclamation. Near the fuel tank a wire cage contains all trash produced at the site.

Material storage area at the main pit

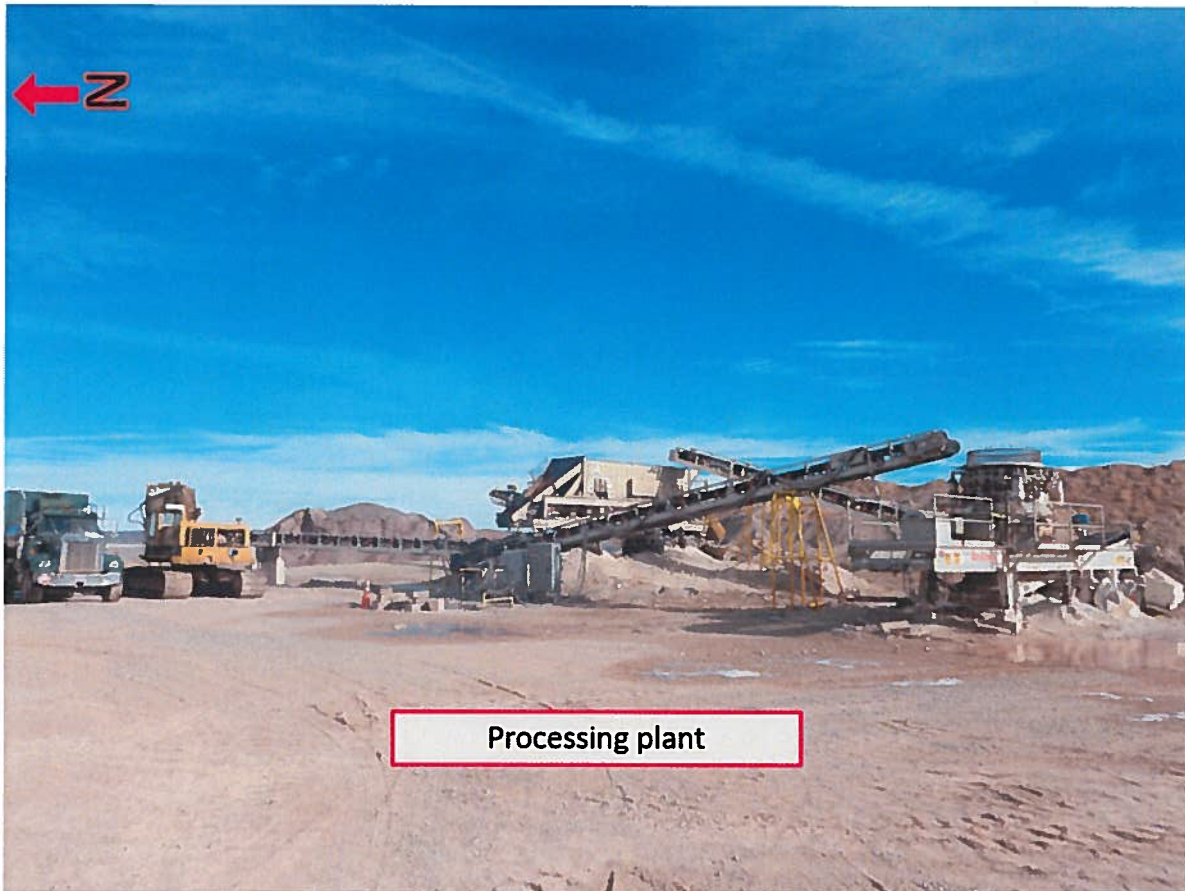
The site is currently operational. One portable crusher is owned by Moffat Limestone Company and remains on site. Periodically they also rent extra equipment on an as needed basis. Generally only a crusher and screen are used to process materials. This area produces limestone products from road base to large dimensional stone. As well as finer products for coal plants. Unusable fines are stockpiled for backfill and reclamation.

Processing plant

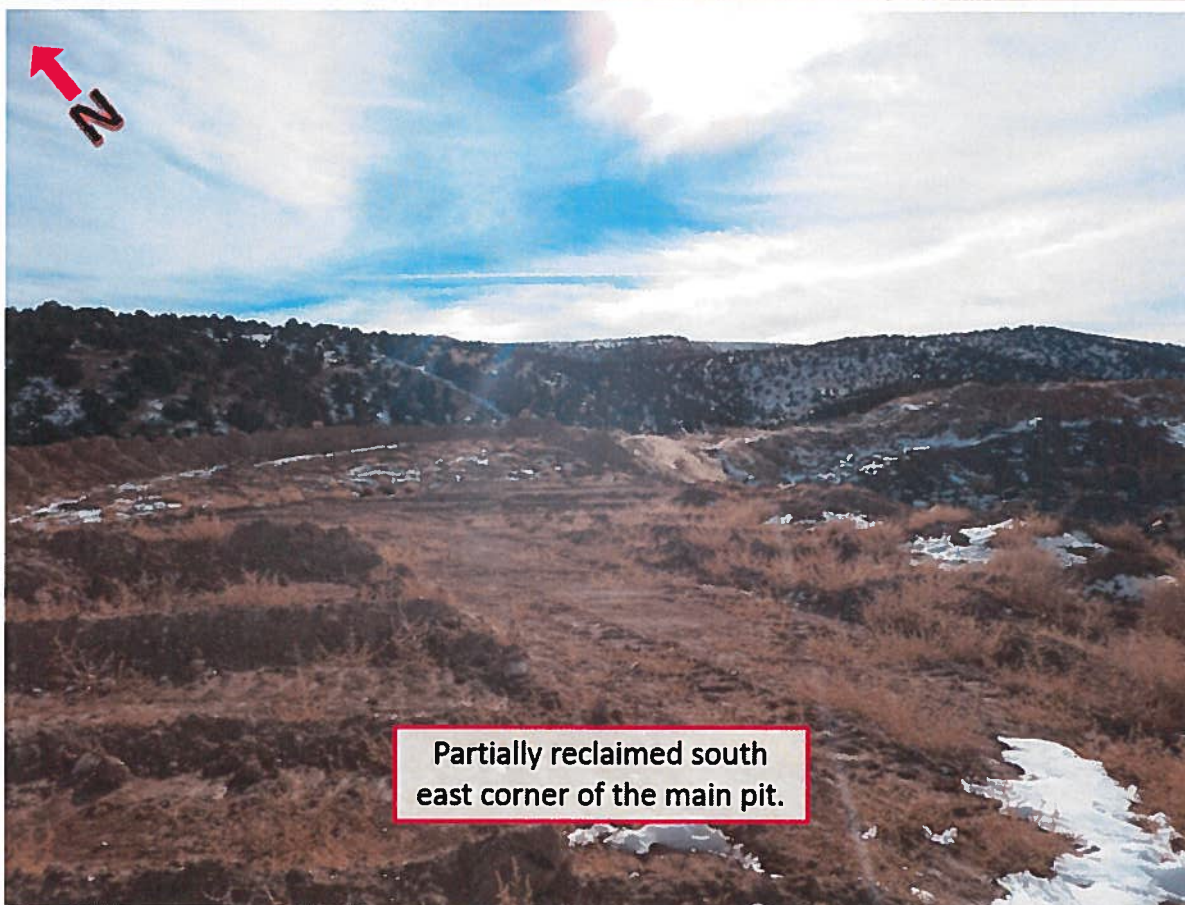
Reclamation has been completed on southeast end of pit. Reclamation was successful and is the area is ready for release if operator no longer needs the land to support the mining operation. Discussions ensued that in the future the operator may need egress through the reclaimed areas and will likely retain the reclaimed ground for the time being.

In CN-1 the reclamation plan states that "whenever disturbed and non-reclaimed mined areas exceed ten acres, a portion of the disturbed area will be reclaimed. This will be done in a manner whereby the total non-reclaimed land will never exceed ten acres." Staff estimates that approximately 20 acres is actively being mined. Approximately 40 acres has been affected to date of which nearly one third is successfully reclaimed.

Partially reclaimed south
east corner of the main pit.
