COLORADO DIVISION OF RECLAMATION, MINING AND SAFETY
MINERALS PROGRAM INSPECTION REPORT
PHONE: (303) 866-3567

MINE NAME: Red Mesa Pit	MINE/PROSPECTING ID#: M-2009-023	MINERAL: Gravel and sand	COUNTY: La Plata
INSPECTION TYPE: Monitoring	INSPECTOR(S): Lucas J. West	INSP. DATE: November 30, 2015	INSP. TIME: 12:30
OPERATOR: Skanska USA Civil West Rocky Mountain Di	OPERATOR REPRESENTATIVE: Joe Schluter, Miles Sturdevant	TYPE OF OPERATION: 112c - Construction Regular Operation

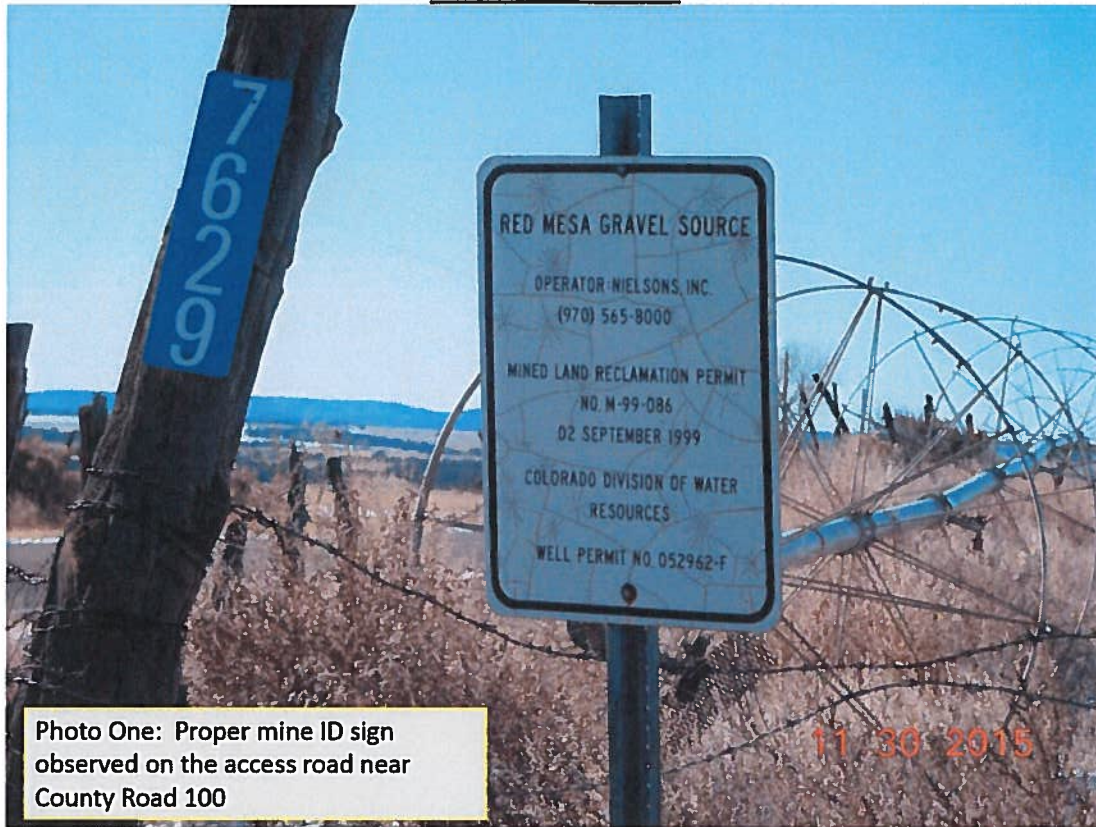
The proper mine ID sign and boundary markers were observed on site. The sign, seen in Photo One, is located on the access road near where it meets County Road 100. All disturbance is within the permitted area which is marked with signs shown in Photo Two. The site was not active during the time of the inspection and no equipment was observed on site. Several stockpiles are located on site, and the Operator expressed that they are continually hauling from the stockpiled material. All stockpiled materials were stable and showed no signs of erosion. Photos Three and Four show the various stockpiles located within the permitted area.

Photo One: Proper mine ID sign observed on the access road near County Road 100

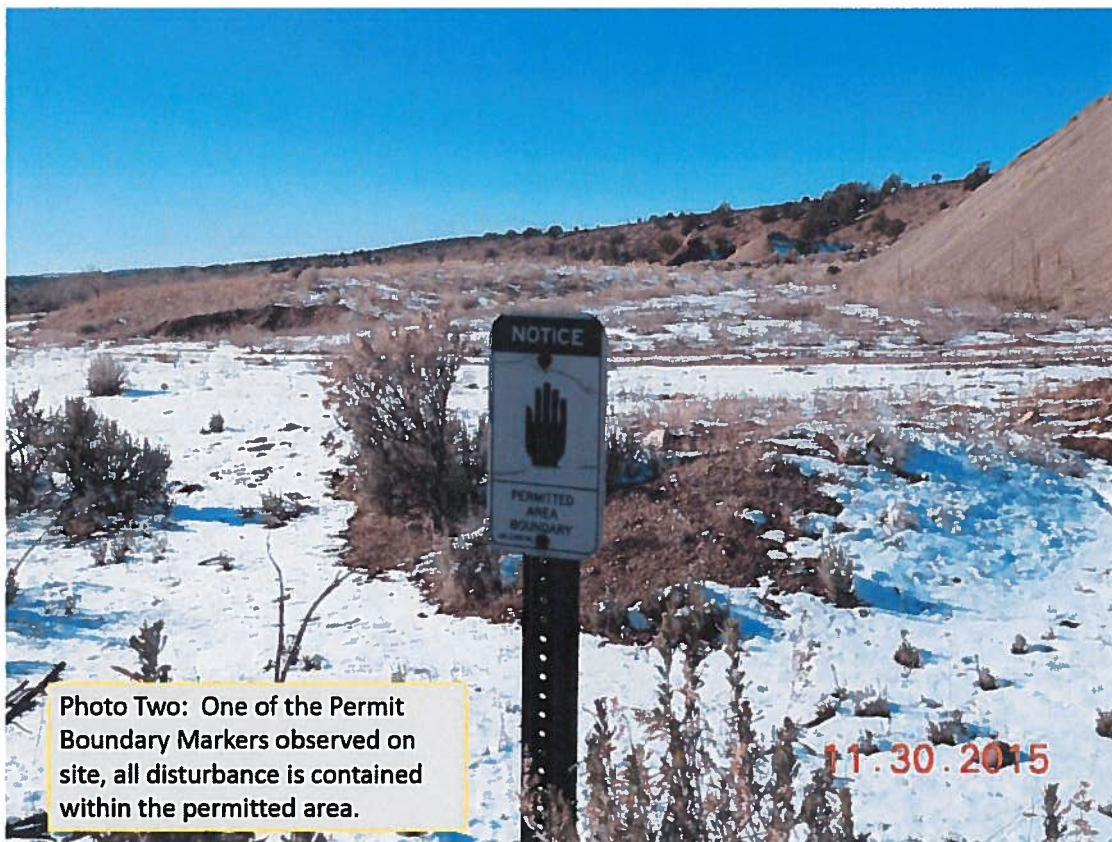
Photo Two: One of the Permit Boundary Markers observed on site, all disturbance is contained within the permitted area.

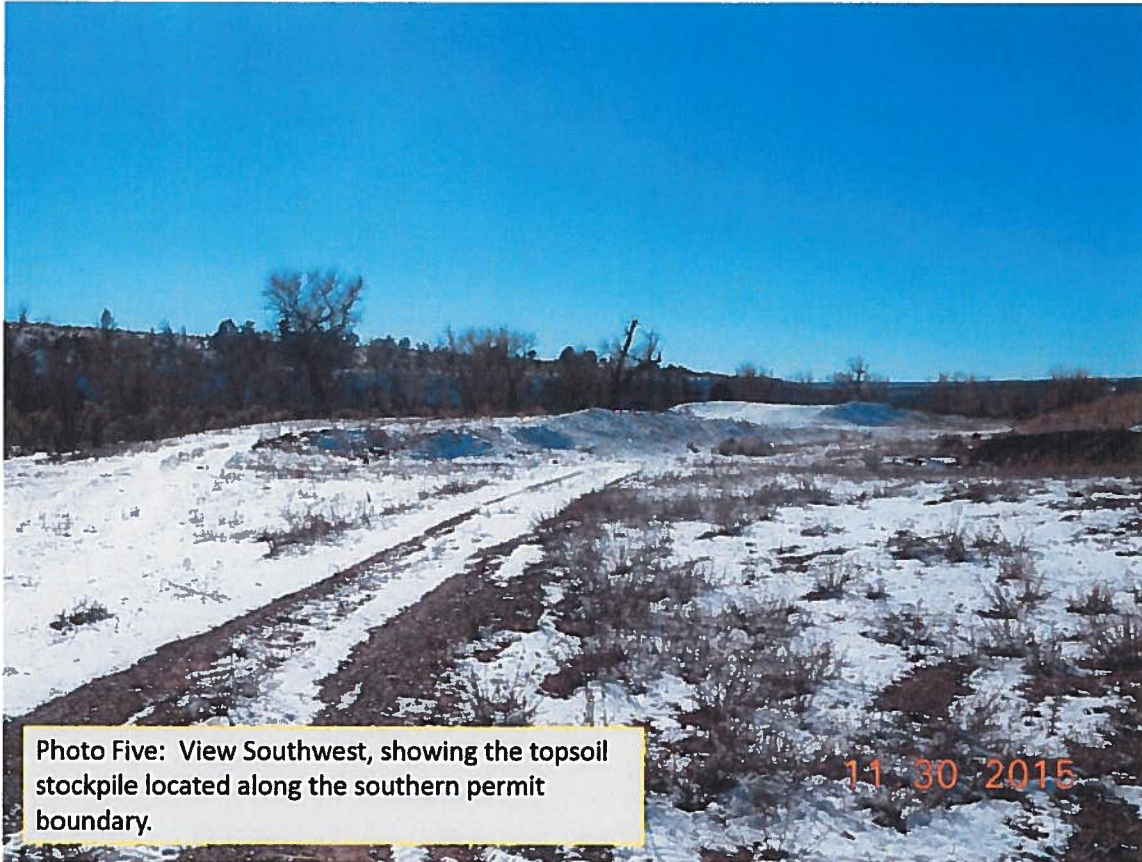
Topsoil has been stockpiled on the southern permit boundary, shown in Photo Five. The stockpile is vegetated and stable. A majority of the site has naturally revegetated itself as those areas are not routinely disturbed. Evidence of ongoing weed treatment was observed.
