COLORADO DIVISION OF RECLAMATION, MINING AND SAFETY
MINERALS PROGRAM INSPECTION REPORT
PHONE: (303) 866-3567

MINE NAME: Ellison Mine	MINE/PROSPECTING ID#: M-1978-342	MINERAL: Uranium and vanadium	COUNTY: San Miguel
INSPECTION TYPE: Multi Person Inspection	INSPECTOR(S): Lucas J. West, Russ Means	INSP. DATE: November 23, 2015	INSP. TIME: 14:45
OPERATOR: Gold Eagle Mining, Inc.	OPERATOR REPRESENTATIVE: None	TYPE OF OPERATION: 110d - Designated Limited Impact

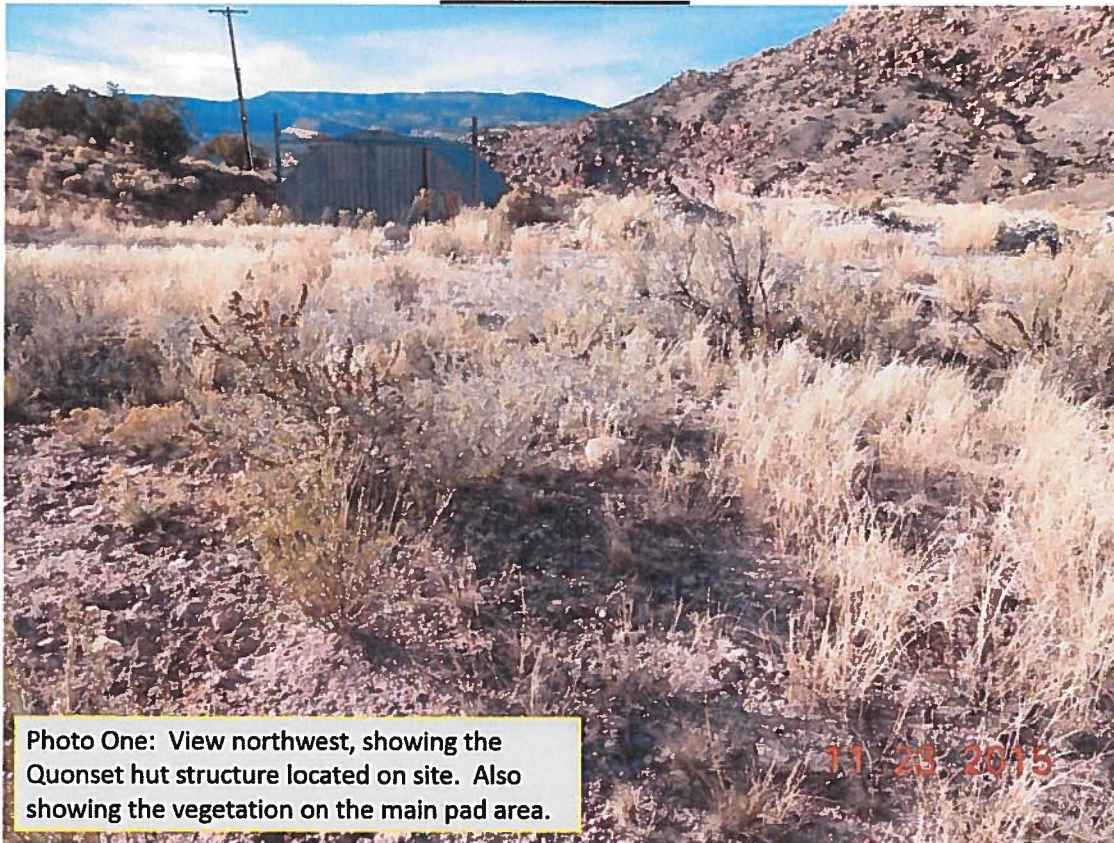
Photo One shows the Quonset hut style structure located on site. The structure was secure and in good condition at the time of this inspection. Also located on site are two shipping containers, shown in Photo Two, used for storage that were also secured and in good condition. The main pad and work area that the structure, containers and portal are located on was in good condition and well vegetated with native grasses and shrubs. The portal, shown in Photo Three, is enforced with a Quonset style structure leading underground, and secured with a locked, welded steel grate. All components associated with the portal are in good condition.

Photo One: View northwest, showing the Quonset hut structure located on site. Also showing the vegetation on the main pad area.

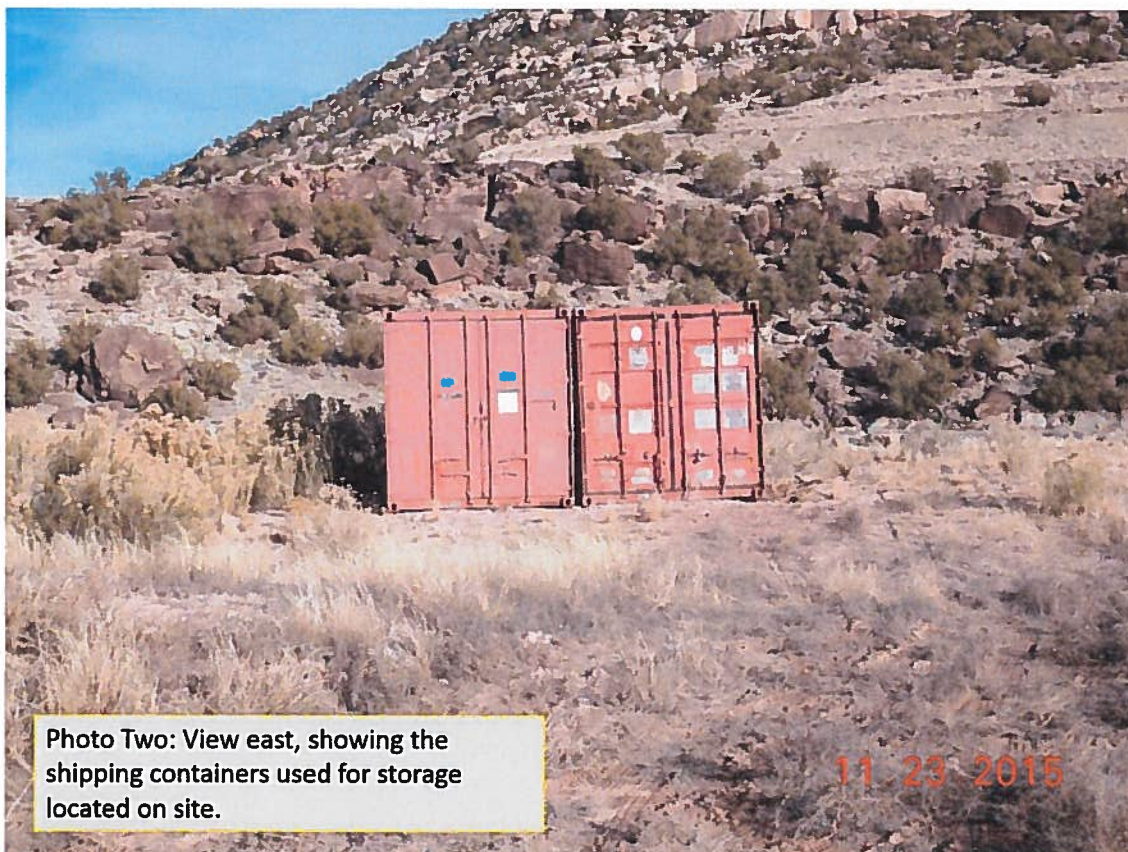
Photo Two: View east, showing the shipping containers used for storage located on site.

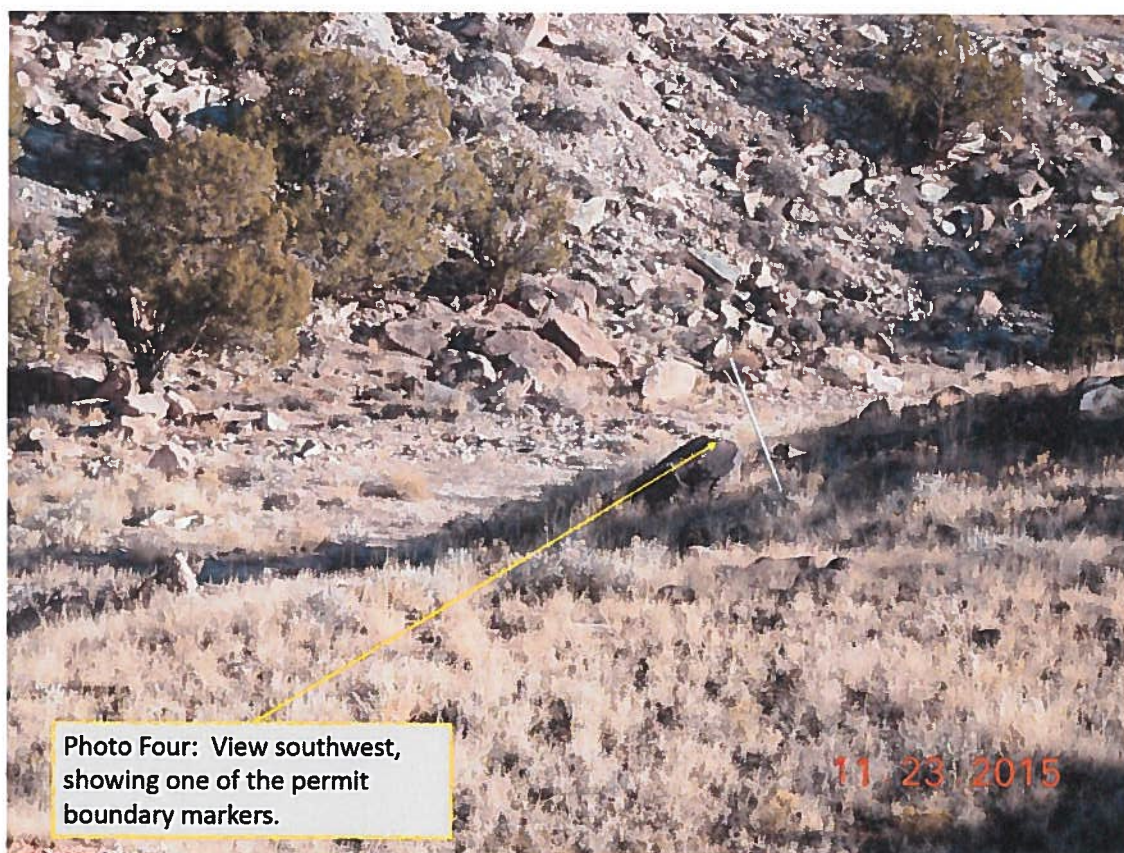
Permit boundary markers were observed as seen in Photo Four, and all disturbance was inside the permitted area. The storm water controls were also observed and appeared to be functioning as designed. Evidence of storm water control device maintenance was observed. The maintenance work was approved and supervised by the DOE. No erosional issues were observed during this inspection. The slopes of the main pad and work area were all well vegetated and appear to be stable.
