**COLORADO DIVISION OF RECLAMATION, MINING AND SAFETY
MINERALS PROGRAM INSPECTION REPORT
PHONE: (303) 866-3567**

MINE NAME: Craig Pit	MINE/PROSPECTING ID#: M-1976-027	MINERAL: Sand and gravel	COUNTY: La Plata
INSPECTION TYPE: Monitoring	INSPECTOR(S): Lucas J. West	INSP. DATE: November 30, 2015	INSP. TIME: 15:00
OPERATOR: Skanska USA Civil West Rocky Mountain Di	OPERATOR REPRESENTATIVE: Joe Schluter, Miles Sturdevant	TYPE OF OPERATION: 112c - Construction Regular Operation

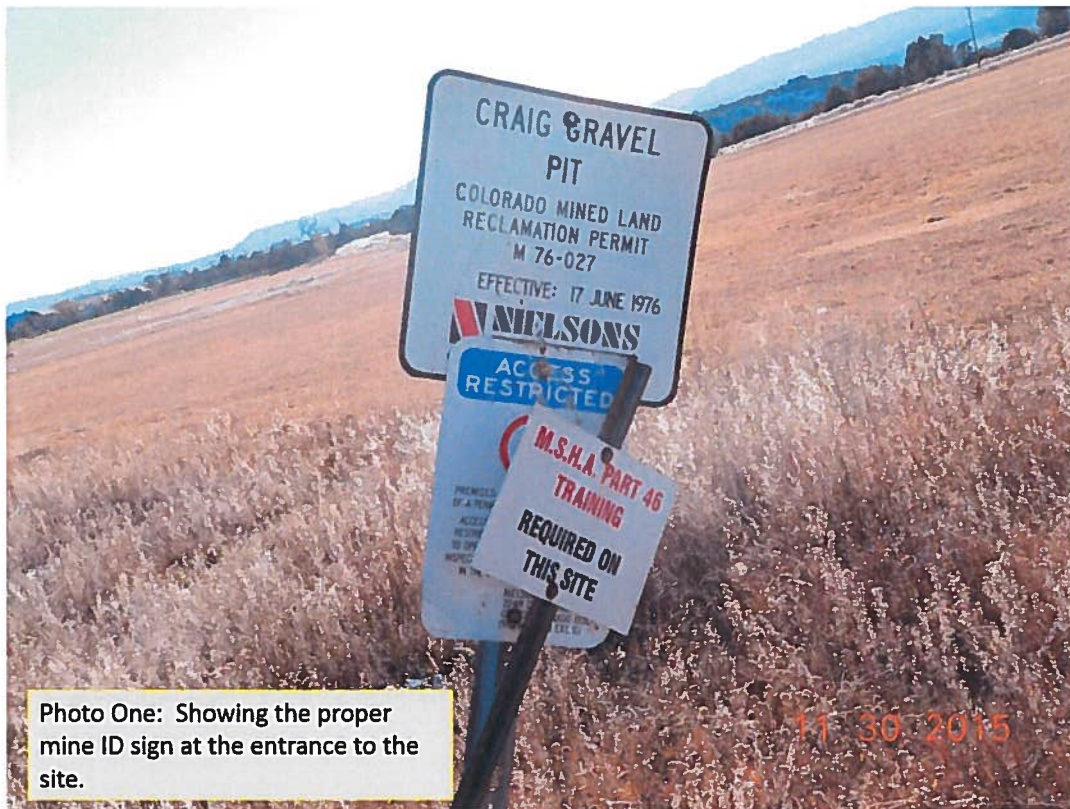
The proper mine ID sign was observed at the entrance to the site, shown in Photo One. Access to the site is restricted by a locked gate, and the boundaries are marked by large earthen berms that also serve as a visual barrier to the site. All disturbances are contained within the permit boundaries. The site consists of a large semi flat area that was previously mined, and is not storage for stockpiles. Several stockpiles were observed including some screened material, natural fines, overburden and topsoil. The natural fines and pitrun stockpiles are shown in Photo Two. All stockpiles were stable and in good condition. The site is well vegetated with native grasses and shrubs, all of which are volunteers as no seeding has taken place on site yet.

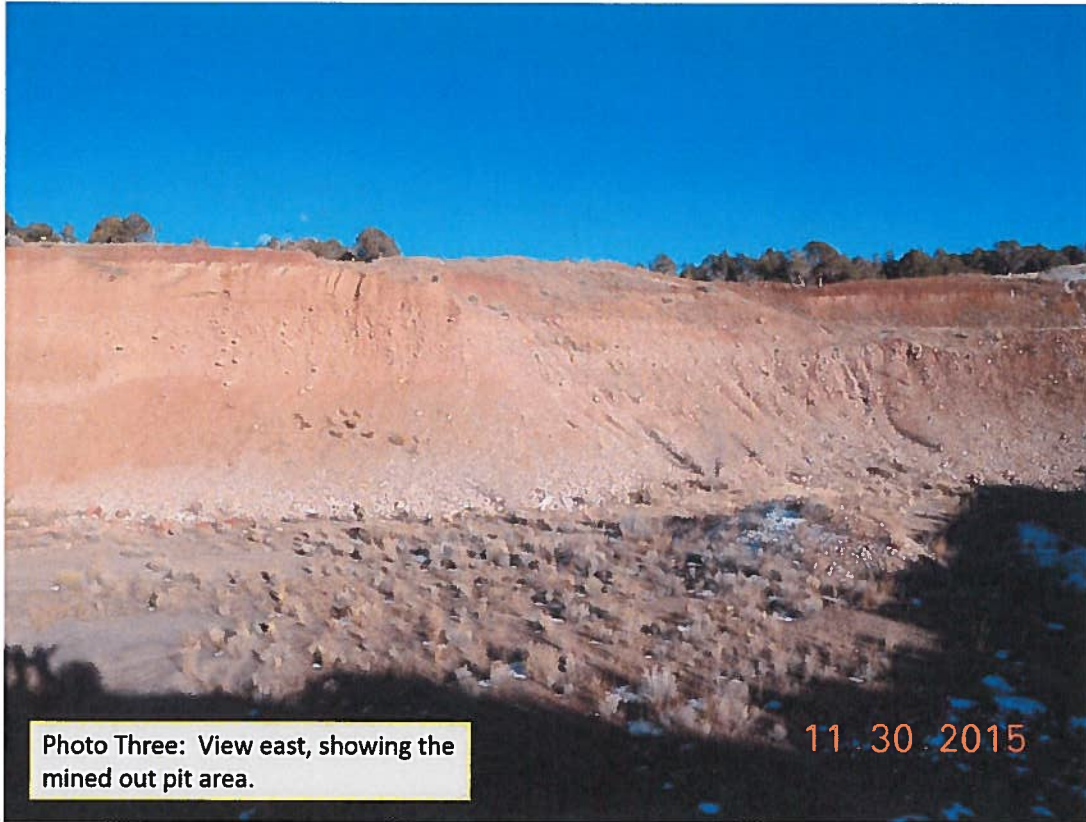
The main pit area is located towards the southeastern corner of the site, shown in Photo Three. When the site was active it consisted of highwall operations isolated in that area. The slopes of the highwall are approximately 1.5:1 and are stable. No erosional issues were observed during this inspection. The main pit floor area is also well vegetated with grasses and shrubs, a small stockpile of material is located in the center of the pit floor.

The Operator indicated that they will be entering final reclamation around the first week of 2016 with the intention of completing the earthwork in time for a winter seeding. The area will be reclaimed to support the post mining land use of pastureland. The Division is awaiting a technical revision to the permit to slightly alter the final grading scheme of the pit, as well as a gravel area requested by the landowner to allow for feeding cattle when the site is muddy. The overall footprint of the site was in good condition and free from trash and debris. No erosional issues or noxious weeds were observed during this inspection. No problems or possible violations were found at this time.
