**COLORADO DIVISION OF RECLAMATION, MINING AND SAFETY**  
**MINERALS PROGRAM INSPECTION REPORT**  
**PHONE: (303) 866-3567**

| <b>MINE NAME:</b><br>Cresson Project | <b>MINE/PROSPECTING ID#:</b><br>M-1980-244 | <b>MINERAL:</b><br>Gold | <b>COUNTY:</b><br>Teller |
| <b>INSPECTION TYPE:</b><br>Monitoring | <b>INSPECTOR(S):</b><br>Amy Eschberger | <b>INSP. DATE:</b><br>December 9, 2015 | <b>INSP. TIME:</b><br>10:15 |

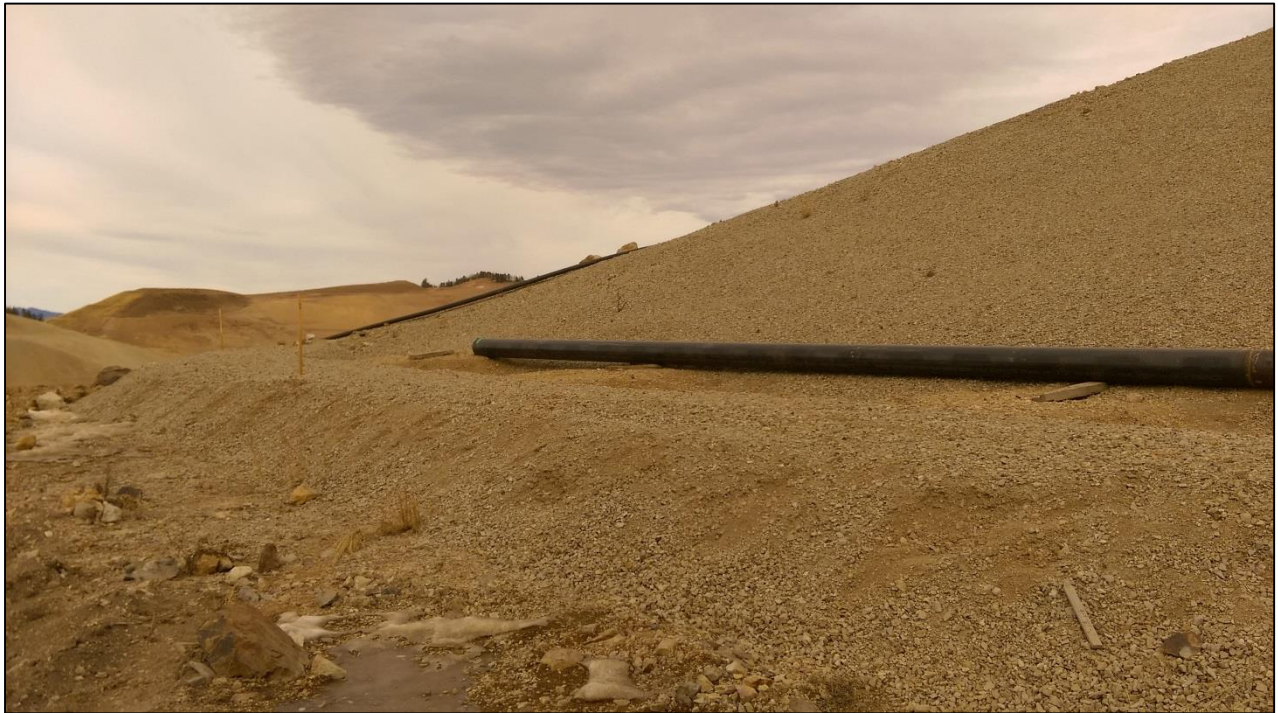
- Location of 14 inch diameter barren solution pipeline (**Photos 1 and 2**) and 10-12 inch diameter fresh water pipeline constructed from the Arequa Gulch Adsorption Desorption and Recovery Plant (AGADR) to the Squaw Gulch Adsorption Desorption and Recovery Plant (SGADR) associated with Technical Revision No. 76 (TR-76) approved by the Division on 11/5/2015. The AGVLF barren solution pipeline is located on the AGVLF lined area. The SGVLF barren solution pipeline is located on the SGVLF lined area. Most of the pipeline connecting the barren solution lines will be placed on the lined Mill Platform Drainline Containment Area (MPDCA). A small portion of the connection pipeline will cross an unlined area (between the edges of the MPDCA and the SGVLF lined areas). However, this portion of the pipeline, and a minimum of 10 additional feet on each end (extending onto the lined areas) will be double-walled (i.e., pipe-in-pipe/sleeved) and constructed as to gravity drain to the lined areas on either end in case of a leak. The fresh water pipeline will not follow the same alignment as the barren solution pipeline. The fresh water pipeline will run from the crusher water line toward the water tank (located south of the High Grade Mill), and then from the water tank to the SGADR.

**Photo 1.** View of southwestern corner of High Grade Mill Platform, showing barren solution pipeline installation (incomplete at this time). This pipeline will connect the AGADR to the SGADR.

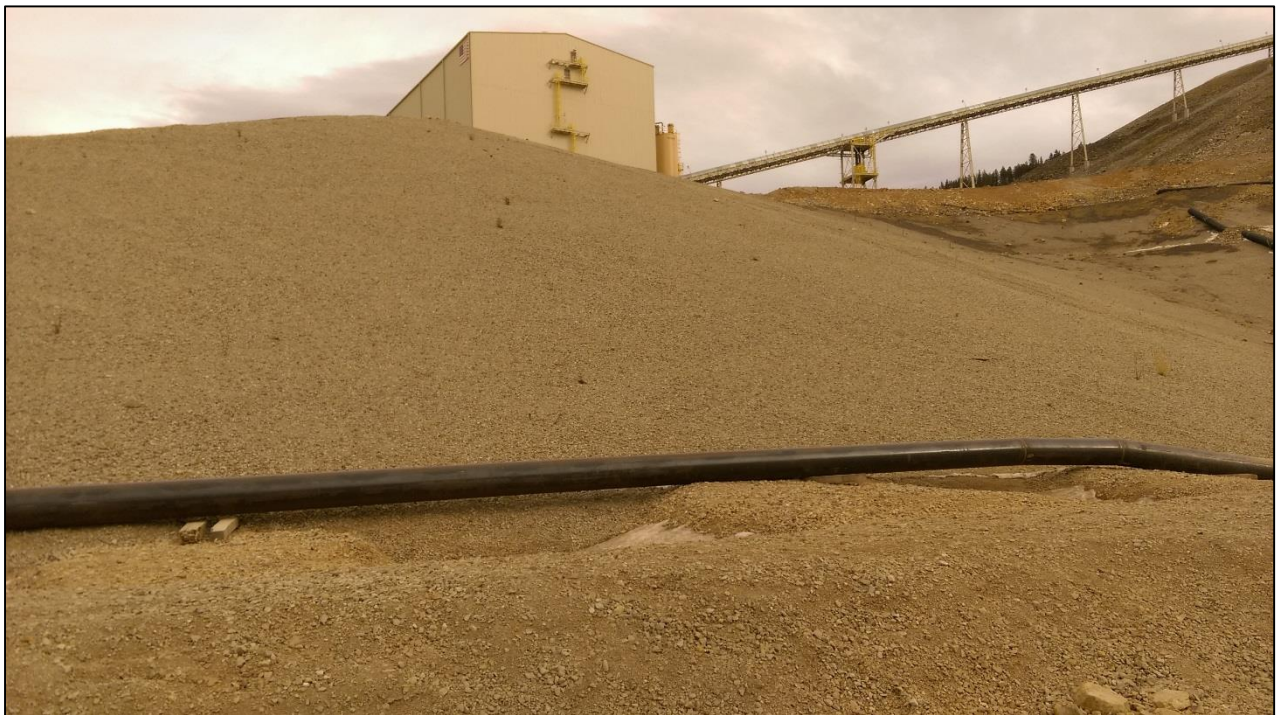
**Photo 2.** View of southwestern edge of High Grade Mill (HGM) Platform, showing barren solution pipeline installation (incomplete at this time). This pipeline will connect the AGADR to the SGADR. Note side of HGM facility and conveyor at top of platform.

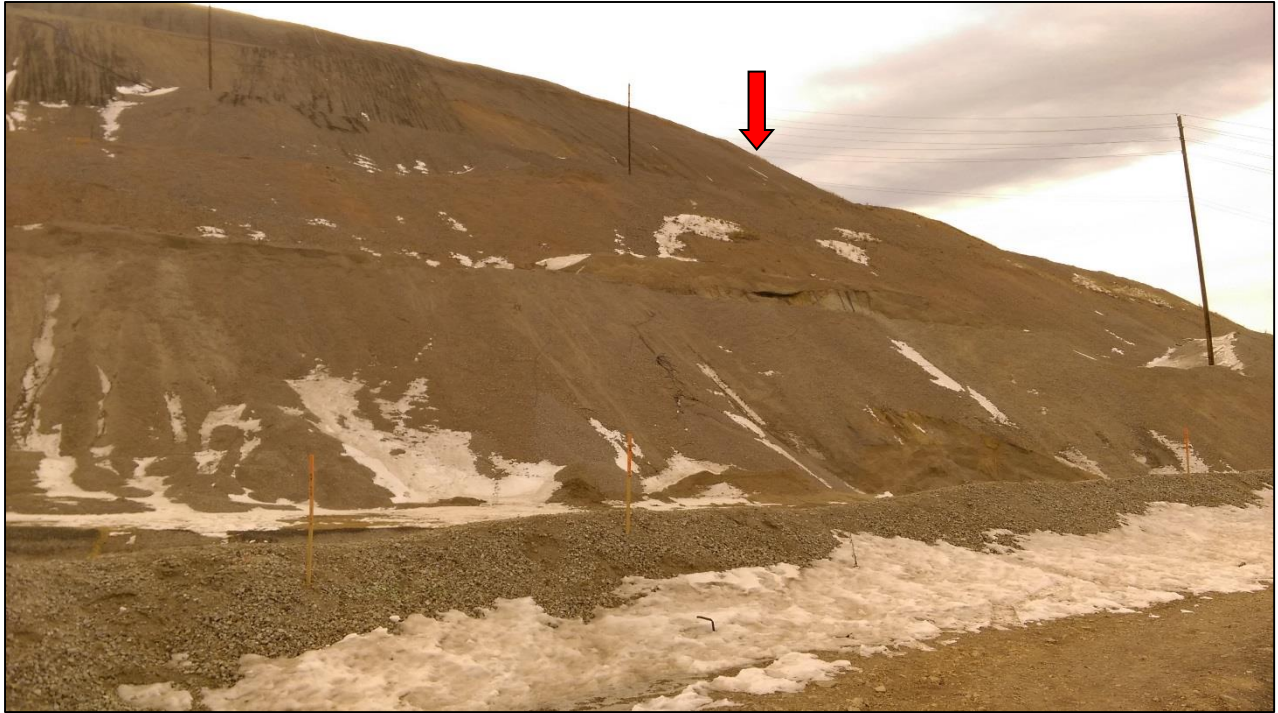
- Location of two new vertical injection wells on northwestern side of AGVLF Phase IV (at 9,950 feet elevation; **Photo 3**). High pH water discharged from the High Grade Mill leach circuit will be pumped via a 4" HDPE pipeline from the High Grade Mill to the AGVLF where it will be injected deep into Phase IV via these two wells. This activity was approved in Amendment No. 10 (AM-10); however, deep injection is an improved method from the surface drip system proposed in AM-10. The operator has found that injecting the high pH water helps reduce the potential for precipitation, and also places it deeper into the heap where it is more readily mixed with process solution. The recently installed wells are very similar to existing wells that were installed in the AGVLF within the past five years. According to the operator, all of the injection wells are monitored regularly for performance and flows are manually directed between the wells. As needed with time, the operator can use the pad injection pump to inject solution at high pressure/volume to flush the area around the wells.

**Photo 3.** View looking south at AGVLF Phase IV, showing approximate location of two new injection wells at 9,950 feet elevation. Wells are located just around edge of bench from where indicated.

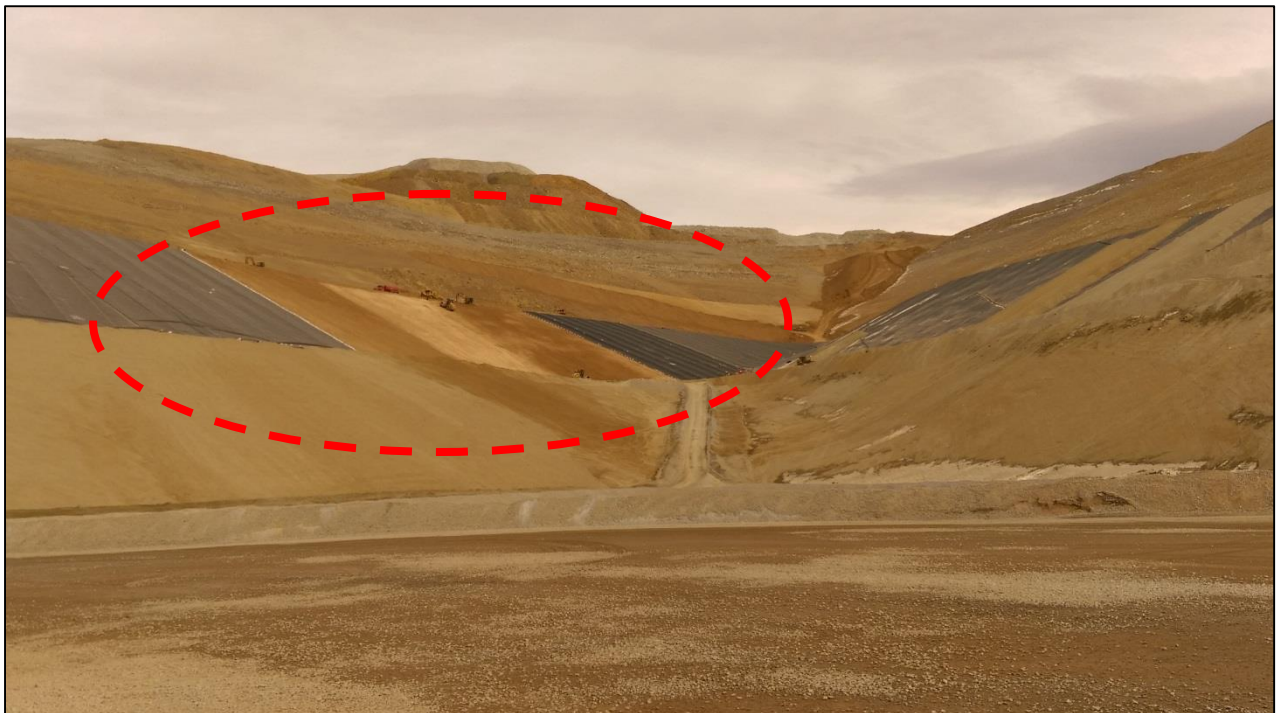
- Soil Liner Fill compaction/moisture conditioning and geomembrane deployment near the northeast corner of SGVLF Phase I (**Photo 4**). Mr. DiDonato indicated that the operational objective is to complete geomembrane liner installation by the end of the week (before the forecasted snowstorm moved through the area).
- Drain Cover Fill (DCF) placement on approved geomembrane liner in SGVLF Phase I (**Photos 5-11**). The operation will attempt to complete DCF placement across all installed and approved liner before the construction season closes. However, the specifications do allow the liner to be exposed for up to 180 days, meaning that if the current construction season ends in December, the operation would have until June 2016 to resume without Amec Foster Wheeler requiring additional conformance testing.

**Photo 4.** View looking at northeastern corner of SGVLF, showing Soil Liner Fill compaction/moisture conditioning and geomembrane deployment in Phase I up to 9,550 feet bench (area circled).

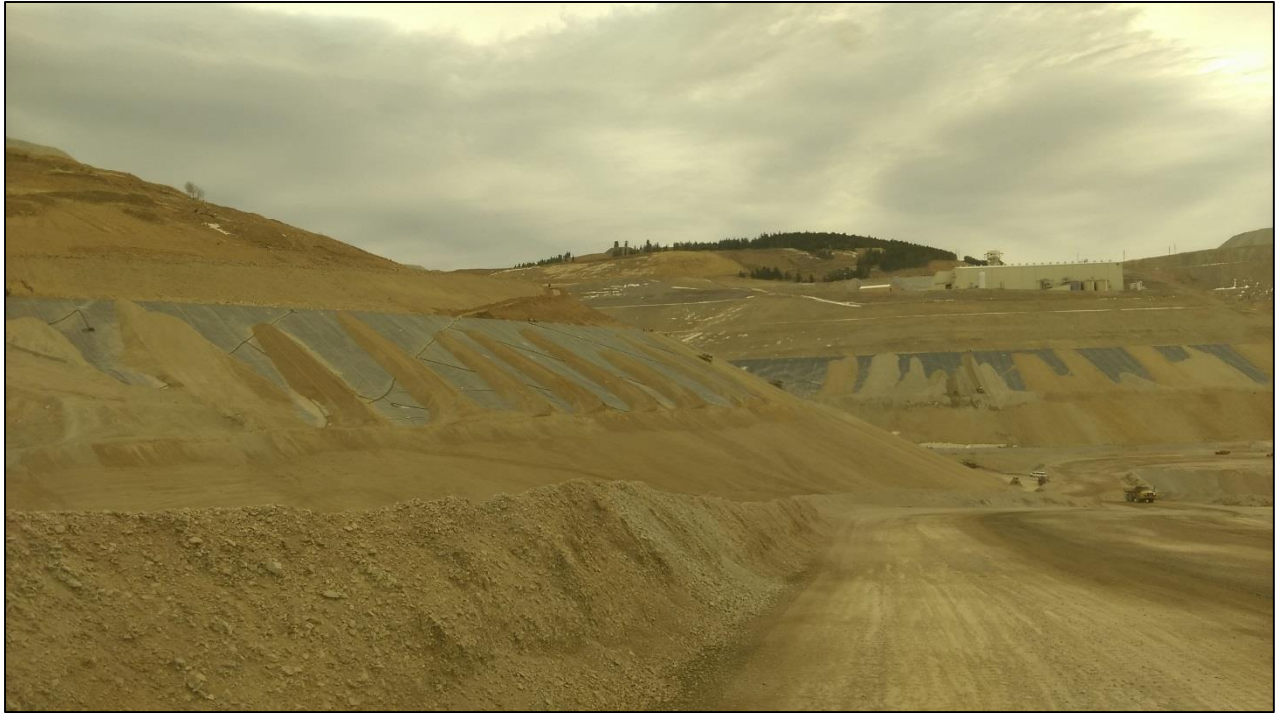
**Photo 5.** View looking east from haul road in northwestern portion of Phase I, showing Drain Cover Fill placement on approved geomembrane liner up to 9,550 foot bench.

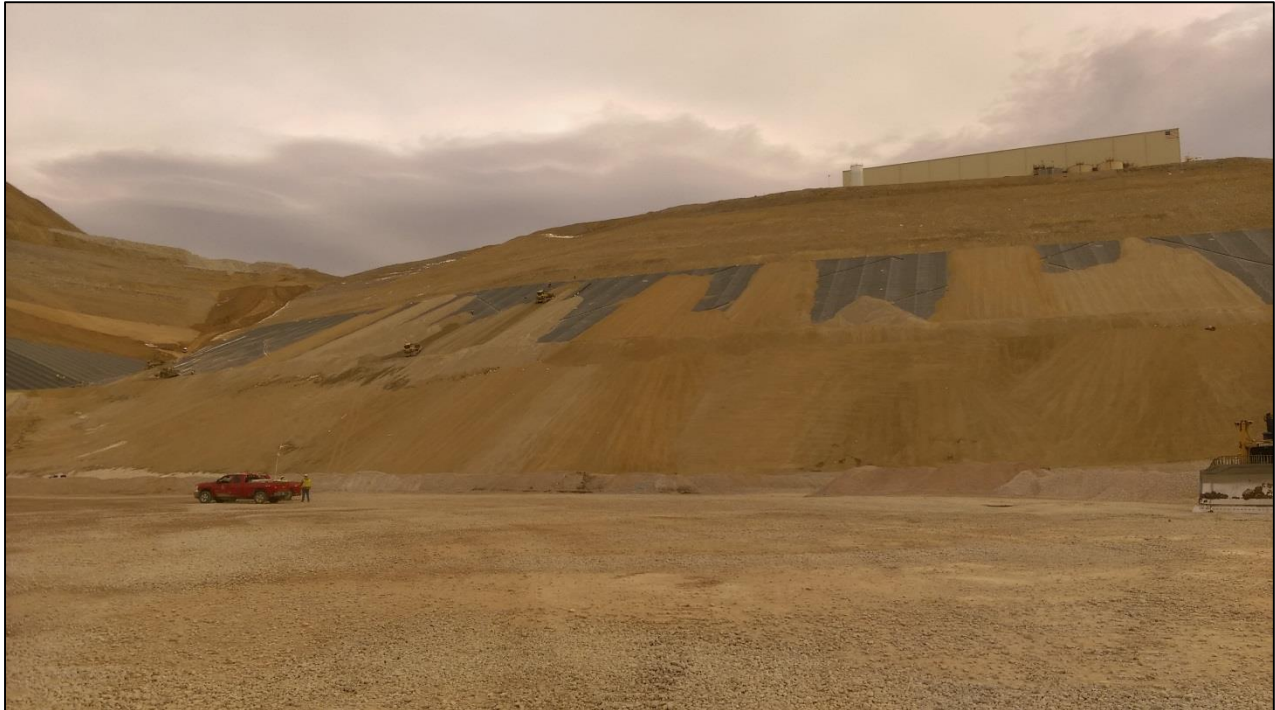
**Photo 6.** View looking east at eastern side of SGVLF, showing Drain Cover Fill placement on approved geomembrane liner up to 9,550 foot bench of Phase I. Note High Grade Mill facility located at top right.

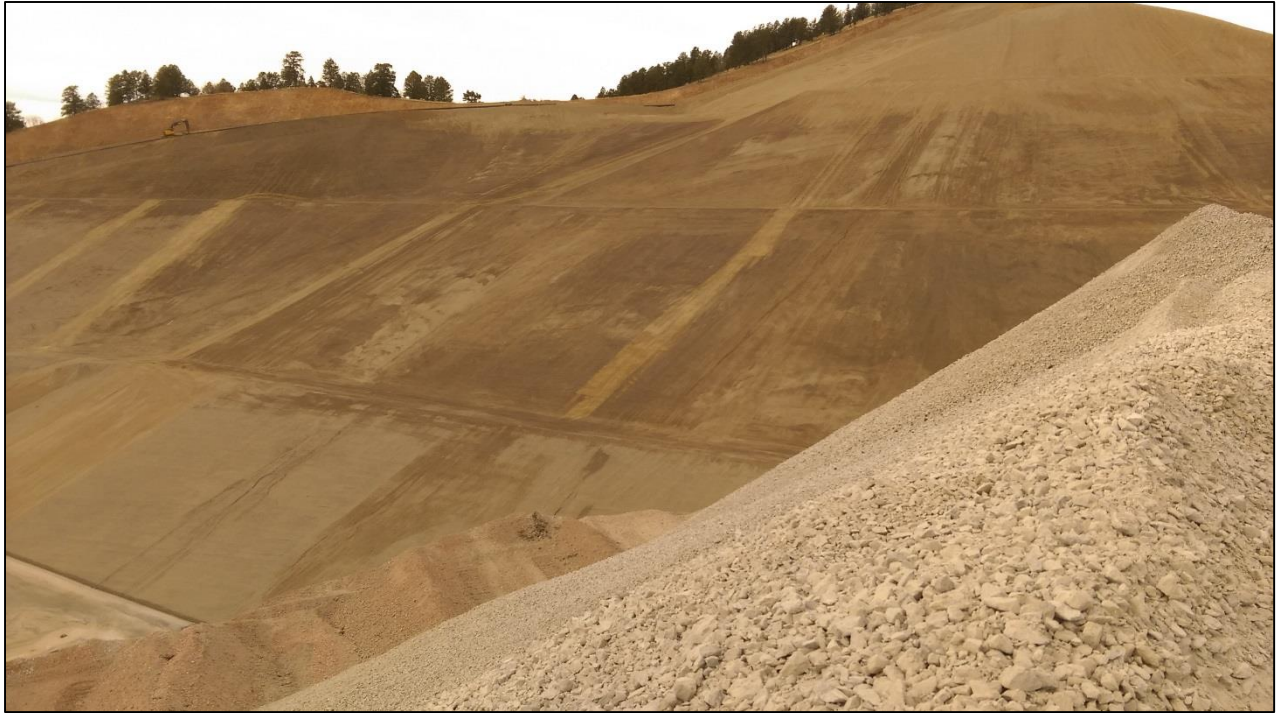
The Division monitored the areas which have received DCF placement for signs of erosion (observed in previous inspections). Previously, the erosion damage appeared to be primarily concentrated in the corners of the Pregnant Solution Storage Area (PSSA) and was attributed to surface water runoff. According to the operator, the DCF washouts were repaired before the PSSA filling activity began. AMEC monitored the repair work at that time, and no damaged liner was encountered. Since that time, the operation has continued to monitor for erosion of the DCF and make repairs as needed. Fresh dozer tracks were observed along contour on the west side of the SGVLF Phase I, evidence of recent DCF grading/repair. All lined areas that have received DCF appeared to be smooth and stable at the time of the inspection.

**Photo 7.** View looking northwest across western side of SGVLF from top of crushed ore lift (inside PSSA), showing Drain Cover Fill (DCF) spread across the slope. Note no DCF erosion evident.

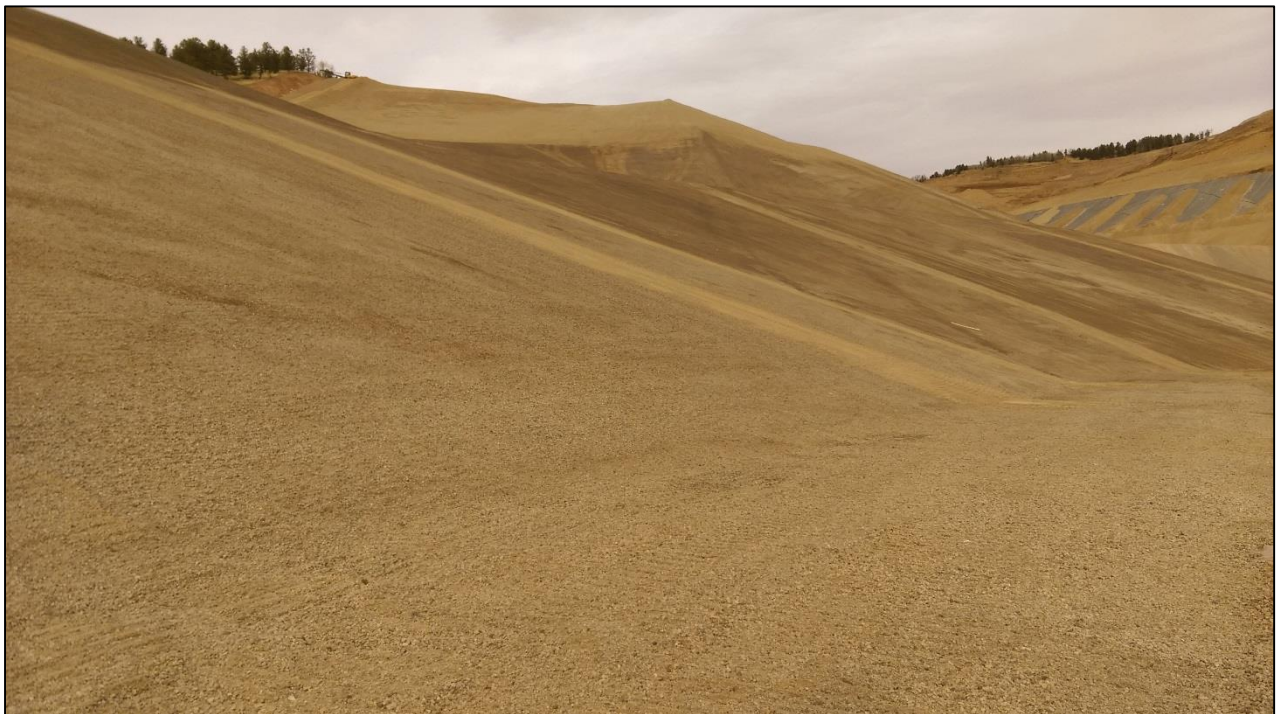
**Photo 8.** View looking northeast across western side of SGVLF Phase I from southwestern corner of the facility, showing Drain Cover Fill (DCF) spread across the slope. Note no DCF erosion evident.

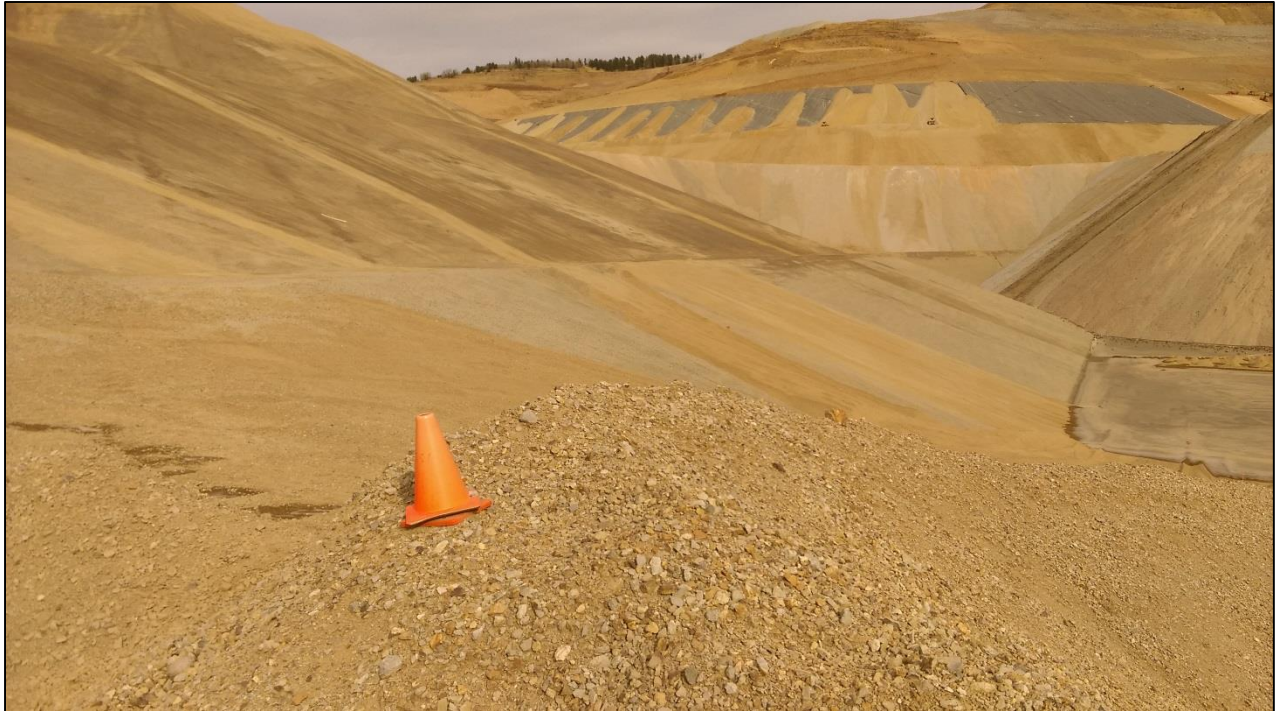
**Photo 9.** View looking northeast across western side of SGVLF PSSA and Phase I from southwestern corner of PSSA, showing Drain Cover Fill (DCF) placed across approved geomembrane liner. Note no DCF erosion evident.

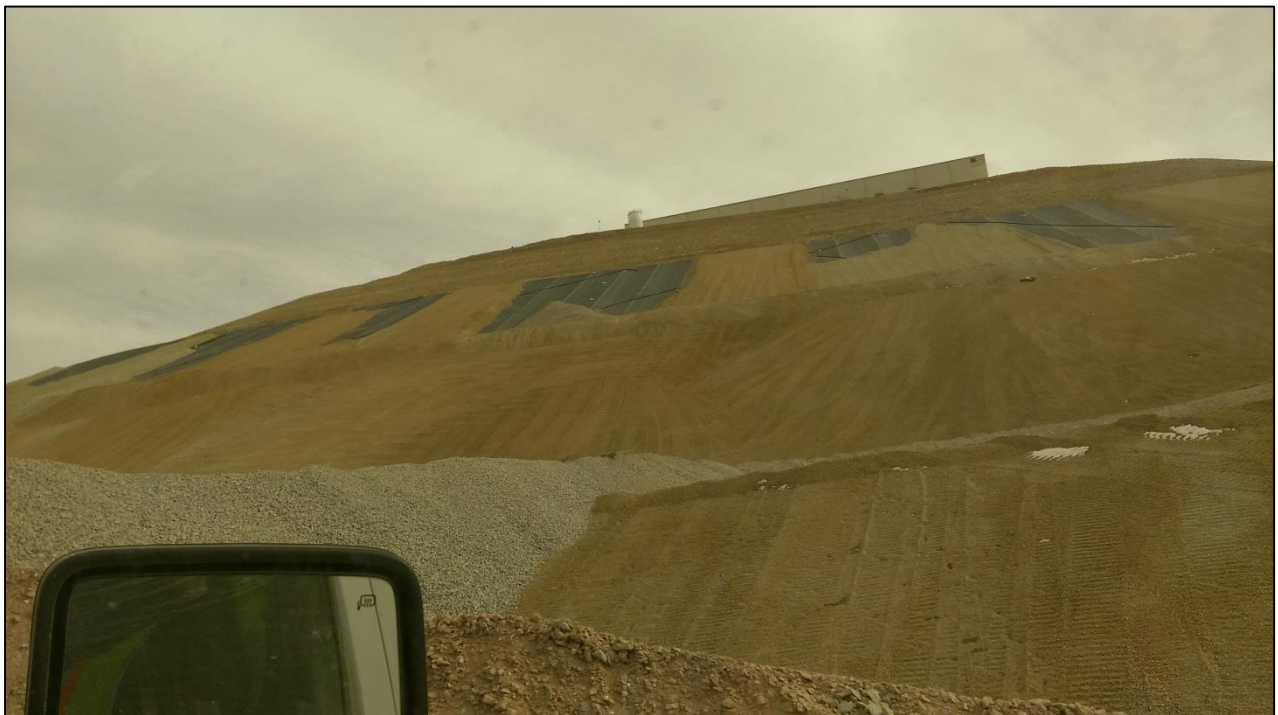
**Photo 10.** View looking east up eastern side of SGVLF, showing Drain Cover Fill placement on approved geomembrane liner up to 9,550 foot bench of Phase I. Note High Grade Mill facility located at top of hill. Portion of access ramp located at bottom left.

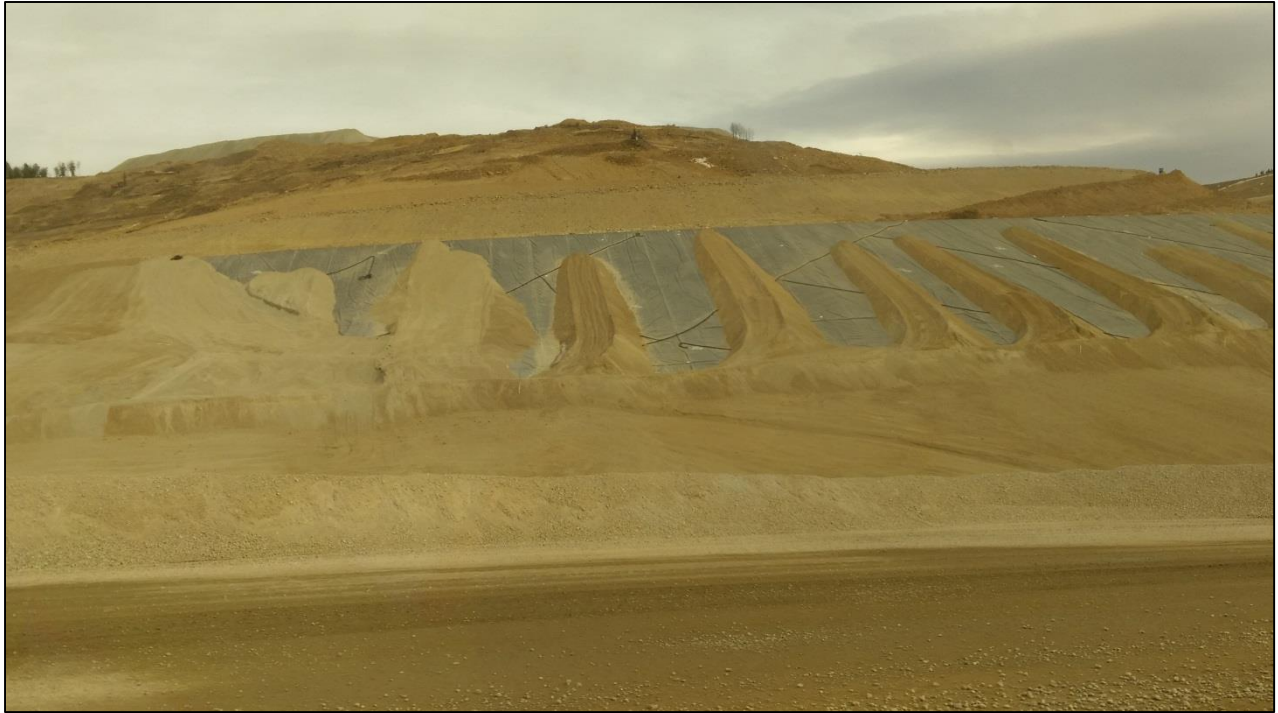
**Photo 11.** View looking northeast at northeastern side of SGVLF, showing Drain Cover Fill placement on approved geomembrane liner up to 9,550 foot bench of Phase I.

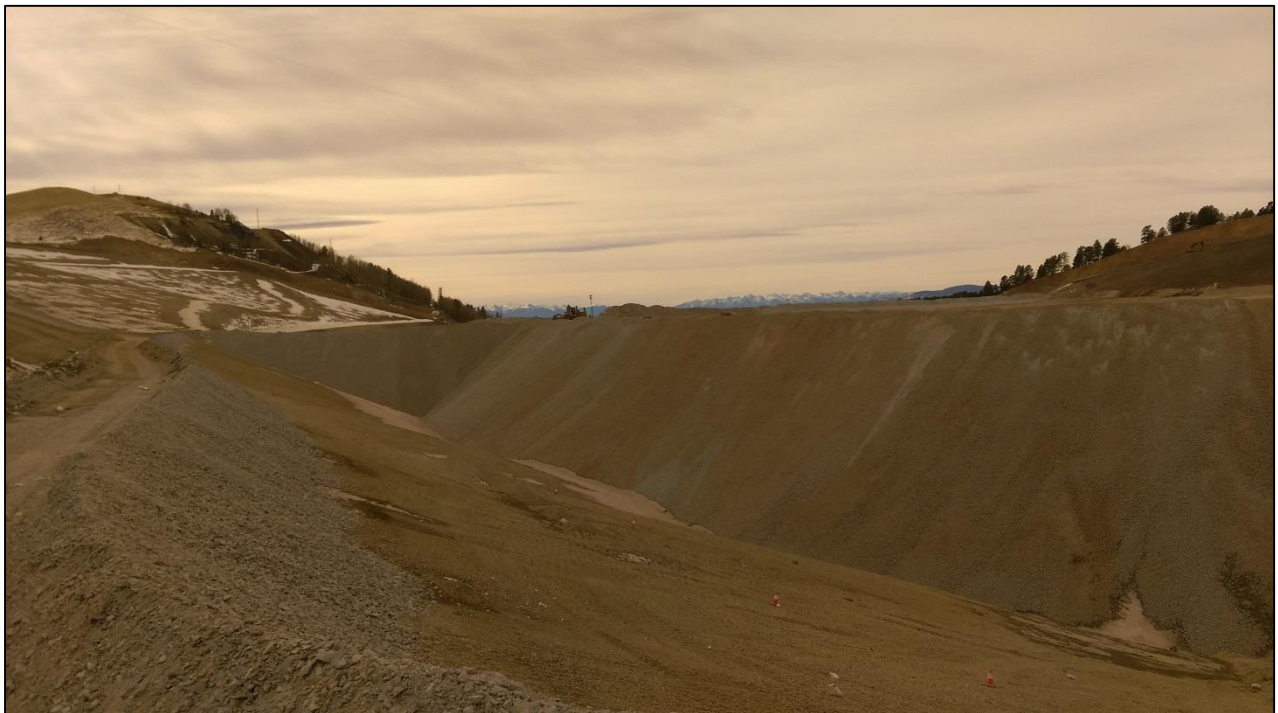
- Placement of Crushed Ore Fill in the eastern portion of the SGVLF PSSA to create an approximate 100 foot lift to load the PSSA up to the 9,550 foot bench (**Photos 12-14**). Mr. DiDonato discussed the operation's objective to begin circulating fluids in the PSSA in February, 2016. Therefore, the PSSA is expected to be loaded with ore to the 9,550 foot bench within the next few months.

**Photo 12.** View looking southwest from northeastern corner of SGVLF PSSA, showing Crushed Ore Fill that was added to eastern portion of PSSA to create an approximate 100 foot lift to load the PSSA to the 9,550 foot bench. Note access ramp at left.

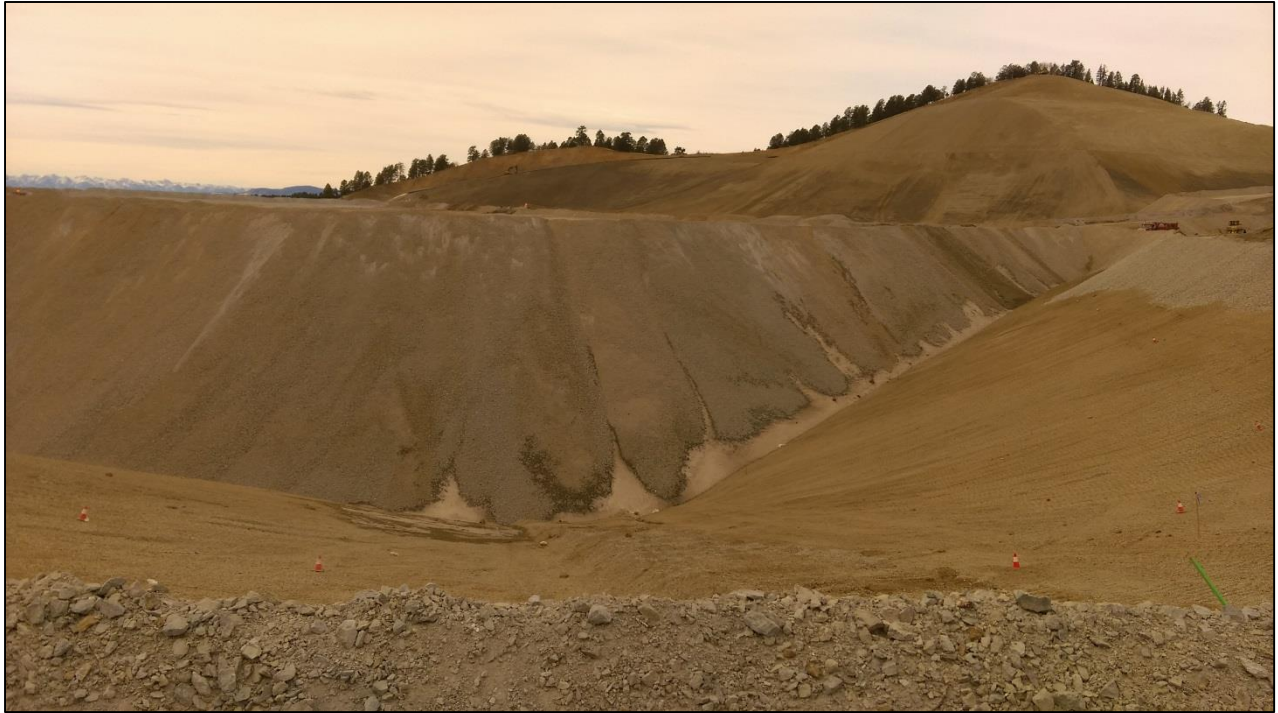
**Photo 13.** View looking northwest from northeastern corner of SGVLF PSSA, showing Crushed Ore Fill that was added to eastern portion of PSSA to create an approximate 100 foot lift to load the PSSA to the 9,550 foot bench. Note access ramp at right.

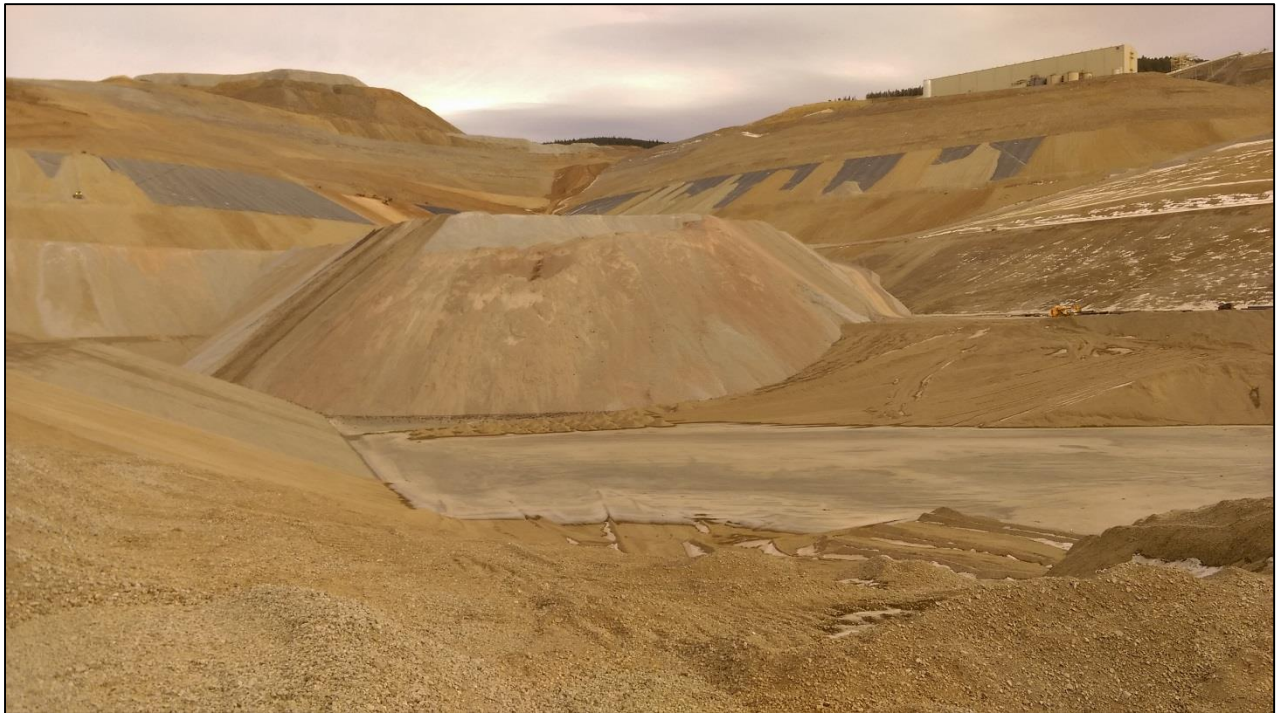
**Photo 14.** View looking northeast from southwestern corner of SGVLF PSSA, showing Crushed Ore Fill that was added to eastern portion of PSSA to create an approximate 100 foot lift to load the PSSA to the 9,550 foot bench. Note displaced water ponded on floor of PSSA (iced over).

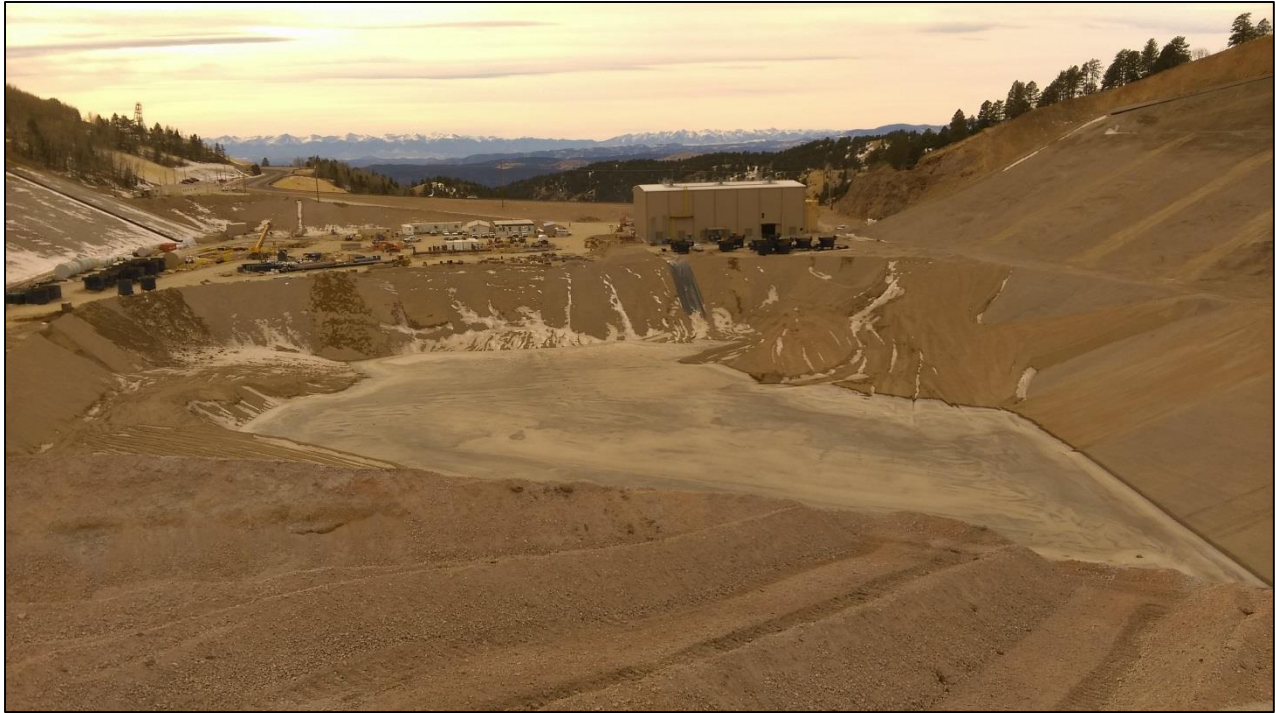
During the inspection, some displaced water was observed in the PSSA at the other end from where the crushed ore is being placed (**Photos 15 and 16**). Mr. DiDonato estimates the displaced water to currently be approximately one foot in depth, and the water level to be at an elevation of approximately 9,402 feet. The operator was not able to meet the objective to eliminate the pooled water by mid-November. However, it is the understanding of the Division that the water will be backfilled with ore within the next two months. No wildlife was observed in or near the SGVLF PSSA during the inspection.

**Photo 15.** View looking southwest from top of crushed ore lift, showing displaced water present on SGVLF PSSA floor (iced over). Note SGADR facility located in background (at right).

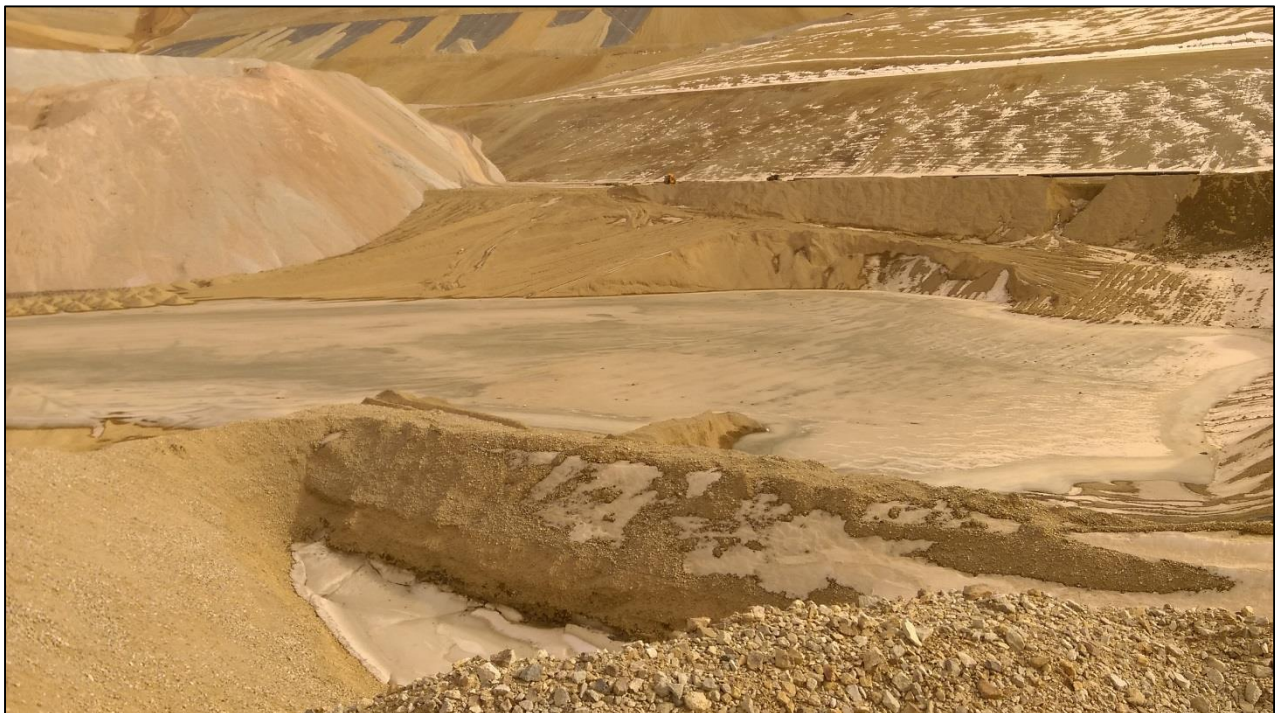
**Photo 16.** View looking east from southwestern corner of SGVLF PSSA, showing displaced water present on PSSA floor (iced over). Note crushed ore lift present in PSSA at left.

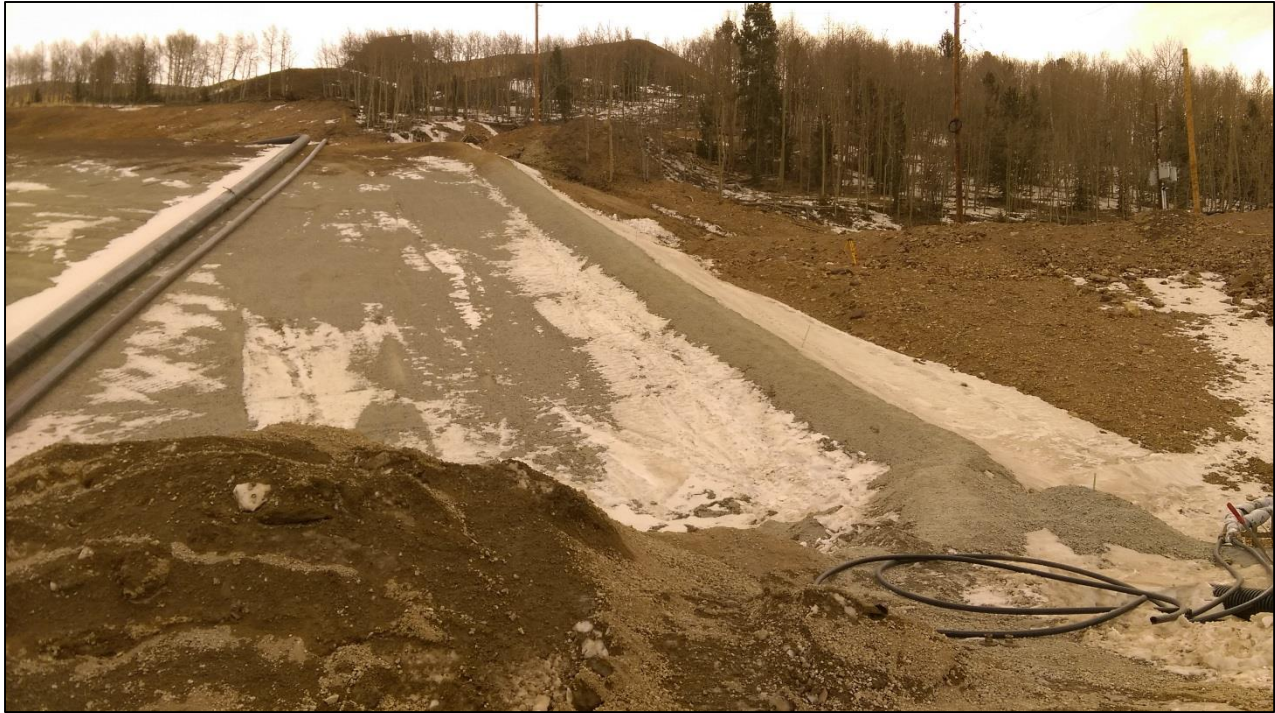
- Soil Liner Fill (SLF) containment berms that were constructed along the western edges of the SGVLF Phase I geomembrane lined areas (**Photos 17 and 18**). The berms are lined with geomembrane and covered with DCF. The operator listed the SLF berms as a drawing deviation in the Quality Assurance Monitoring and Test Results Final Report for Phase I (9,450 foot to 9,550 foot bench) that was submitted in October. The berms are low-lying with slopes that are steeper than 2H:1V. However,

**Photo 17.** View looking at southern edge of geomembrane liner in southeastern corner of SGVLF, showing Soil Liner Fill containment berm constructed along this edge. Note berm is covered with Drain Cover Fill. Also note barren solution pipeline located approximately 15 feet from (left of) the berm.

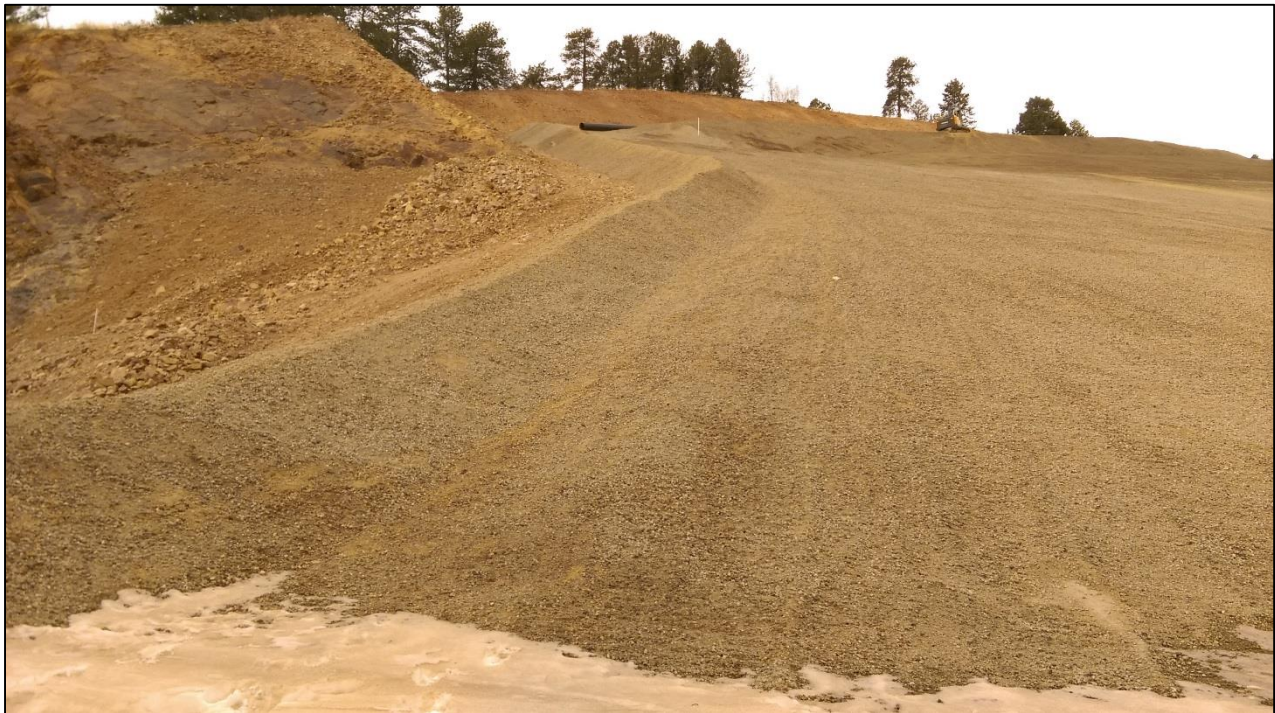
**Photo 18.** View looking at southern edge of geomembrane liner in southwestern corner of SGVLF, showing Soil Liner Fill containment berm constructed along this edge. Note berm is covered with Drain Cover Fill.

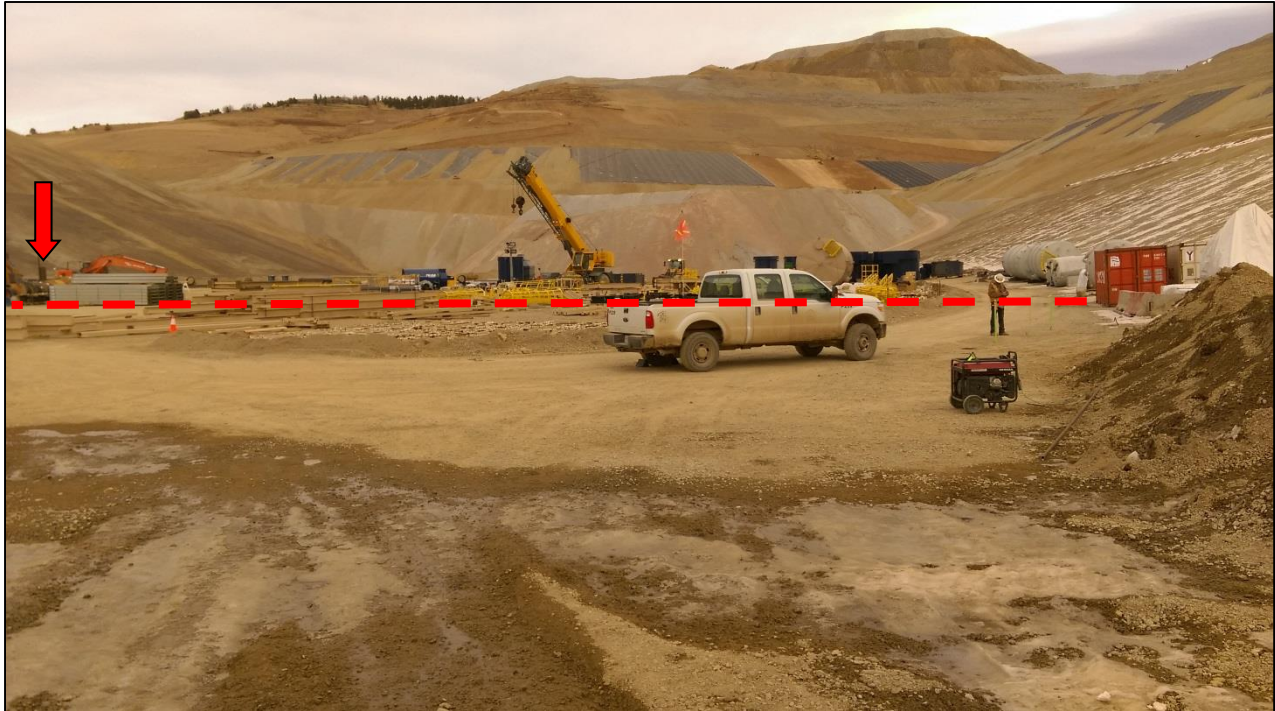
according to the project specifications, the berms will never be loaded with ore or leached. Mr. DiDonato pointed out during the inspection that the berms are located at least 100 feet from where the spent ore will toe out in the SGVLF (**Photo 19**). The barren solution pipeline was installed approximately 15 feet from the berms. Mr. DiDonato explained the purpose of the berms is to work as a containment feature if the barren solution pipeline were to leak. In this event, the berms should help keep any leaked barren solution on the lined area. Similar berms were also constructed in the AGVLF.

**Photo 19.** View looking northeast from southeastern corner of SGVLF, showing location of HVSCS riser pipes (indicated at left) and approximate location of where ore will toe out (indicated with dashed red line) once facility is loaded to 9,550 elevation.

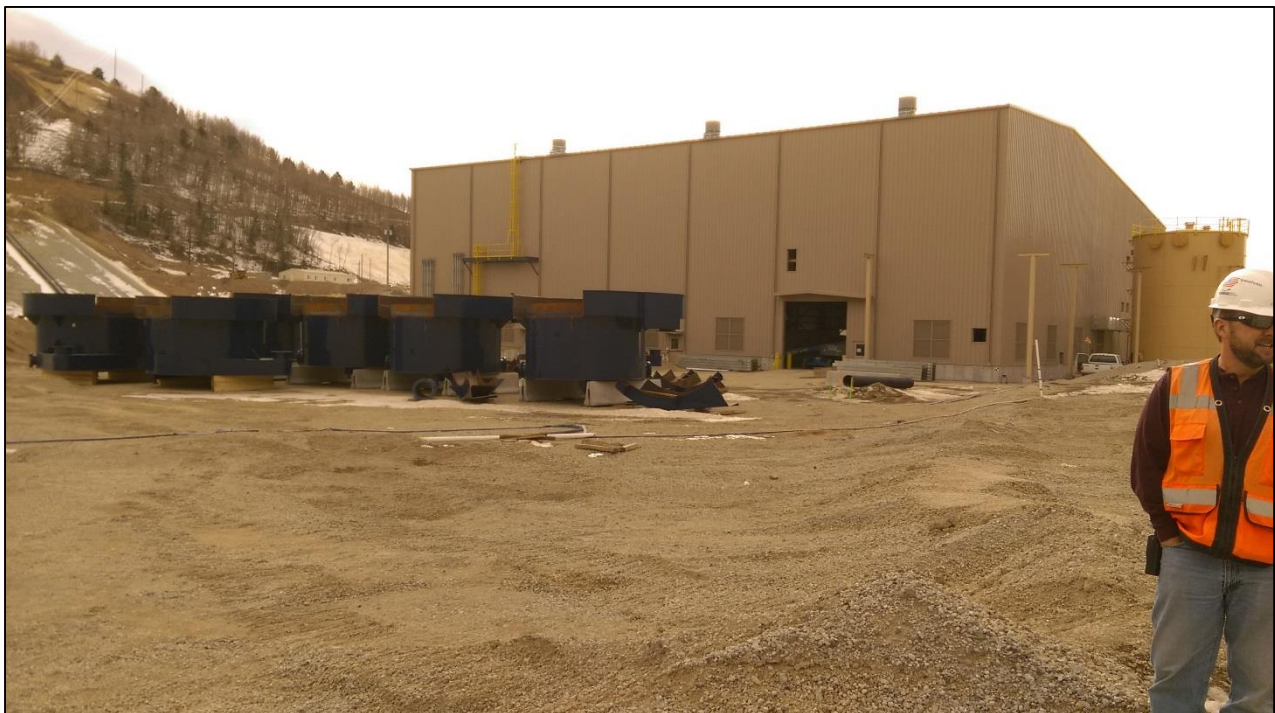
- Continued construction of the SGADR facility (**Photo 20**). This project appears to still be in its phase 1 of construction where mainly support framework is being installed. Several pieces of equipment that will be installed inside the SGADR (e.g., vat leach tanks) were temporarily staged outside of the facility. This equipment is expected to be installed shortly (as part of phase 2 of construction).

**Photo 20.** View of SGADR facility located at southwestern corner of SGVLF. The operation appears to be completing support framework of this facility. Inside equipment (e.g, vat leach tanks shown in foreground) is expected to be installed shortly.

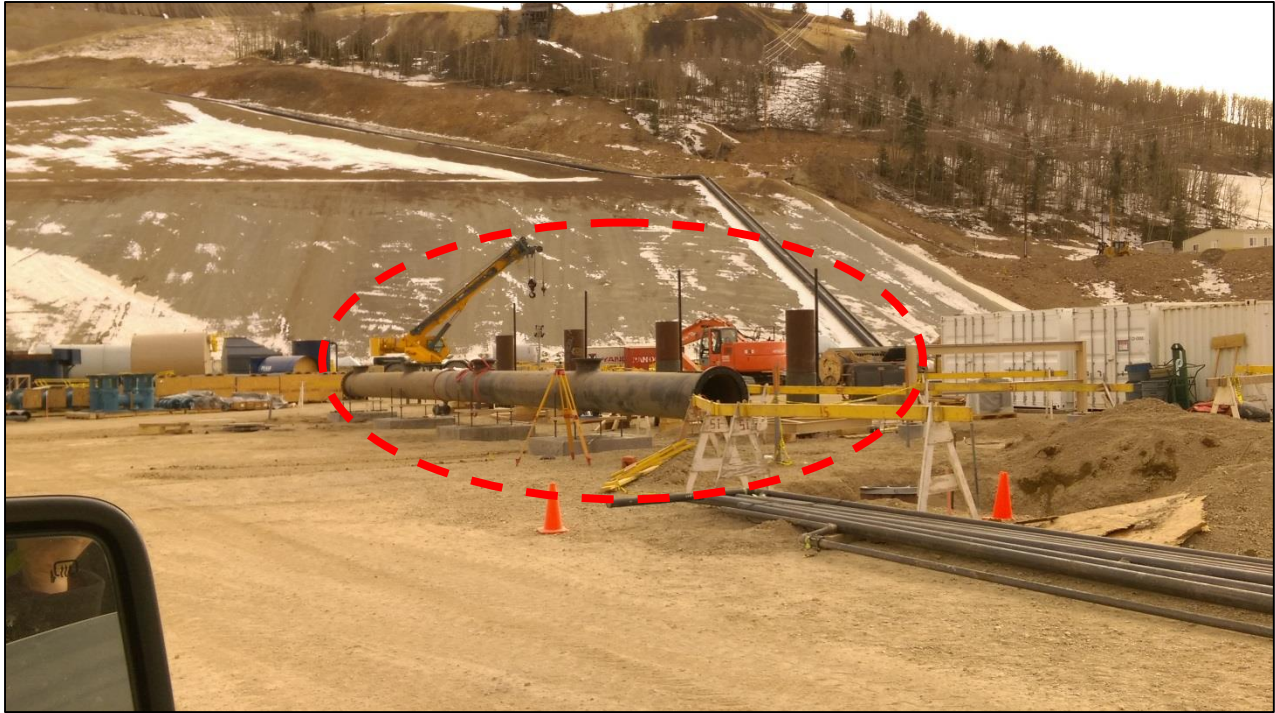
- SGVLF High Volume Solution Collection System riser pipes located at southern edge of PSSA; header to be installed shortly (**Photo 21**).
- Location where processed product from the new High Grade Mill is mixed with fresh ore hauled in from the AGVLF load out bin to place into the SGVLF (**Photo 22**). The Division received notice from the operator describing this activity on 11/05/2015. Approximately two 30 yard buckets of processed product is added to each 240 ton load of fresh ore. This activity began in November and is expected to continue throughout the life of the SGVLF.

**Photo 21.** View looking southeast, showing the four HVSCS riser pipes (circled) located at southern edge of SGVLF; header will be installed soon.
