**COLORADO DIVISION OF RECLAMATION, MINING AND SAFETY**  
**MINERALS PROGRAM INSPECTION REPORT**  
**PHONE: (303) 866-3567**

| <b>MINE NAME:</b><br>Cresson Project | <b>MINE/PROSPECTING ID#:</b><br>M-1980-244 | <b>MINERAL:</b><br>Gold | <b>COUNTY:</b><br>Teller |
| <b>INSPECTION TYPE:</b><br>Monitoring | <b>INSPECTOR(S):</b><br>Amy Eschberger | <b>INSP. DATE:</b><br>December 9, 2015 | <b>INSP. TIME:</b><br>10:15 |

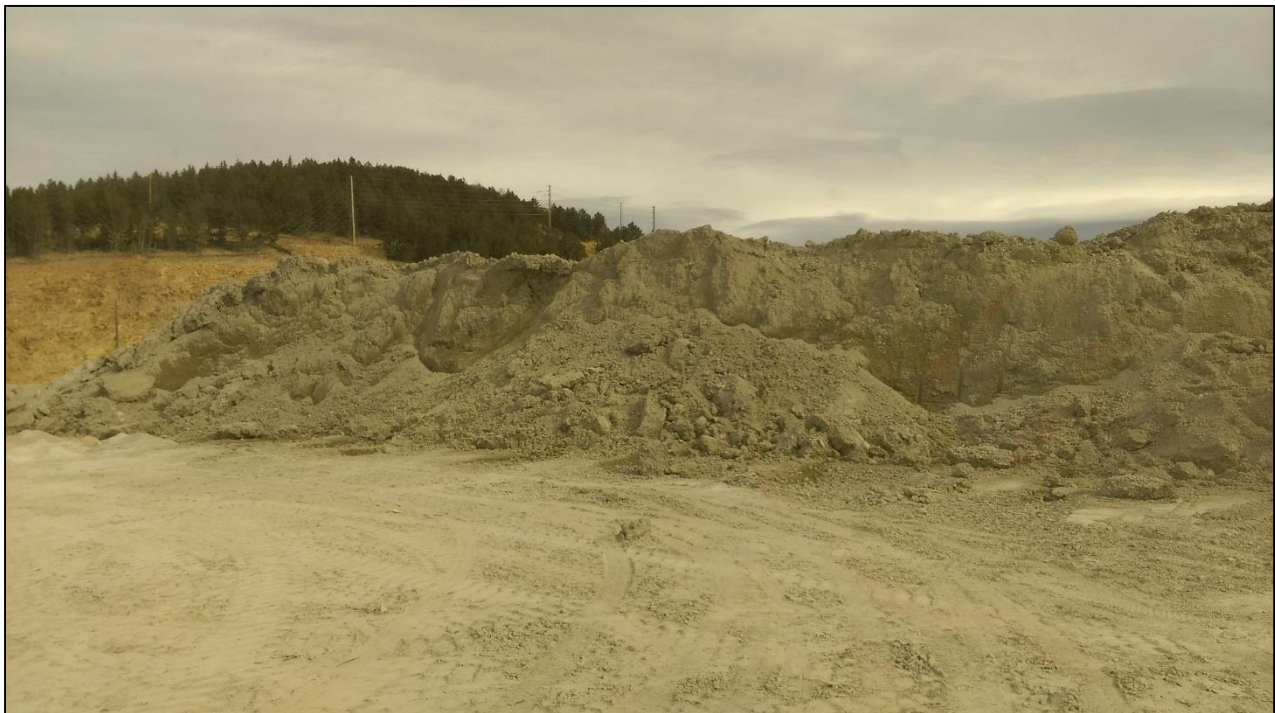
**Photo 22.** View of stockpile of processed product from High Grade Mill (HGM) that is mixed here (east of HGM) with fresh ore hauled in from AGVLF load out bin, then is hauled to the SGVLF PSSA.

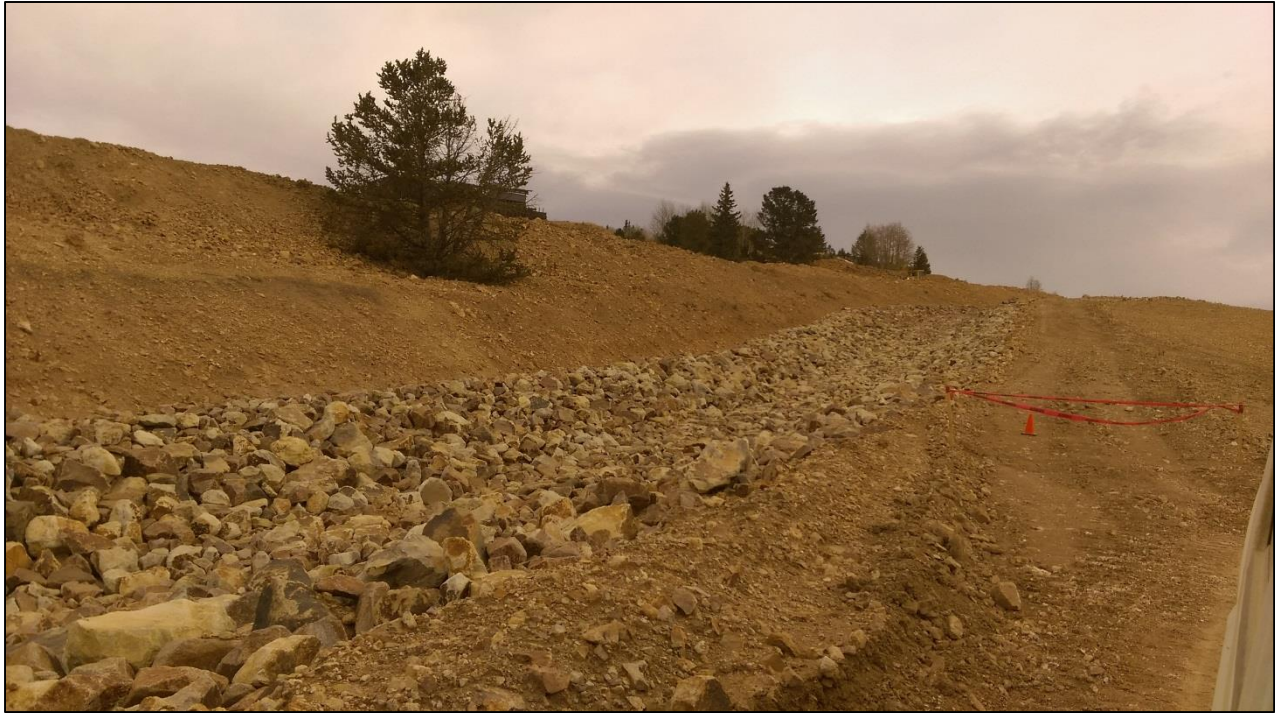
- Completed SGVLF Phase II stormwater diversion ditches (**Photos 23 and 24**) appeared to be in good repair.

**Photo 23.** View of SGVLF Phase II stormwater diversion ditch, which appears to be in good repair.

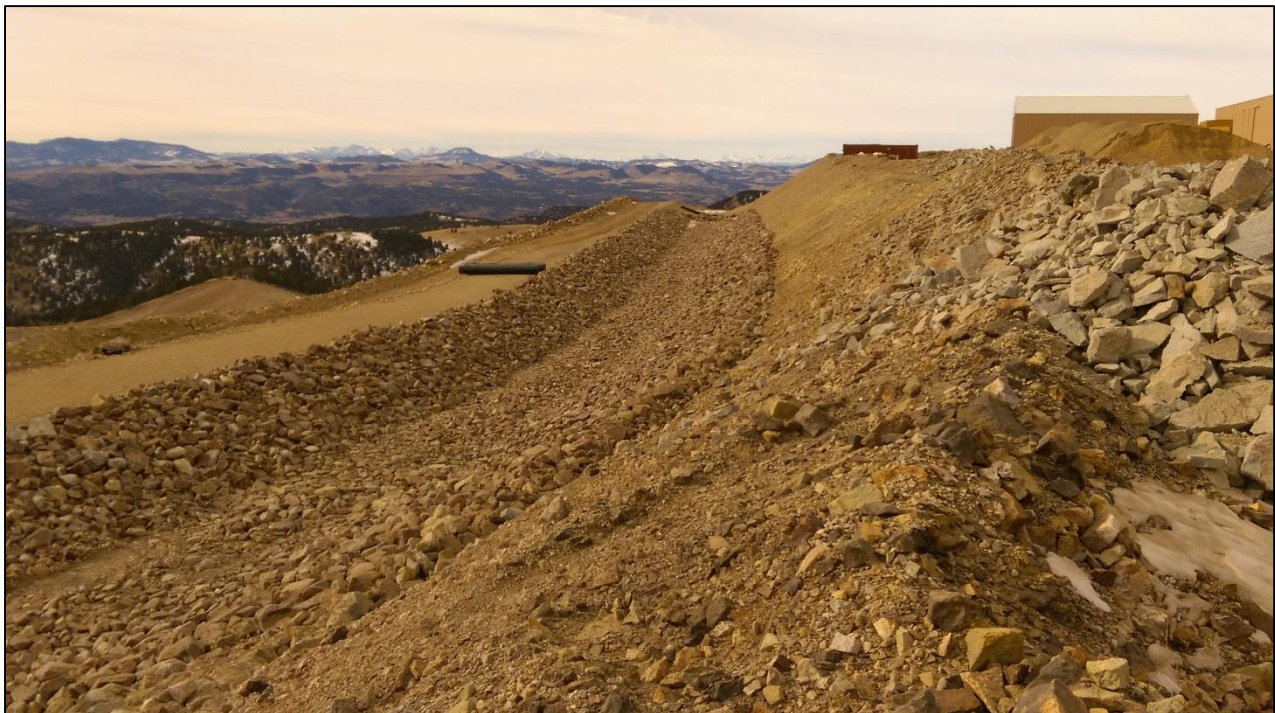
**Photo 24.** View of SGVLF Phase II stormwater diversion ditch (different ditch than one shown in **Photo 23**), which appears to be in good repair.

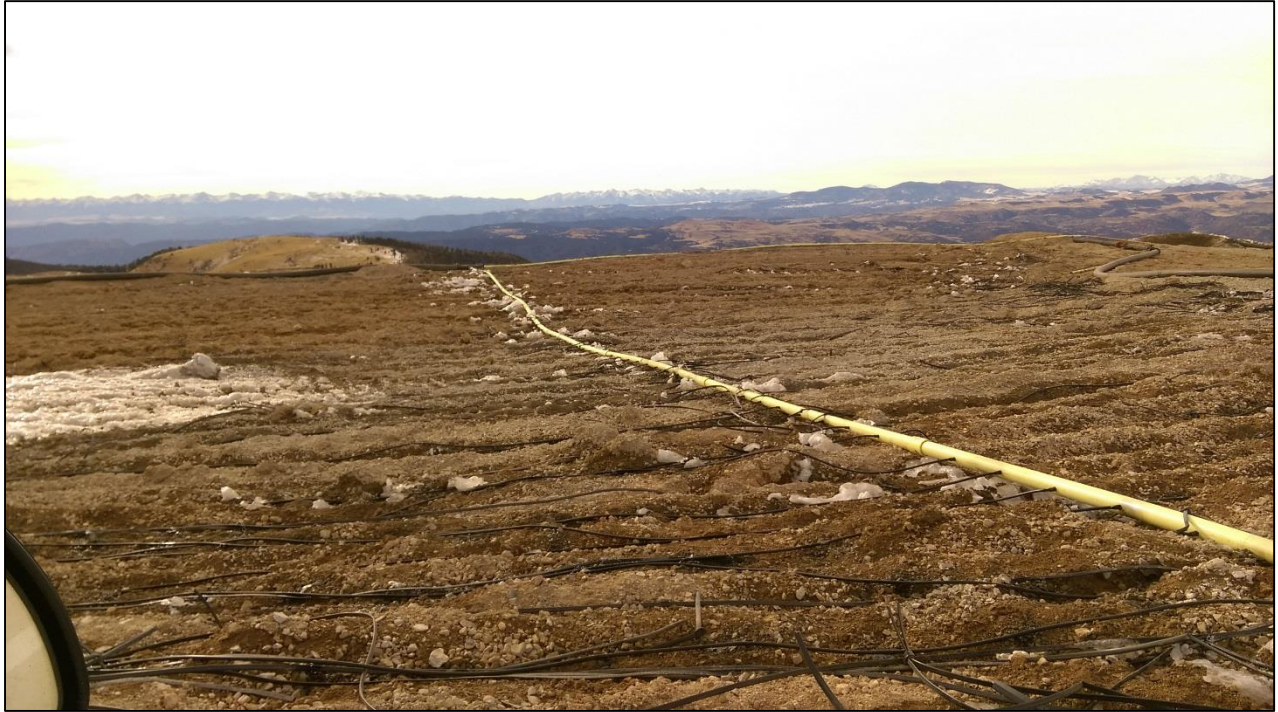
At the time of the inspection, the Division noted some small patches of ice and a few small puddles (less than 1 foot x 1 foot in surface area) mainly around the driplines (**Photos 25-32**). However, no evidence of larger scale

**Photo 25.** View of top surface of AGVLF (at 10,300 feet elevation), showing some minor ice around driplines, but no ponding of solution greater than 3 foot x 3 foot in surface area is evident. Note ripped surface.

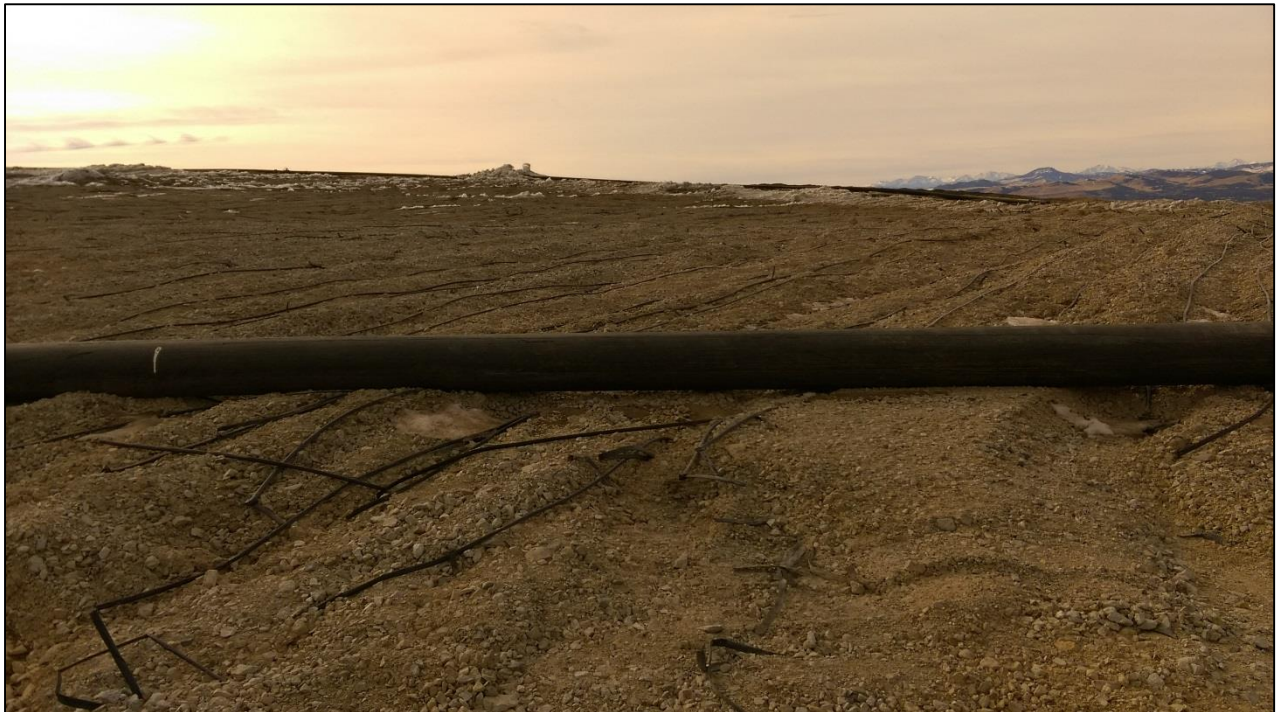
**Photo 26.** View of top surface of AGVLF (at 10,300 feet elevation), showing no ponding of solution greater than 3 foot x 3 foot in surface area is evident. Note ripped surface.

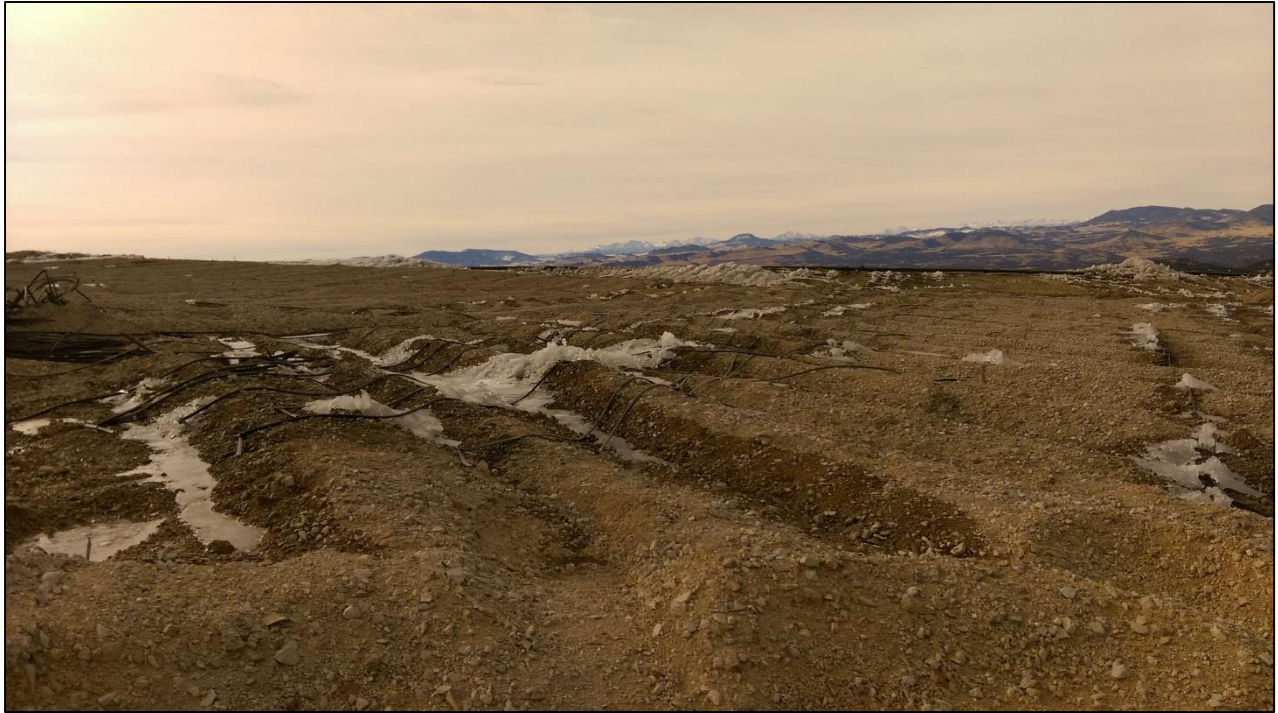
**Photo 27.** View of top surface of AGVLF (at 10,300 feet elevation), showing some minor ice around driplines, but no ponding of solution greater than 3 foot x 3 foot in surface area is evident. Note ripped surface.

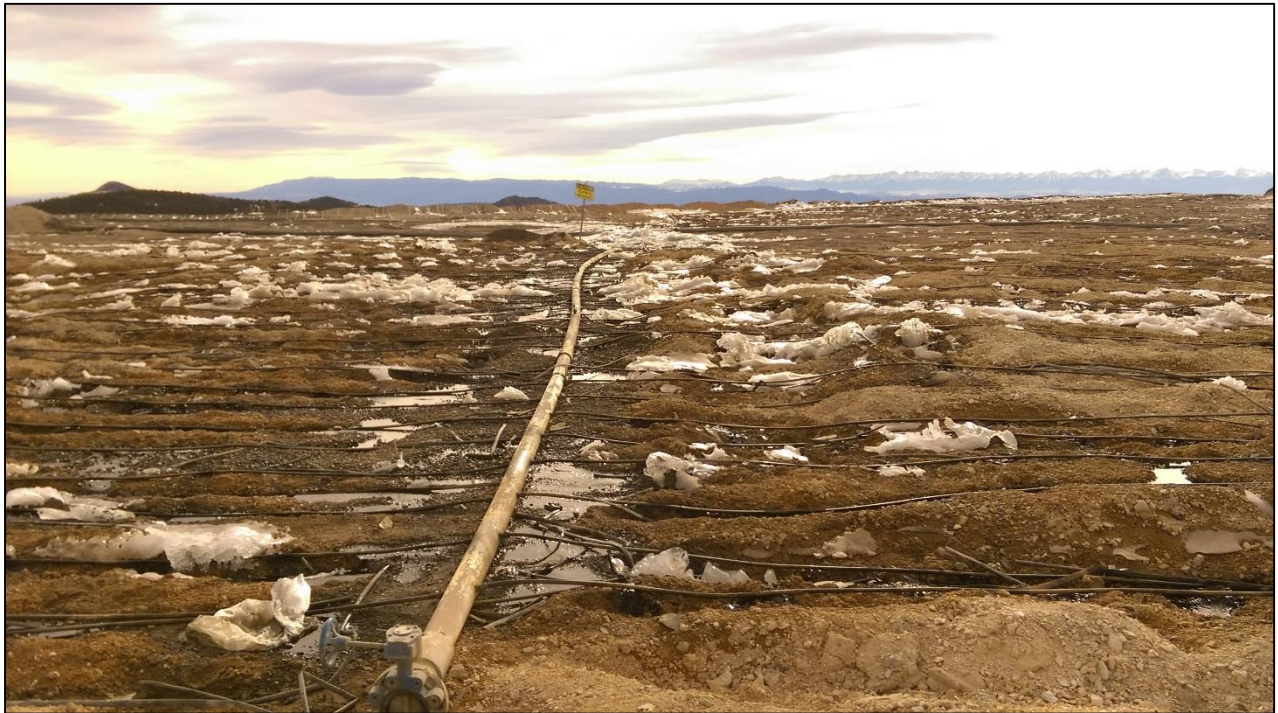
**Photo 28.** View of top surface of AGVLF (at 10,300 feet elevation), showing some minor ice and ponding around driplines, but no ponding of solution greater than 3 foot x 3 foot in surface area is evident. Note ripped surface.

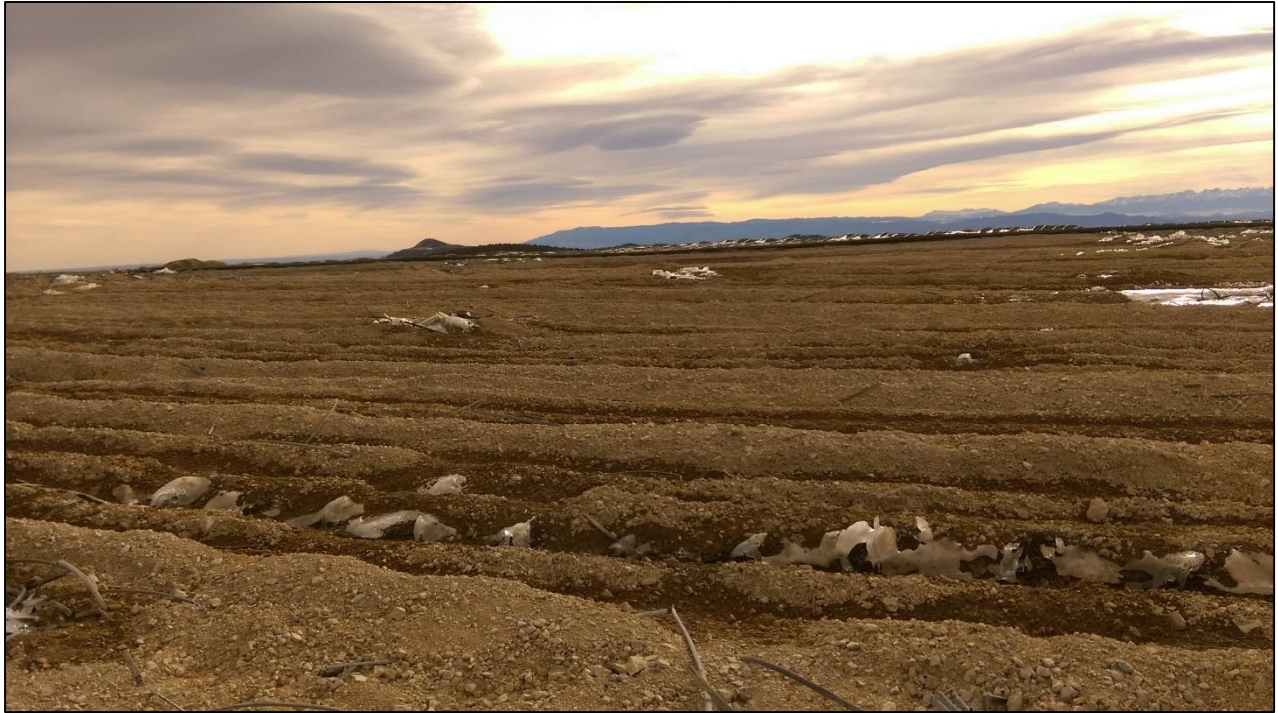
**Photo 29.** View of top surface of AGVLF (at 10,300 feet elevation), showing some minor ice around driplines, but no ponding of solution greater than 3 foot x 3 foot in surface area is evident. Note ripped surface.

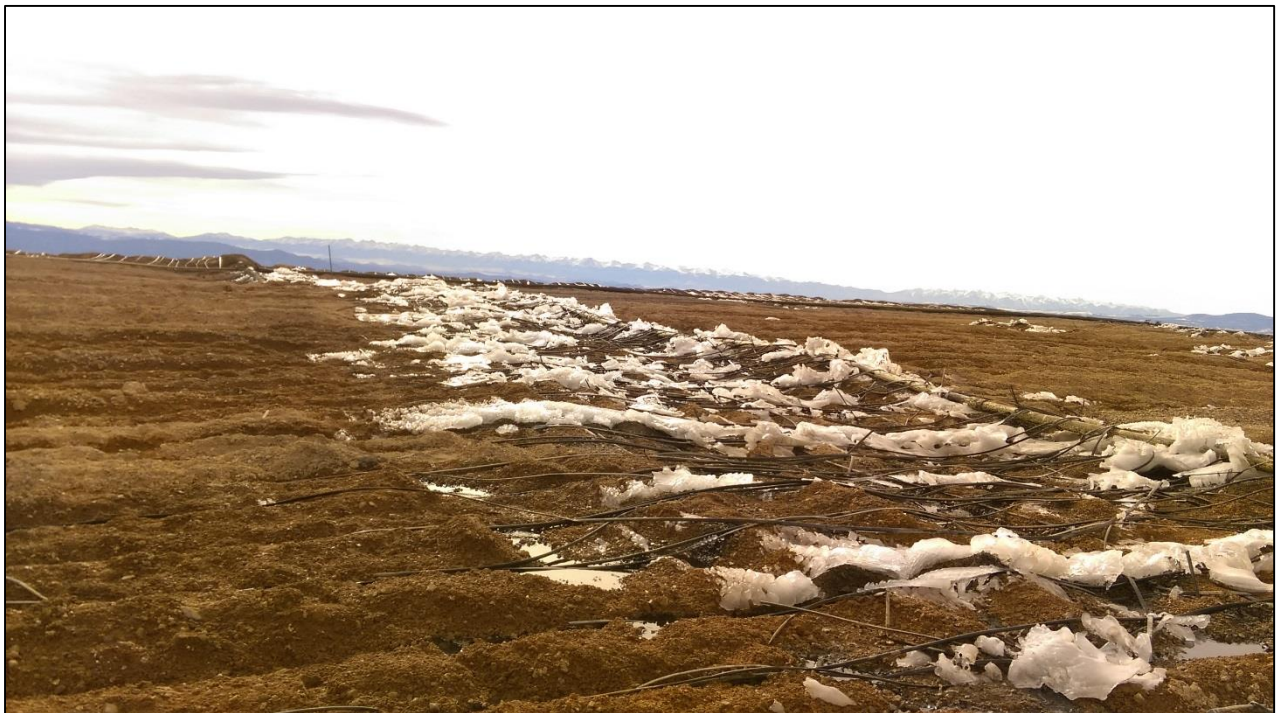
**Photo 30.** View of top surface of AGVLF (at 10,300 feet elevation), showing some minor ice around driplines, but no ponding of solution greater than 3 foot x 3 foot in surface area is evident. Note ripped surface.

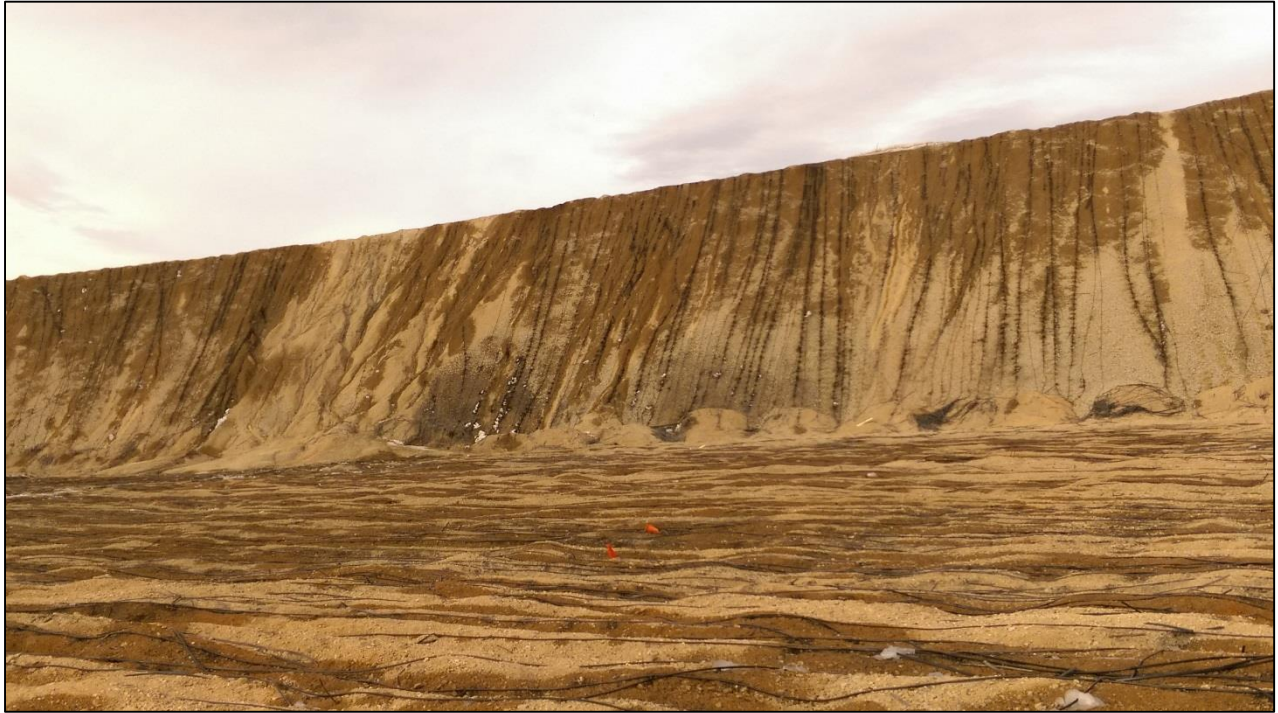
**Photo 31.** View of top surface of AGVLF (at 10,300 feet elevation) and side of next ore lift, showing no ponding of solution greater than 3 foot x 3 foot in surface area is evident.

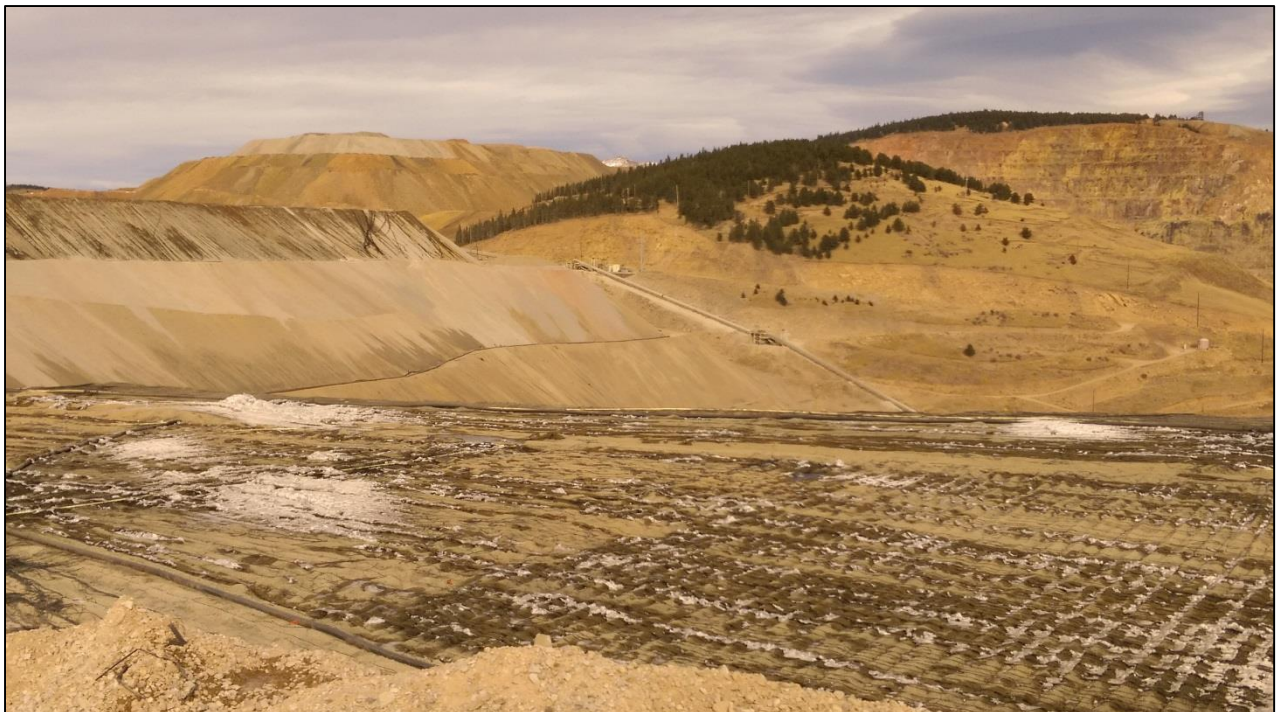
**Photo 32.** View of top surface of AGVLF (at 10,300 feet elevation), showing some minor ice around driplines, but no ponding of solution greater than 3 foot x 3 foot in surface area is evident. Note conveyor (near center) which runs from crusher area (at right; not shown) to LOB (at left; not shown). Top of large overburden stockpile in Squaw Gulch Overburden Stockpile Area shown in background (at top left).
