COLORADO DIVISION OF RECLAMATION, MINING AND SAFETY
MINERALS PROGRAM INSPECTION REPORT
PHONE: (303) 866-3567

MINE NAME: Greer Pit	MINE/PROSPECTING ID#: M-1985-115	MINERAL: Sand and gravel	COUNTY: La Plata
INSPECTION TYPE: Monitoring	INSPECTOR(S): Lucas J. West	INSP. DATE: November 30, 2015	INSP. TIME: 13:30
OPERATOR: J Pat and Lila N Greer	OPERATOR REPRESENTATIVE: J Pat Greer, Jim Greer	TYPE OF OPERATION: 110c - Construction Limited Impact

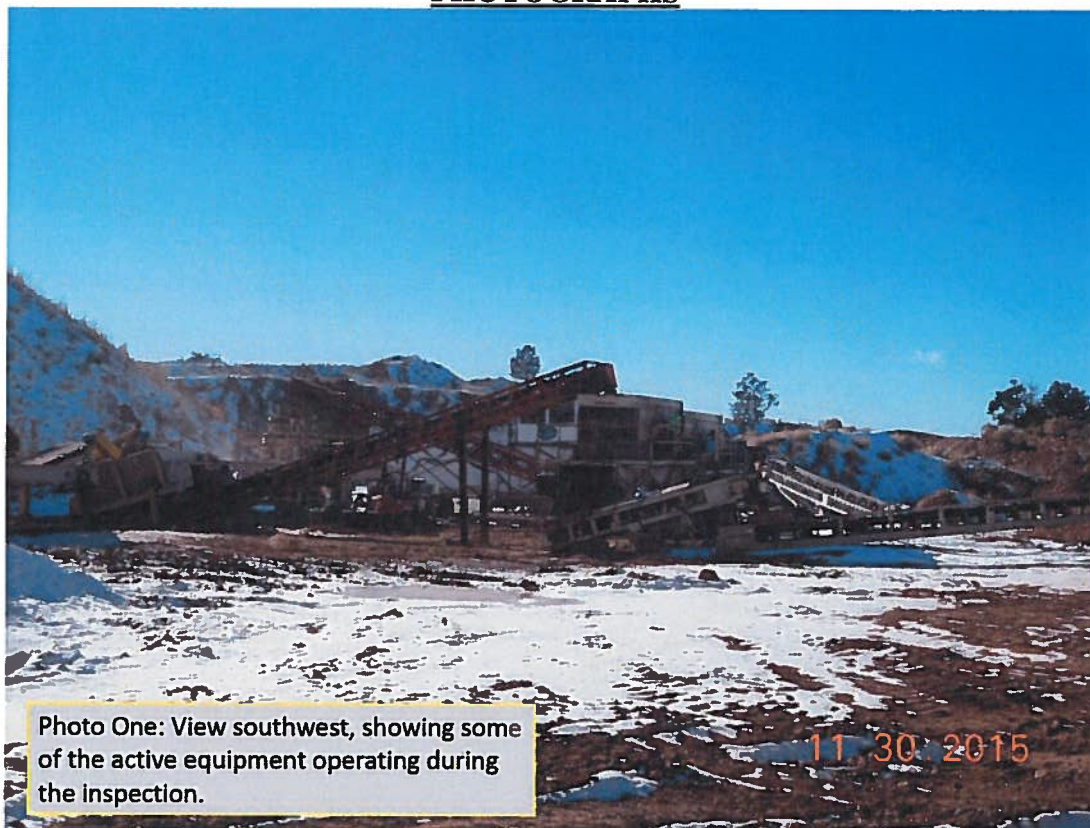
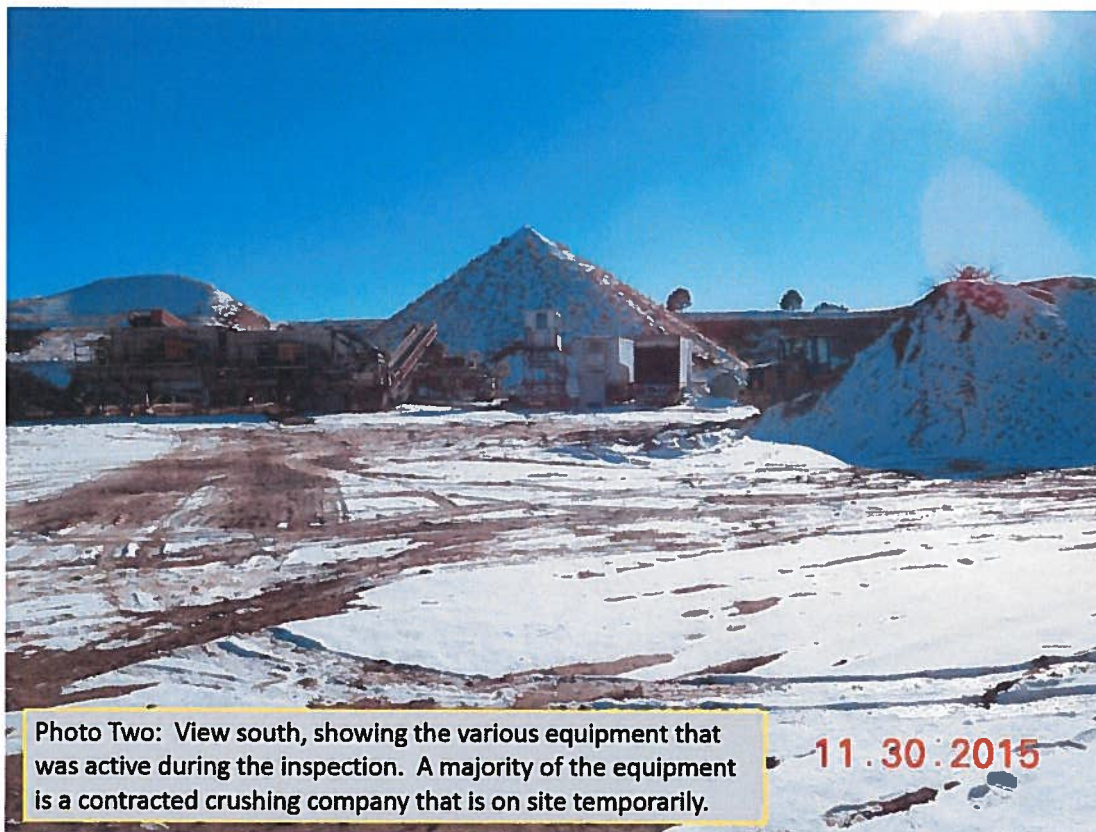
The site was active during the time of the inspection, various equipment including a loader, crusher, screen and conveyors were observed on site and operating. Photos One and Two show the equipment that was active during the day of the inspection. The Operator contracts out for crushing and screening services, and continually hauls from the stockpiled material. The material being screened was being excavated from the highwall shown in Photo Three located in the southwest corner of the disturbed area. The Operator explained that that section was almost mined out, and would be backfilled and seeded in the coming weeks. The final configuration will be the approved 2:1 slope similar to what is shown in Photo Four.

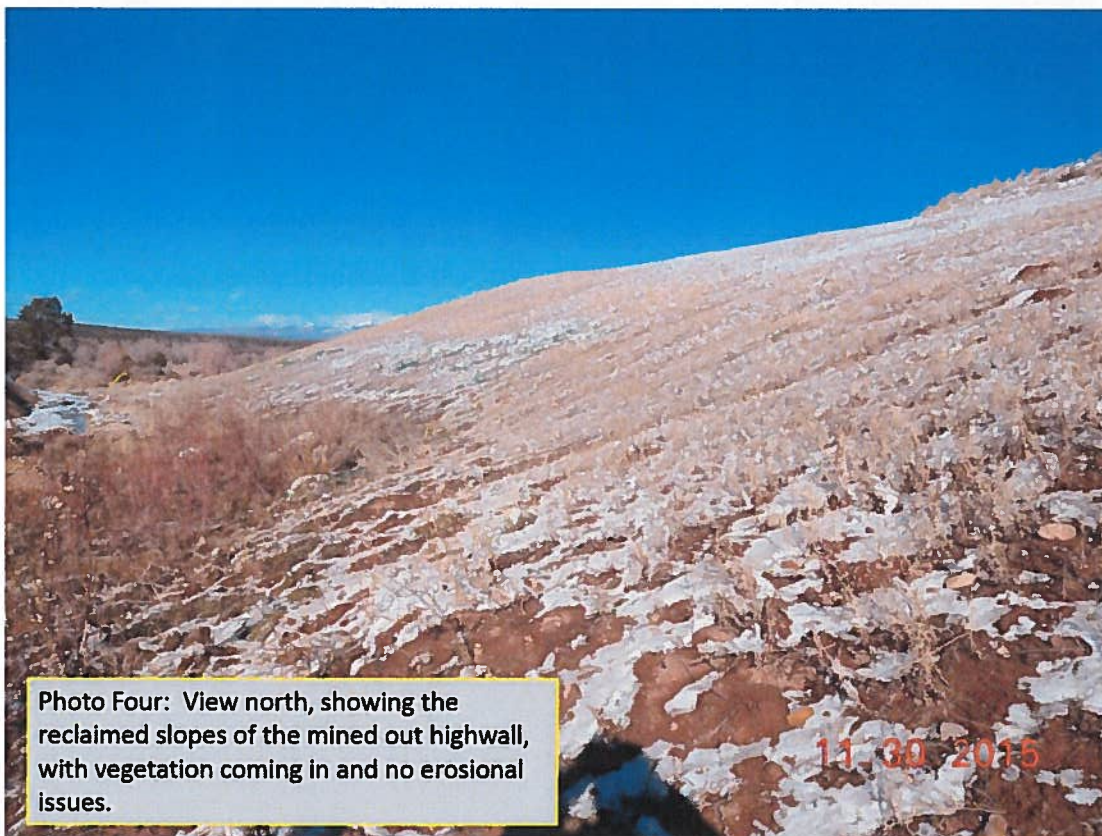
Reclamation work is ongoing in a phased mining and phased reclamation plan. A section of previously mined highwall has been backfilled and reseeded. Photo Four shows the approved 2:1 slopes, with vegetation beginning to be established. No erosional issues or noxious weeds were observed on the reclaimed slope. The pit floor and all other disturbed areas exhibit positive drainage and no erosional issues were observed.

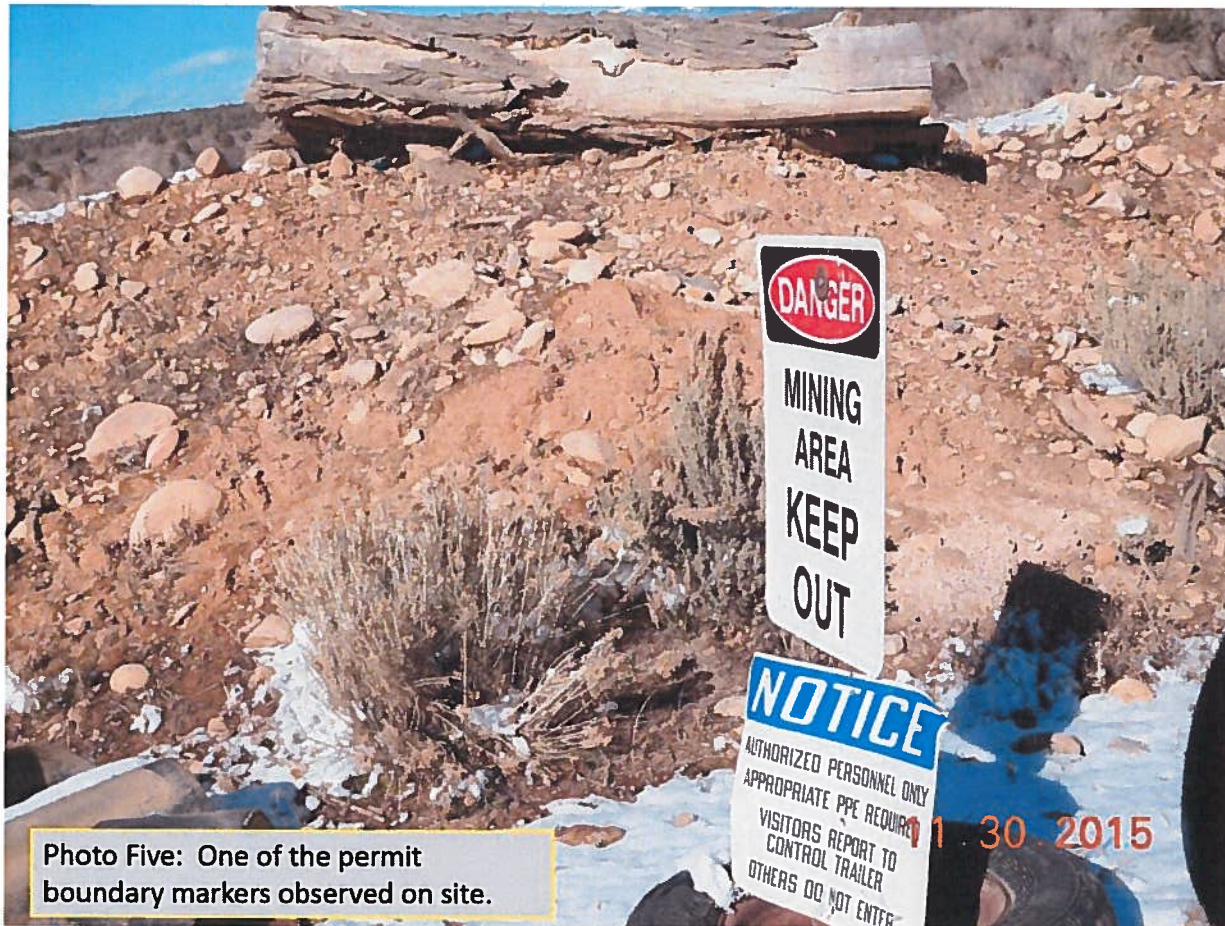
Stockpiles of material, overburden and topsoil were all observed. The top soil and overburden stockpiles have been revegetated by volunteer vegetation and are stable. The Operator explained that chemical weed treatment is ongoing. Photo Five shows the stockpiled material as well as one of the overburden stockpiles. Proper mine ID signage and permit boundary markers were observed. Photo Four shows one of the boundary marker signs, a majority of the boundaries are marked with berms or barbed wire fencing.
