COLORADO DIVISION OF RECLAMATION, MINING AND SAFETY
MINERALS PROGRAM INSPECTION REPORT
PHONE: (303) 866-3567

MINE NAME: Parkdale Project	MINE/PROSPECTING ID#: M-1997-054	MINERAL: Sandstone (silica, stone quartzite), gravel and granite gneiss	COUNTY: Fremont
INSPECTION TYPE: Monitoring	INSPECTOR(S): Timothy A. Cazier	INSP. DATE: April 28, 2015	INSP. TIME: 10:00
OPERATOR: Front Range Aggregates, LLC	OPERATOR REPRESENTATIVE: Clayton Morrow	TYPE OF OPERATION: 112c - Construction Regular Operation

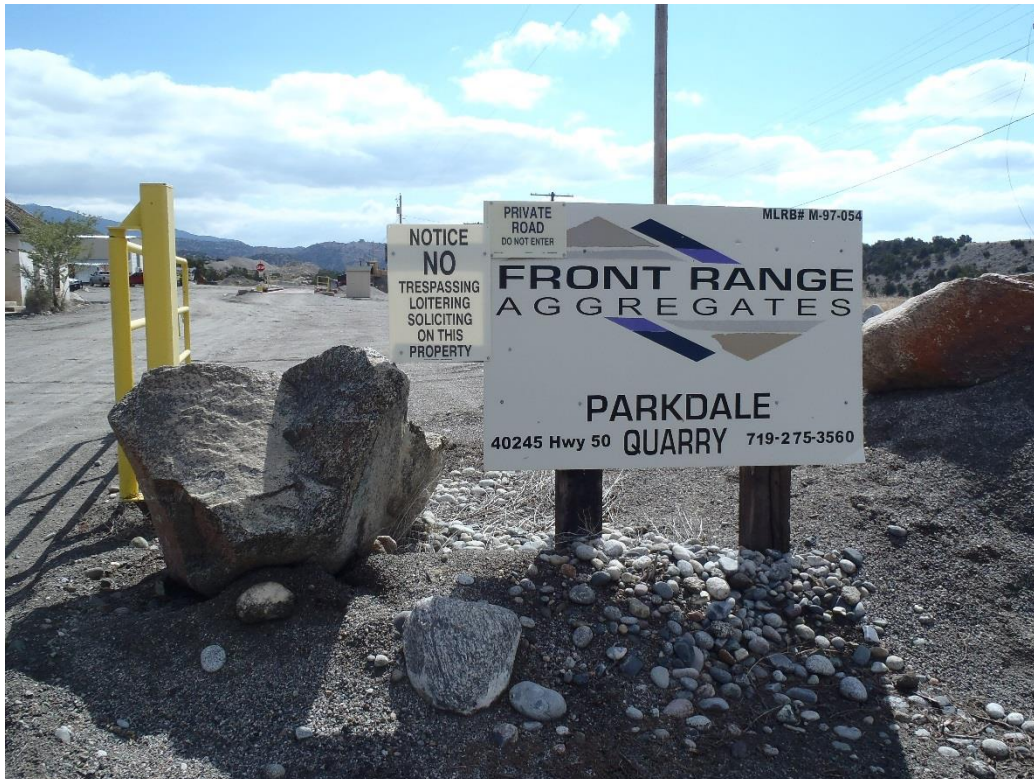
Photo 1. Permit identification sign.

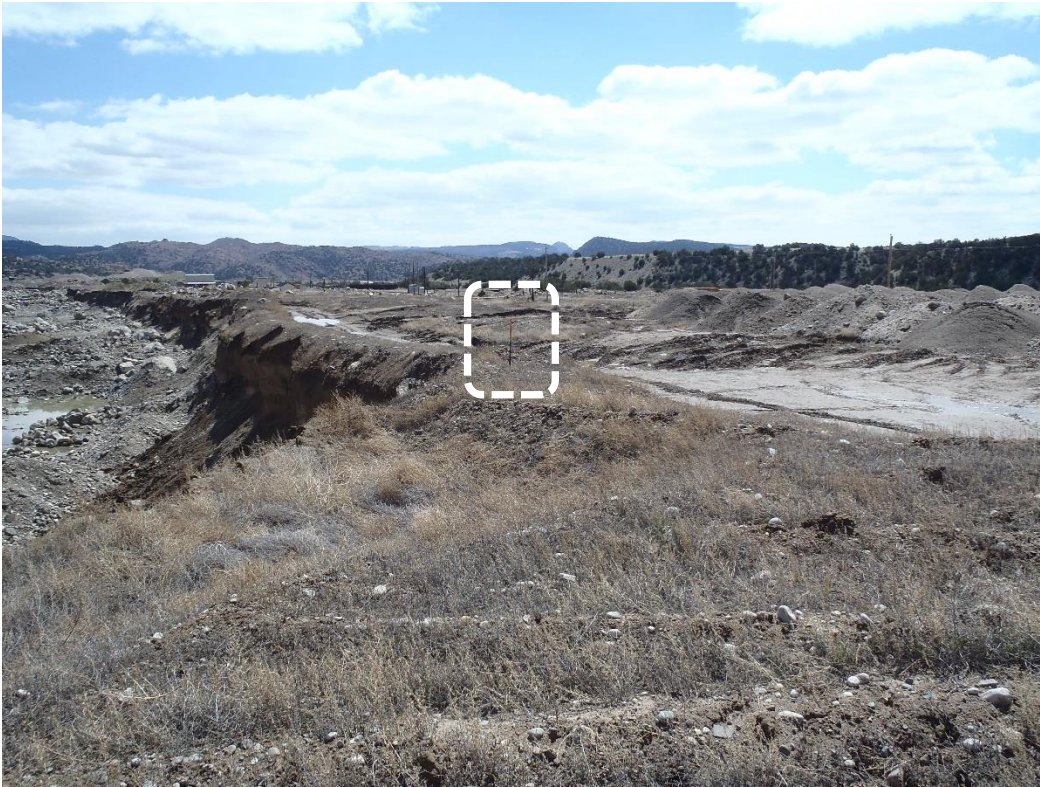
Photo 2. T-post affected area boundary marker in southwest corner of the pit (south side looking east).

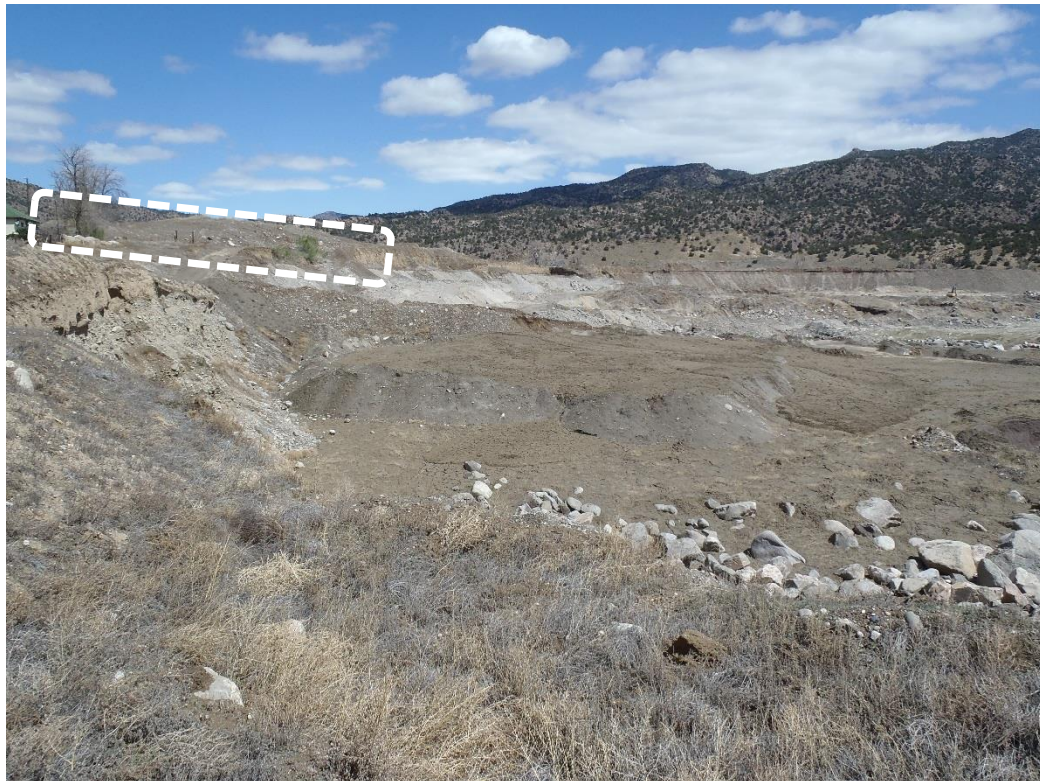
Photo 3. Affected area boundary fencing in southwest corner of the pit (south side looking north).

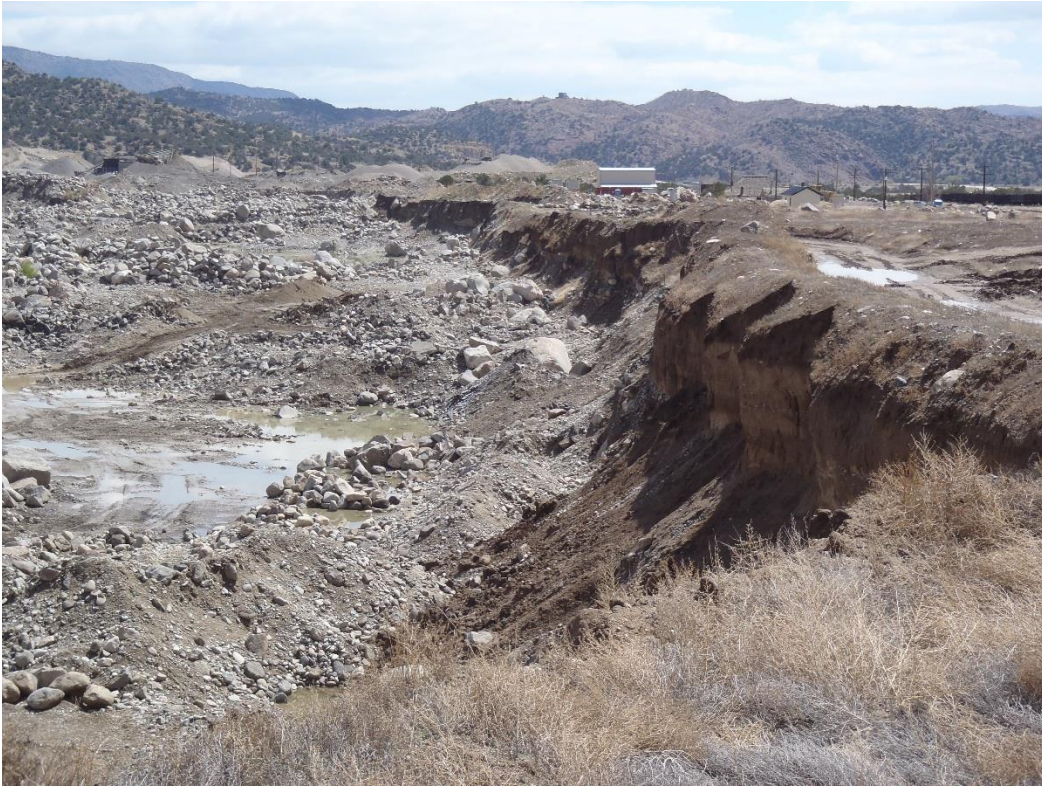
Mining Plan – Working highwalls were observed to be near vertical (see **Photo 4**). The approved mine plan appears to allow 0.5H:1V slopes during mining to be flattened to 3H:1V using overburden material after placing a 15-foot thick clay blanket against the excavated highwall.

Photo 4. Working highwalls observed to be near vertical (looking east).

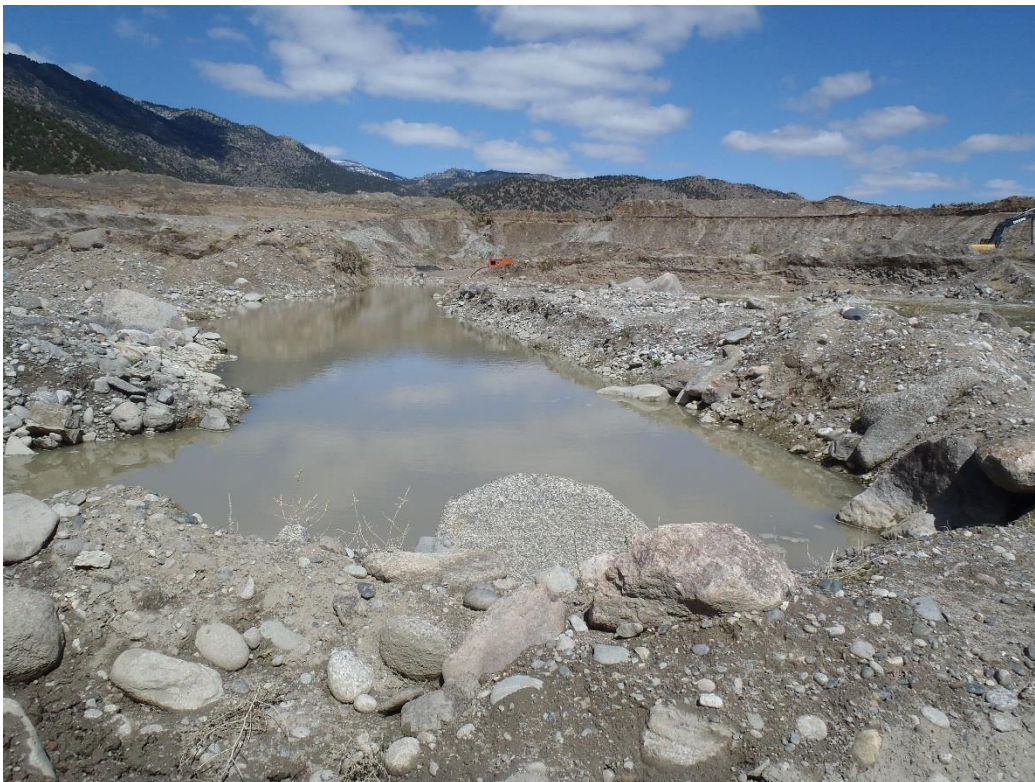
Photo 5. Pit dewatering trench (looking NW).

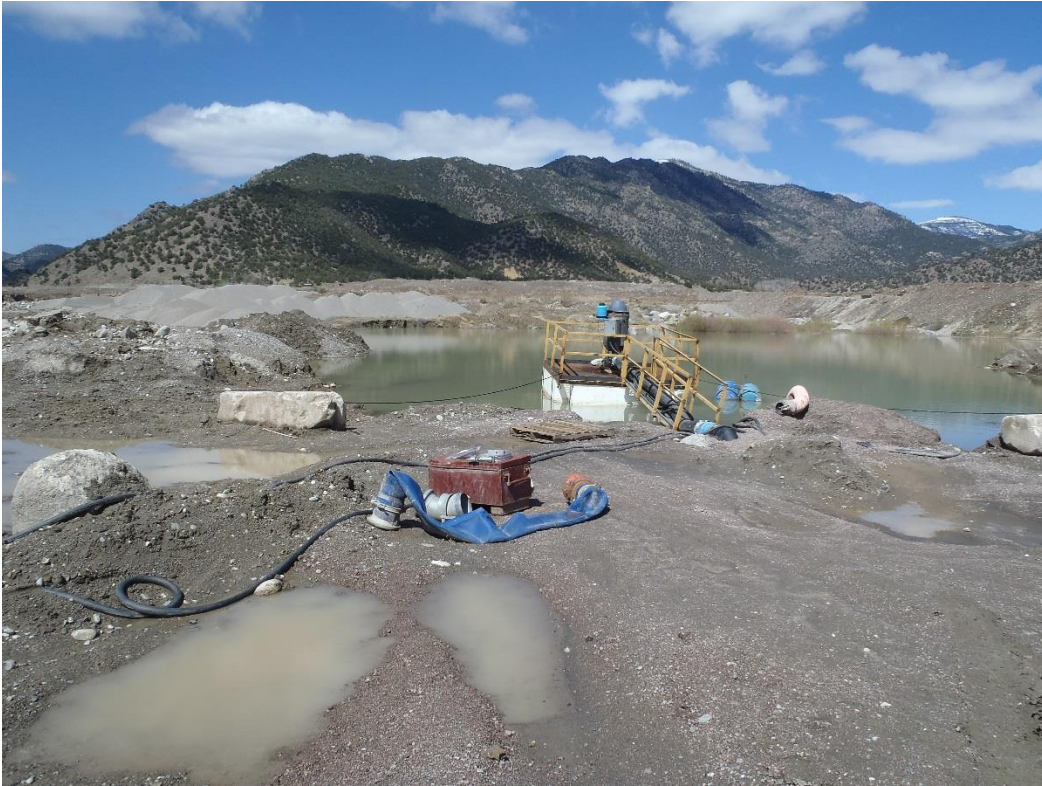
Photo 6. Settling pond (looking west).

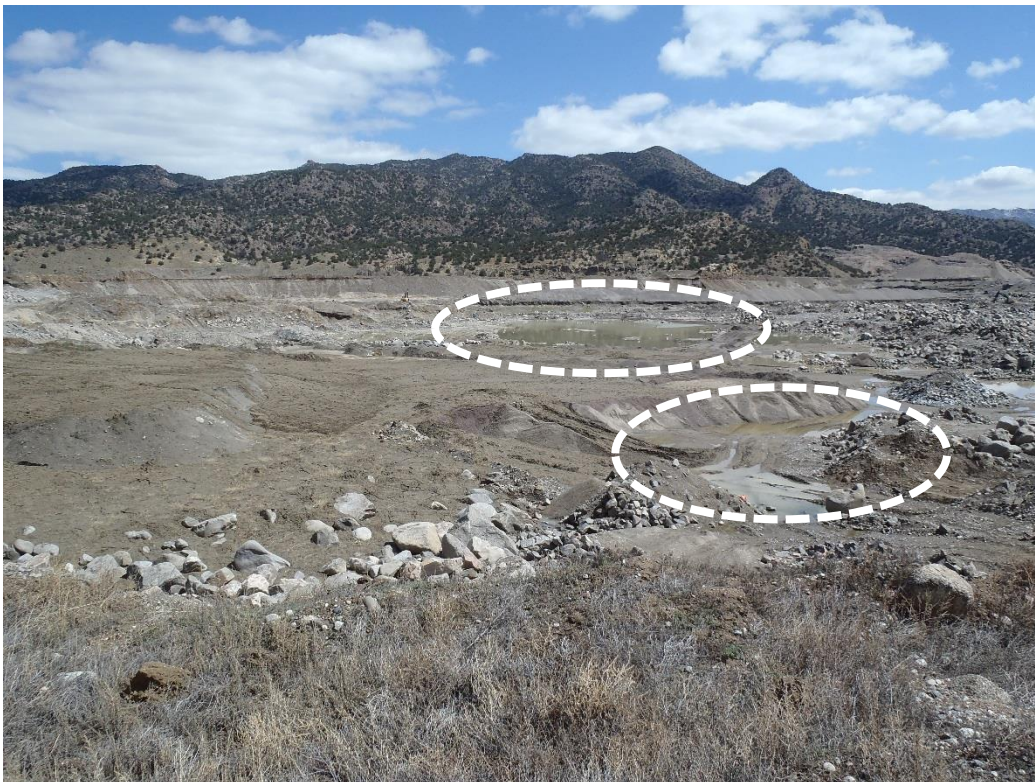
Mr. Morrow indicated Cañon City received 3.16 inches of rain on April 25, but did not have a total rainfall for the site. The saturation of the site soils and the observed ponding in the pit (see **Photos 7 and 8**) suggest the site also received a similar significant amount of rainfall. The observed highwall sloughing is likely at least partly a result of this rain and why the Division stipulated highwall inspections after significant precipitation events (see **Attachment A**, stipulation Series No. 6).

Photo 7. Observed ponding in the pit (looking NE).

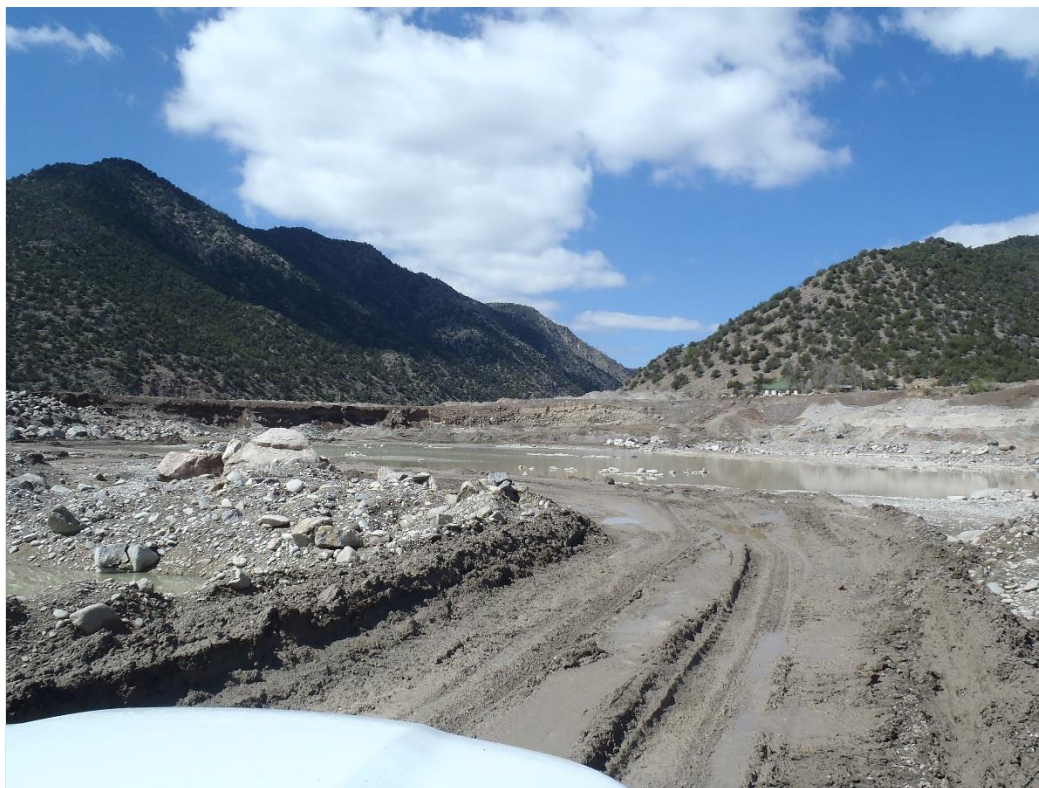
Photo 8. Saturated pit floor soils and observed ponding in the pit (looking west).
