COLORADO DIVISION OF RECLAMATION, MINING AND SAFETY
MINERALS PROGRAM INSPECTION REPORT
PHONE: (303) 866-3567

MINE NAME: Andersen Farms	MINE/PROSPECTING ID#: M-2006-050	MINERAL: Sand and gravel	COUNTY: Lincoln
INSPECTION TYPE: Monitoring	INSPECTOR(S): Amy Eschberger	INSP. DATE: December 10, 2015	INSP. TIME: 10:00
OPERATOR: Lincoln County	OPERATOR REPRESENTATIVE: John DeWitt, Mark McHone	TYPE OF OPERATION: 110c - Construction Limited Impact

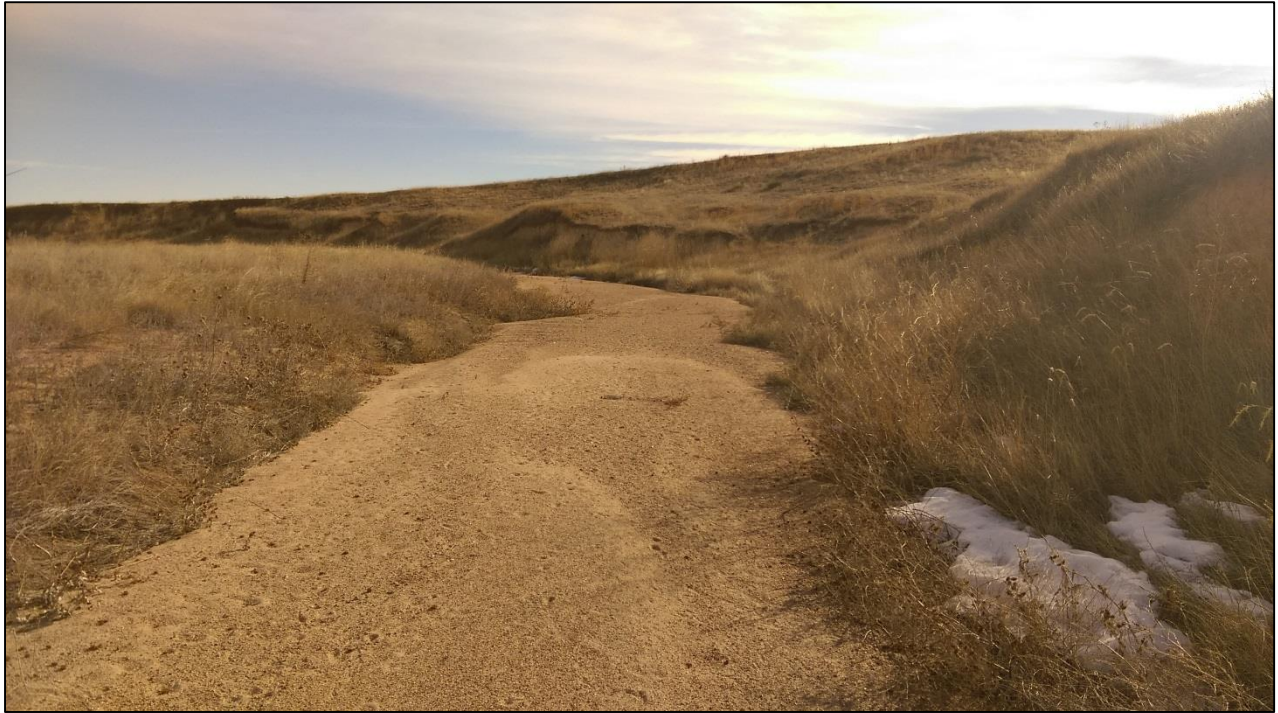
At the time of the inspection, the weather was partly cloudy and warm, and the ground was dry. No standing water was observed in the pit area or in the creek bed (**Photo 1**). A permit sign was posted at the main entrance to the site off of Co Rd 35 (**Photo 2**). The permit boundary was properly delineated with metal posts (**Photo 3**). The site was not active at the time of the inspection, and no equipment was present on site. According to the operator, the site is active every year, which is in accordance with its intermittent status. All mining activities appeared to be restricted to the north side of the creek. The creek bed itself appeared to have not been mined in some time. The horseshoe-shaped pit opens up to the south, with the mined slopes at 3H:1V or flatter (**Photos 4-8**). The pit was approximately 8-10 feet deep. The northern mined slopes exhibited some erosional damage which the operator should continue to monitor and repair as needed. In addition, the pit appears to no longer be separated from the creek by a berm. A small earthen berm was observed along the southern and eastern edges of the pit in the inspection report for 03/16/2011. The Division recommends the operator restore the berm along the southern edge of the pit to help keep stormwater runoff from draining into the creek from the pit area.

Photo 1. View looking east (downstream) in portion of Dugout Creek inside permit area, showing creek bed was dry during inspection.

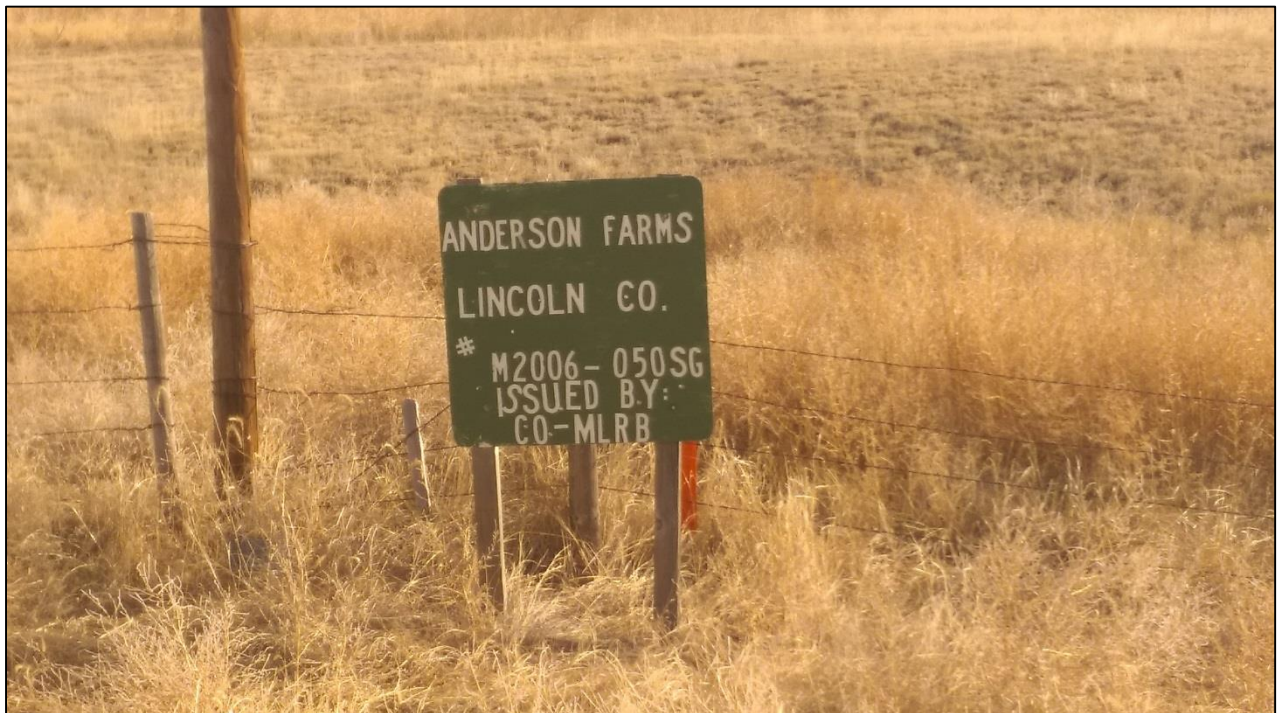
Photo 2. View of permit sign posted at main site entrance off of Co Rd 35.

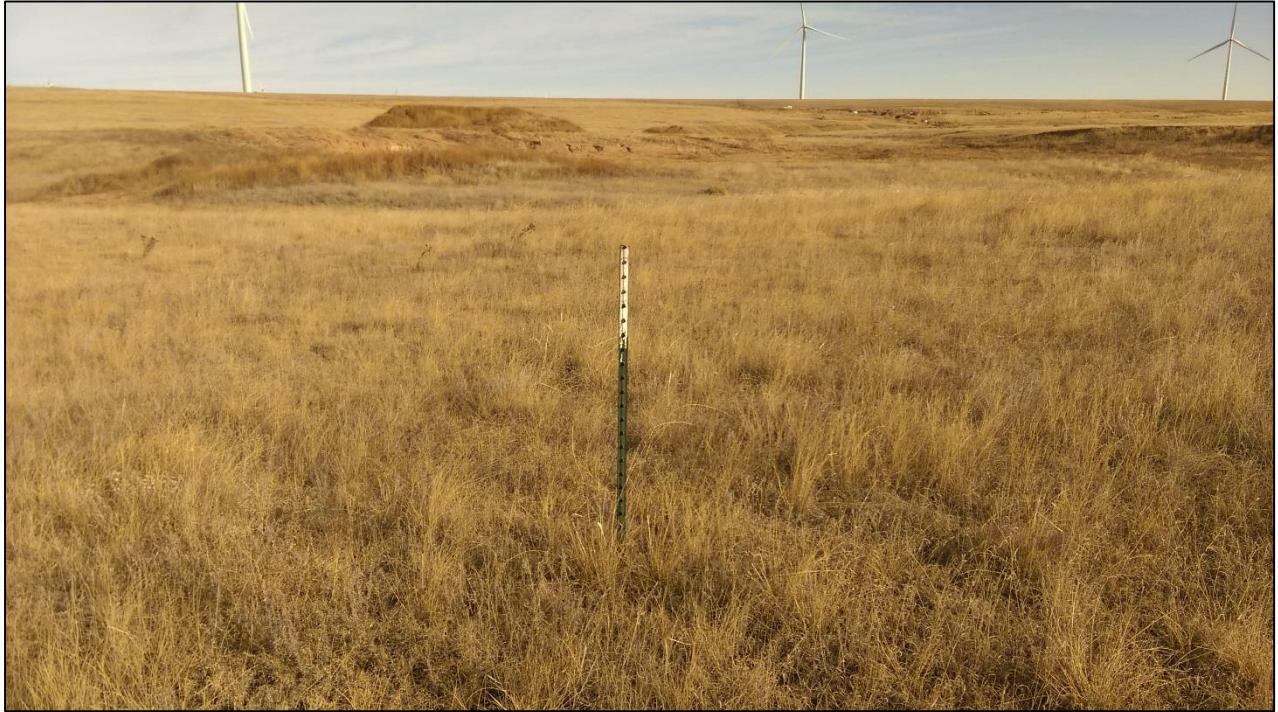
Photo 3. View looking northeast, showing metal post marking southwestern corner of permit boundary.

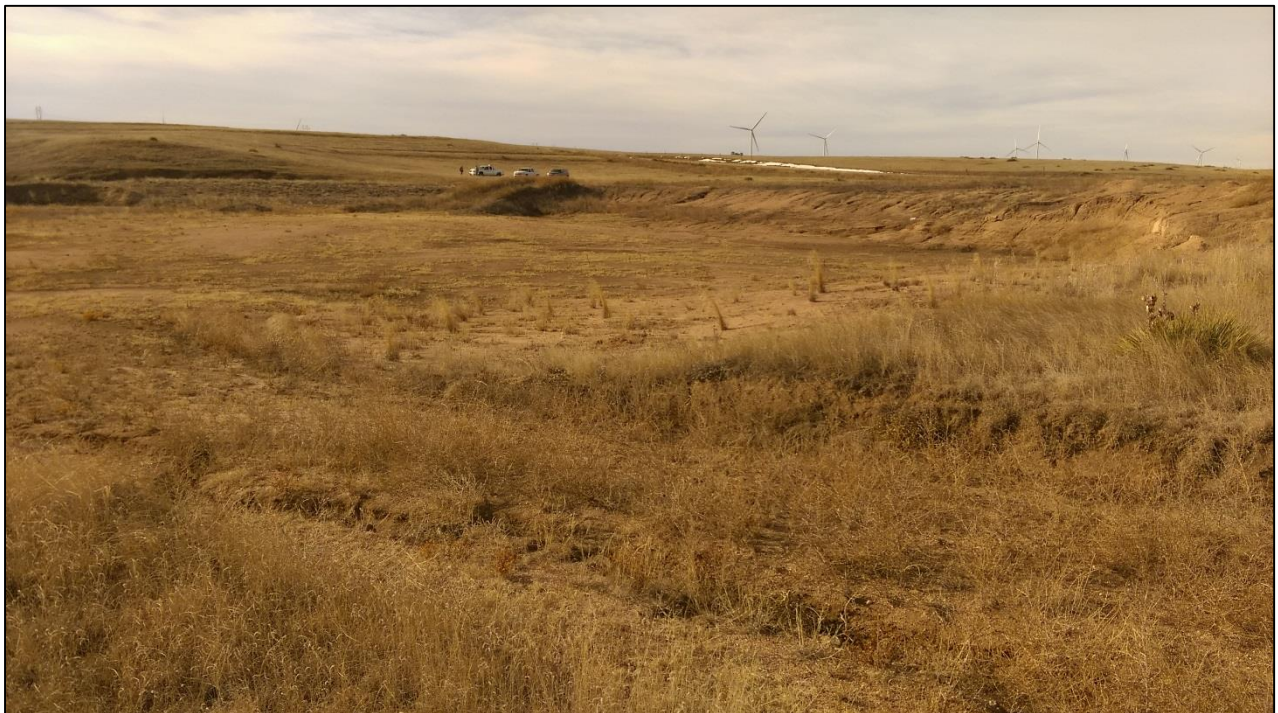
Photo 4. View looking southwest across mined pit located north of Dugout Creek.

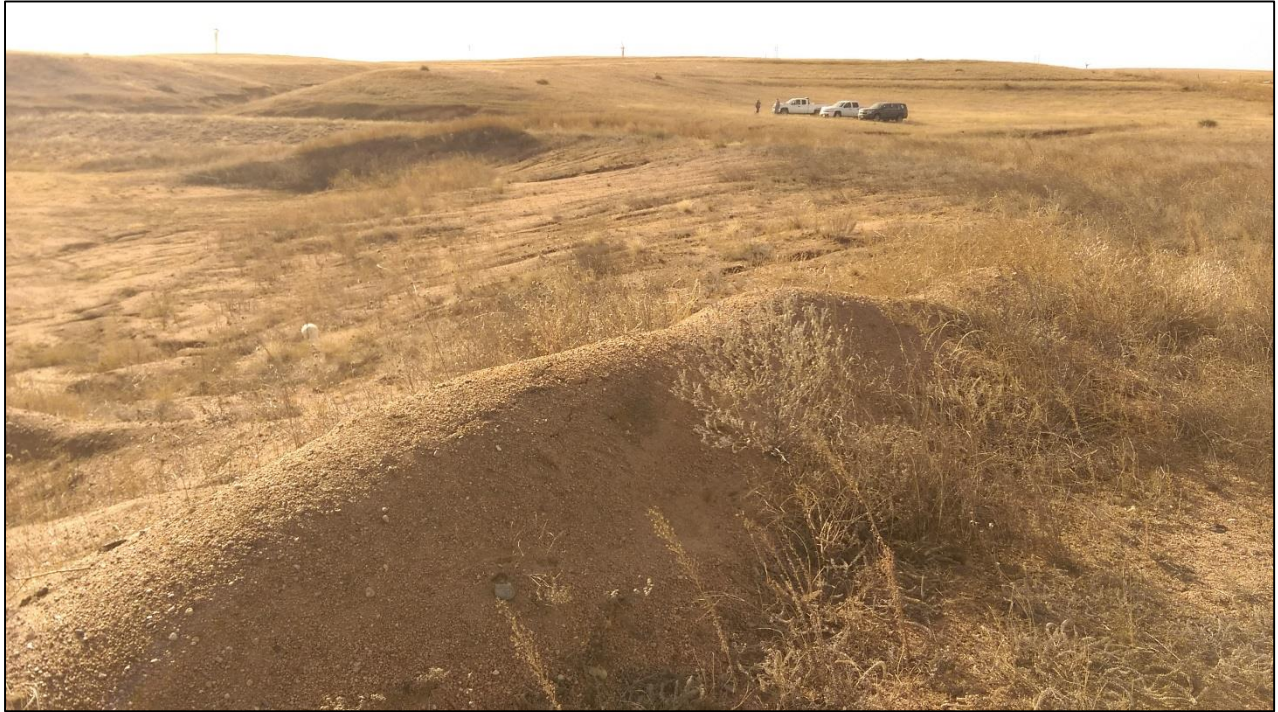
Photo 5. View looking south across northwestern mined wall of pit with slopes of 3H:1V or flatter.

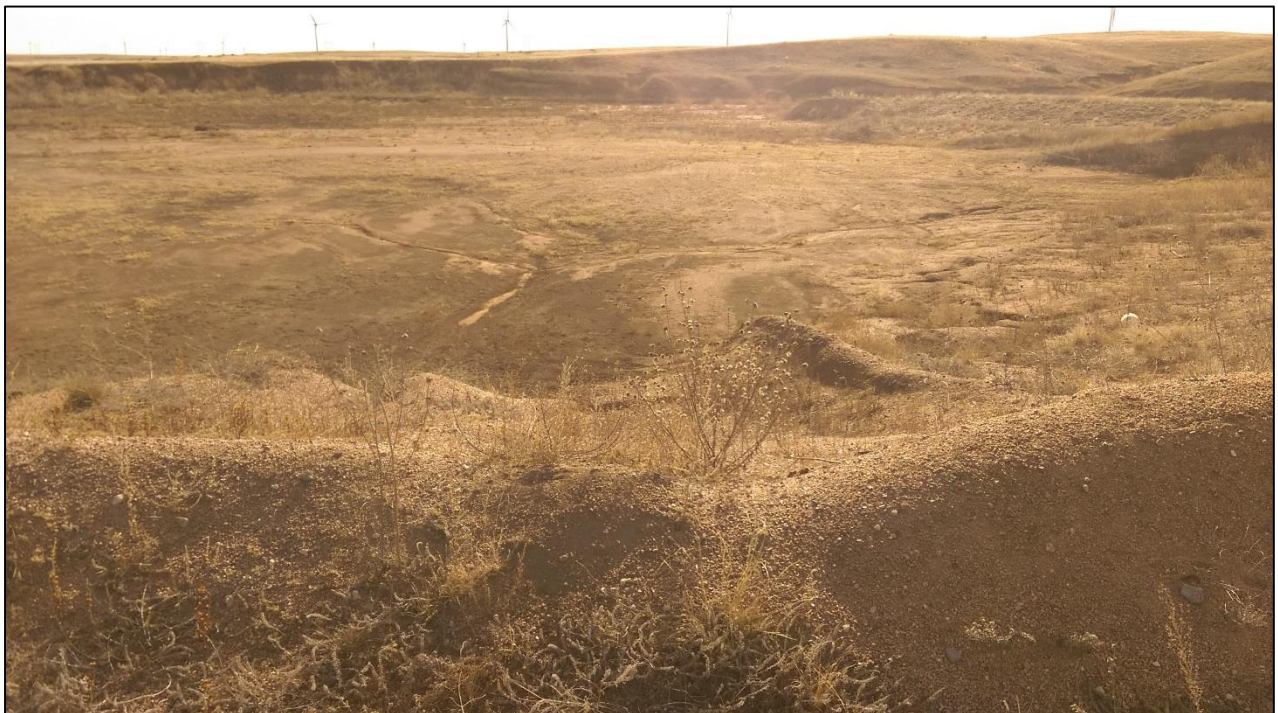
Photo 6. View looking southeast across center of mined pit located north of Dugout Creek.

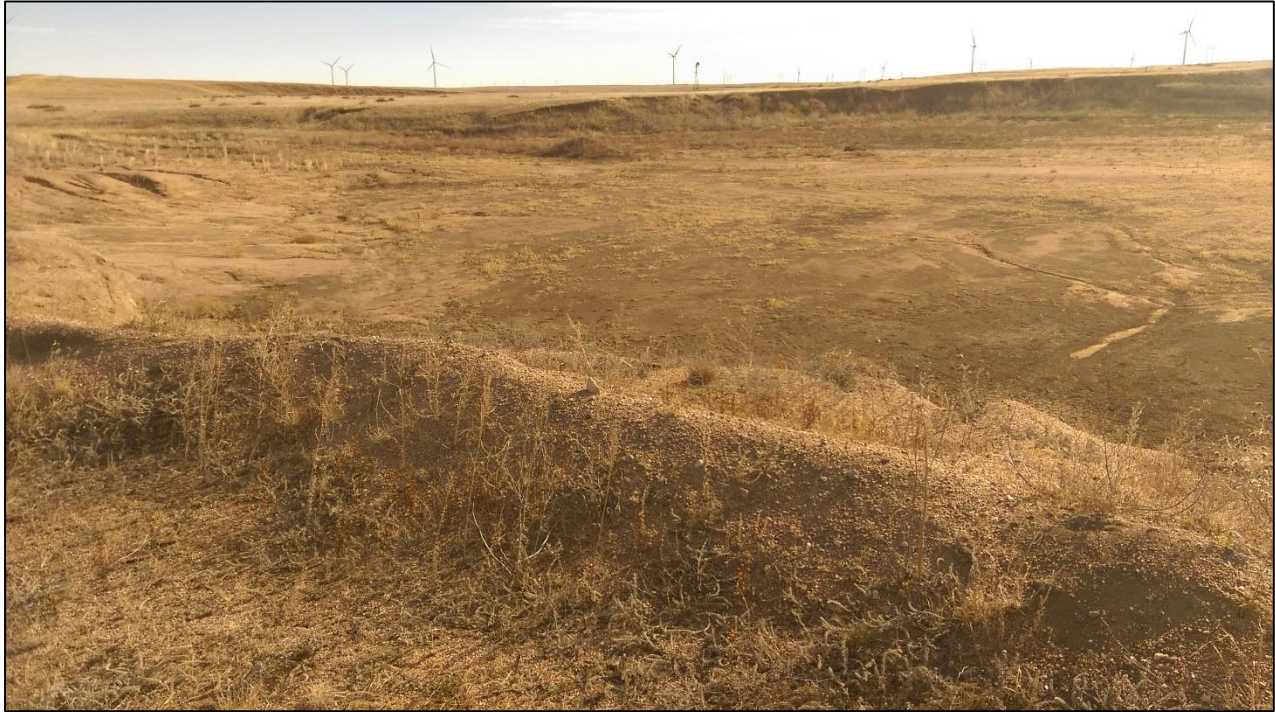
Photo 7. View looking east across mined pit located north of Dugout Creek.

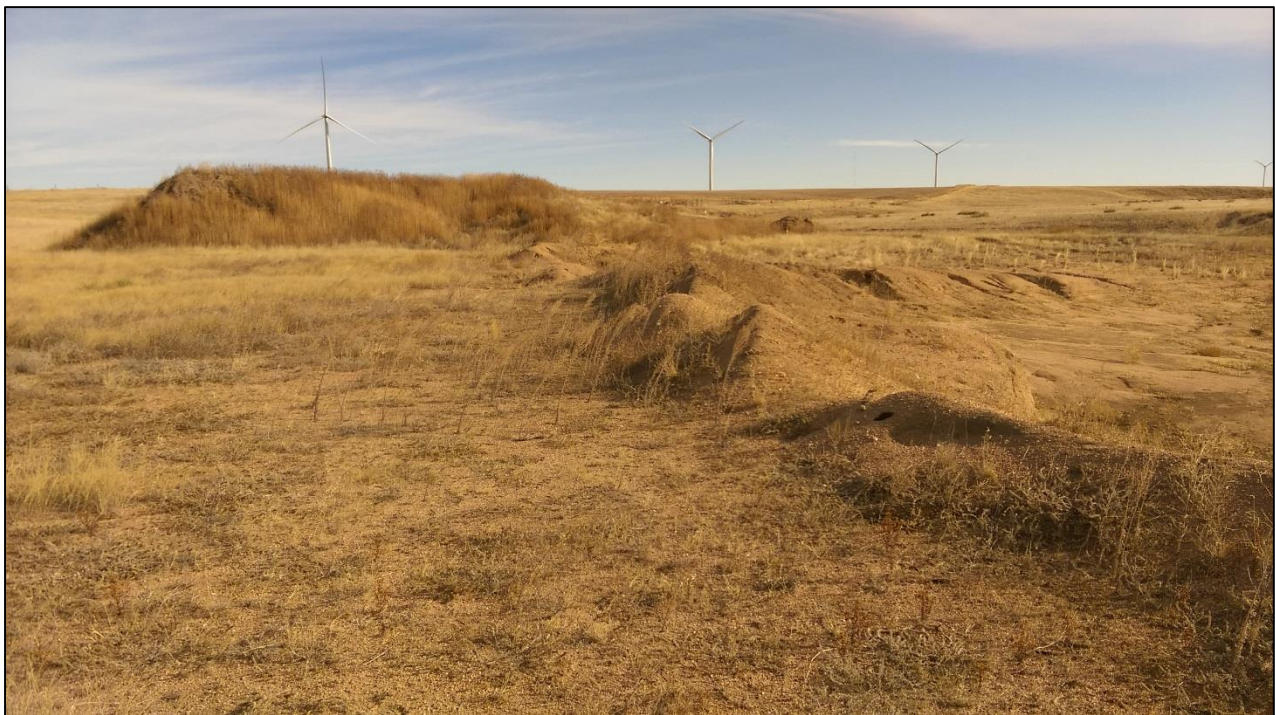
Two topsoil stockpiles (one much smaller than the other) were stored north of the mining area (see **Photo 8**). These stockpiles appeared to be stable with vegetative cover (primarily annual weeds). The approved reclamation plan allows for importing additional topsoil for reclamation if needed. Native grasses, forbs, and annual weeds are volunteering across the disturbed area. The creek banks upstream (**Photo 9**) and downstream (**Photo 10**) of the site appeared to be preserved, showing no evidence of erosion. Overall, the site appeared to be stable. No problems were observed.

Photo 8. View looking east across northern edge of mined pit. Note topsoil stockpile stored north of pit, stable with vegetative cover (primarily annual weeds).

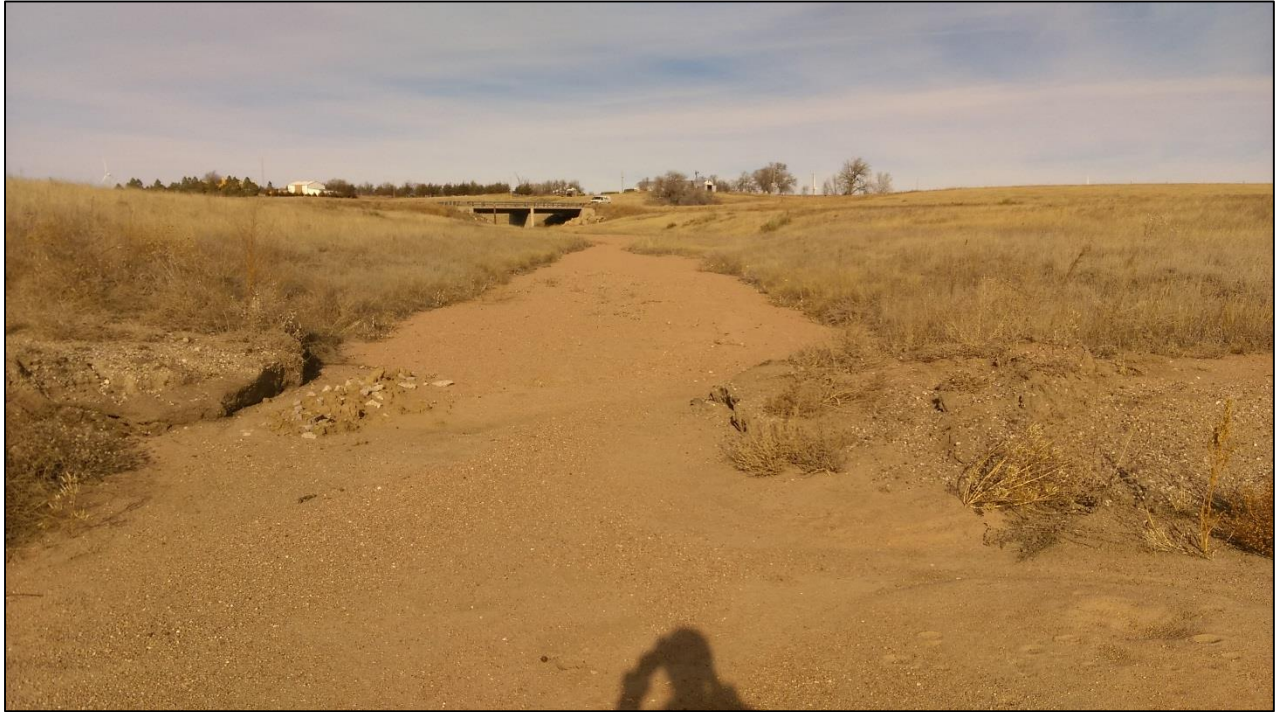
Photo 9. View of Dugout Creek upstream from permit area, showing creek banks appear stable with no erosion problems observed.

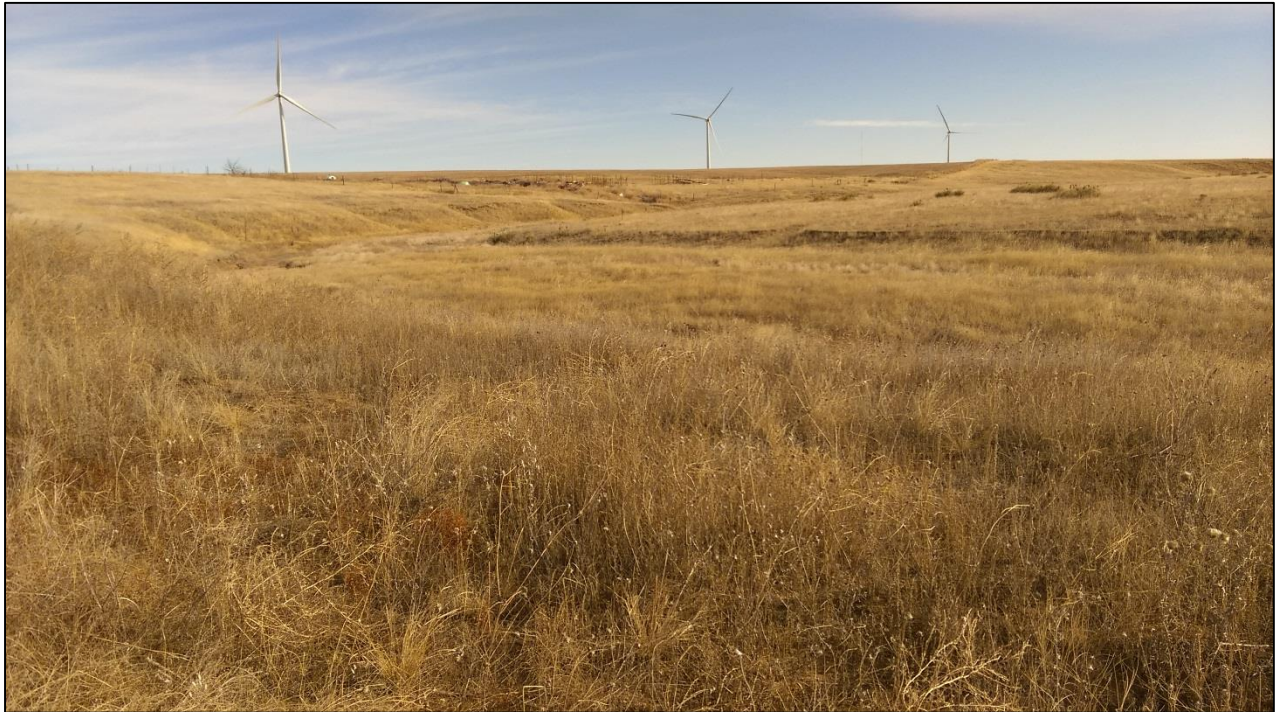
Photo 10. View of Dugout Creek downstream from permit area, showing creek banks appear stable with good vegetative cover.
