**COLORADO DIVISION OF RECLAMATION, MINING AND SAFETY**  
**MINERALS PROGRAM INSPECTION REPORT**  
**PHONE: (303) 866-3567**

<b>MINE NAME:</b> Enderson Pit	<b>MINE/PROSPECTING ID#:</b> M-1979-111	<b>MINERAL:</b> Sand and gravel	<b>COUNTY:</b> Lincoln
<b>INSPECTION TYPE:</b> Monitoring	<b>INSPECTOR(S):</b> Amy Eschberger	<b>INSP. DATE:</b> December 10, 2015	<b>INSP. TIME:</b> 11:20
<b>OPERATOR:</b> Lincoln County	<b>OPERATOR REPRESENTATIVE:</b> John DeWitt, Mark McHone	<b>TYPE OF OPERATION:</b> 110c - Construction Limited Impact

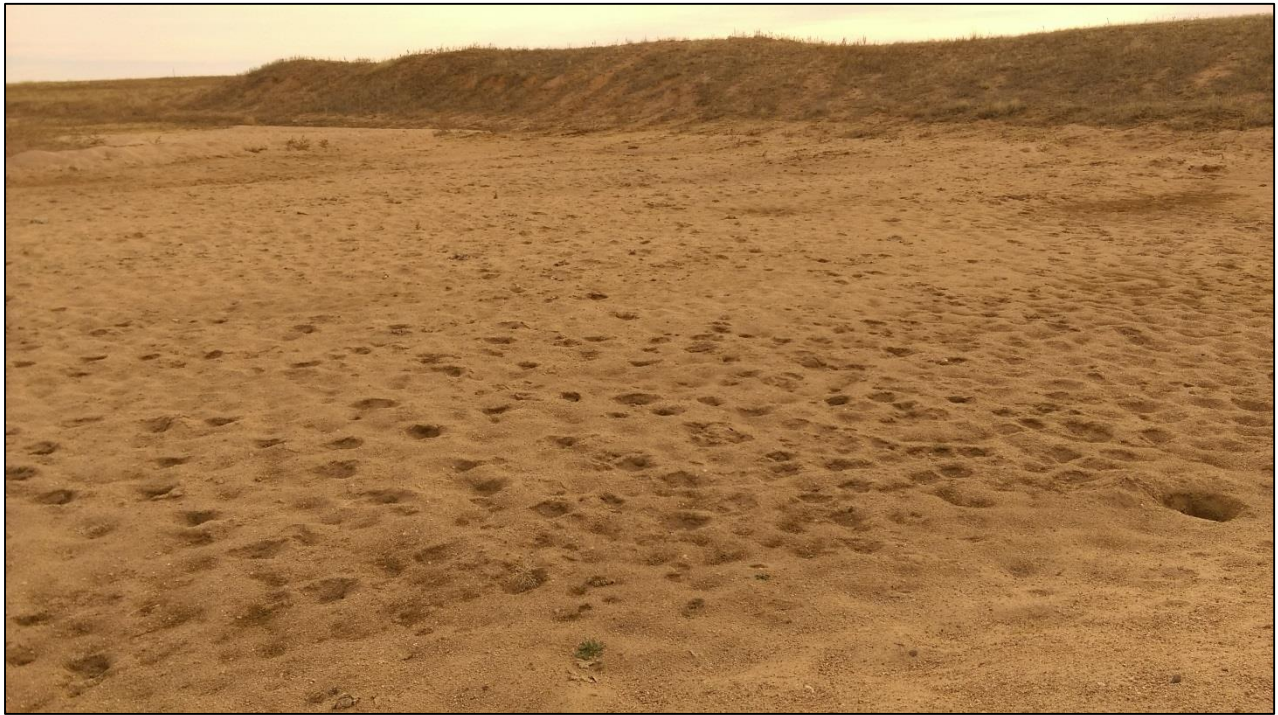
A clay stockpile was left along the southern river bank (inside the permit area; **Photo 1**) by the previous operator, Colorado Department of Transportation (CDOT). The Division approved a permit transfer from CDOT to Lincoln County on 09/28/2012 (Revision No. SO-01). In the inspection report for 02/18/2011, the Division noted that to leave the clay stockpile after reclamation, the operator would need to revise the approved reclamation plan. On 03/30/2015, the Division approved Technical Revision No. 2 (Revision No. TR-02) submitted by the current operator, which addressed leaving the clay stockpile for the landowner's use. This revision updated the mining plan map and reclamation plan map to more accurately define the permit boundary using GPS coordinates. The revision was submitted as part of the county's recent initiative to make sure all of their permitted sites are in compliance with regards to properly delineating the approved permit boundaries.

**Photo 1.** View looking south across river channel at clay stockpile stored along southern river bank. Note stockpile is stable with vegetative cover.

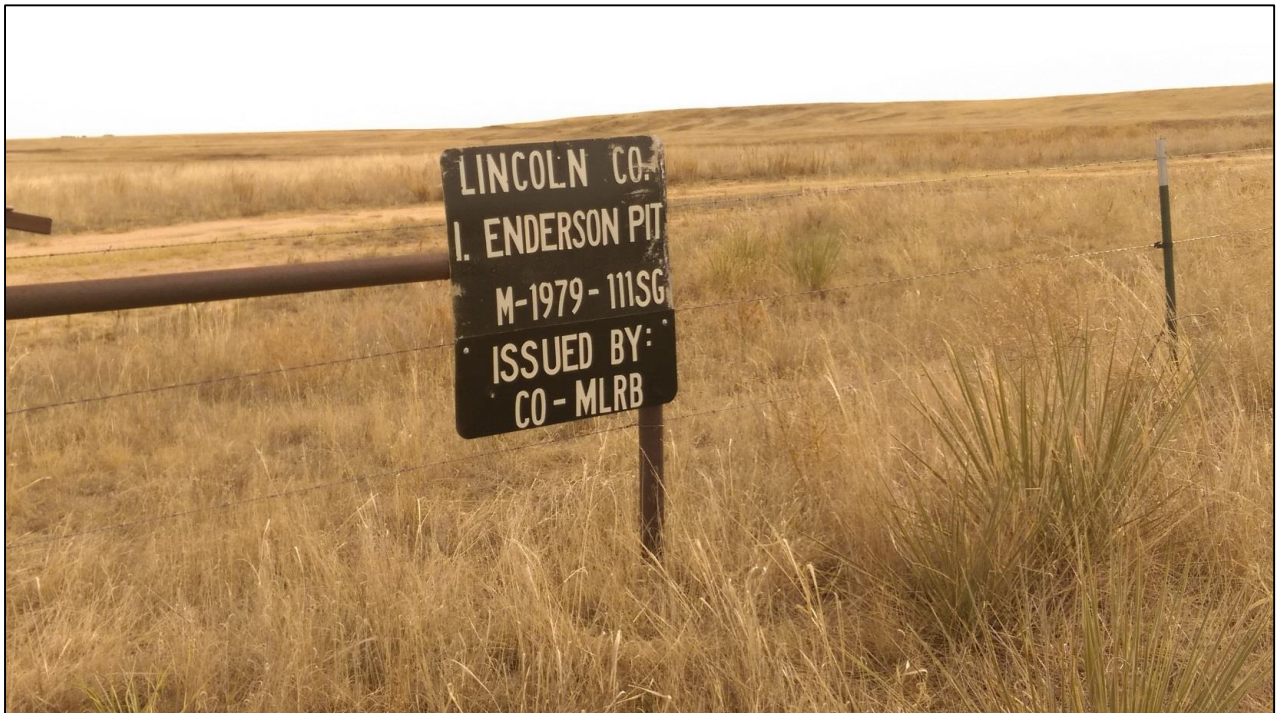
At the time of the inspection, the weather was partly cloudy and breezy, and the ground was dry. No standing water was observed on site. A permit sign was posted at the main site entrance off of Co Rd 43 (**Photo 2**). The permit boundary was properly delineated with metal posts (**Photo 3**). The site was not active at the time of the inspection, and no equipment was present on site. However, according to the operator, this site is active every year, which is in compliance with its intermittent status.

**Photo 2.** View of permit sign posted at main site entrance off of Co Rd 43.

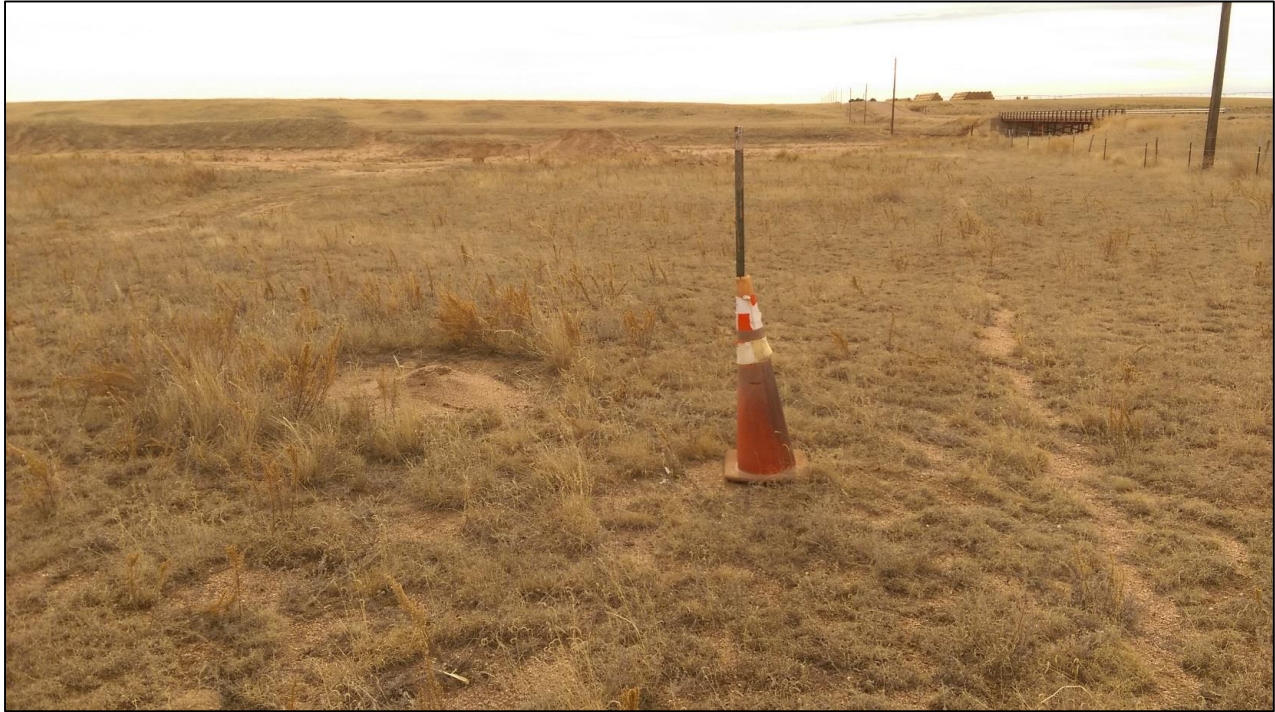
**Photo 3.** View looking south, showing metal post marking northwestern corner of permit boundary.

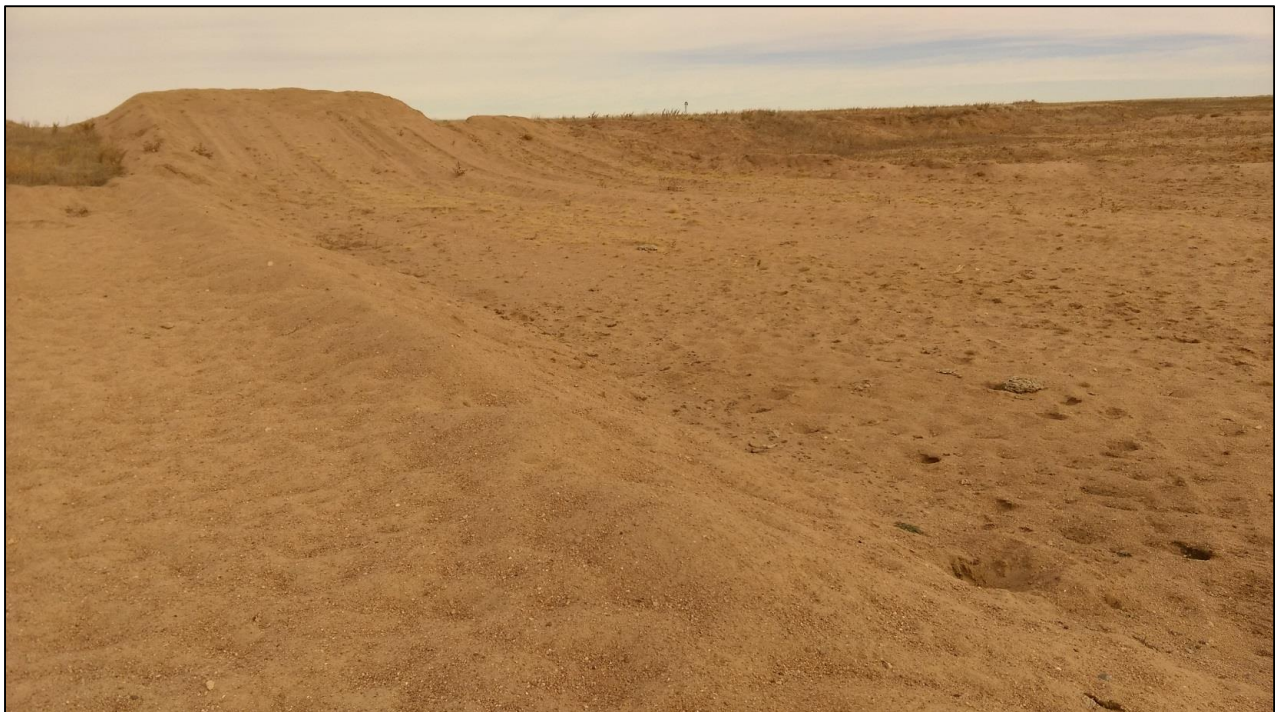
The Division observed a shallow depression (approximately one foot in depth) in the river bed where material was pushed up to the northern bank (**Photos 4 and 5**). Outside of this depression, the river bed appeared to be relatively flat and even. Very little stockpiled material remained along the northern bank (**Photos 6 and 7**). The stockpiling area located north of the river had some native grasses (primarily blue grama and buffalograss) volunteering across the disturbed land (**Photo 8**). The clay stockpile stored along the southern river bank appeared to be stable with vegetative cover (see **Photo 1**).

**Photo 4.** View looking north, showing shallow depression left in river bed (at right) where material was pushed up northern river bank (at left).

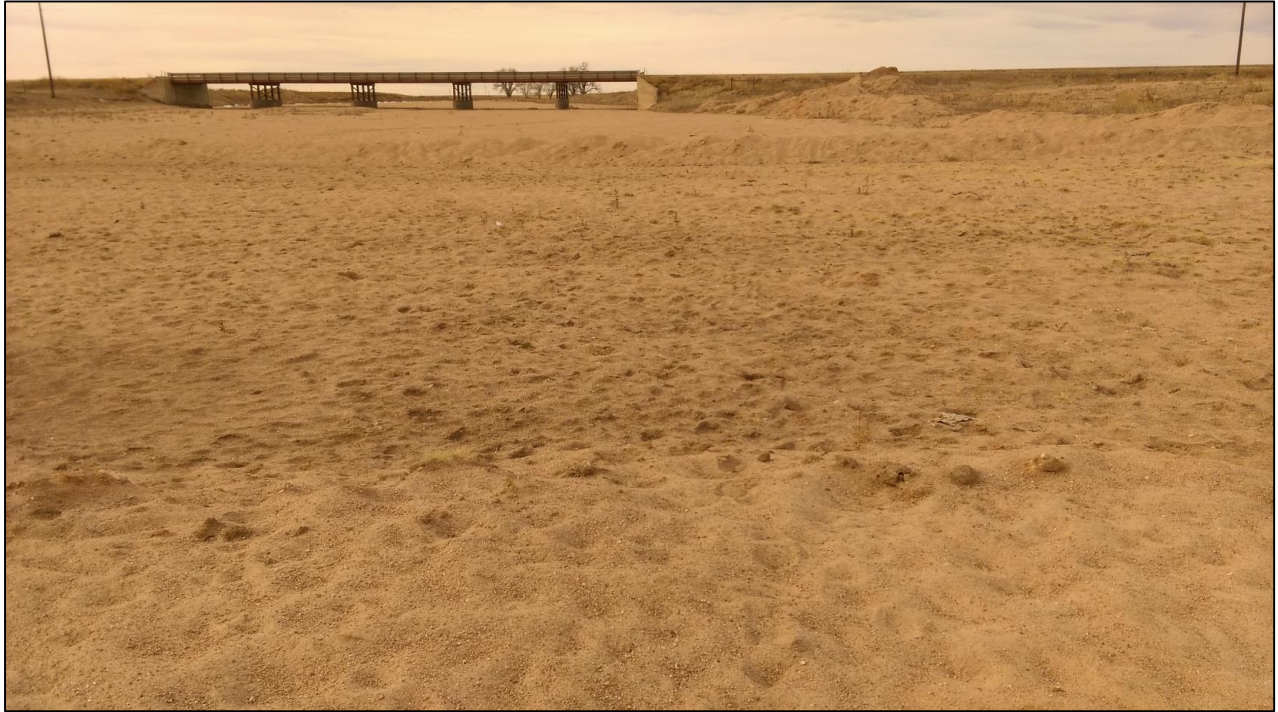
**Photo 5.** View looking upstream in river channel (west), showing shallow depression left in river bed (at center) where material was excavated.

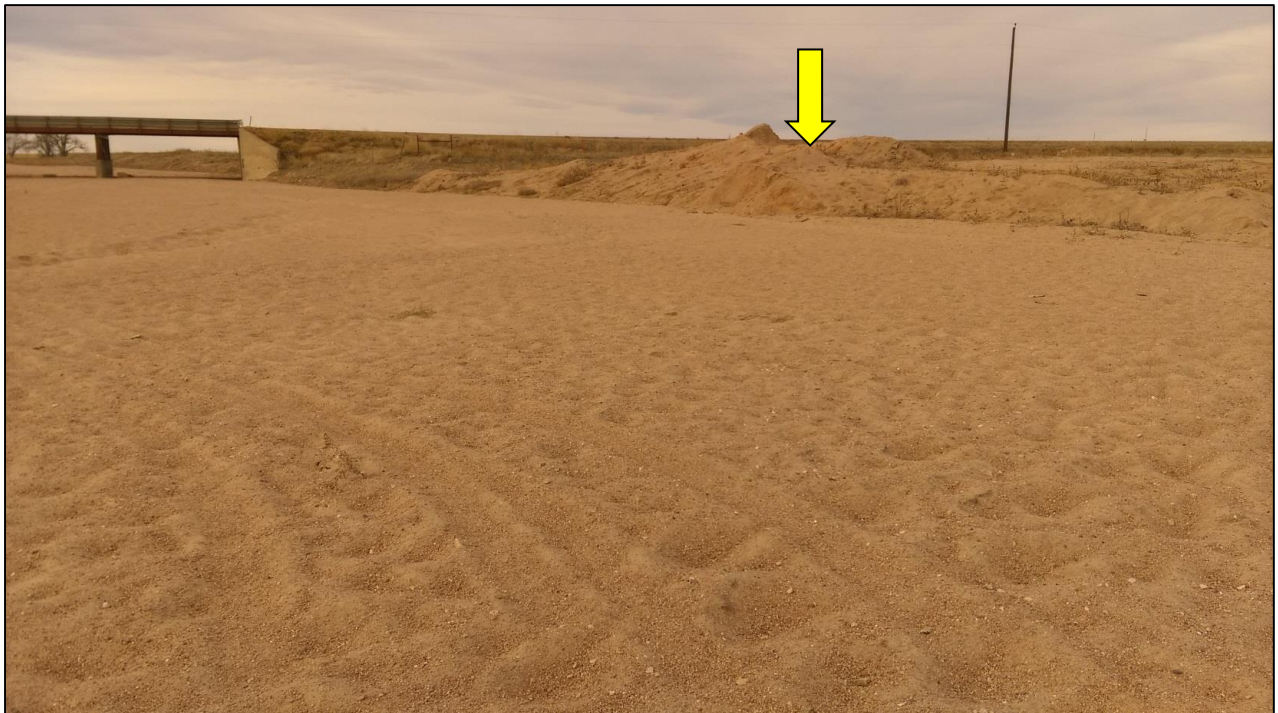
**Photo 6.** View looking northwest across river channel, showing material stockpiled along northern river bank (indicated) where it was pushed up from the river bed.

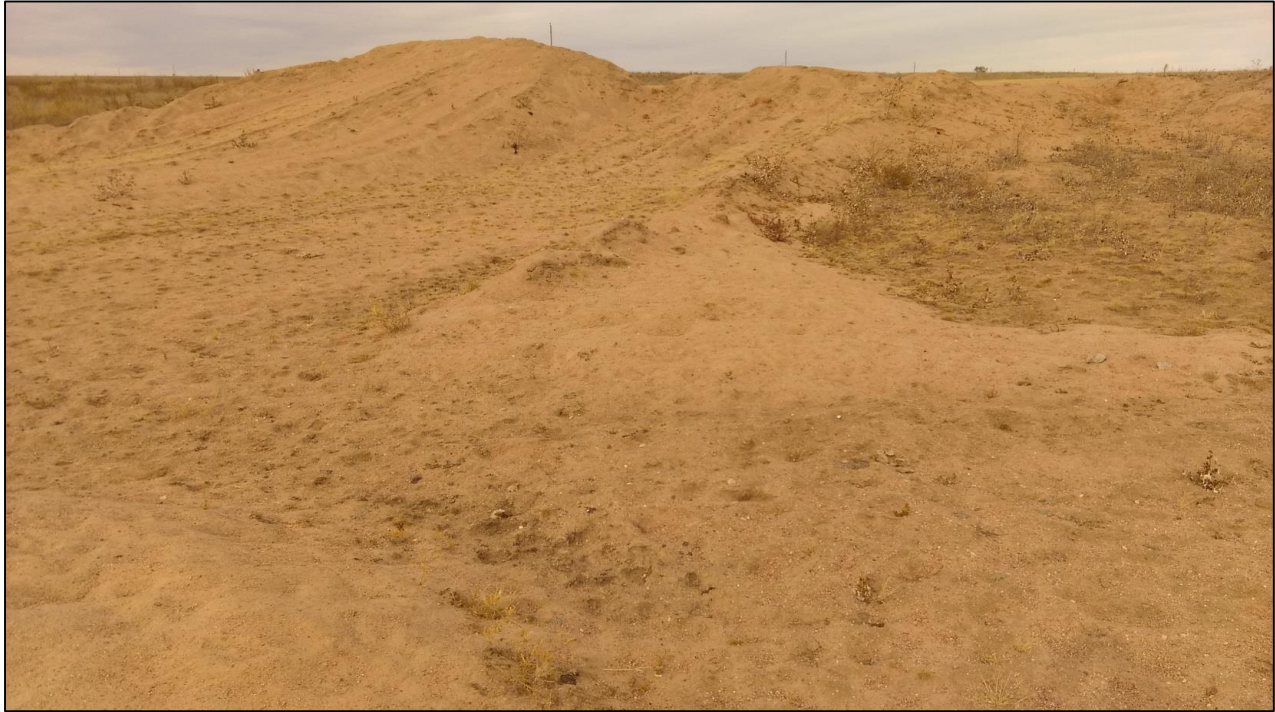
**Photo 7.** View of material stockpiled along northern river bank where it was pushed up from the river bed.

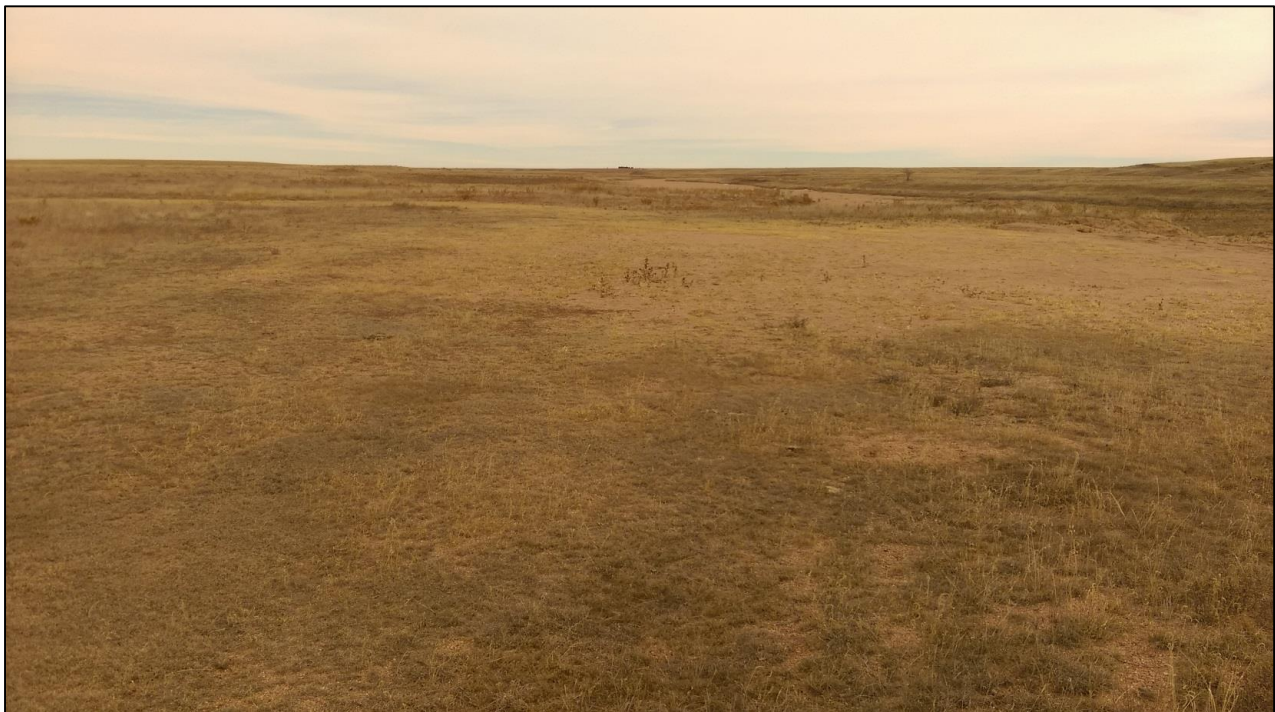
**Photo 8.** View looking east across stockpiling area located north of river. Note native grasses volunteering across the disturbed land.

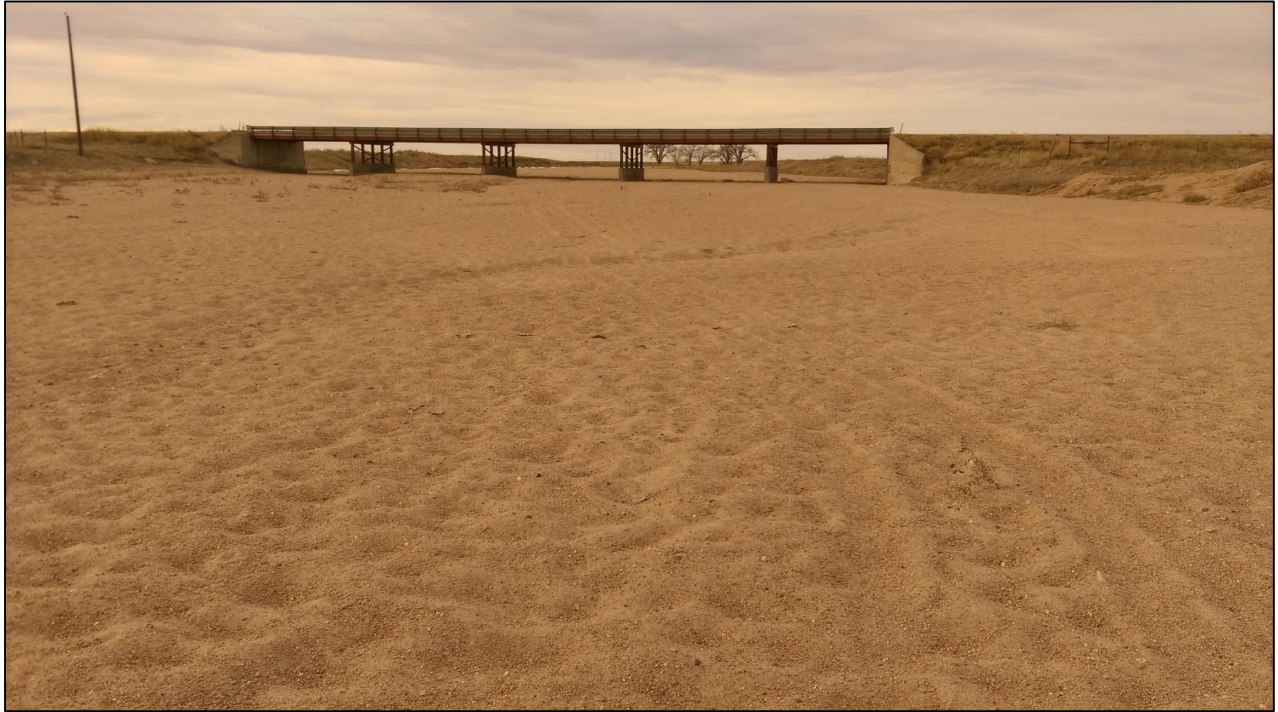
The river channel upstream (**Photo 9**) and downstream (**Photo 10**) of the mining area appeared to be preserved, showing no evidence of erosion. Overall, the site appeared to be stable. No problems were observed.

**Photo 9.** View looking upstream (west) from mining area, showing river channel appears to be preserved with no evidence of erosion.

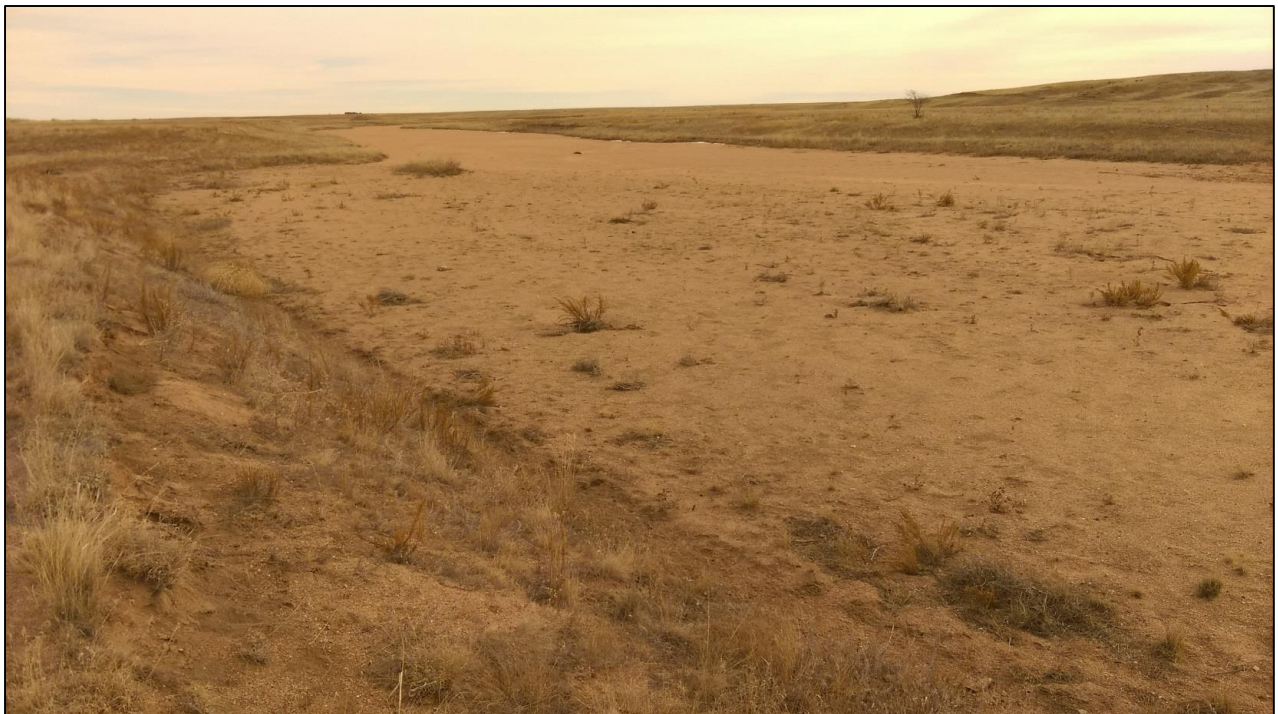
**Photo 10.** View looking downstream (east) from mining area, showing river channel appears to be preserved with no evidence of erosion.
