**COLORADO DIVISION OF RECLAMATION, MINING AND SAFETY**  
**MINERALS PROGRAM INSPECTION REPORT**  
**PHONE: (303) 866-3567**

<b>MINE NAME:</b> Raymond Enderson Pit	<b>MINE/PROSPECTING ID#:</b> M-2000-066	<b>MINERAL:</b> Sand and gravel	<b>COUNTY:</b> Lincoln
<b>INSPECTION TYPE:</b> Monitoring	<b>INSPECTOR(S):</b> Amy Eschberger	<b>INSP. DATE:</b> December 10, 2015	<b>INSP. TIME:</b> 11:00
<b>OPERATOR:</b> Lincoln County	<b>OPERATOR REPRESENTATIVE:</b> John DeWitt, Mark McHone	<b>TYPE OF OPERATION:</b> 110c - Construction Limited Impact

# M2000-066 / Raymond Enderson Pit / Lincoln County

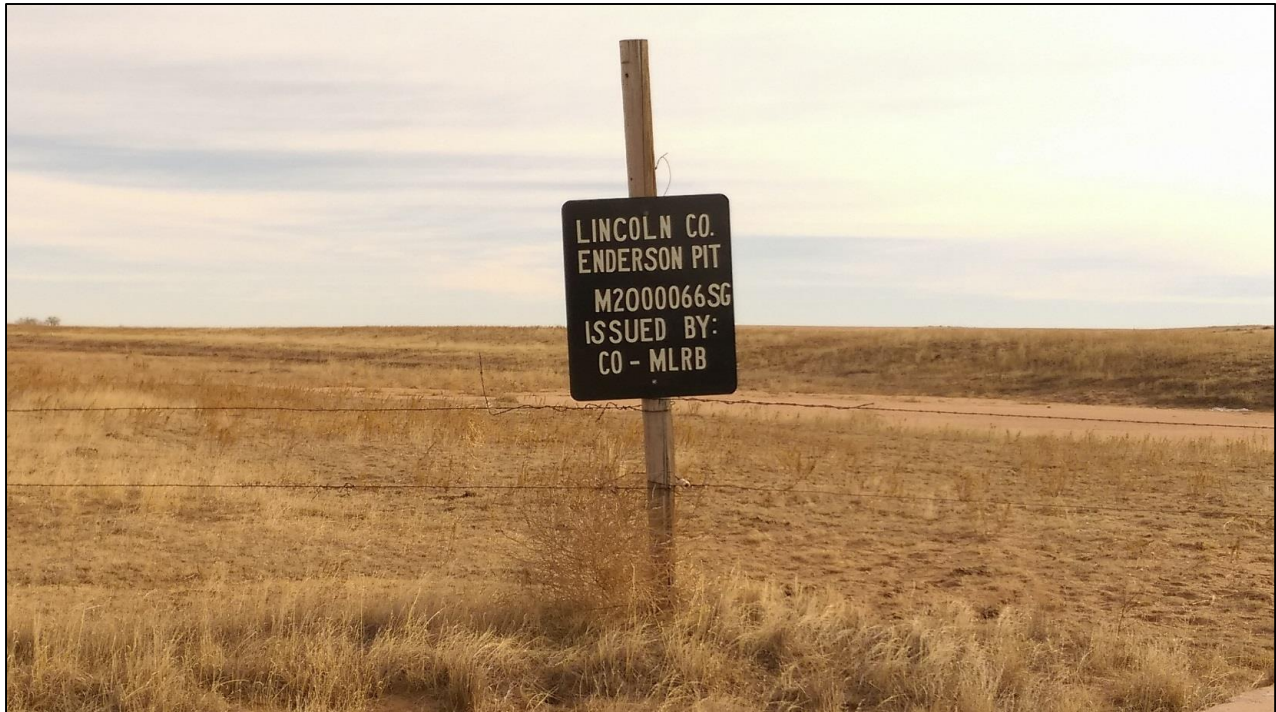
At the time of the inspection, the weather was partly cloudy and breezy, and no standing water was observed on site. The creek bed was dry. A permit sign was posted at the main site entrance off of Co Rd 41 (**Photo 1**). The permit boundary was properly delineated with metal posts (**Photo 2**). The site was not active at the time of the inspection, and no equipment was stored on site. However, according to the operator, this site is active every year, which is in compliance with its intermittent status.

**Photo 1.** View of permit sign posted at main site entrance off of Co Rd 41.

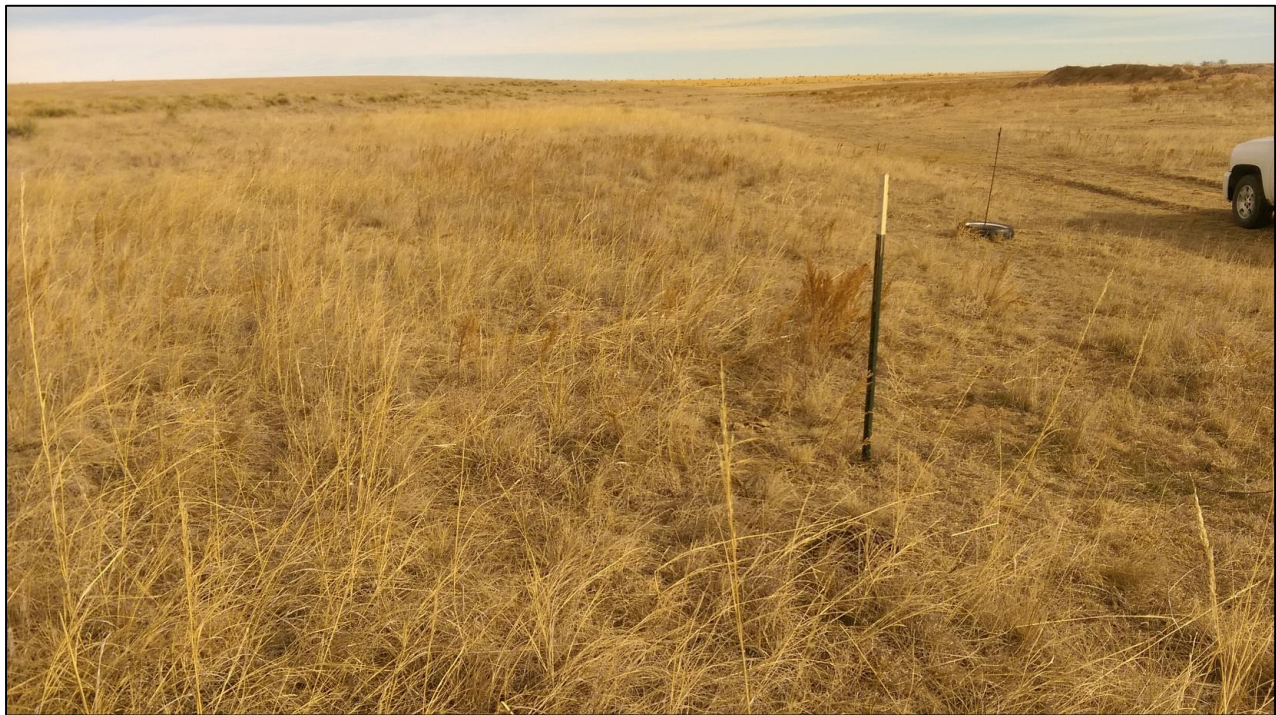
**Photo 2.** View looking south, showing metal post marking northwestern corner of permit boundary.

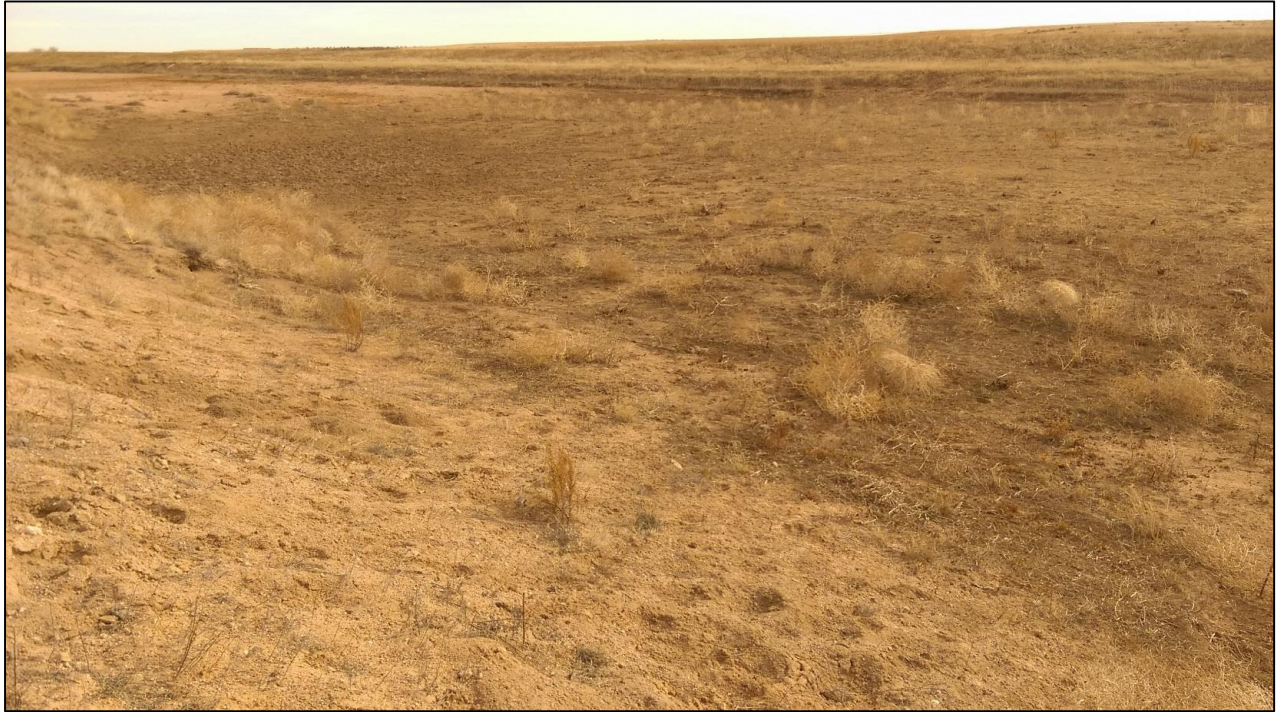
The Division observed a shallow depression (approximately 1-2 feet in depth) in the river bed where material was extracted and pushed up to the northern bank (**Photos 3 and 4**). This depression was approximately 400 feet in length down the river channel. Outside of this depression, the river bed appeared to be relatively flat and even. A few small stockpiles of material were stored along the northern bank (**Photos 5 and 6**). In a few areas along the northern bank, it appeared that the operation continued a little too far out of the channel while extracting (**Photo 7**). This has left a few small trenches along the northern river bank. If the operator wishes to mine the river banks or land outside of the river, a Technical Revision will need to be submitted to revise the mining plan and reclamation plan. Otherwise, the Division recommends the operator restrict all extraction activities to the river bed as committed to in the original permit. The stockpiling area located north of the river had native grasses (primarily blue grama and buffalograss) and some yucca volunteering across the disturbed land (**Photo 8**).

**Photo 3.** View looking east (downstream), showing the shallow depression left in the river channel where material was excavated.

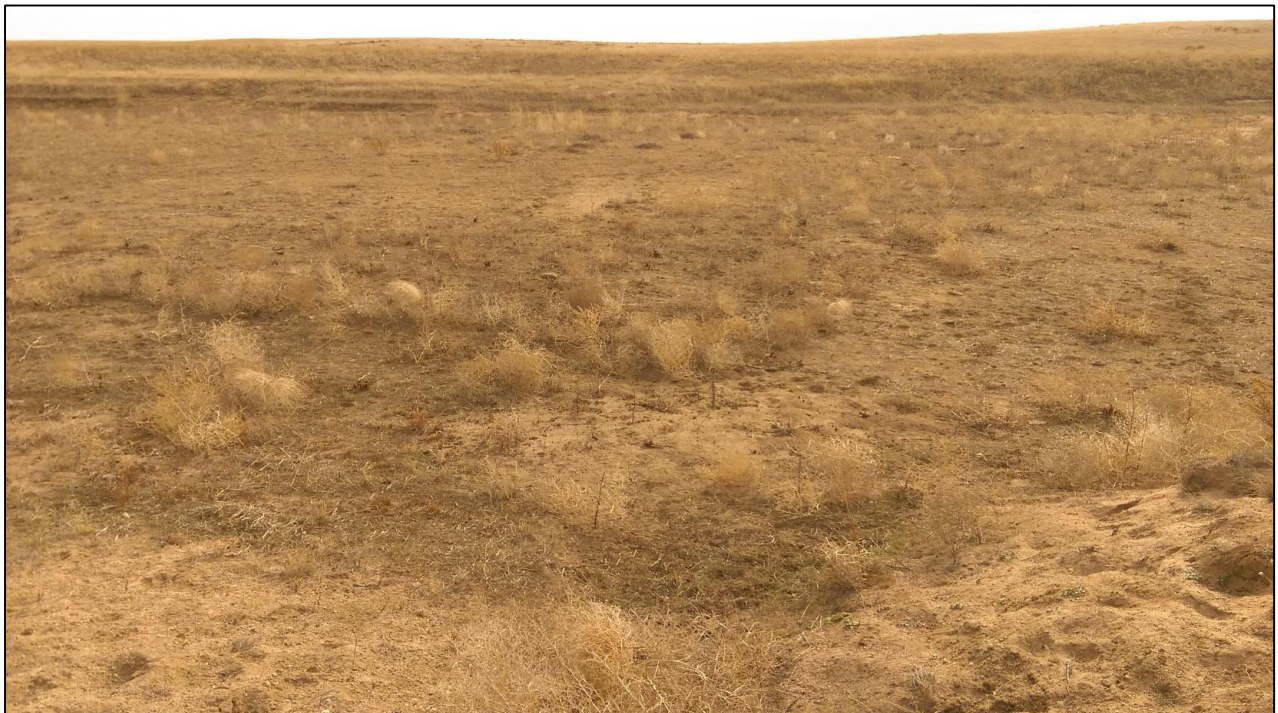
**Photo 4.** View looking south across the river, showing the center of the shallow depression left in the river channel where material was excavated.

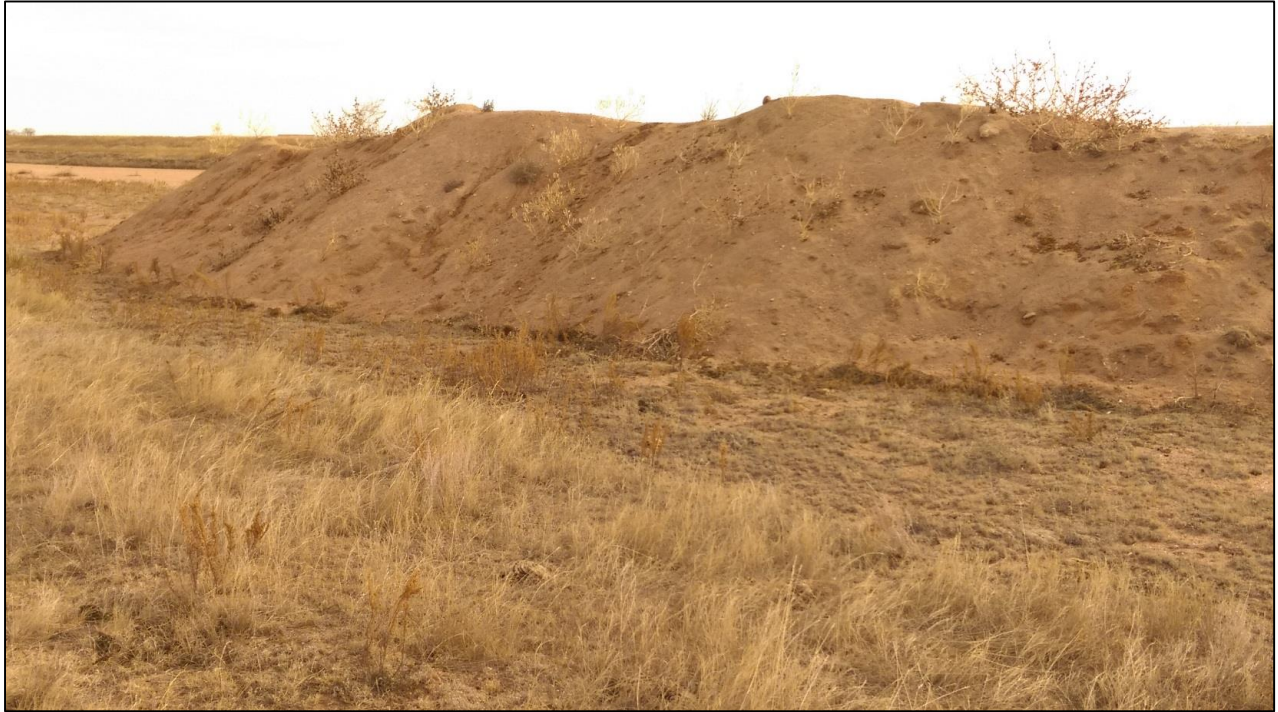
**Photo 5.** View looking south, showing material stockpiled along northern river bank where it was pushed up from the river bed.

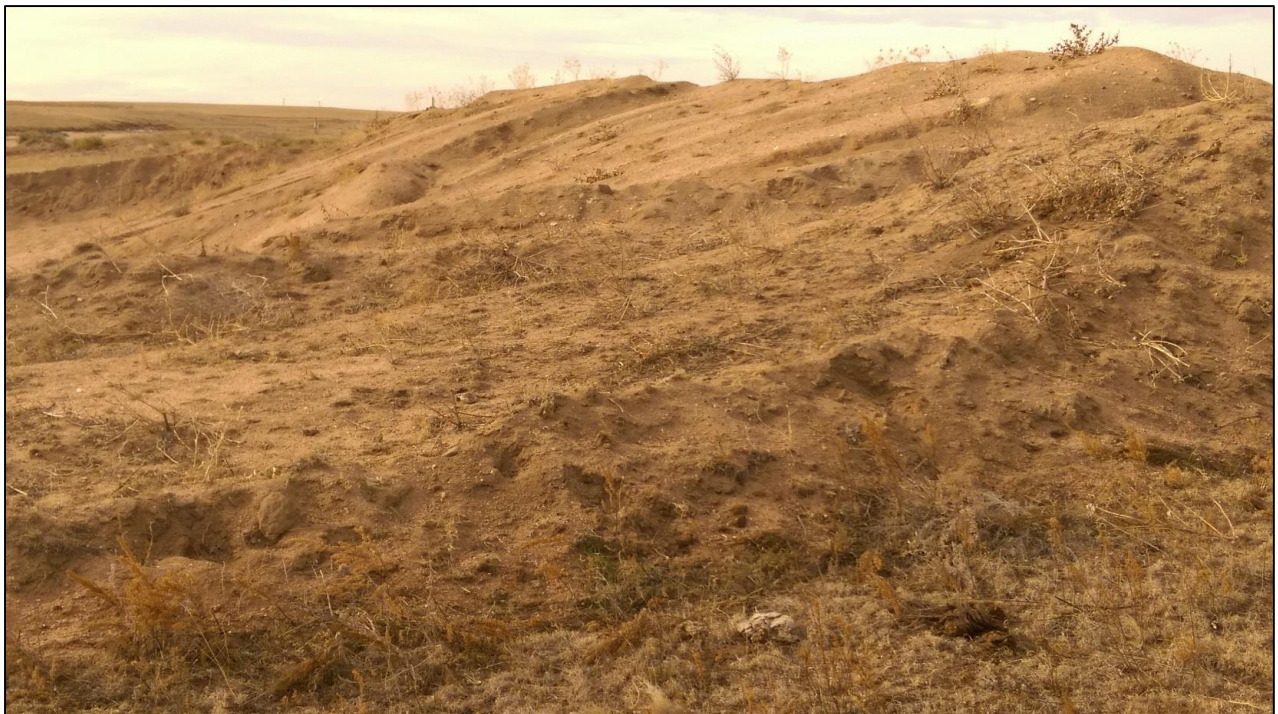
**Photo 6.** View looking west, showing side of material stockpile stored along northern river bank where it was pushed up from the river bed.

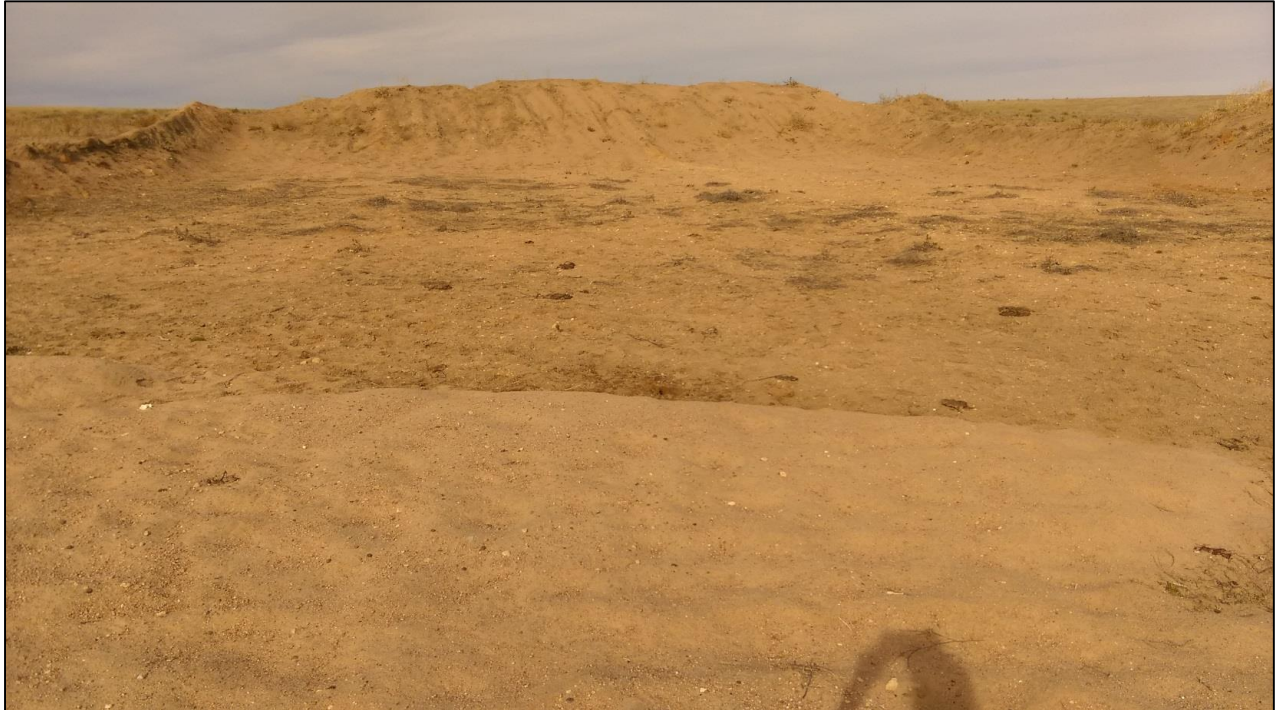
**Photo 7.** View looking north from inside river channel, showing small trench that was dug into the northern river bank.

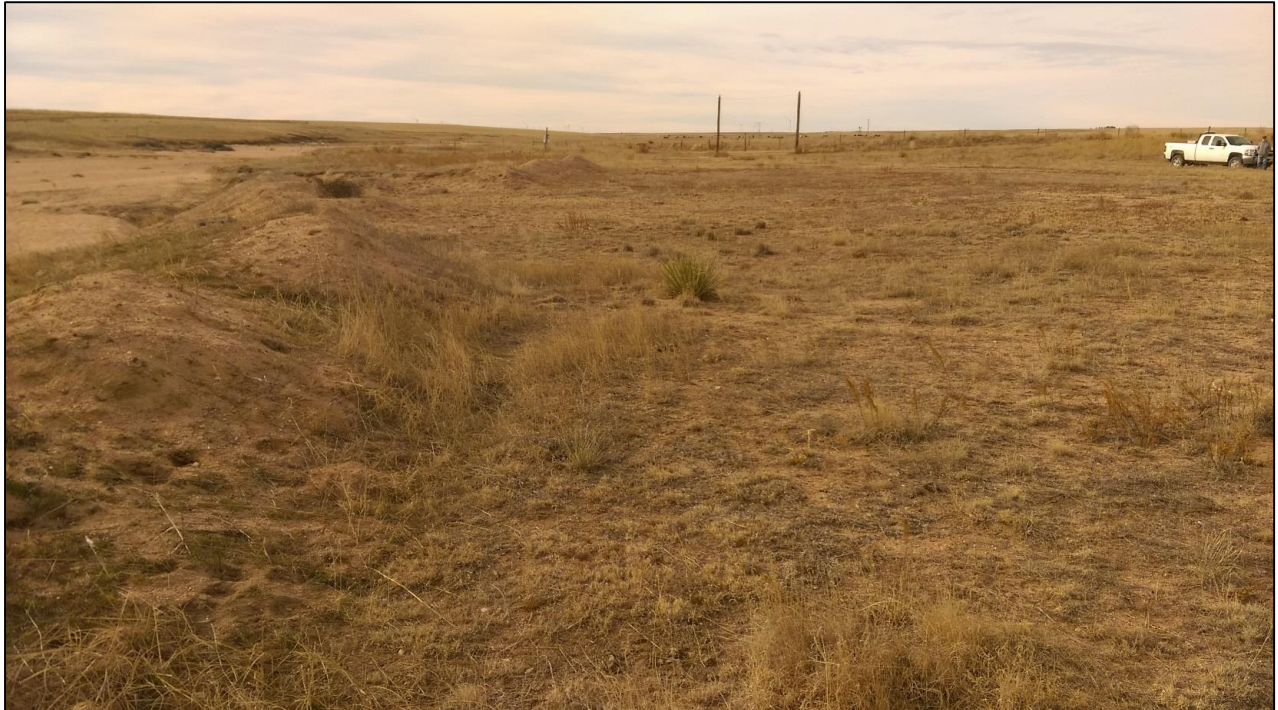
**Photo 8.** View looking west across the stockpiling area located just north of the river. Note native grasses and some yucca volunteering across the disturbed land.

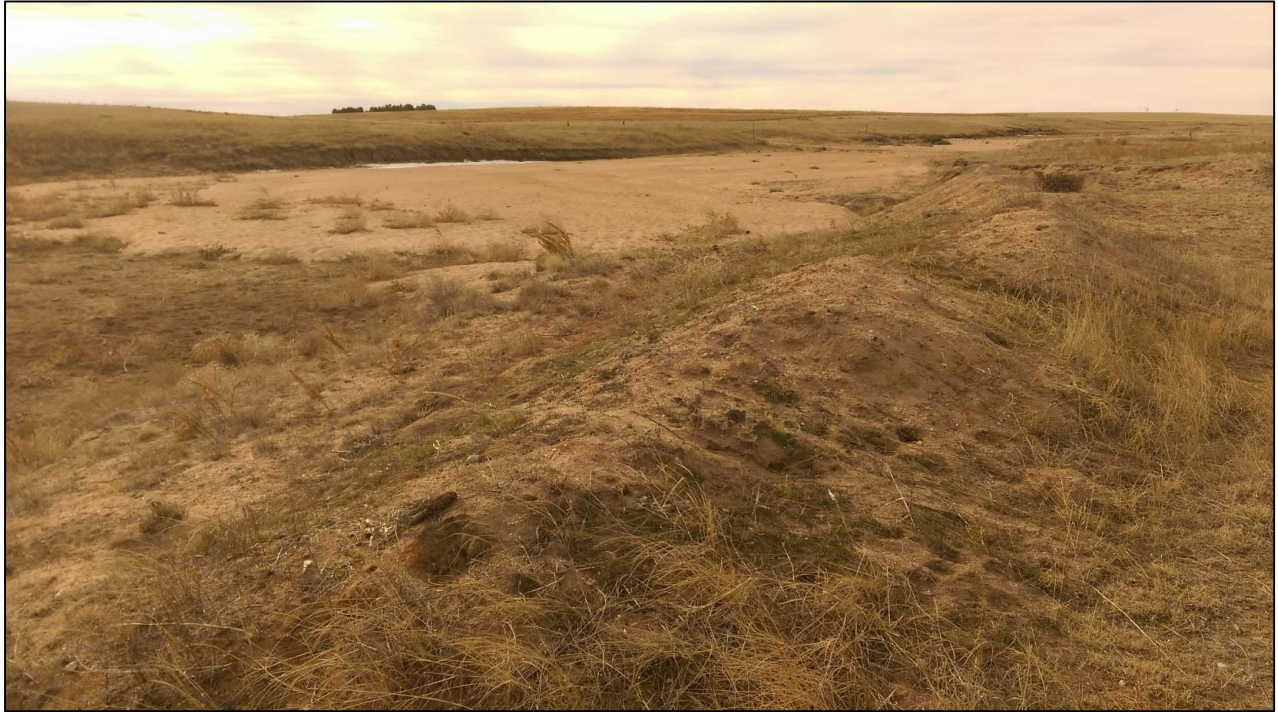
The river channel upstream (**Photo 9**) and downstream (**Photo 10**) of the mining area appeared to be preserved, showing no evidence of erosion. Overall, the site appeared to be stable. No problems were observed.

**Photo 9.** View looking southwest (upstream) from mining area, showing river channel appears to be preserved with no evidence of erosion. Note edge of depression (at left) where material is extracted.

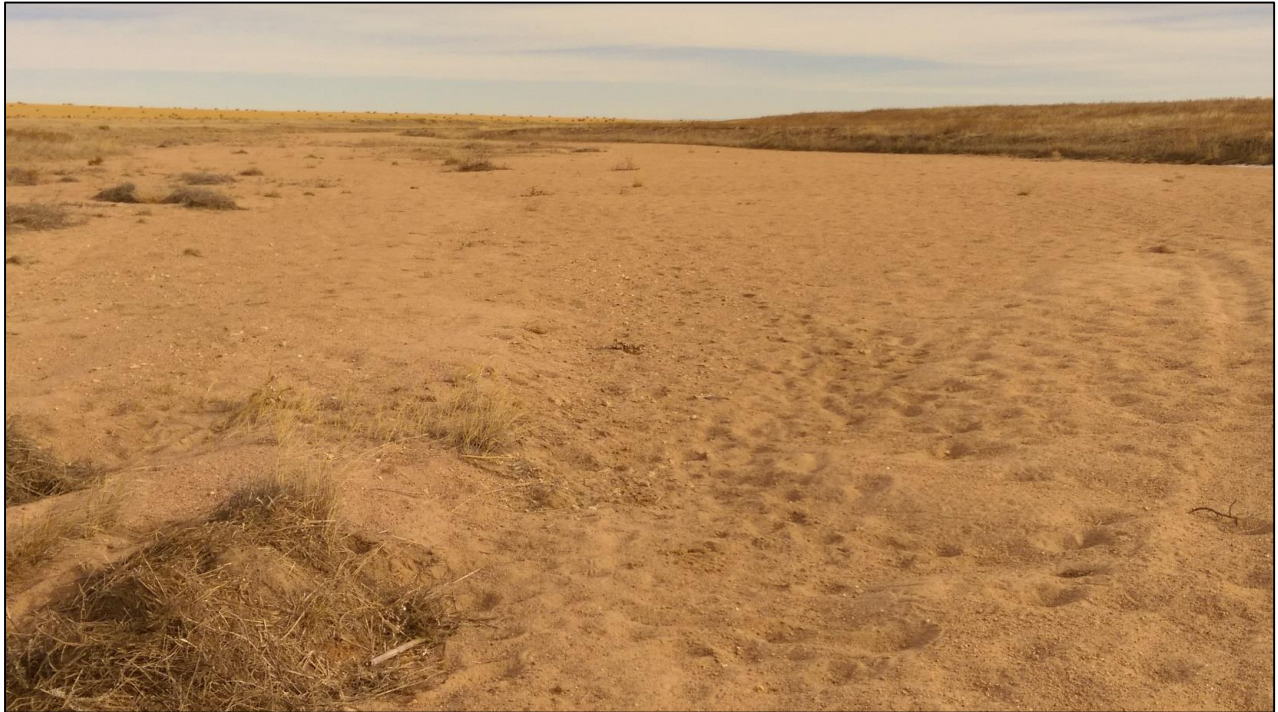
**Photo 10.** View looking east (downstream) from mining area, showing river channel appears to be preserved with no evidence of erosion.
