COLORADO DIVISION OF RECLAMATION, MINING AND SAFETY
MINERALS PROGRAM INSPECTION REPORT
PHONE: (303) 866-3567

MINE NAME: Cresson Project	MINE/PROSPECTING ID#: M-1980-244	MINERAL: Gold	COUNTY: Teller
INSPECTION TYPE: Aerial Inspection	INSPECTOR(S): Timothy A. Cazier	INSP. DATE: December 28, 2015	INSP. TIME: 16:25
OPERATOR: Cripple Creek & Victor Gold Mining Company	OPERATOR REPRESENTATIVE: None	TYPE OF OPERATION: 112d-3 - Designated Mining Operation

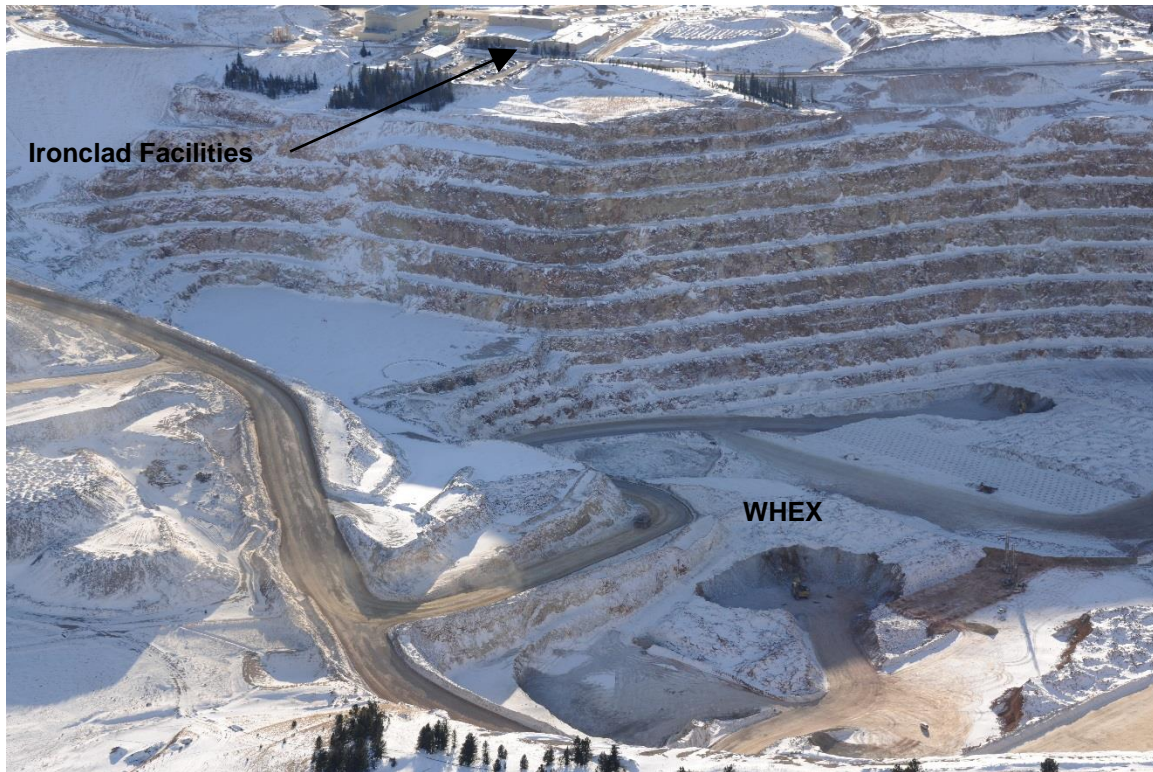
Photo 1. Wildhorse Extension Pit (Looking SW).

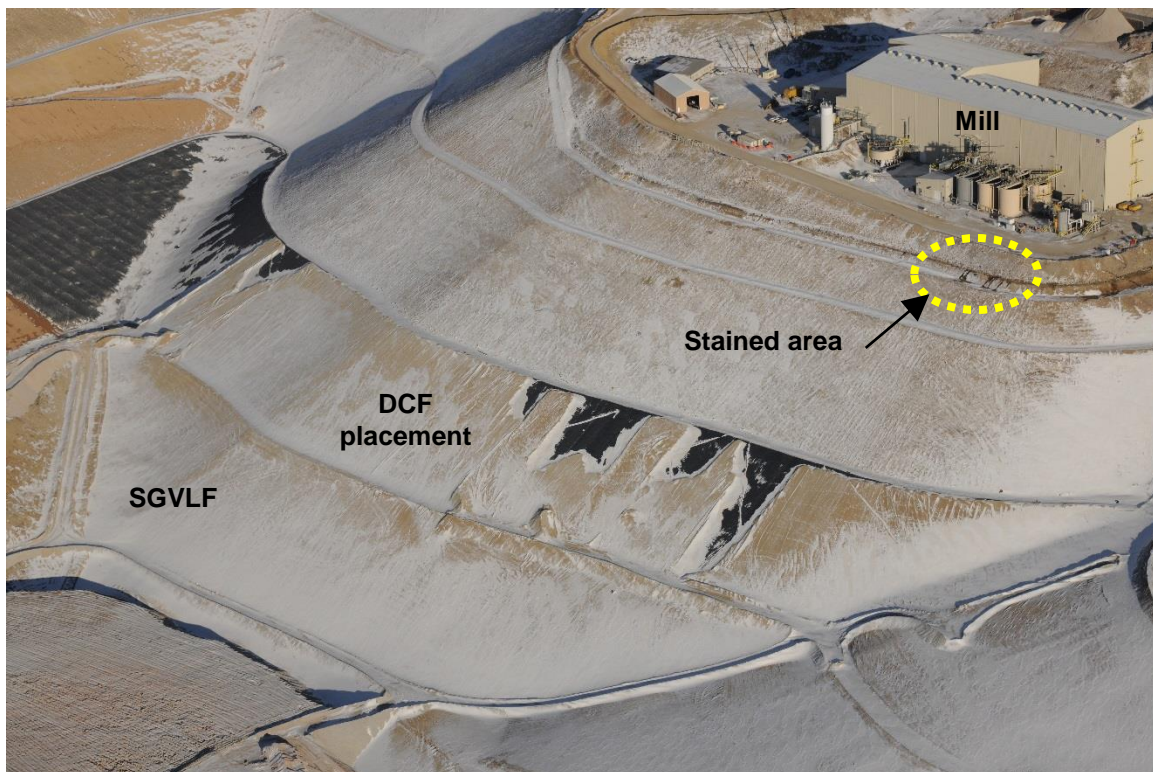
The observed staining outside the High Grade Mil berm needs to be checked on the ground (see **Photo 2**). The Division will inspect the channel during the next inspection

Photo 2. High Grade Mill (Looking east).

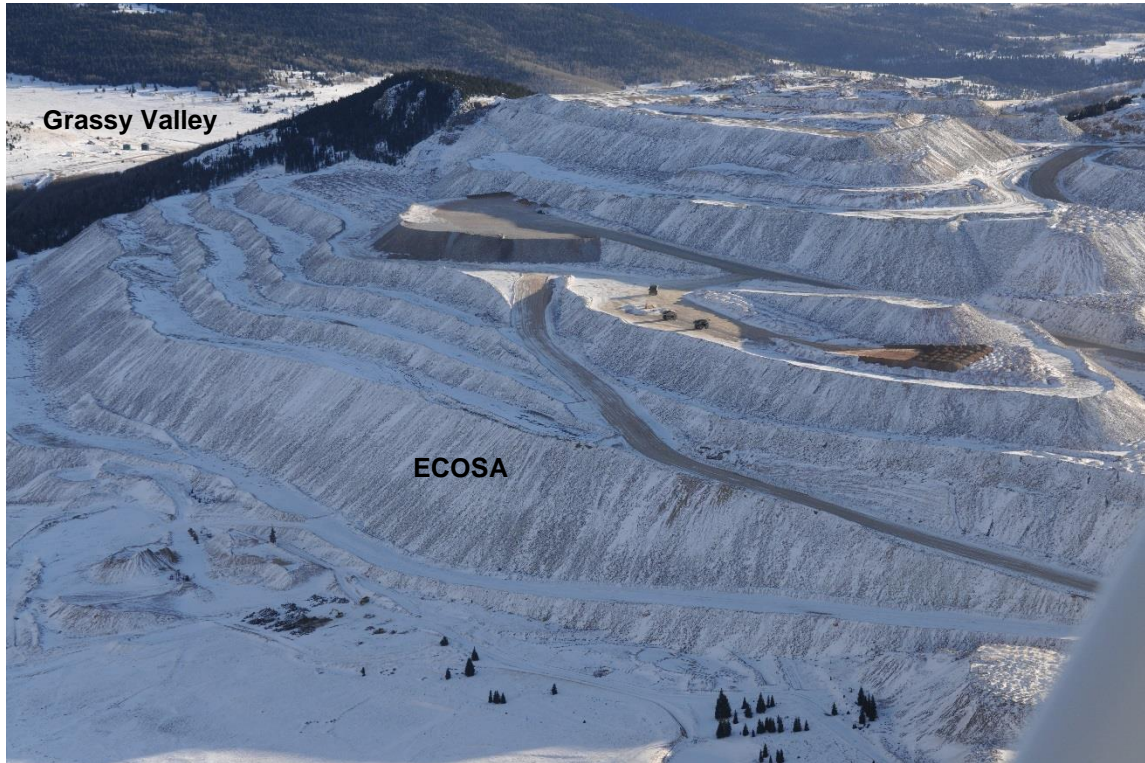
Photo 3. East Cresson OSAs (looking SE).

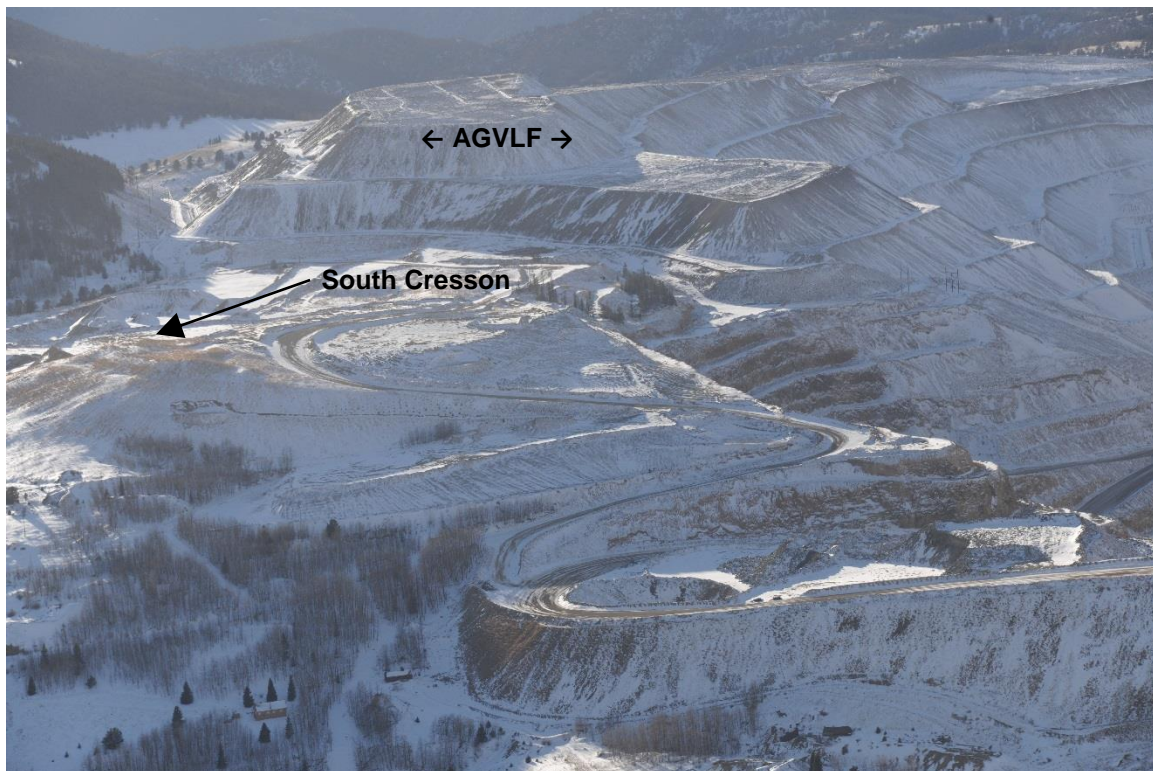
Photo 4. South Cresson (looking SW).

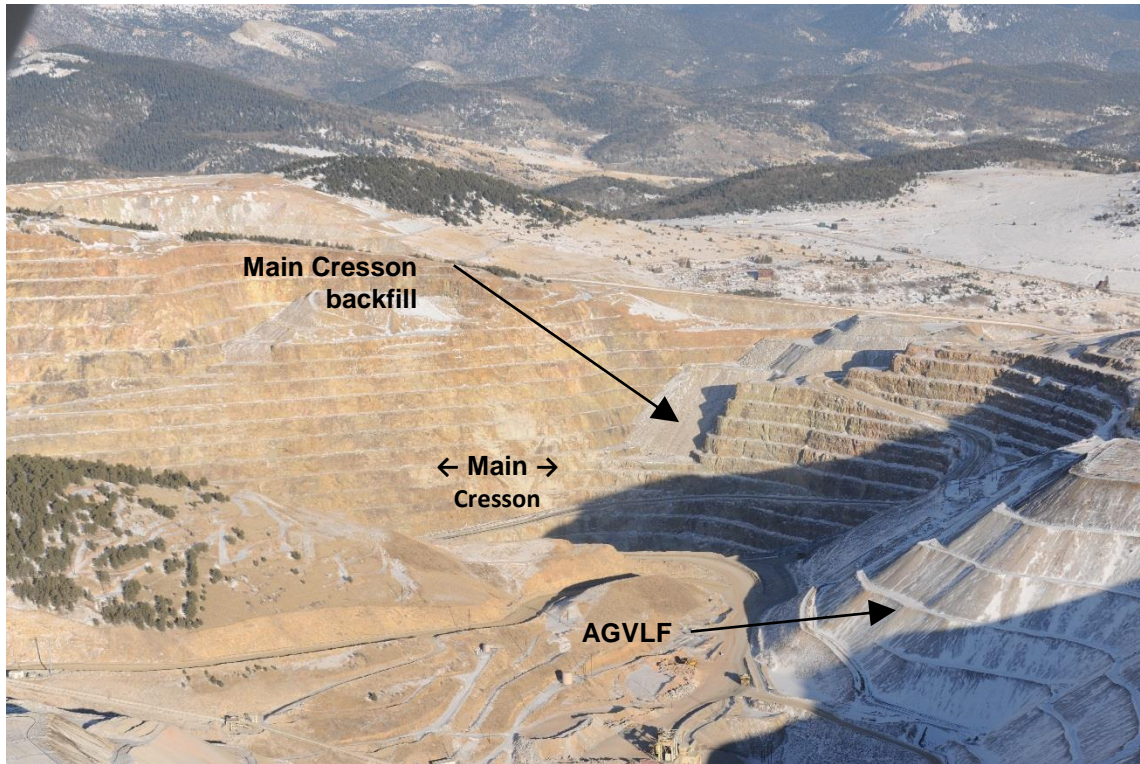
Photo 5. Main Cresson Pit (looking east).

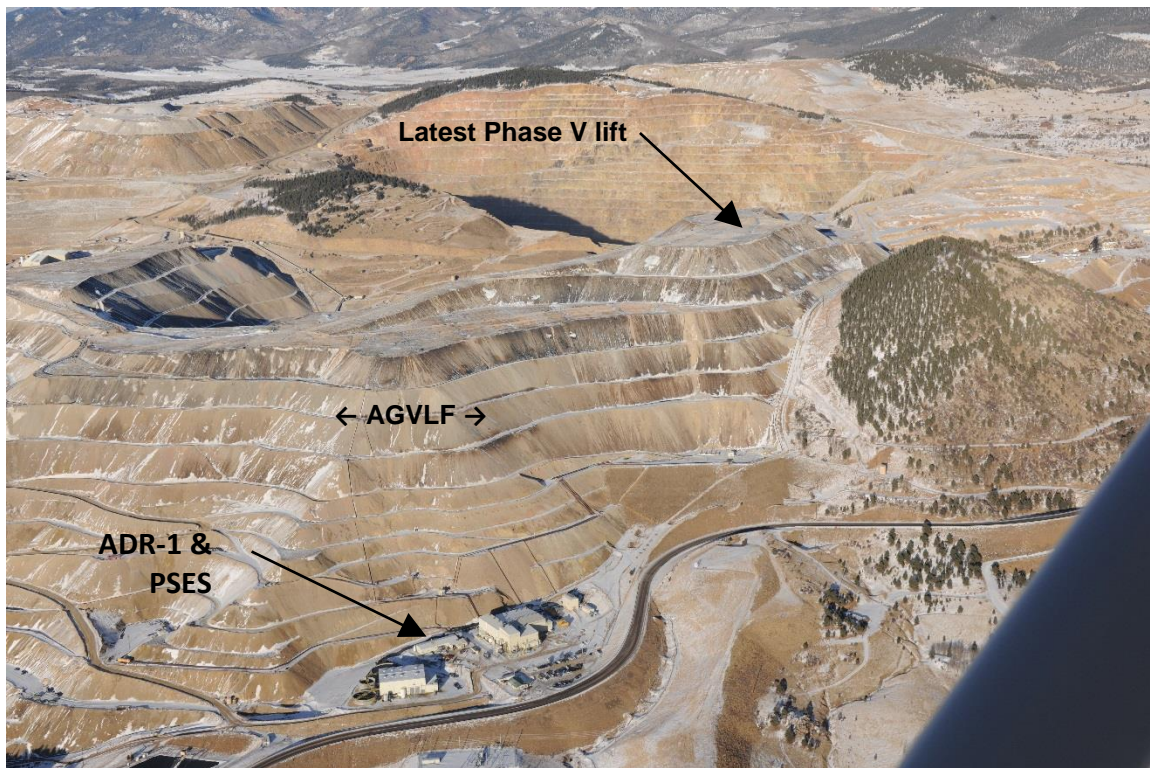
Photo 6. Arequa Gulch VLF (looking east).

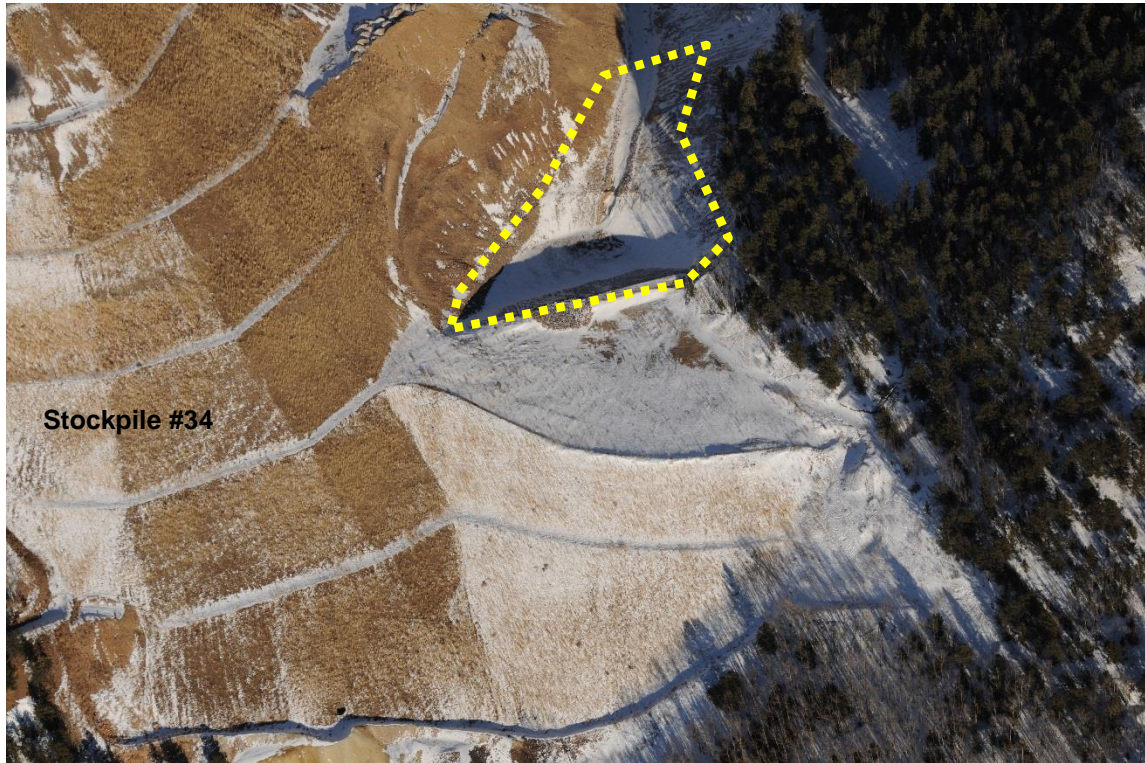
Photo 7. Phase 1/EMP-008c Pond & New growth medium stockpile #34 (looking east).

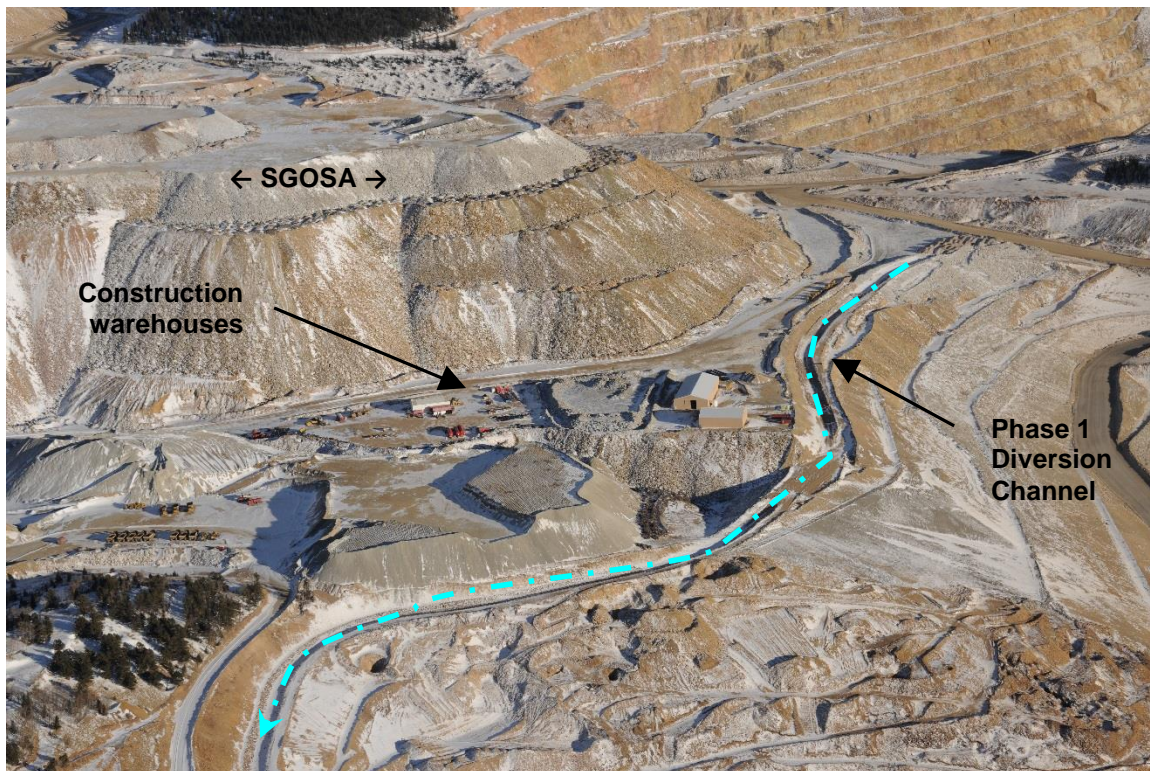
Photo 8. Squaw Gulch OSA (Looking east).

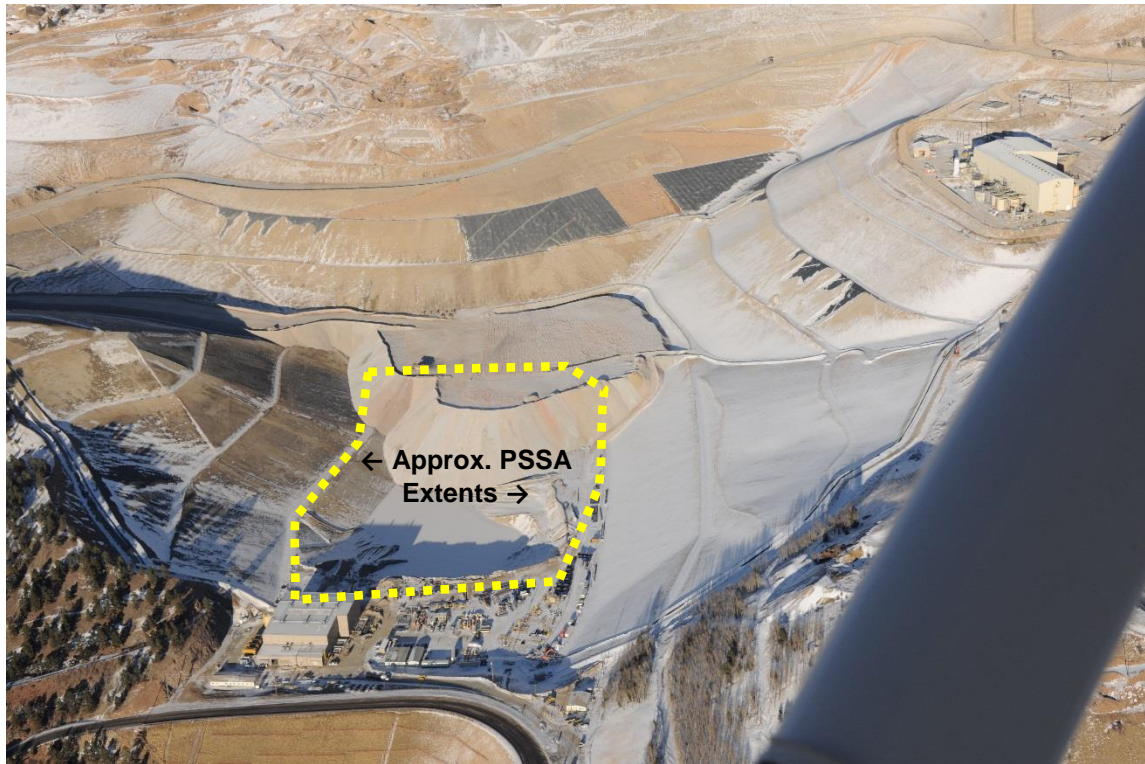
Photo 9. Squaw Gulch VLF - note PSSA filling in center (Looking NE).

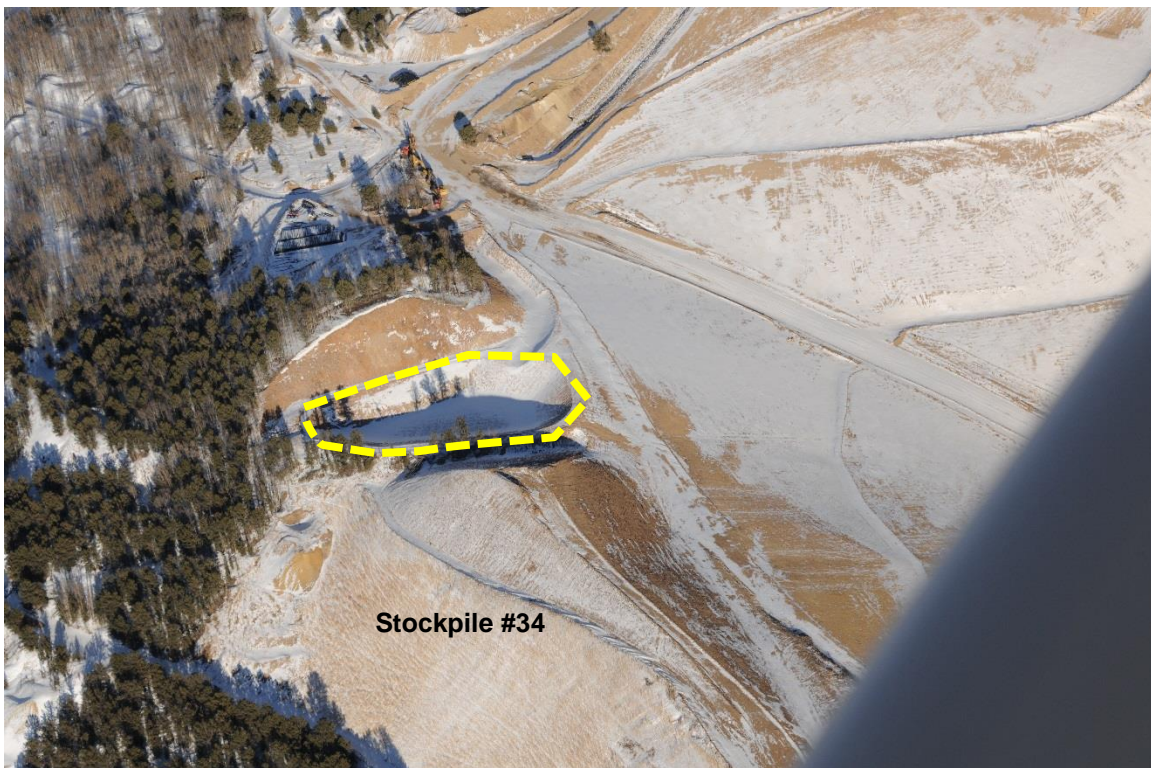
Photo 10. Phase 2/EMP-008b Pond & New growth medium stockpile #34 (looking NE).
