**COLORADO DIVISION OF RECLAMATION, MINING AND SAFETY**  
**MINERALS PROGRAM INSPECTION REPORT**  
**PHONE: (303) 866-3567**

<b>MINE NAME:</b> Barton Pit	<b>MINE/PROSPECTING ID#:</b> M-2000-149	<b>MINERAL:</b> Gravel	<b>COUNTY:</b> Logan
<b>INSPECTION TYPE:</b> Monitoring	<b>INSPECTOR(S):</b> Elliott R. Russell	<b>INSP. DATE:</b> April 15, 2015	<b>INSP. TIME:</b> 15:00
<b>OPERATOR:</b> DUMB AND DUMBER TRUCKING, LLC	<b>OPERATOR REPRESENTATIVE:</b> Brian Barton	<b>TYPE OF OPERATION:</b> 112c - Construction Regular Operation

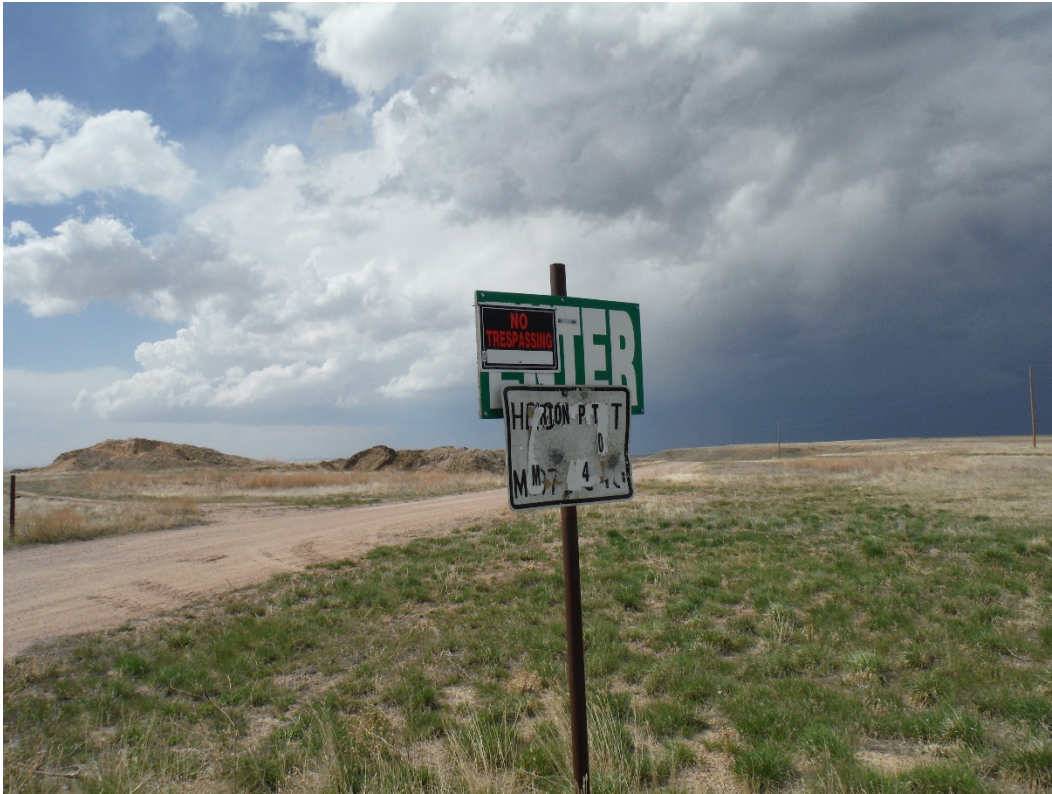
**PROBLEM/POSSIBLE VIOLATION:** Problem: The mine identification sign was not posted at the entrance of the mine site. This is a problem for failure to post a mine identification sign as required by Rule 3.1.12(1).

Out-of-compliance permit identification sign at the site entrance; looking northwest.

**CORRECTIVE ACTIONS:** The operator shall, at the entrance of the mine site, post a sign which shall be clearly visible from the access road with the following:

- the name of the operator
- a statement that a reclamation permit for the operation has been issued by the Colorado Mined Land Reclamation Board
- the permit number

The operator shall submit photo documentation that a proper sign has been posted by the corrective action date.

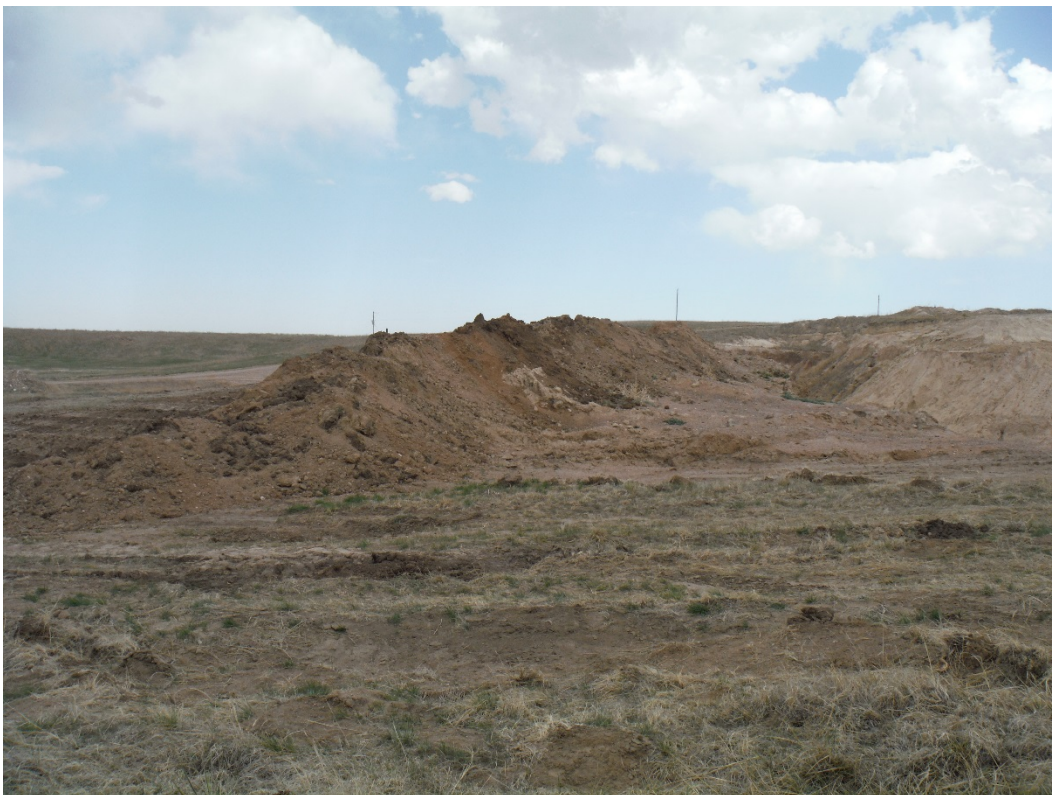
Topsoil stockpiled along crest of the western highwall; looking east.

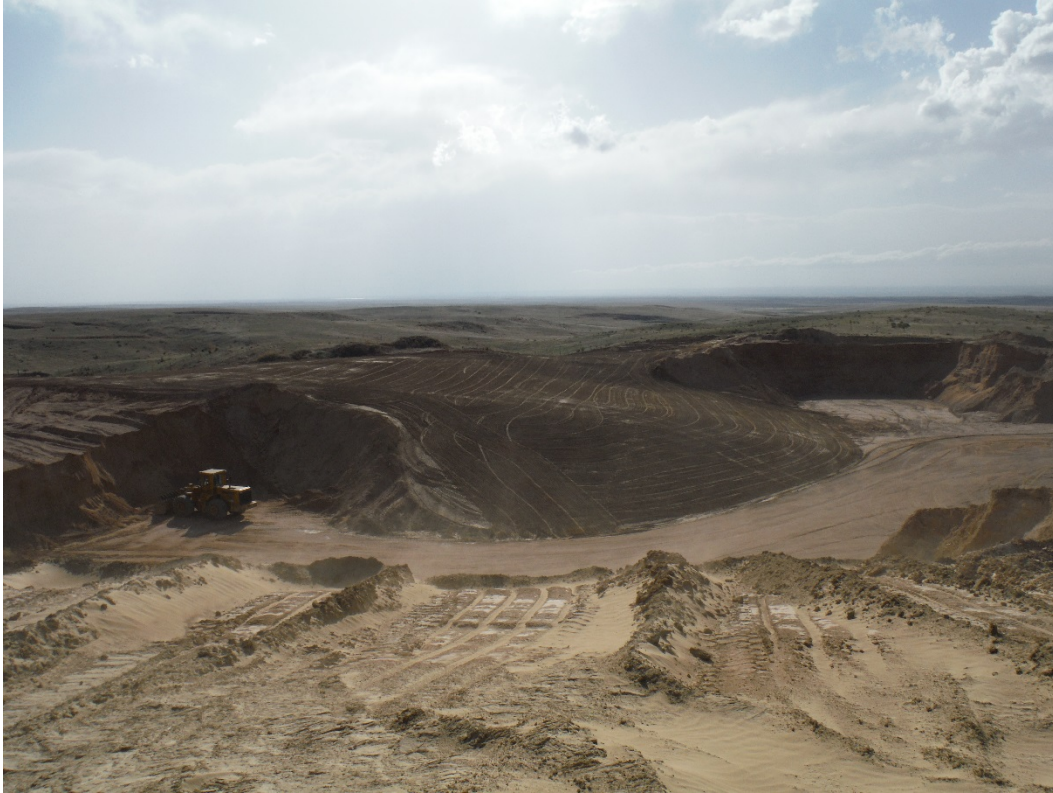
The site consist of a large "horse-shoe" excavated area in the south west portion of the permit. Topsoil and overburden had been stockpiled in various areas around the crest of the excavation. Slopes varied from near-vertical (southern and western portion), to angle of repose (eastern portion), and to 3H:1V (southwestern portion). The Operator is reminded that the permit calls for all slopes to be kept at or flatter than 3H:1V and anything steeper would need to be requested through a Technical Revision (TR), which would likely lead to an increase of the financial warranty to account for the additional cost of grading the slope. When mining is advanced, the Operator will need to keep a 3H:1V slope instead of the vertical highwall. Any deviation from this will need to be handled through a TR.

Pit overview from; looking west from the eastern highwall crest.

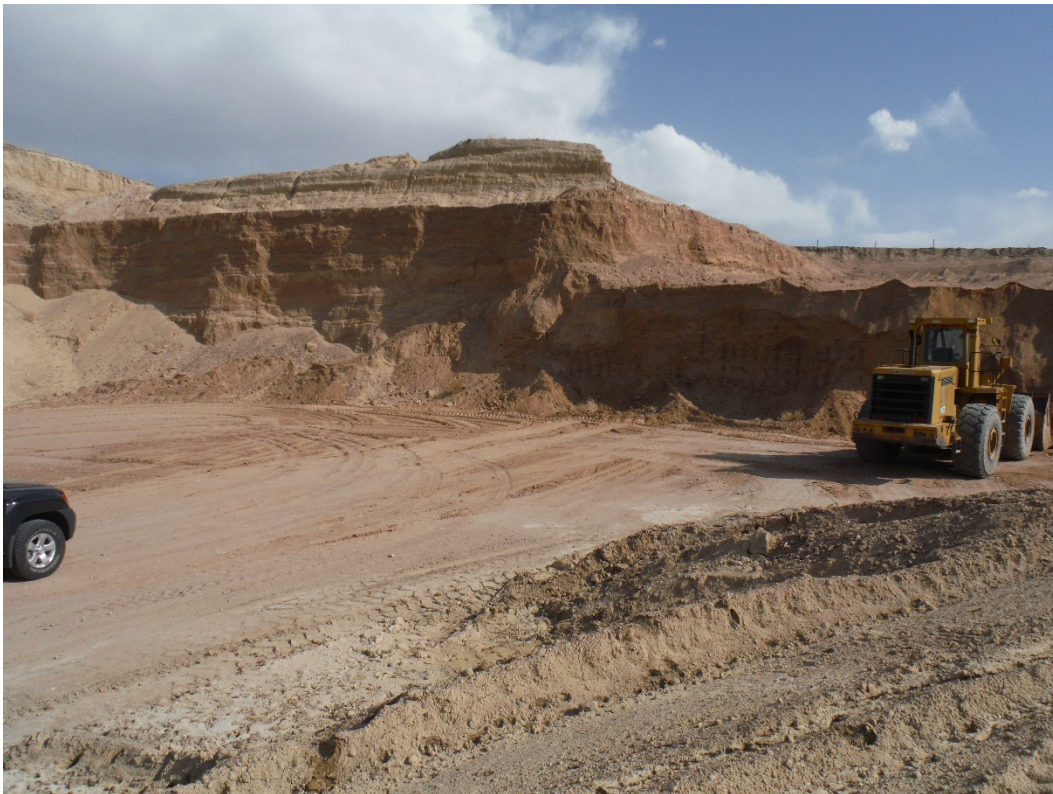
Active mining face; looking south.

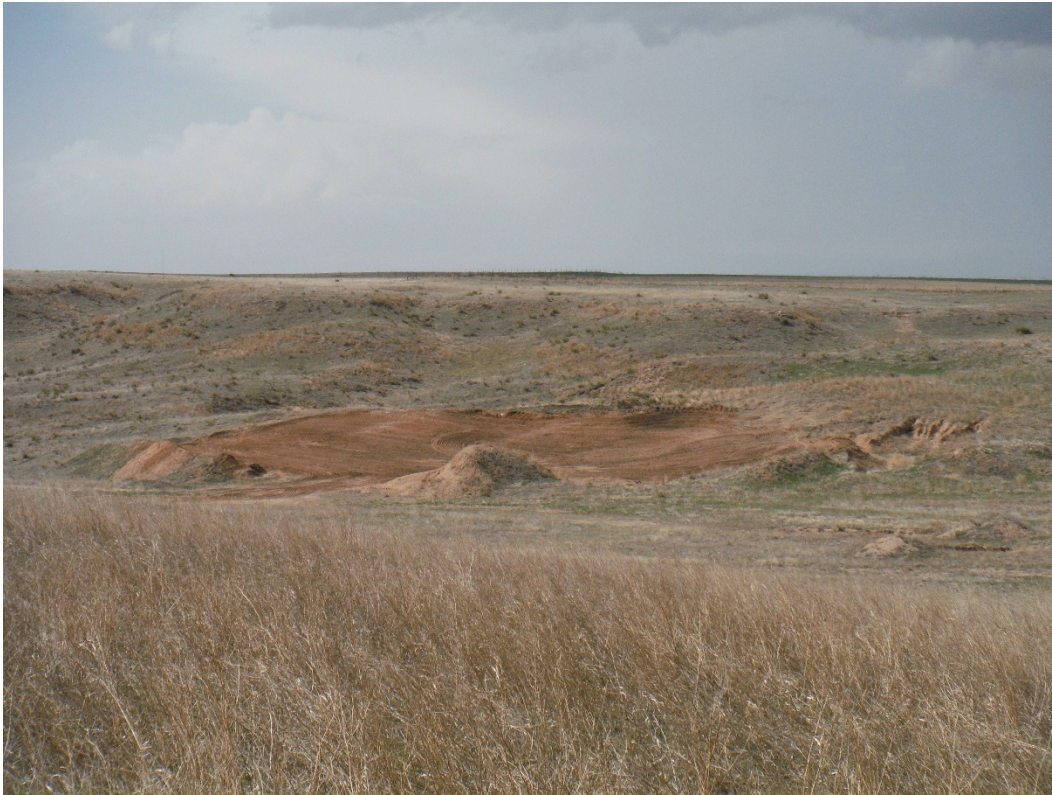
The Division observed a small half-acre disturbance in Phase 6. The Operator stated that this area had recently been graded and seeded and he was planning on removing or flattening out the remaining mounds of dirt. During the next inspection, if vegetation is not established on this area, the Division may include the remaining grading and re-seeding tasks in the reclamation cost estimate.

Disturbance located in Phase 6; looking north.

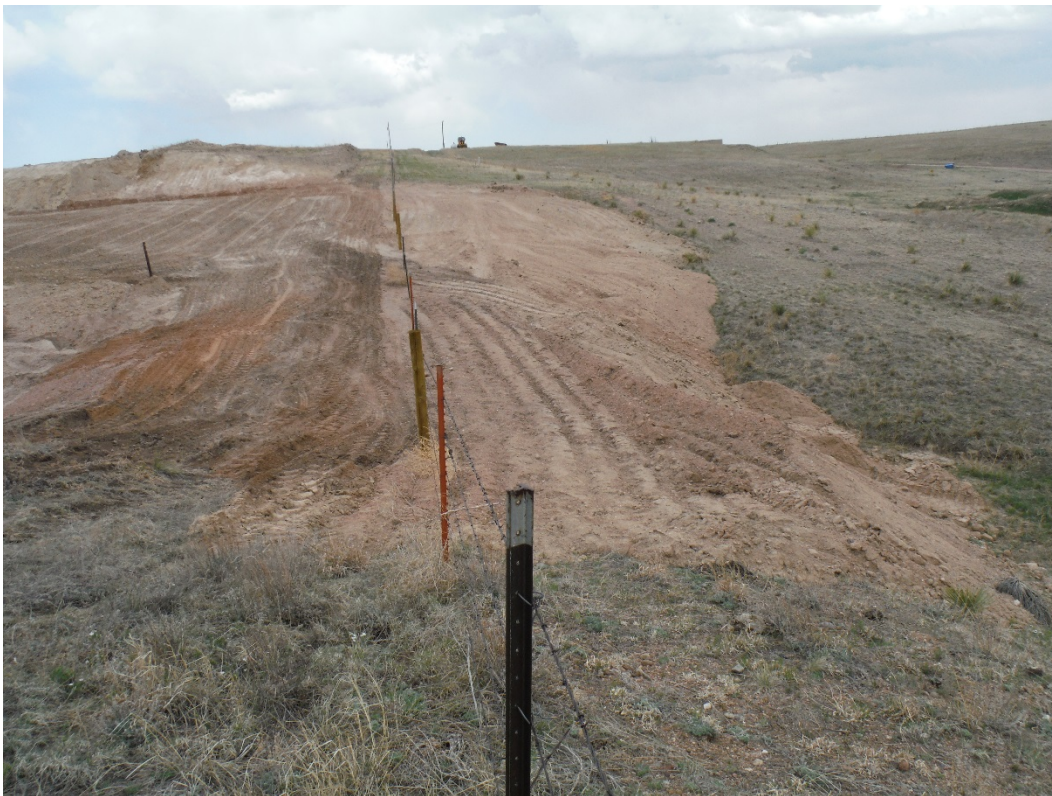
The Division also observed a small area south of the permit that had recently been disturbed, graded, and seeded. The Operator explained that the adjacent landowner had requested a small ravine be filled in so a vehicle could travel along the southern side of the fence line. No further action is needed because the area didn't appear to be disturbed by mining activities, but the Division kindly requests the Operator to inform the Division prior to doing adjacent earthwork in the future to reduce any confusion with possible violations.

Earthwork located south of the permit boundary; looking east.
