COLORADO DIVISION OF RECLAMATION, MINING AND SAFETY
MINERALS PROGRAM INSPECTION REPORT
PHONE: (303) 866-3567

MINE NAME: McKenzie Pit	MINE/PROSPECTING ID#: M-1980-224	MINERAL: Sand and gravel	COUNTY: Fremont
INSPECTION TYPE: Monitoring	INSPECTOR(S): Timothy A. Cazier	INSP. DATE: September 30, 2015	INSP. TIME: 11:05
OPERATOR: Fremont Paving & Redi-Mix, Inc.	OPERATOR REPRESENTATIVE: John Paul Ary & Jodi Ricker	TYPE OF OPERATION: 112c - Construction Regular Operation	
REASON FOR INSPECTION: Normal I&E Program	BOND CALCULATION TYPE: Complete Bond	BOND AMOUNT: \$58,241.00	
DATE OF COMPLAINT: NA	POST INSP. CONTACTS: None	JOINT INSP. AGENCY: None	
WEATHER: Cloudy	INSPECTOR'S SIGNATURE:

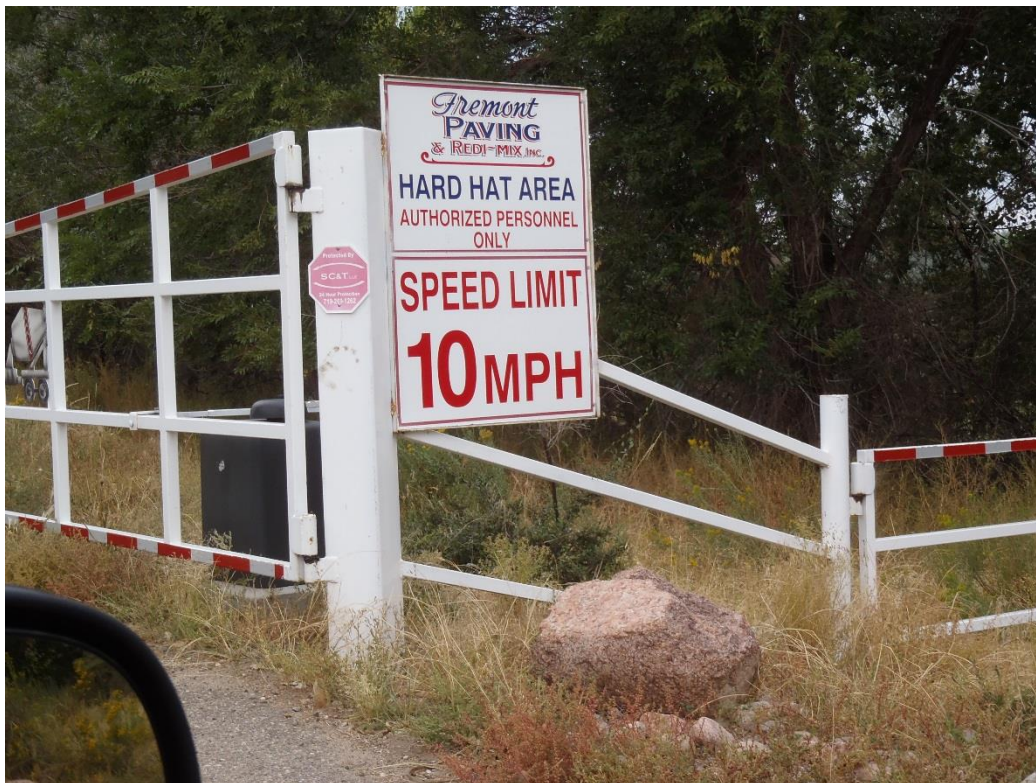
PROBLEM/POSSIBLE VIOLATION: Problem: The mine identification sign was not posted at the entrance of the mine site. This is a problem for failure to post a mine identification sign as required by Section 3.1.12(1) of the rule.

Markers & Boundary – A permit sign was not displayed at either site entrance (see **Photos 1** and **2**). This is **cited as a problem on page 1 of this report**. Boundaries appeared to be adequately marked with T-posts and fences (see **Photos 3** and **4**).

Photo 1. MacKenzie Ave. site entrance without Permit identification sign.

CORRECTIVE ACTIONS: The operator shall, at both the entrances of the mine site, post a sign which shall be clearly visible from the access road with the following: the name of the operator, a statement that a reclamation permit for the operation has been issued by the Colorado Mined Land Reclamation Board; and the permit number. The operator shall submit photo documentation that a proper signs have been posted by the corrective action date.

1. The Operator must post permit signs at both entrances (Santa Fe Drive at Hwy 115 and MacKenzie Ave.) and submit photographic evidence of having done so by the corrective action due date.
2. The Operator should check their records to be sure structure damage agreements are current for all structures within 200 feet of the permit boundary.

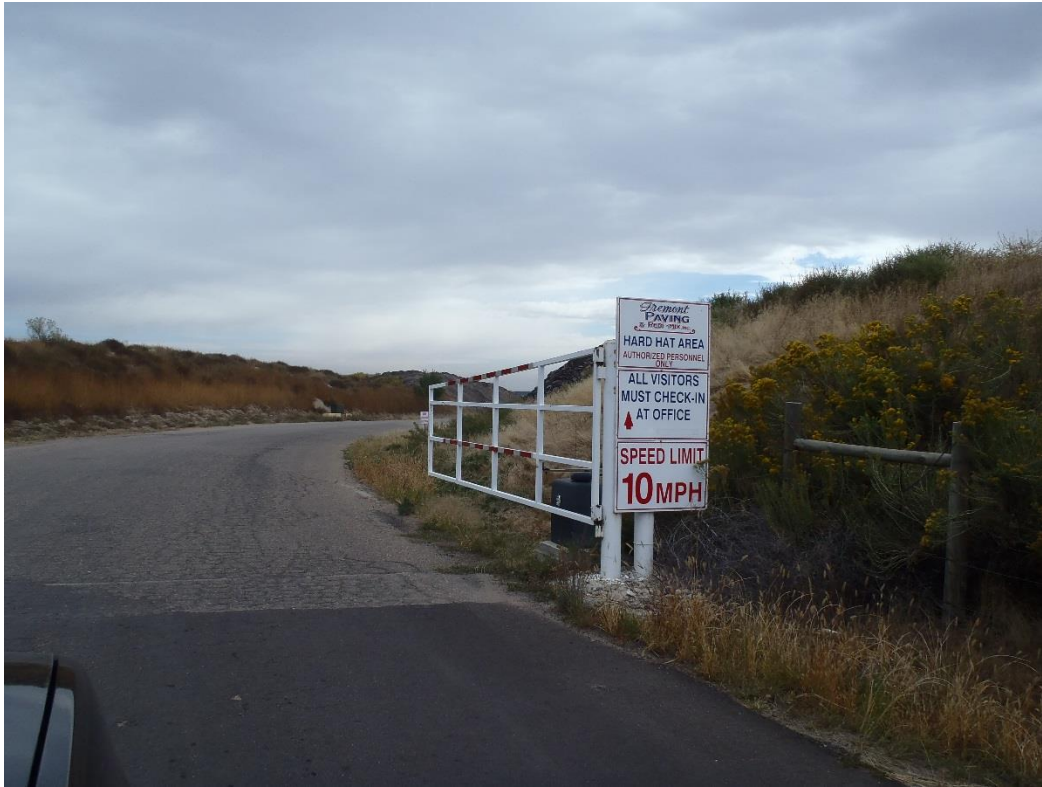
Photo 2. Hwy 115 site entrance without Permit identification sign.

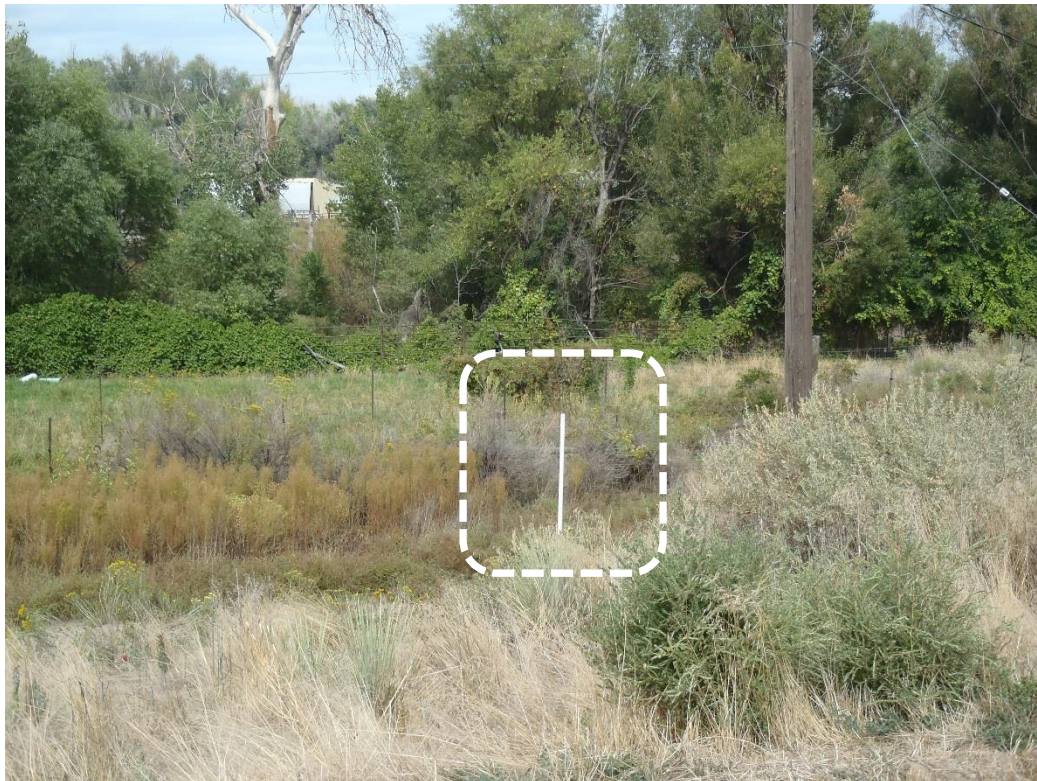
Photo 3. T-post affected area boundary marker on west side of the pit (west side looking NW).

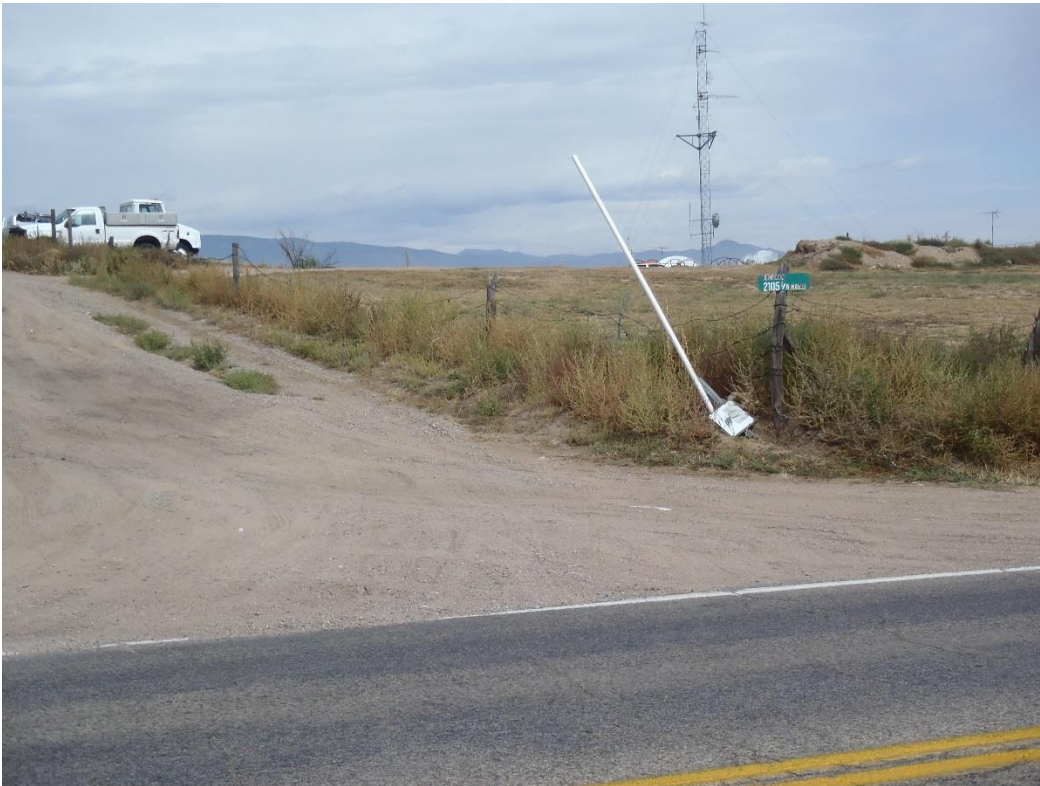
Photo 4. Affected area boundary fencing in south center area (south side looking north).

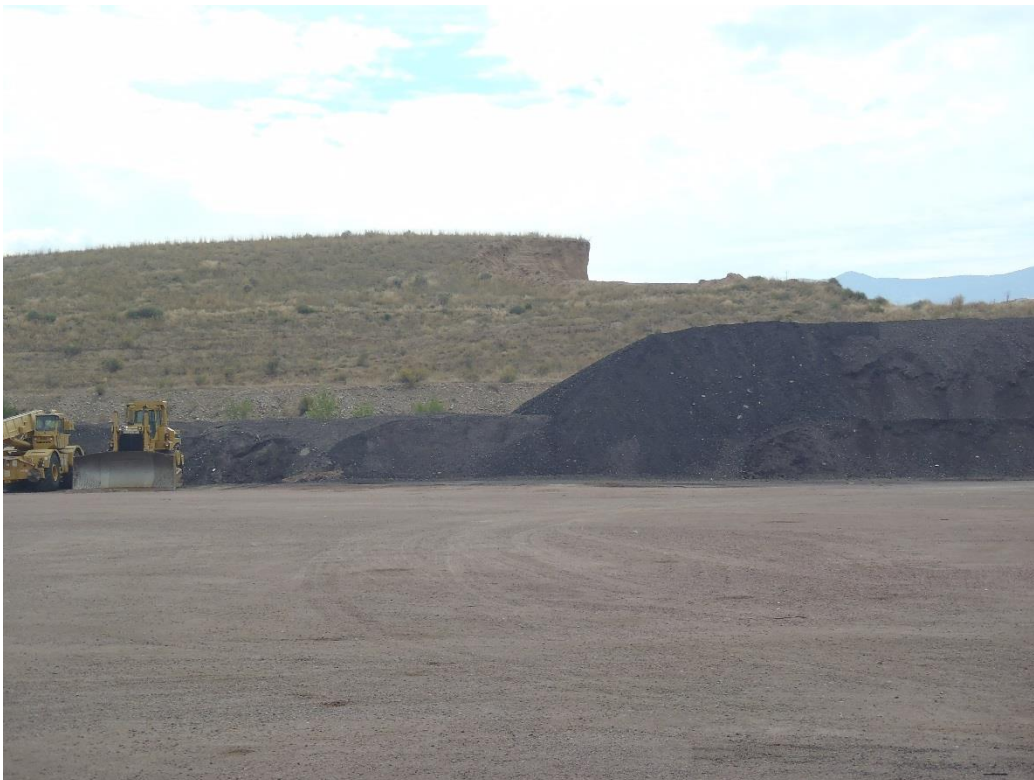
Reclamation – A topsoil stockpile was observed on the upgradient side of the highwall (see **Photo 4**). Mr. Ary indicated interim reclaimed slopes would be at 4H:1V and seeded. It was agreed that this would be clarified in the aforementioned TR.

Photo 5. Topsoil stockpile (looking south).
