**COLORADO DIVISION OF RECLAMATION, MINING AND SAFETY**  
**MINERALS PROGRAM INSPECTION REPORT**  
**PHONE: (303) 866-3567**

<b>MINE NAME:</b> Sundance Sand and Gravel Resource	<b>MINE/PROSPECTING ID#:</b> M-2006-073	<b>MINERAL:</b> Sand and gravel	<b>COUNTY:</b> El Paso
<b>INSPECTION TYPE:</b> Surety-Related Inspection	<b>INSPECTOR(S):</b> Timothy A. Cazier	<b>INSP. DATE:</b> November 19, 2014	<b>INSP. TIME:</b> 11:00
<b>OPERATOR:</b> Martin Marietta Materials, Inc.	<b>OPERATOR REPRESENTATIVES:</b> Rusty Cochrane & Mike Drabing	<b>TYPE OF OPERATION:</b> 112c - Construction Regular Operation	
<b>REASON FOR INSPECTION:</b> Surety Related	<b>BOND CALCULATION TYPE:</b> Partial Bond	<b>BOND AMOUNT:</b> \$1,464,697.35	
<b>DATE OF COMPLAINT:</b> NA	<b>POST INSP. CONTACTS:</b> None	<b>JOINT INSP. AGENCY:</b> None	
<b>WEATHER:</b> Clear	<b>INSPECTOR'S SIGNATURE:</b>

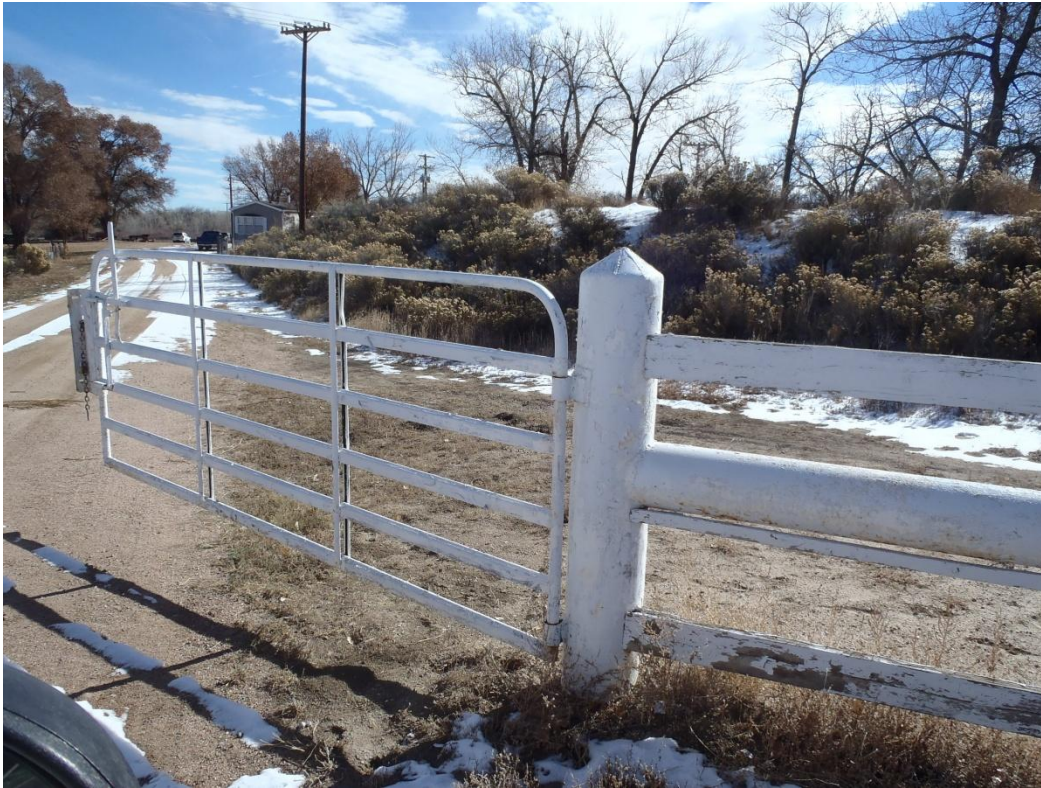
**PROBLEM/POSSIBLE VIOLATION:** Problem: The mine identification sign was not posted at the entrance of the mine site. This is a problem for failure to post a mine identification sign as required by Section 3.1.12(1) of the rule.

The permit sign was not displayed as required (see **Photo 1**). Mr. Cochrane called after the inspection to notify the Division that the sign had been located and would be re-posted. The missing sign is cited as a problem on page 1 of this report. The permit boundaries were marked by fences (see **Photo 2**).

Photo 1. Missing permit sign at entrance gate (looking SE).

**CORRECTIVE ACTIONS:** The operator shall, at the entrance of the mine site, post a sign which shall be clearly visible from the access road with the following: the name of the operator, a statement that a reclamation permit for the operation has been issued by the Colorado Mined Land Reclamation Board; and the permit number. The operator shall submit photo documentation that a proper sign has been posted by the corrective action date.

- 1) The Operator will need to send the Division photos of the re-posted permit sign by the Corrective Action due date shown on page 1.
- 2) The Division will recommend approval of the surety reduction request. No disturbance has occurred and the parties involved have agreed to re-post the full bond prior to initiating mining activity.

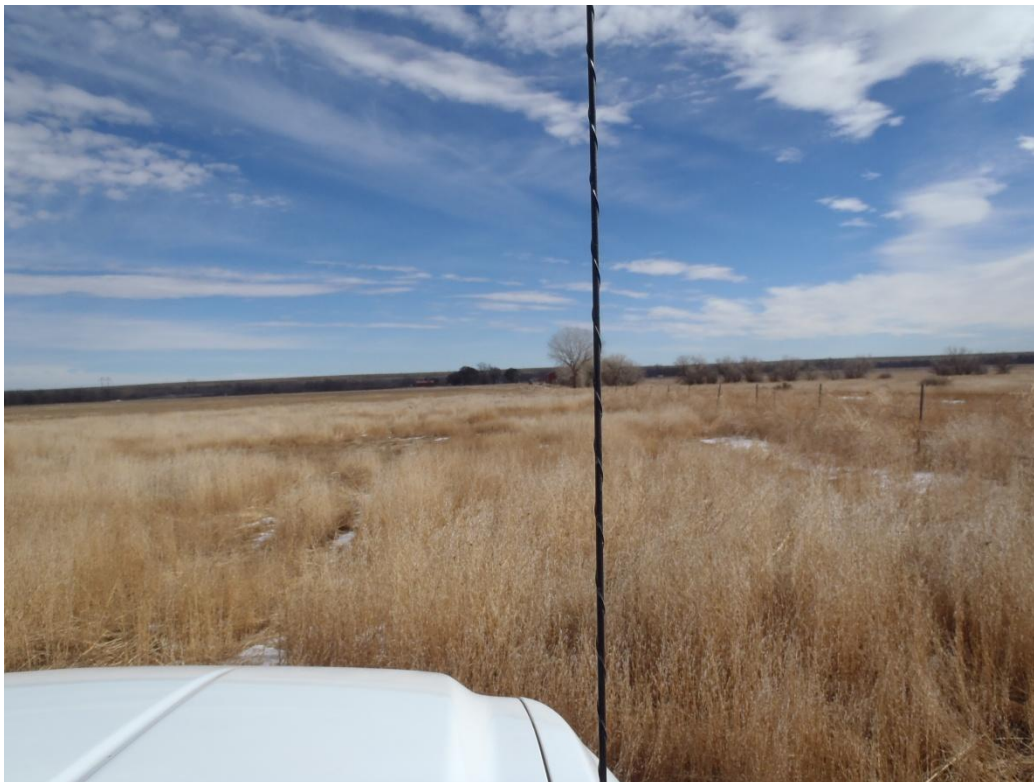
Photo 2. South boundary fence (looking east).
