COLORADO DIVISION OF RECLAMATION, MINING AND SAFETY
MINERALS PROGRAM INSPECTION REPORT
PHONE: (303) 866-3567

MINE NAME: Gilsonite Gravel Pit	MINE/PROSPECTING ID#: M-2002-111	MINERAL: Sand and gravel	COUNTY: Mesa
INSPECTION TYPE: Monitoring	INSPECTOR(S): Stephanie J. Mitchell	INSP. DATE: November 3, 2015	INSP. TIME: 09:30
OPERATOR: Fruita Development LLC	OPERATOR REPRESENTATIVE: Gary Murphy	TYPE OF OPERATION: 112c - Construction Regular Operation

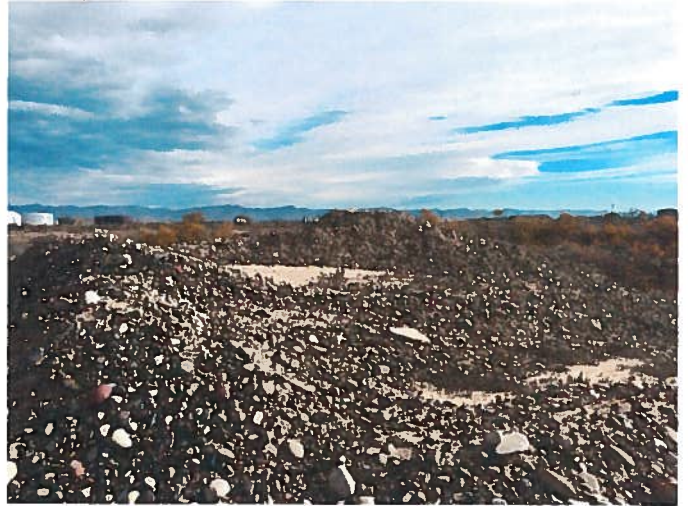
Stockpiles

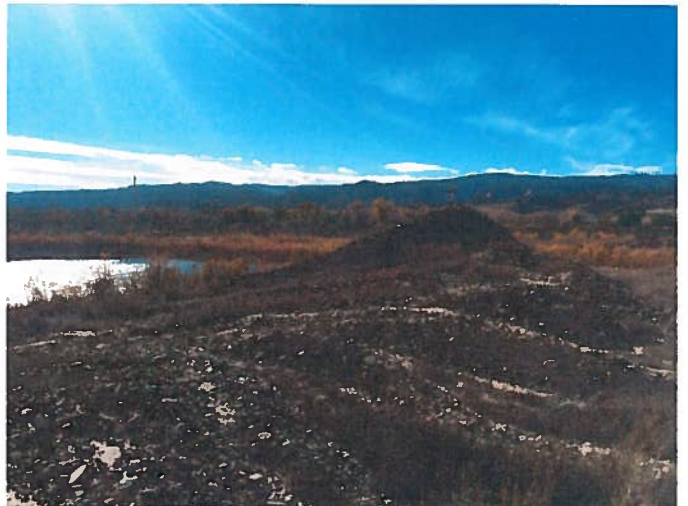
Stockpiles

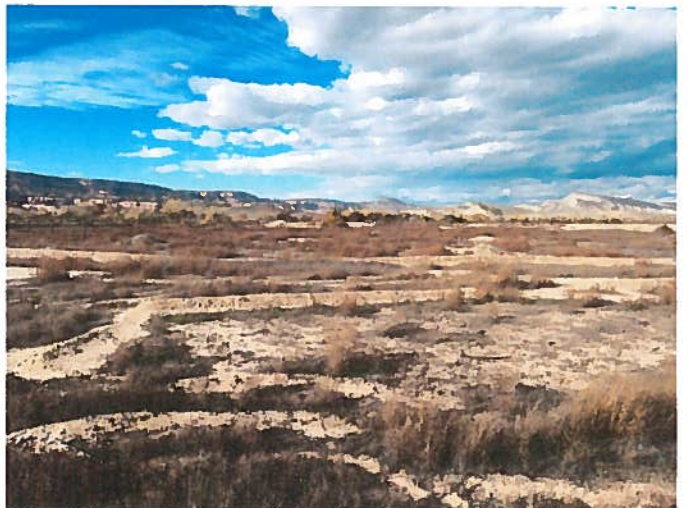
Monitoring Wells
