**COLORADO DIVISION OF RECLAMATION, MINING AND SAFETY**  
**MINERALS PROGRAM INSPECTION REPORT**  
**PHONE: (303) 866-3567**

<b>MINE NAME:</b> Mekelburg Pit No 1	<b>MINE/PROSPECTING ID#:</b> M-1981-179	<b>MINERAL:</b> Sand and gravel	<b>COUNTY:</b> Yuma
<b>INSPECTION TYPE:</b> Monitoring	<b>INSPECTOR(S):</b> Elliott R. Russell	<b>INSP. DATE:</b> June 9, 2015	<b>INSP. TIME:</b> 13:10
<b>OPERATOR:</b> Yuma County	<b>OPERATOR REPRESENTATIVE:</b> Kent Twiss and Matt Martin	<b>TYPE OF OPERATION:</b> 112c - Construction Regular Operation

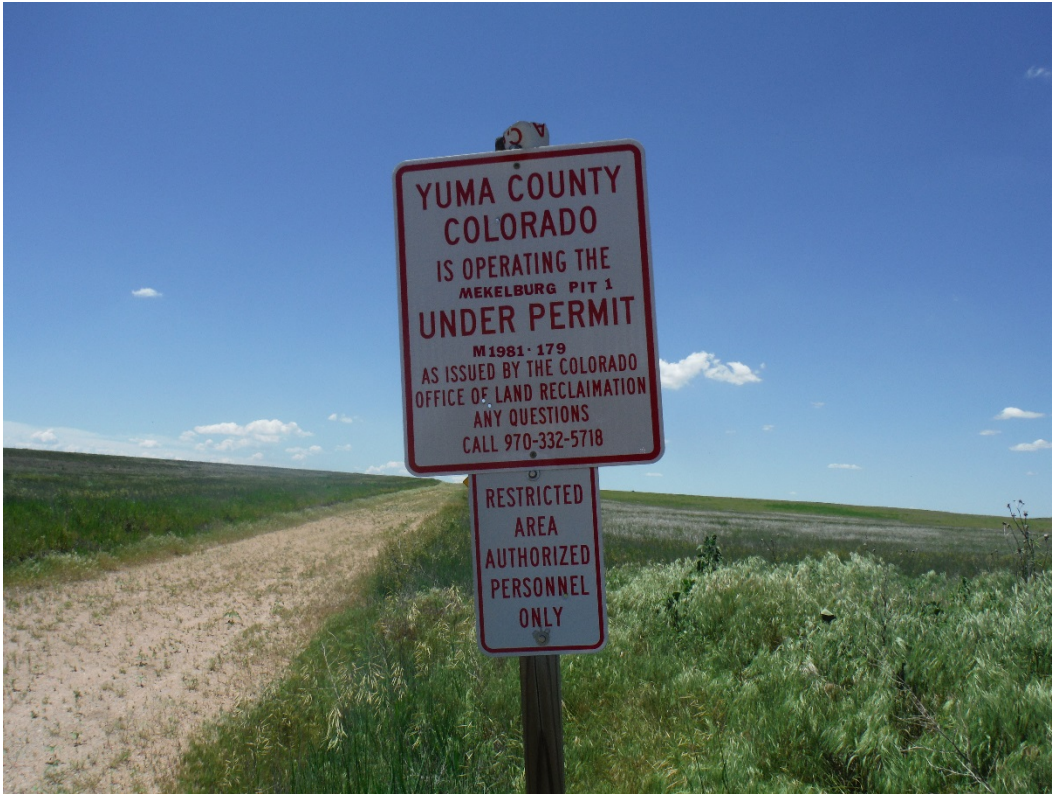
Permit identification sign at the entrance of the access road; looking west.

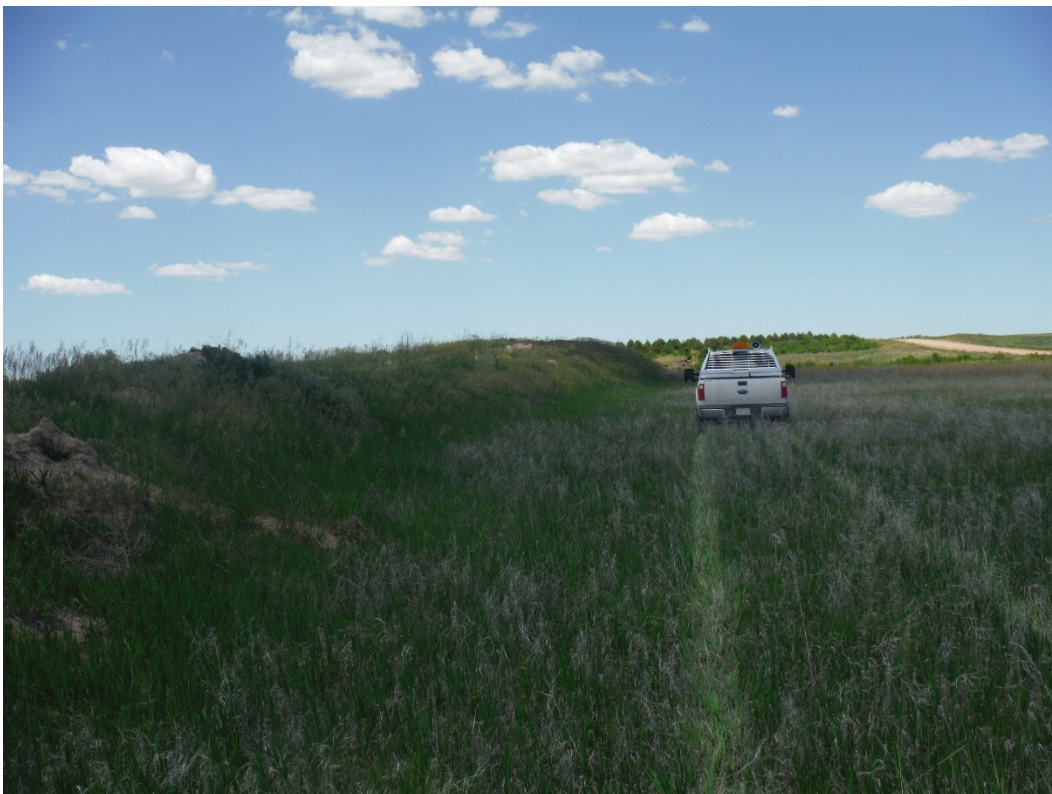
Topsoil stockpiled along eastern boundary; looking north.

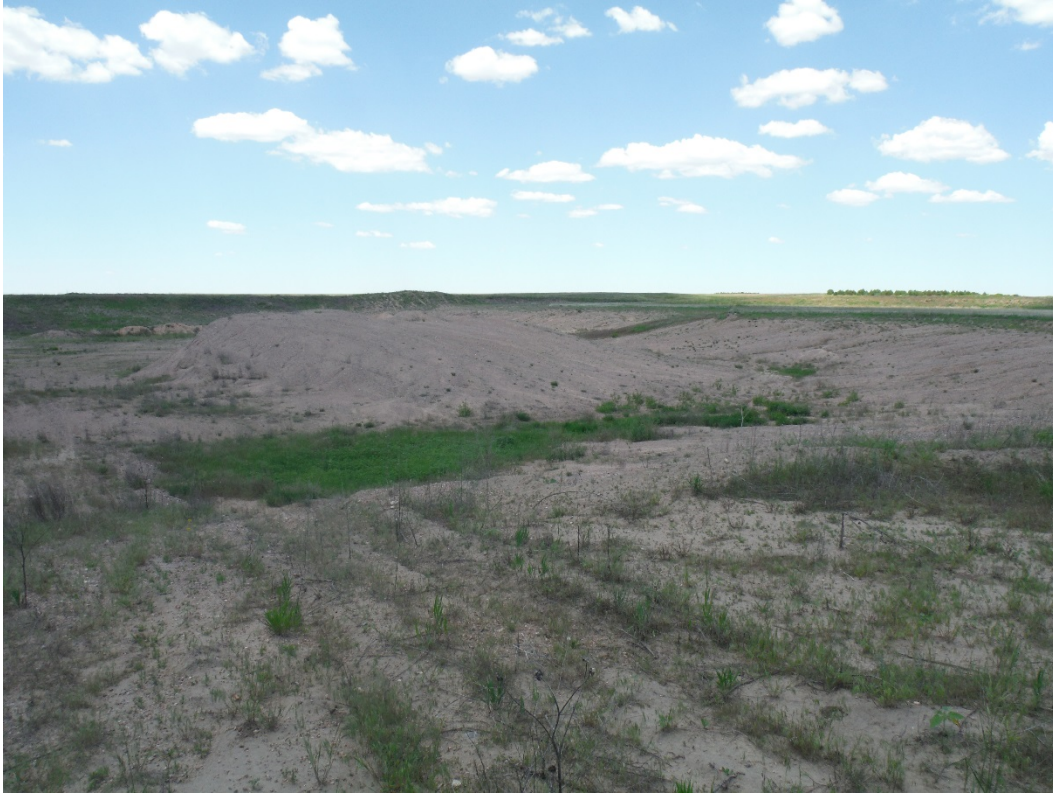
Older, eastern pit overview; looking northwest.

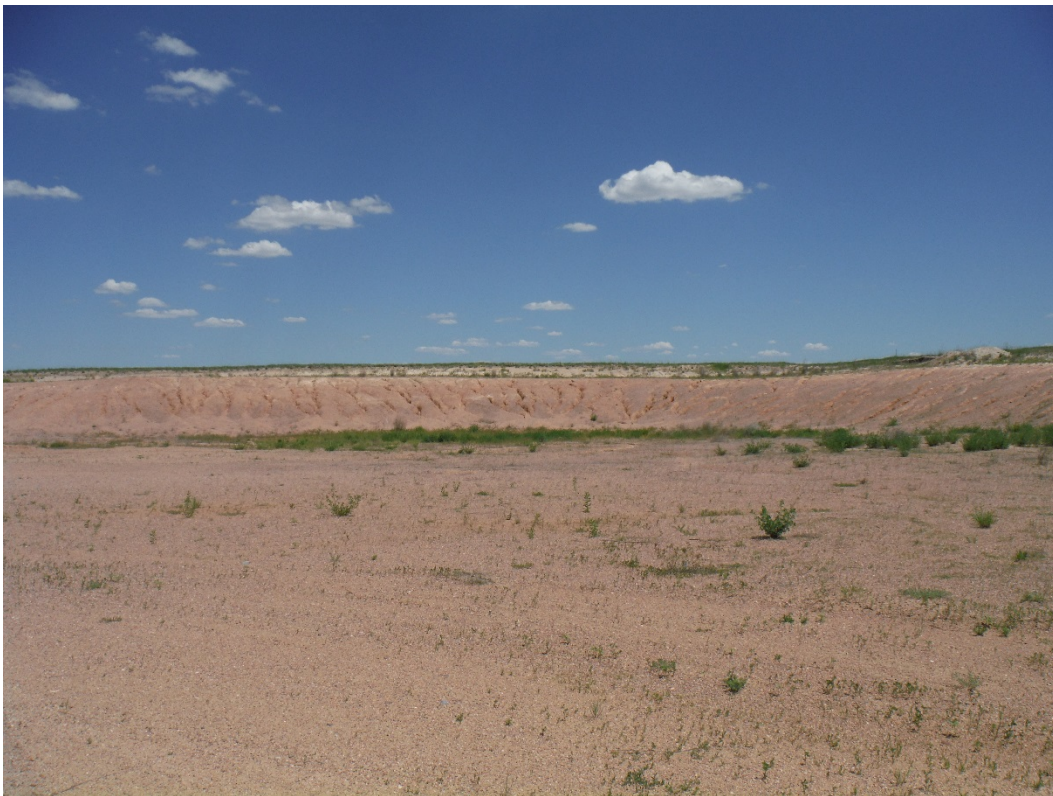
Active, western pit overview; looking east.

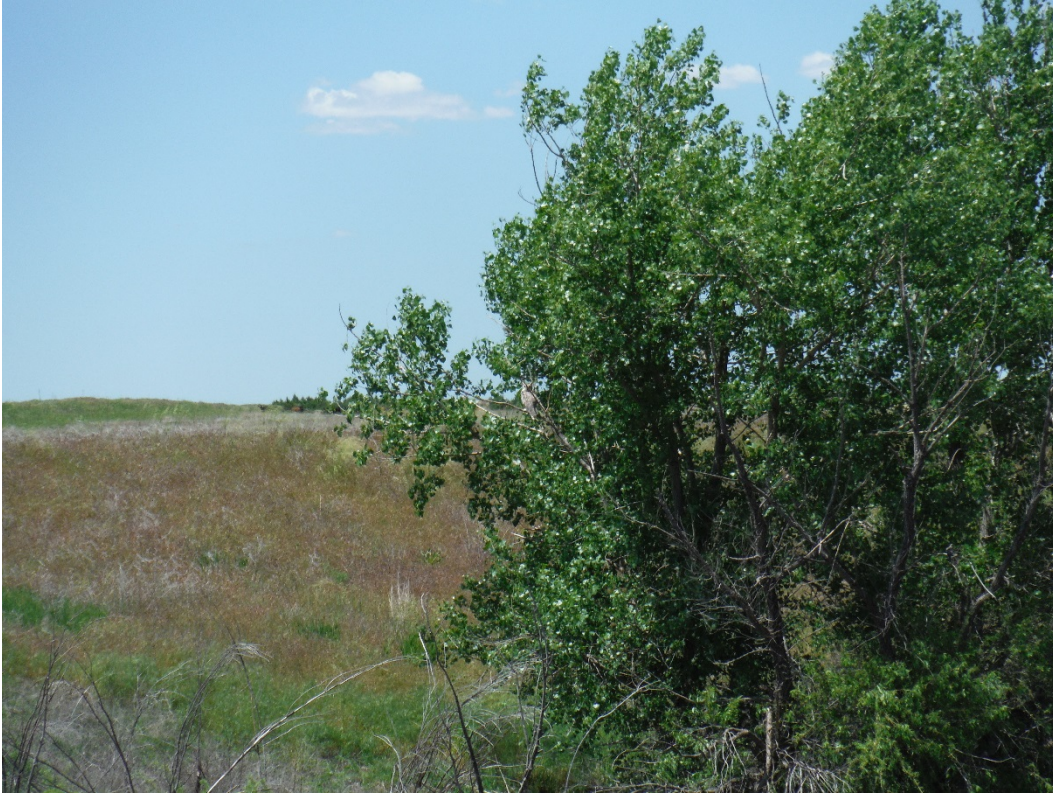
Great horned owl in a tree near the western permit boundary; looking northwest.
