COLORADO DIVISION OF RECLAMATION, MINING AND SAFETY
MINERALS PROGRAM INSPECTION REPORT
PHONE: (303) 866-3567

MINE NAME: Witherbee Pit	MINE/PROSPECTING ID#: M-2009-070	MINERAL: Gravel and Borrow	COUNTY: Yuma
INSPECTION TYPE: Monitoring	INSPECTOR(S): Elliott R. Russell	INSP. DATE: July 9, 2015	INSP. TIME: 14:15
OPERATOR: Yuma County	OPERATOR REPRESENTATIVE: Matt Martin	TYPE OF OPERATION: 112c - Construction Regular Operation

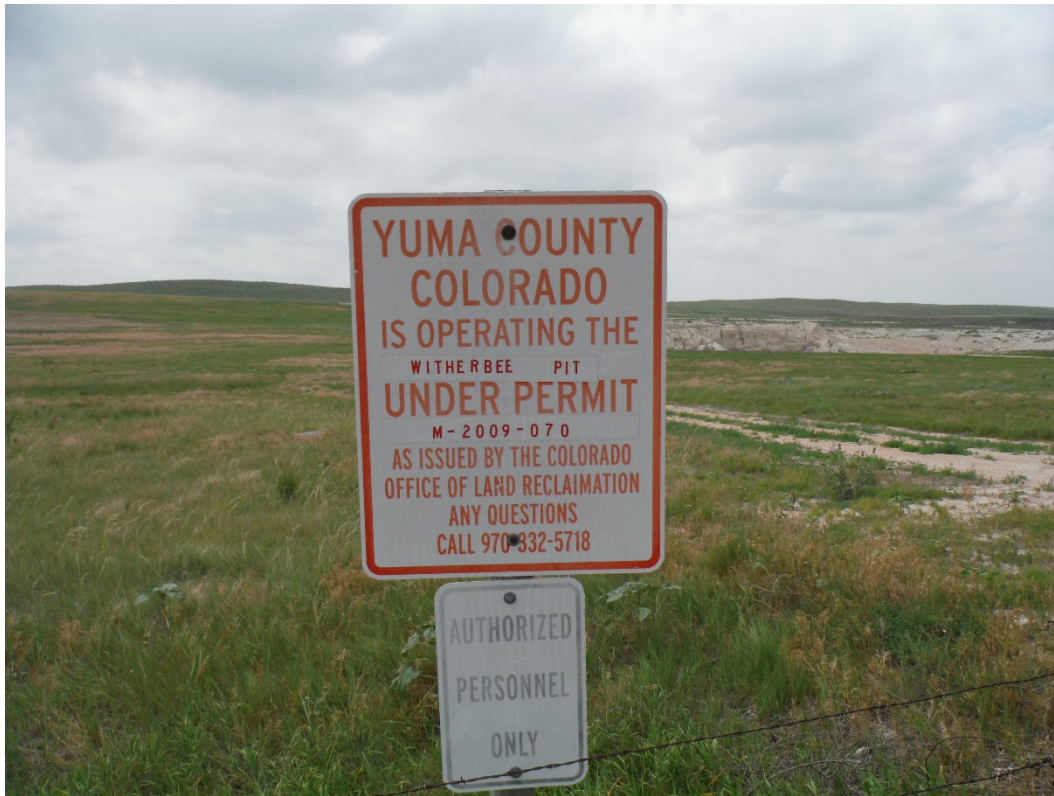
Permit identification sign at the site's entrance; looking west.

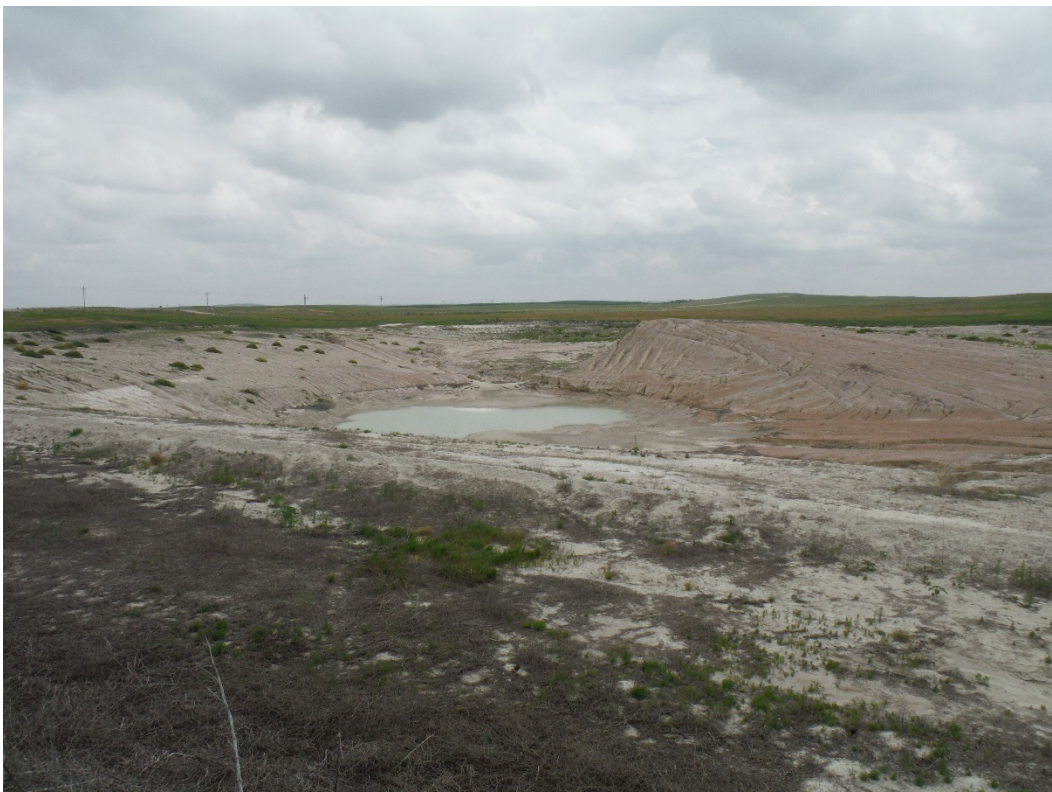
Overview of the pit; looking southeast.

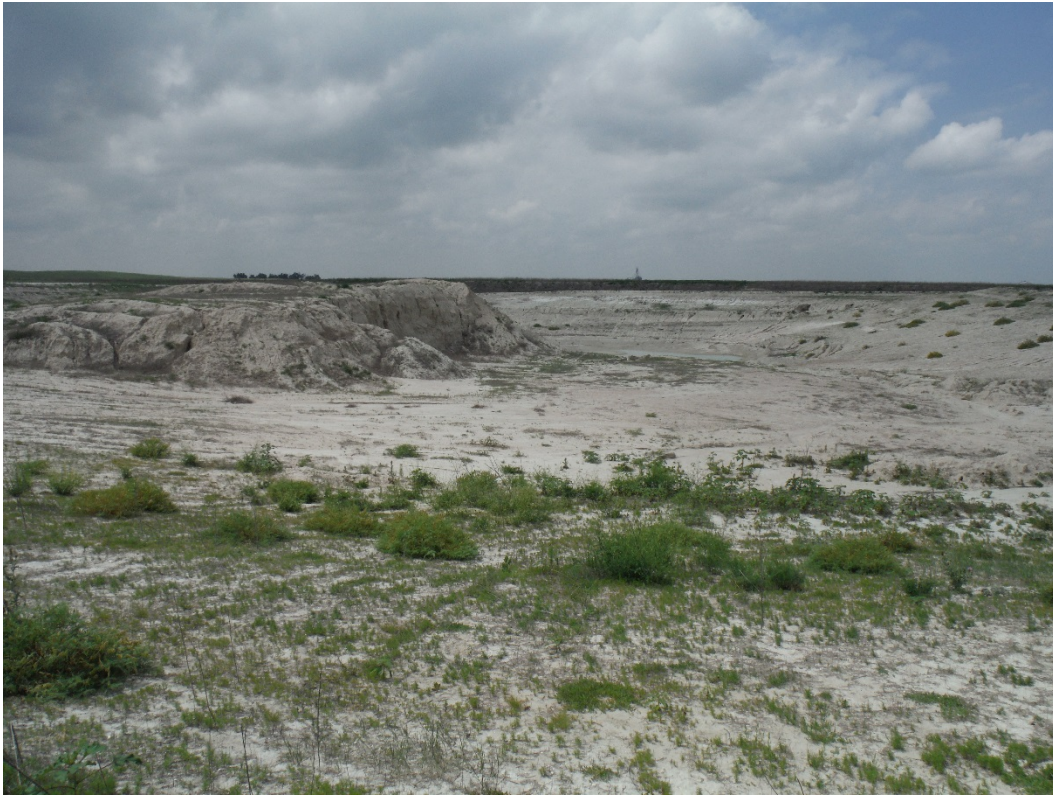
Overview of the pit; looking northwest.

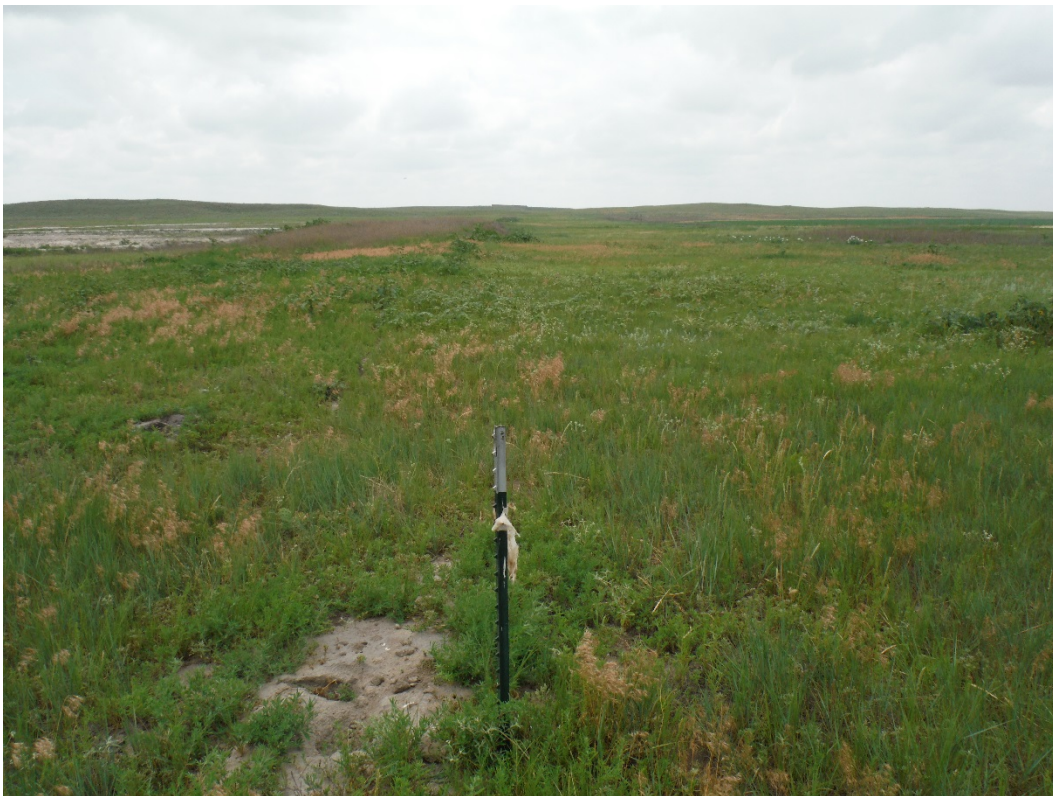
Northeast boundary marker, topsoil stockpile on the inside; looking west.

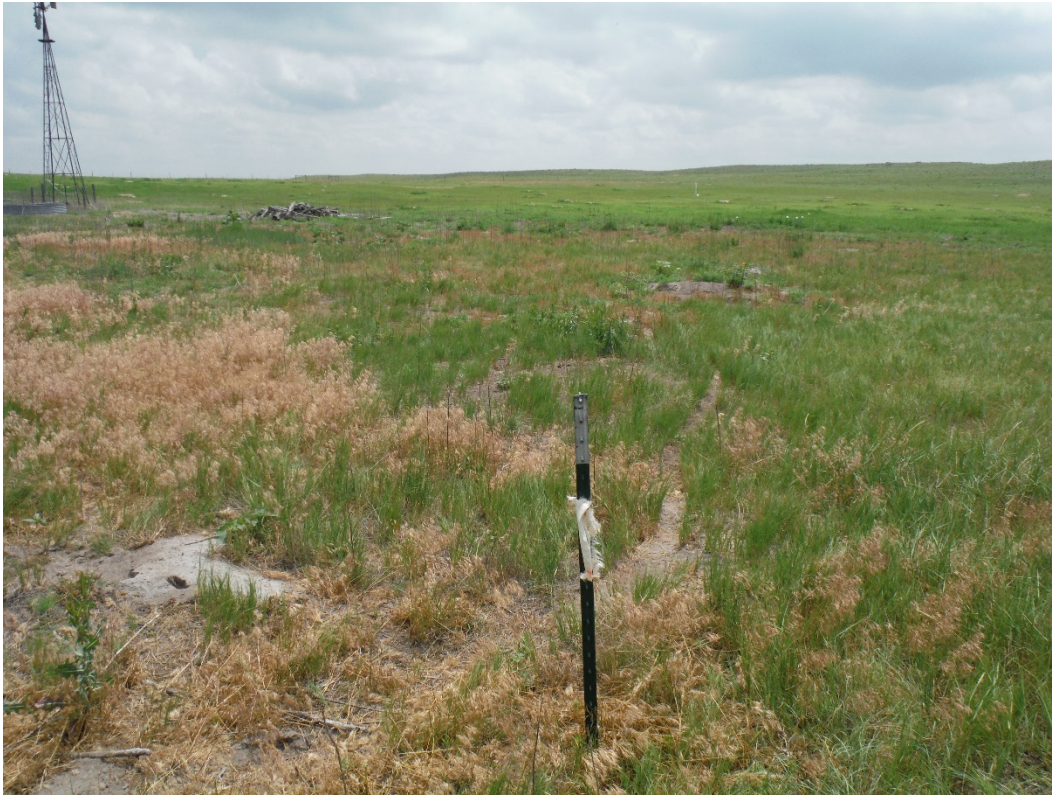
Permit boundary marker located on the curve around the windmill, permit is 200' around the structure; looking south.
