COLORADO DIVISION OF RECLAMATION, MINING AND SAFETY
MINERALS PROGRAM INSPECTION REPORT
PHONE: (303) 866-3567

MINE NAME: Deterding Pit	MINE/PROSPECTING ID#: M-2011-006	MINERAL: Sand and gravel	COUNTY: Yuma
INSPECTION TYPE: Monitoring	INSPECTOR(S): Elliott R. Russell	INSP. DATE: July 9, 2015	INSP. TIME: 12:00
OPERATOR: Yuma County	OPERATOR REPRESENTATIVE: Matt Martin	TYPE OF OPERATION: 112c - Construction Regular Operation

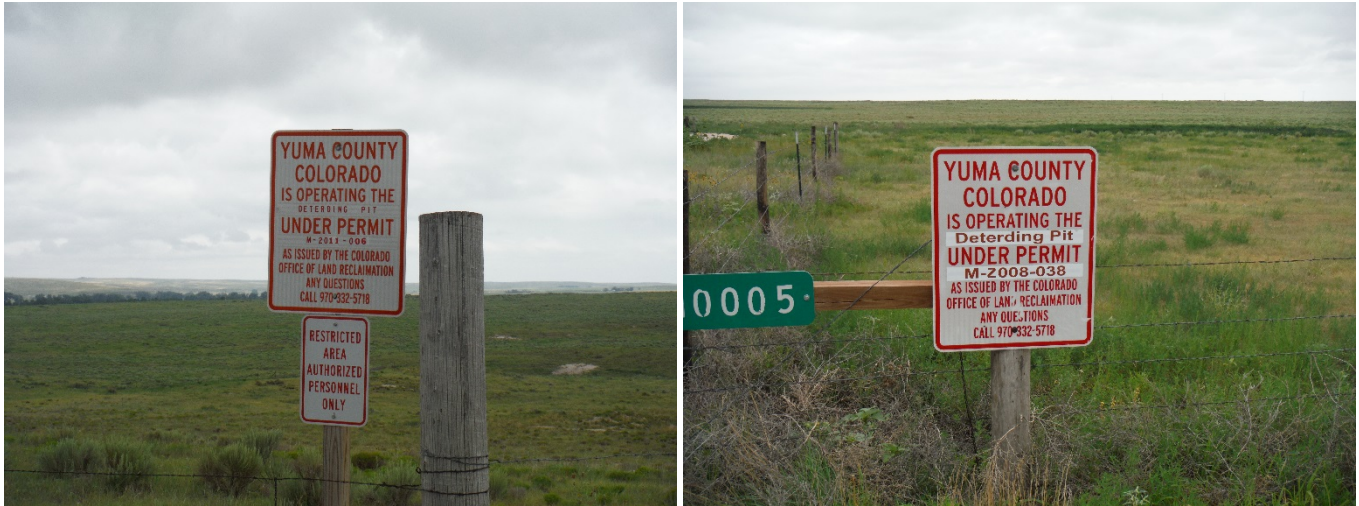
PROBLEM/POSSIBLE VIOLATION: Problem: The mine identification sign was not posted correctly at the entrance of the mine site. This is a problem for failure to post a mine identification sign as required by Rule 3.1.12(1).

Permit identification signs at each entrance, western (right picture) has incorrect permit number; looking south.

CORRECTIVE ACTIONS: The operator shall correct the permit number on the mine identification sign at the western entrance. The operator shall submit photo documentation that a proper sign has been posted by the corrective action date.

CORRECTIVE ACTION DUE DATE: 2/5/16

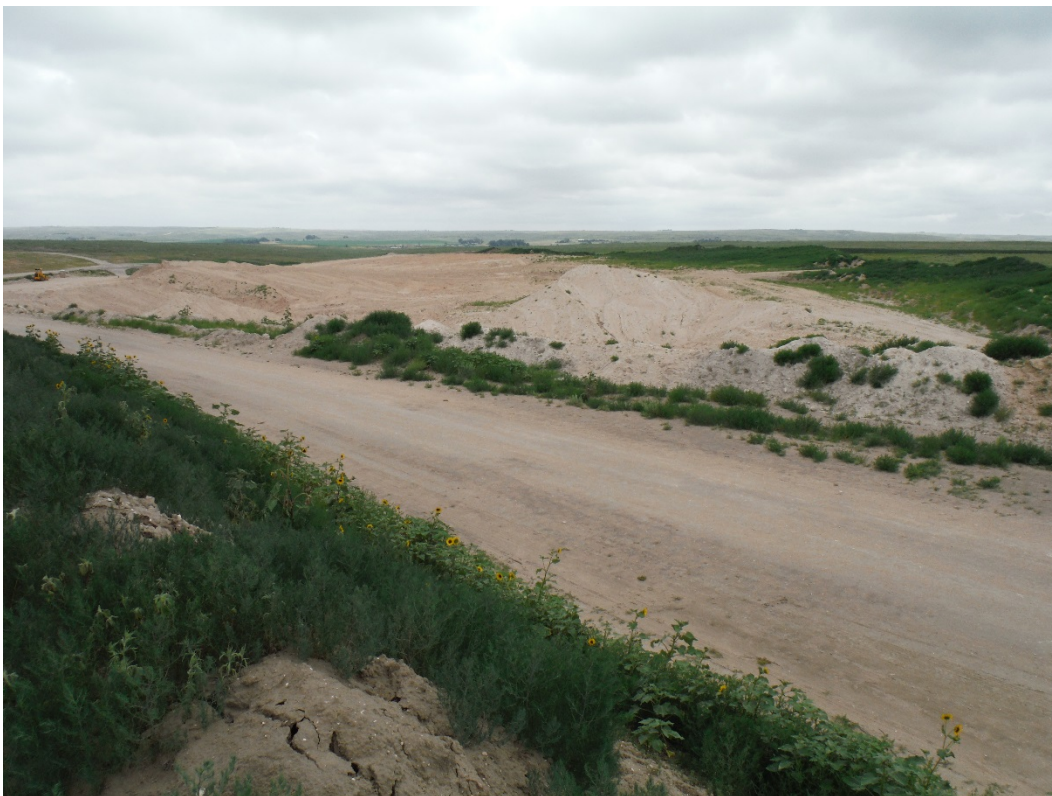
Overview of the active area; looking southeast.

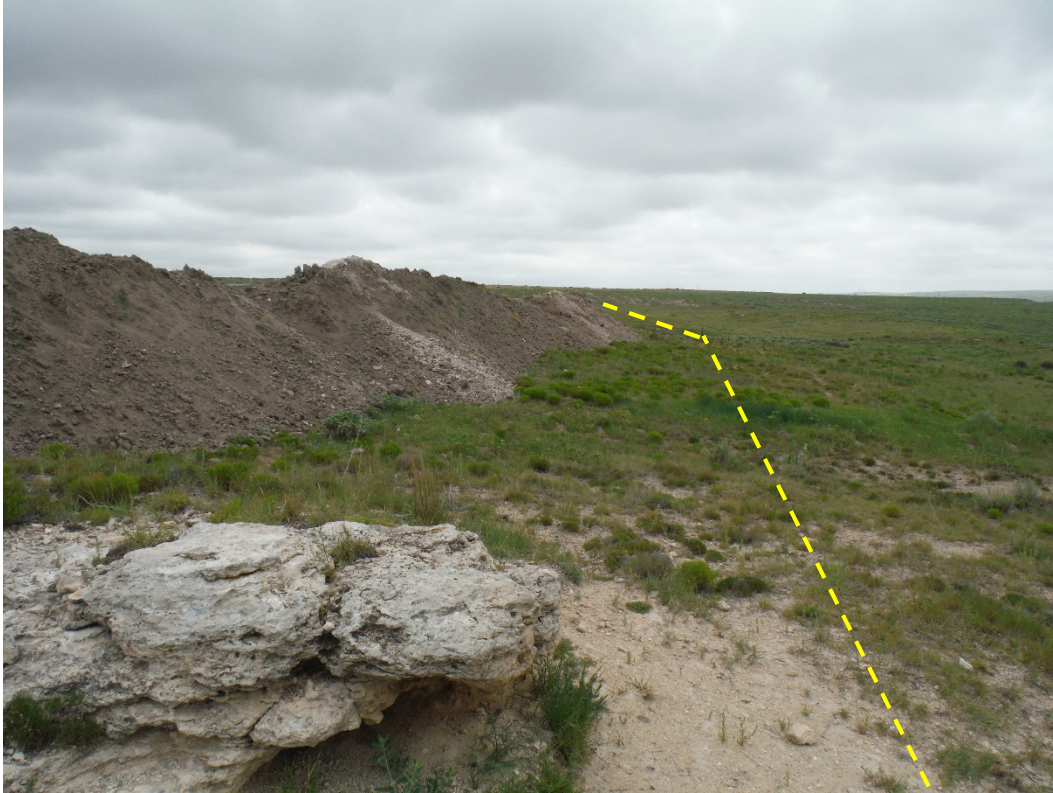
Topsoil being pushed up the southern permit boundary (approximated by the dashed yellow line); looking east.

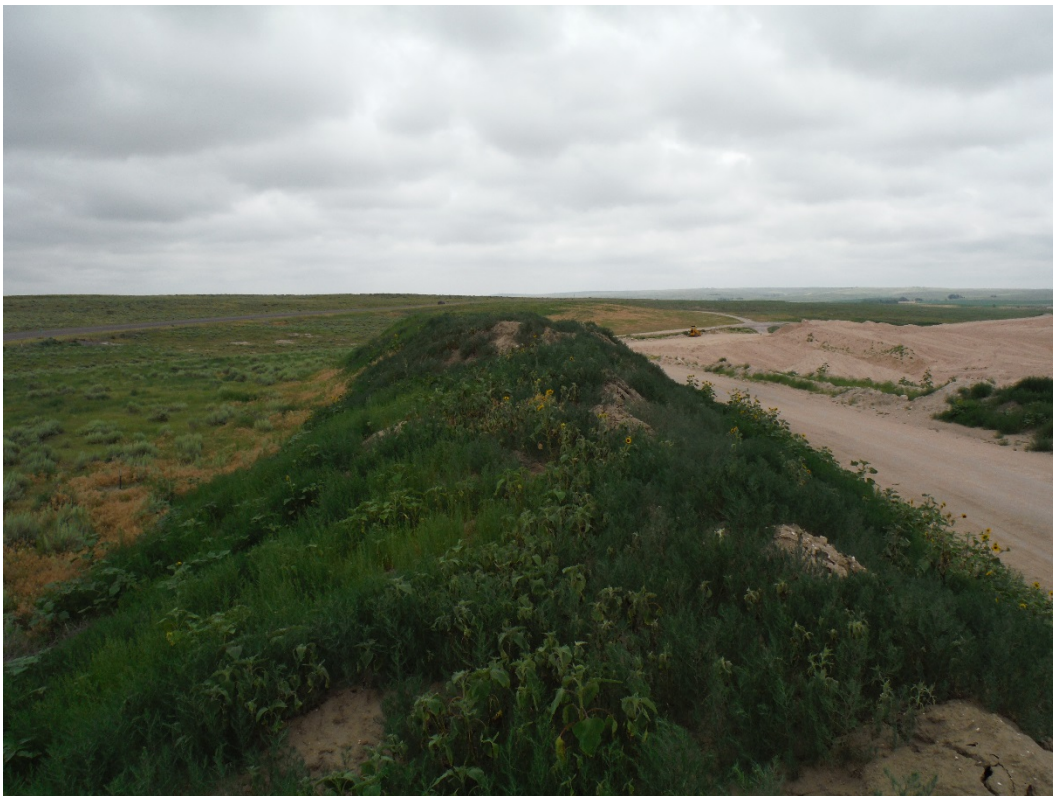
The site consists of two mining areas split by a small drainage that runs to the south. Mining has concluded on the eastern side, so active mining operations were occurring just west of the drainage. Mr. Martin indicated that the county was going to advance the mine to the west once material is depleted in the active area. Topsoil had been stripped and piled along the southern permit boundary as well as a small amount along the western half of the northern boundary. It appeared that topsoil had been stripped and piled by scrapers in the past, but active stripping was being done by a bulldozer. There was some confusion on what stockpiles were topsoil versus overburden; the Operator was reminded that these need to be kept separate and that they have specific reclamation purposes. The Division observed kochia growing on the topsoil stockpiles. Please note that if stockpile remain for longer than one growing season, they will need to be seeded to prevent erosion and weeds from establishing on them. The Division recommends using the permits approved reclamation seed mixture for this in order to build up a potential seed base in the topsoil. Over compaction of these topsoil stockpiles may hinder the ability for appropriate vegetation to establish.

Stockpile of topsoil or overburden along northern boundary; looking east.

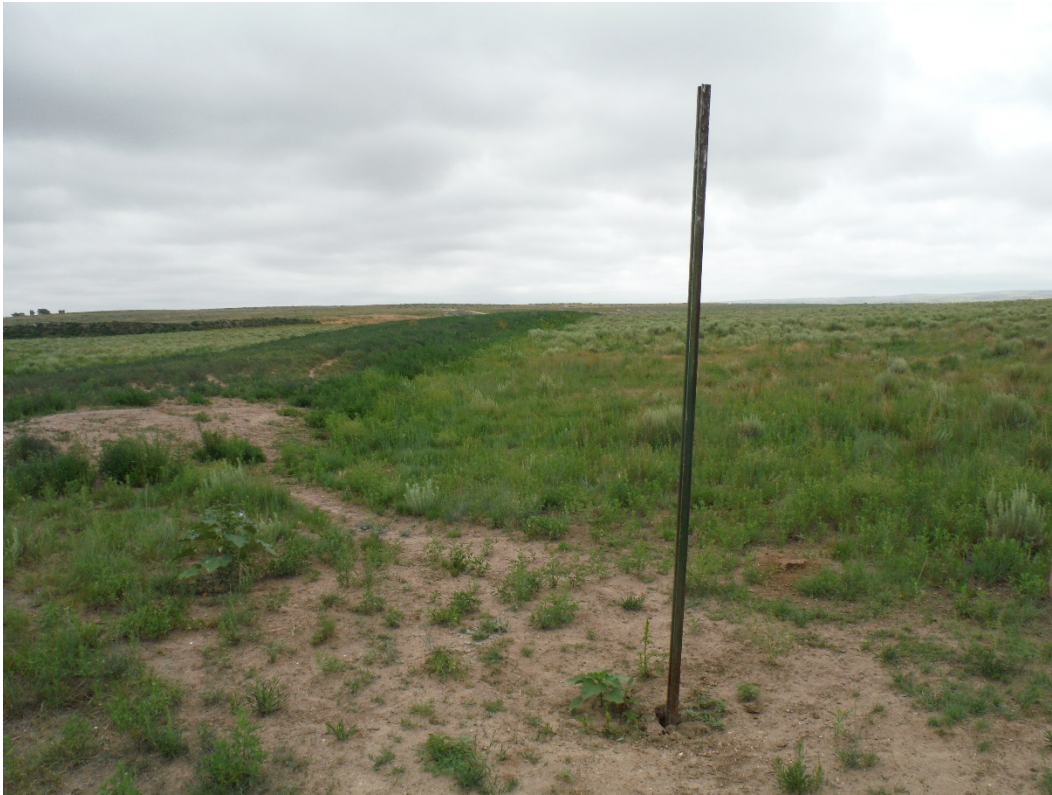
Southwest boundary marker, topsoil stockpile on the inside; looking east.
