COLORADO DIVISION OF RECLAMATION, MINING AND SAFETY
MINERALS PROGRAM INSPECTION REPORT
PHONE: (303) 866-3567

MINE NAME: Airport Gravel Pit	MINE/PROSPECTING ID#: M-1983-039	MINERAL: Sand and gravel	COUNTY: Las Animas
INSPECTION TYPE: Monitoring	INSPECTOR(S): Amy Eschberger	INSP. DATE: September 9, 2015	INSP. TIME: 11:30
OPERATOR: Las Animas County	OPERATOR REPRESENTATIVE: Bob Santistevan	TYPE OF OPERATION: 112c - Construction Regular Operation

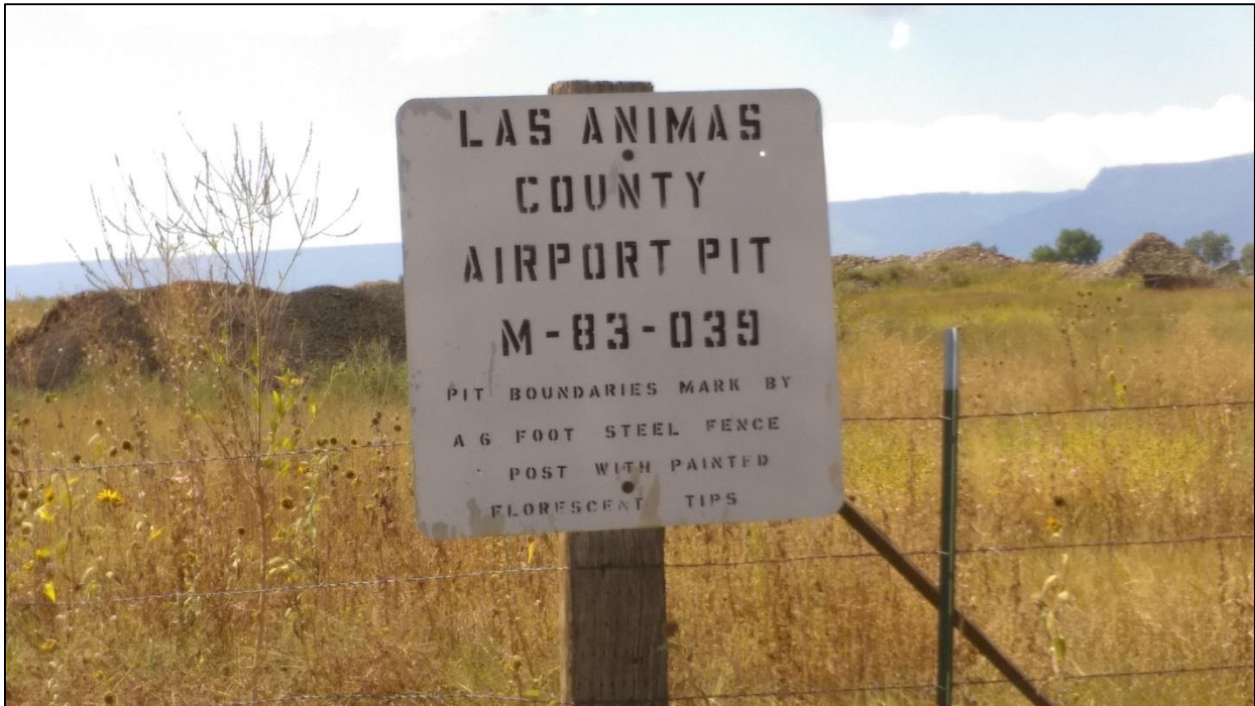
Photo 1. View of permit sign posted at main site entrance off of Co Rd 36. Sign includes operator name and permit number as required by Rule 3.1.12(1). However, to be in full compliance with the Rule, sign should also include a statement that the permit was “issued by the CO MLRB”.

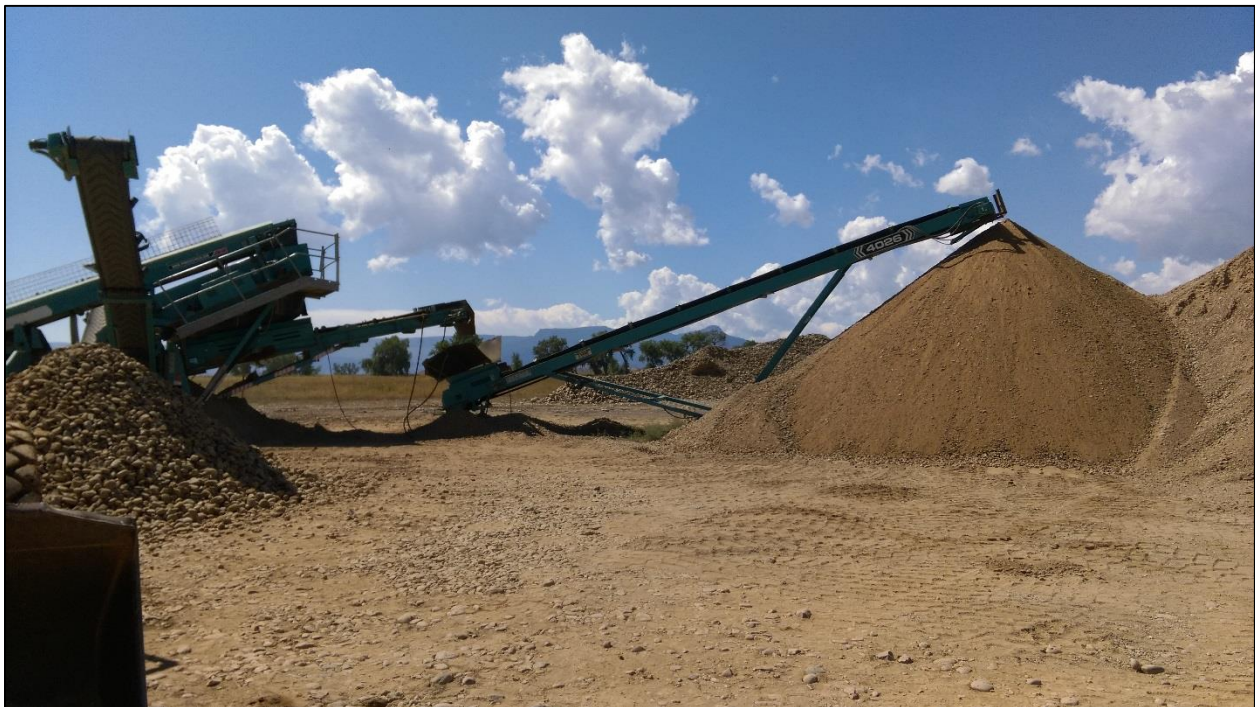
Photo 2. View of mobile material processing plant located west of and adjacent to active pit.

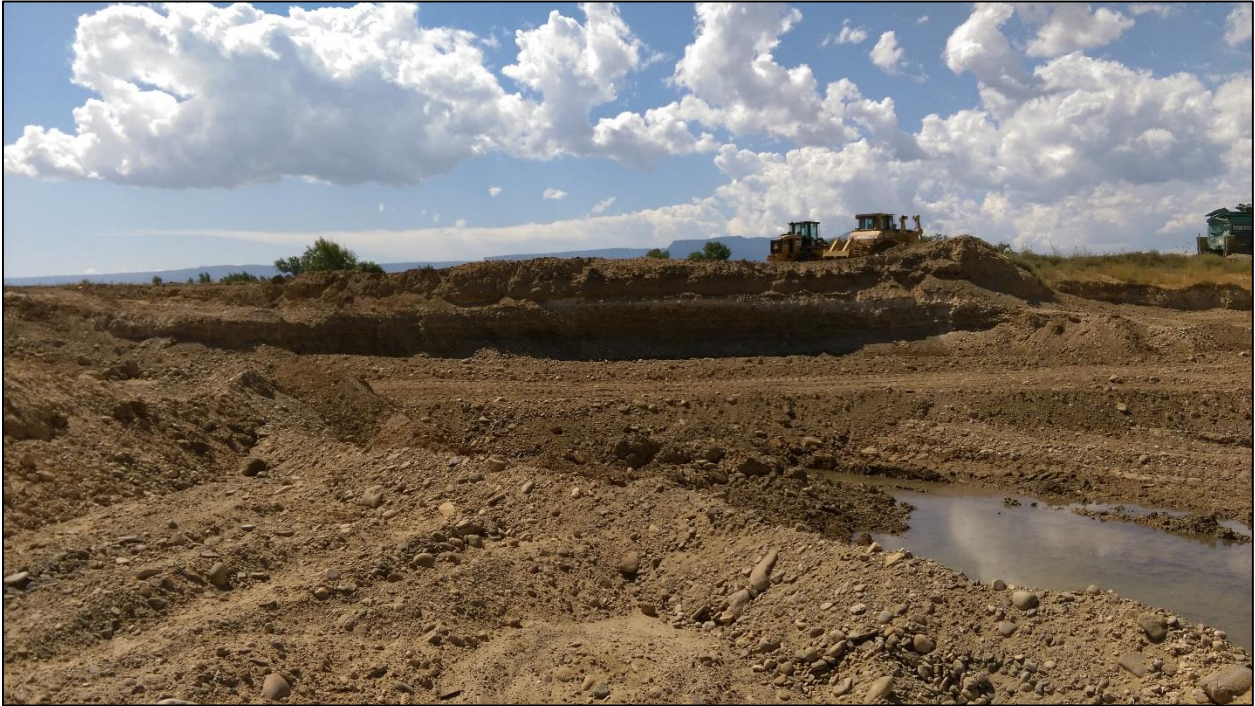
Photo 3. View looking southwest from western portion of active pit, showing mined wall approximately 10 feet in height. Note exposed groundwater in foreground (at right).

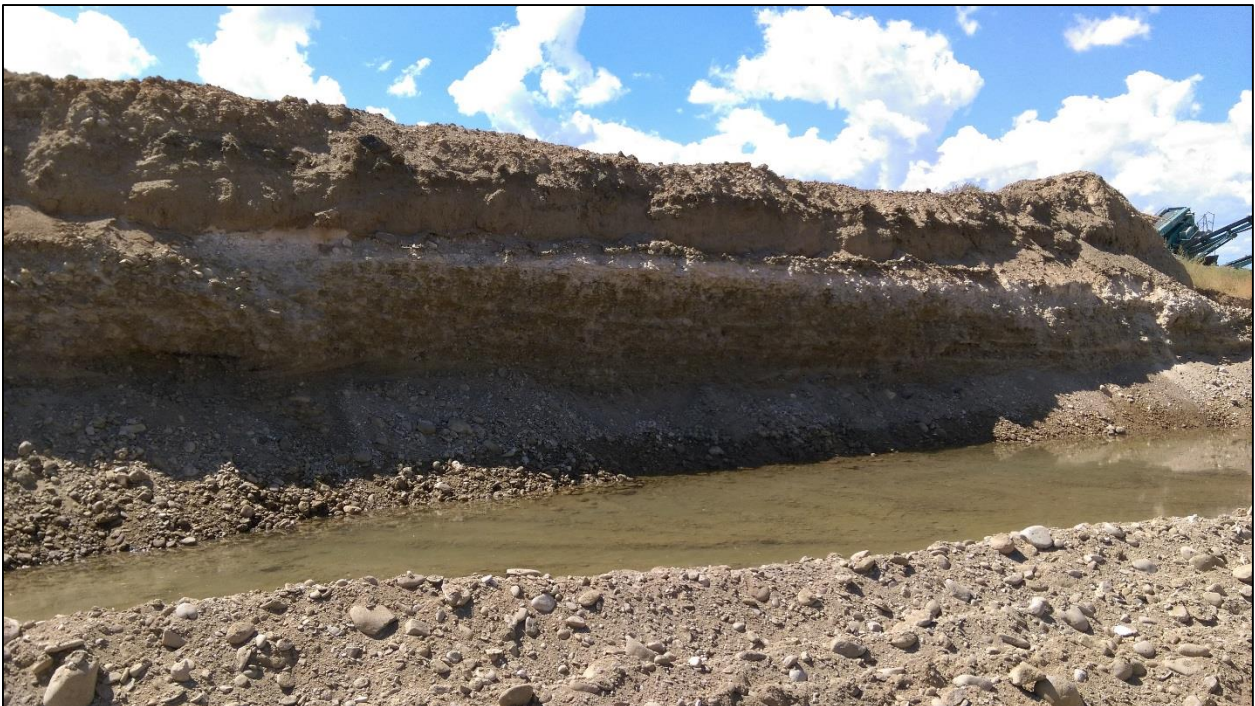
Photo 4. Closer view of mined wall shown in **Photo 3**, showing slope gradients of approximately -0.5H:1V. Note exposed groundwater along bottom edge of highwall.

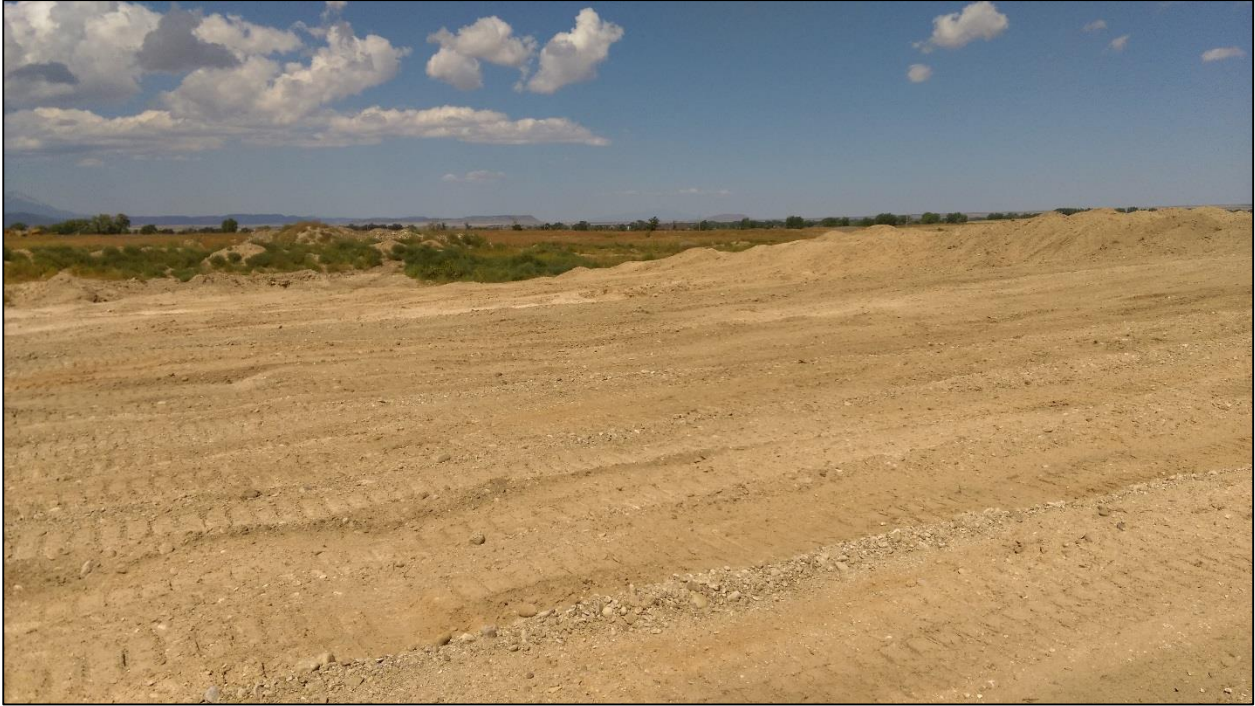
Photo 5. View looking west across eastern portion of active pit area that has been backfilled and graded to slopes flatter than 3H:1V.

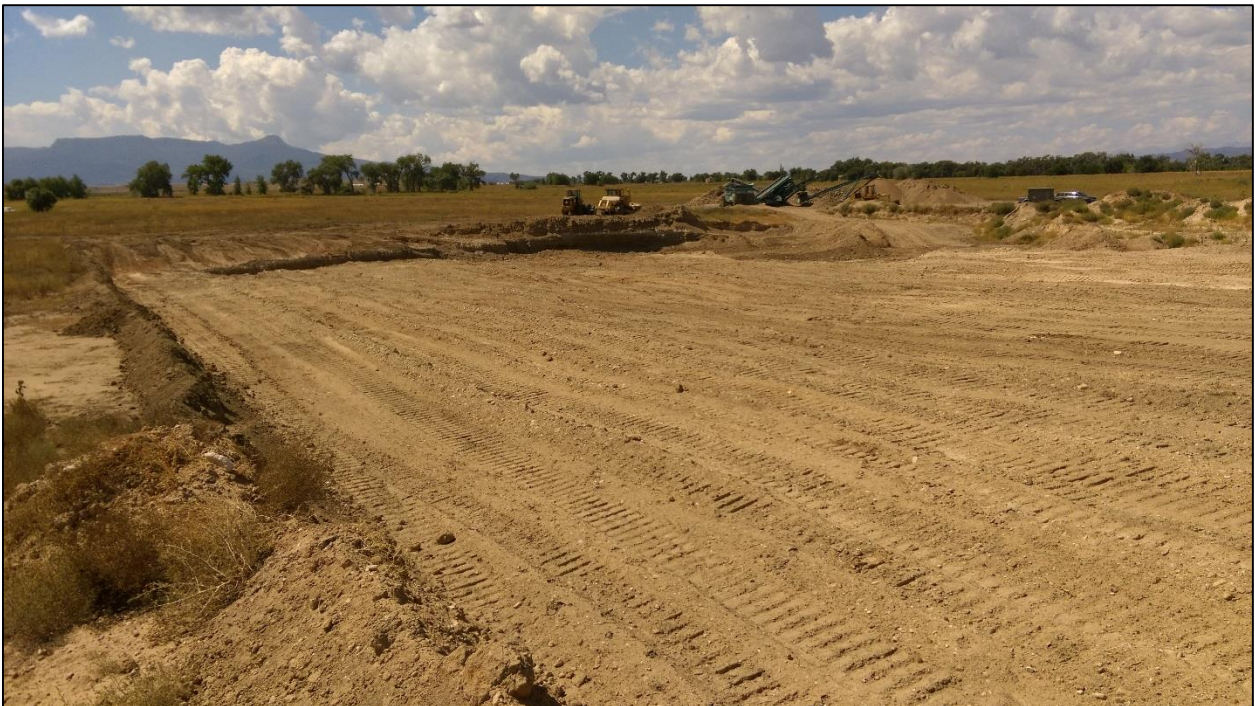
Photo 6. View looking southwest across eastern portion of active pit area that has been backfilled and graded to slopes flatter than 3H:1V.

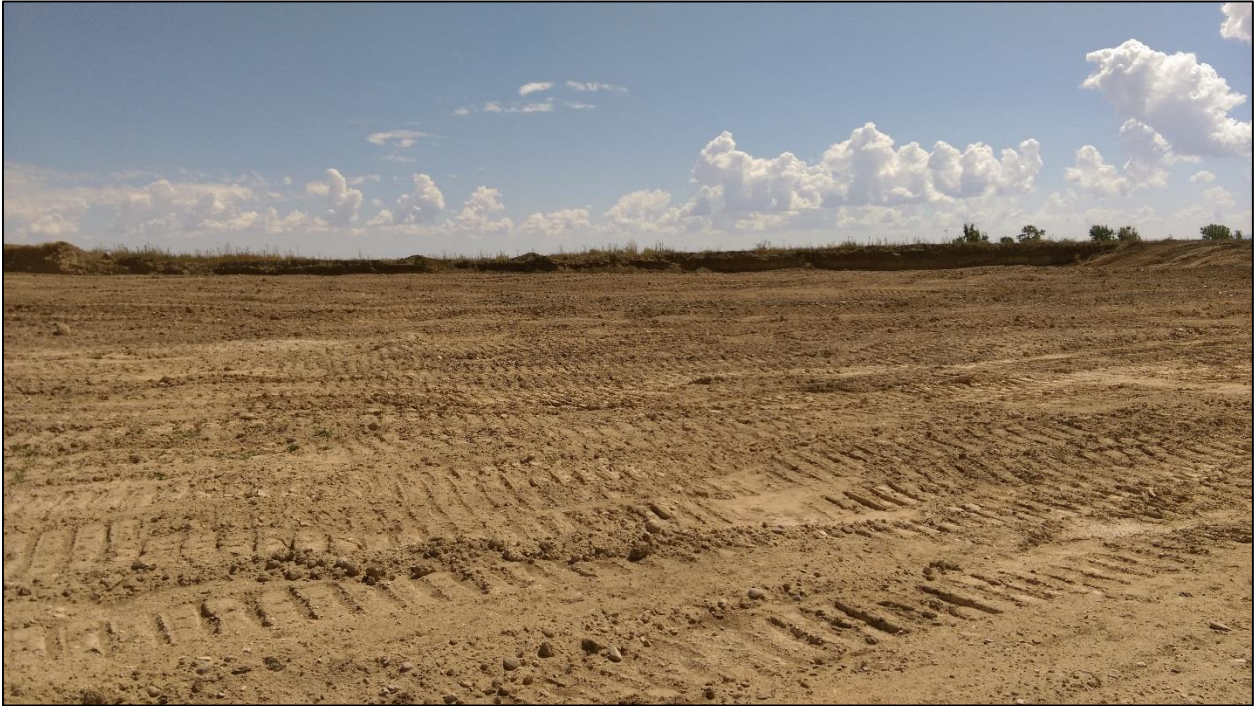
Photo 7. View looking east across eastern portion of active pit area that has been backfilled and graded to slopes flatter than 3H:1V.

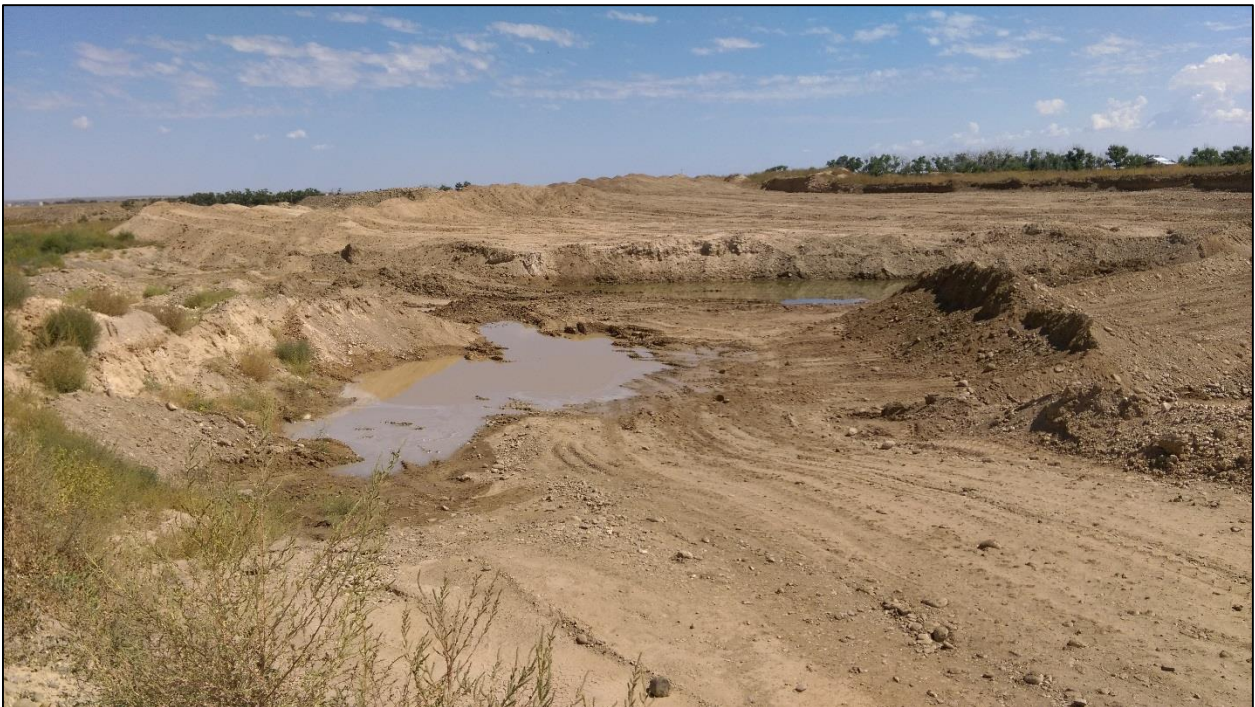
PROBLEM/POSSIBLE VIOLATION: Problem: The Division has no evidence that the operator has a valid well permit, substitute water supply plan, or approved water augmentation plan for the exposed groundwater at the site. This is a problem related to 34-32.5-116(4)(h) of the Colorado Revised Statutes and 3.1.6(1)(a) of the Construction Materials Rules and Regulations governing injury to existing water rights.

In the western portion of the pit, standing water was observed in a few areas (**Photos 8-10; also shown in Photos 3 and 4**). After speaking with Mr. Santistevan during the inspection, it appears that the standing water is exposed groundwater. This was cited as a problem in the inspection report for 12/9/2010. The problem was considered abated after the operator submitted photos to the Division showing that the exposed groundwater had been backfilled to two feet above the static groundwater level. On 04/30/2010, the Division sent a letter to all operators regarding mining operations with exposed groundwater (see enclosed letter). This letter identified four approaches for operators to gain compliance with the Division for exposed groundwater. Besides the fact that the county is not required to post a financial warranty, one of the four approaches outlined in the enclosed letter should be implemented at this site. According to Mr. Santistevan, the operation is currently attempting to mine at depths less than 10 feet to avoid exposing groundwater in the future. The operator has indicated that the operation is typically able to mine down to 15-20 feet deep in the eastern pit. However, when the adjacent irrigation ditches are full of water (approximately every 3-5 years), the operation is unable to mine more than approximately 10 feet deep without exposing groundwater. During such times, the operator backfills the exposed groundwater and works to expand the pit at less than 10 feet deep.

Photo 8. View looking northeast, showing standing water present in western portion of active pit area.

CORRECTIVE ACTIONS: The operator shall demonstrate that the operation is in compliance with the Office of the State Engineer (SEO), show evidence that the operator is taking measures to bring the site into compliance with the SEO, or backfill the pits to at least two feet above the groundwater surface by the corrective action date specified.

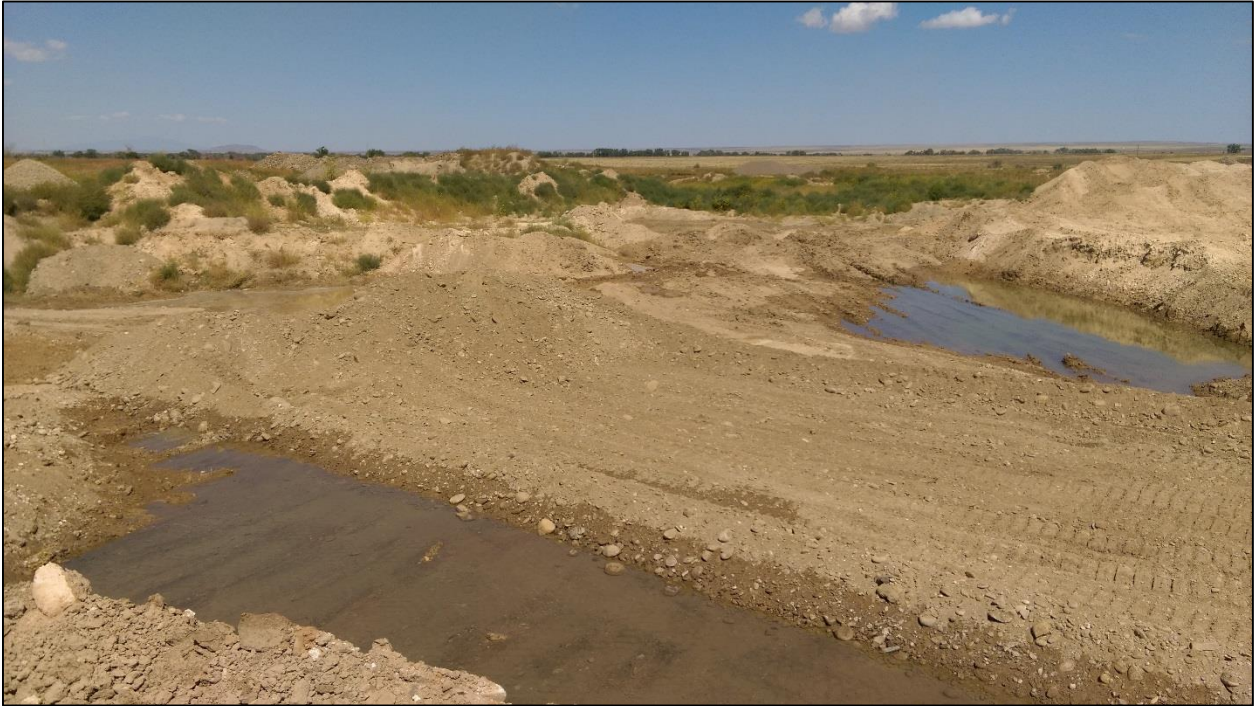
Photo 9. View looking north, showing standing water present in western portion of active pit area.

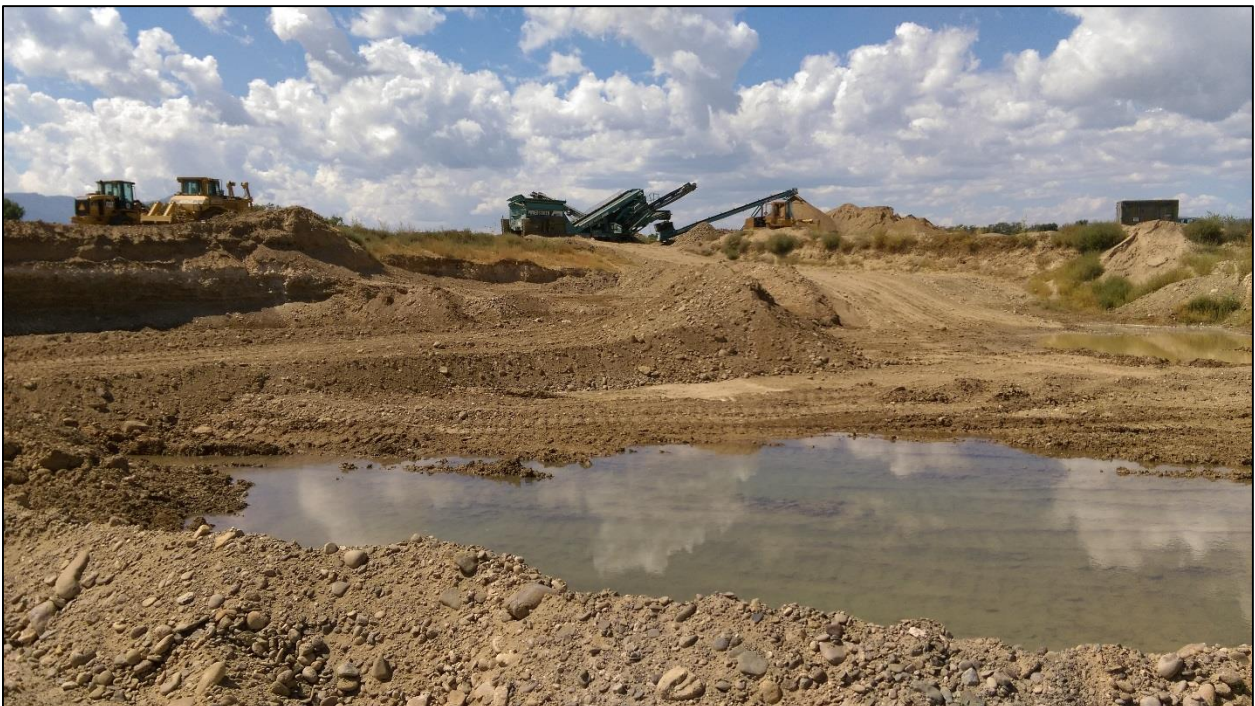
Photo 10. View looking west, showing standing water present in western portion of active pit area. Note processing plant located adjacent to pit (in background).

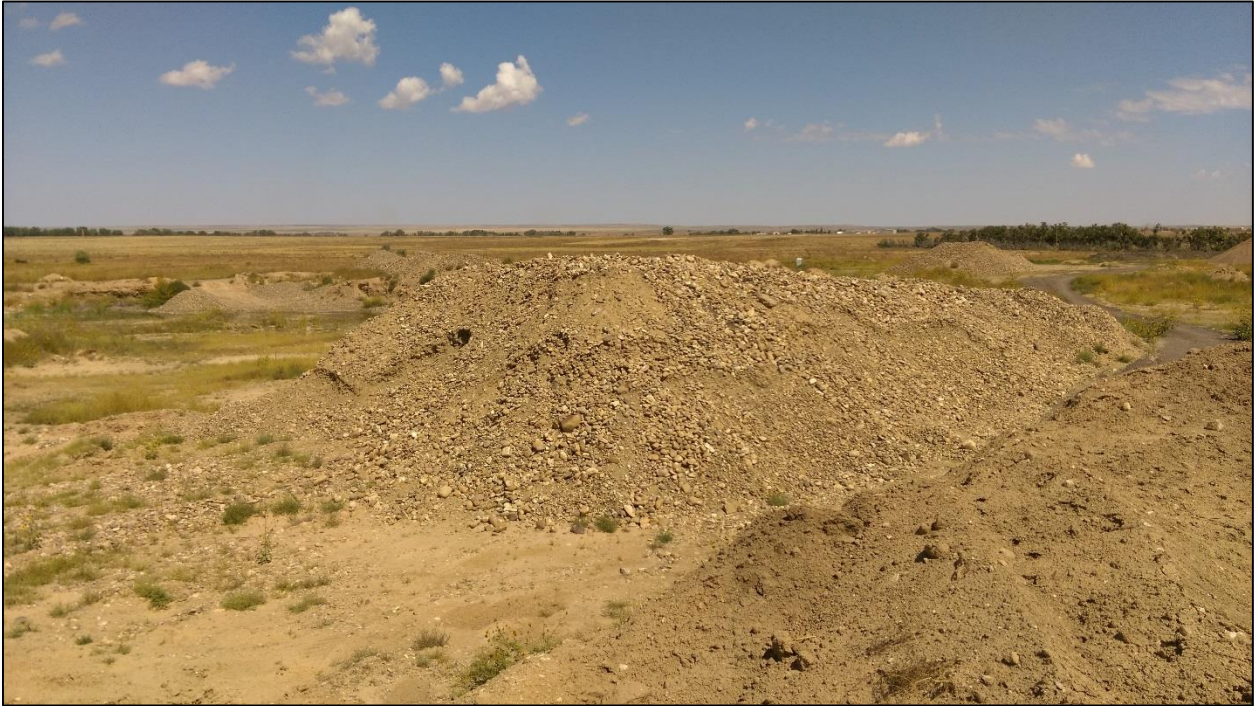
Photo 11. View of material stockpiled just north of the pit.

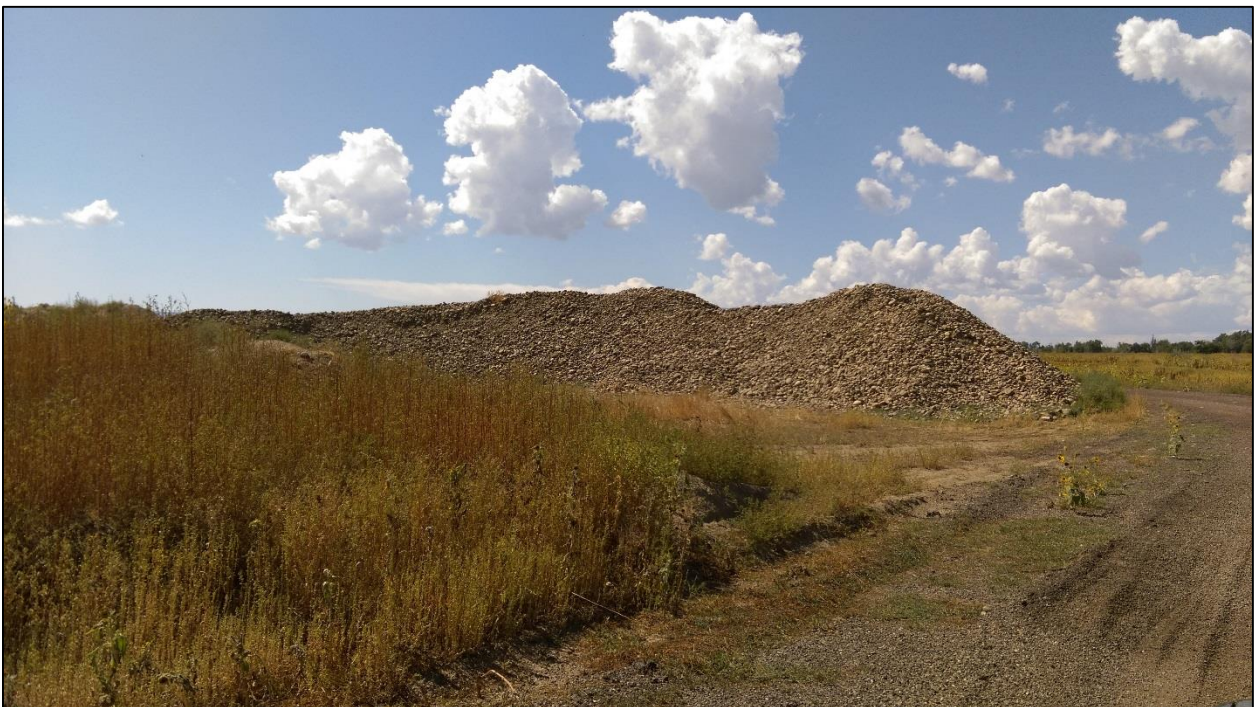
Photo 12. View of material stockpiled near the haul road, west of the pit.

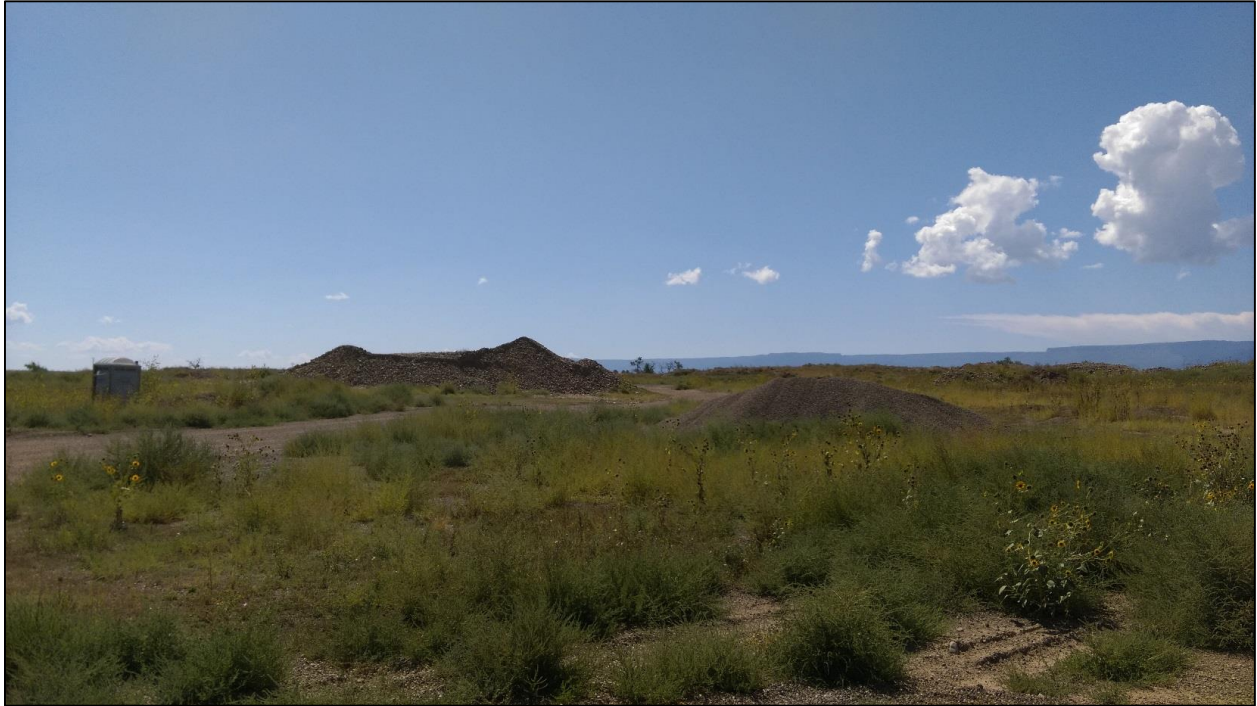
Photo 13. View of material stockpiled north of the pit, near the main entrance.

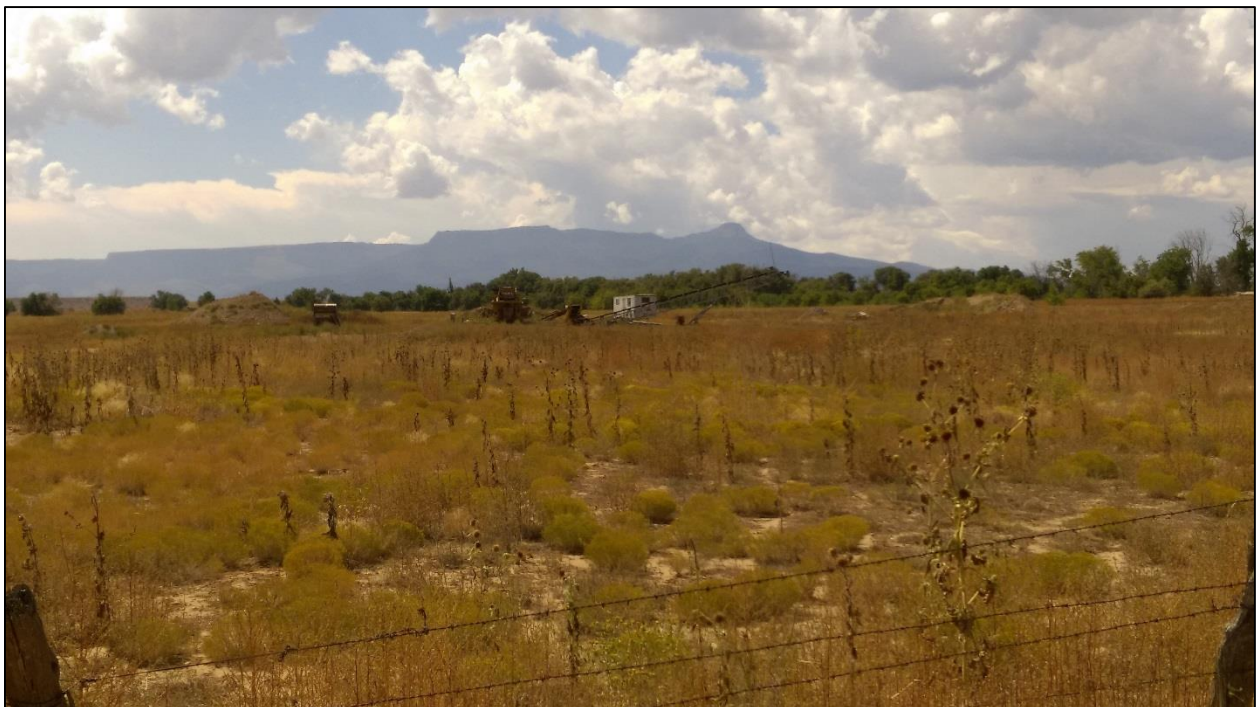
Photo 14. View looking south from Co Rd 36, showing western portion of permit area where mining has been completed for some time. Current disturbance in this area includes a few small stockpiles, and storage of some processing equipment and a small trailer (shown in background).

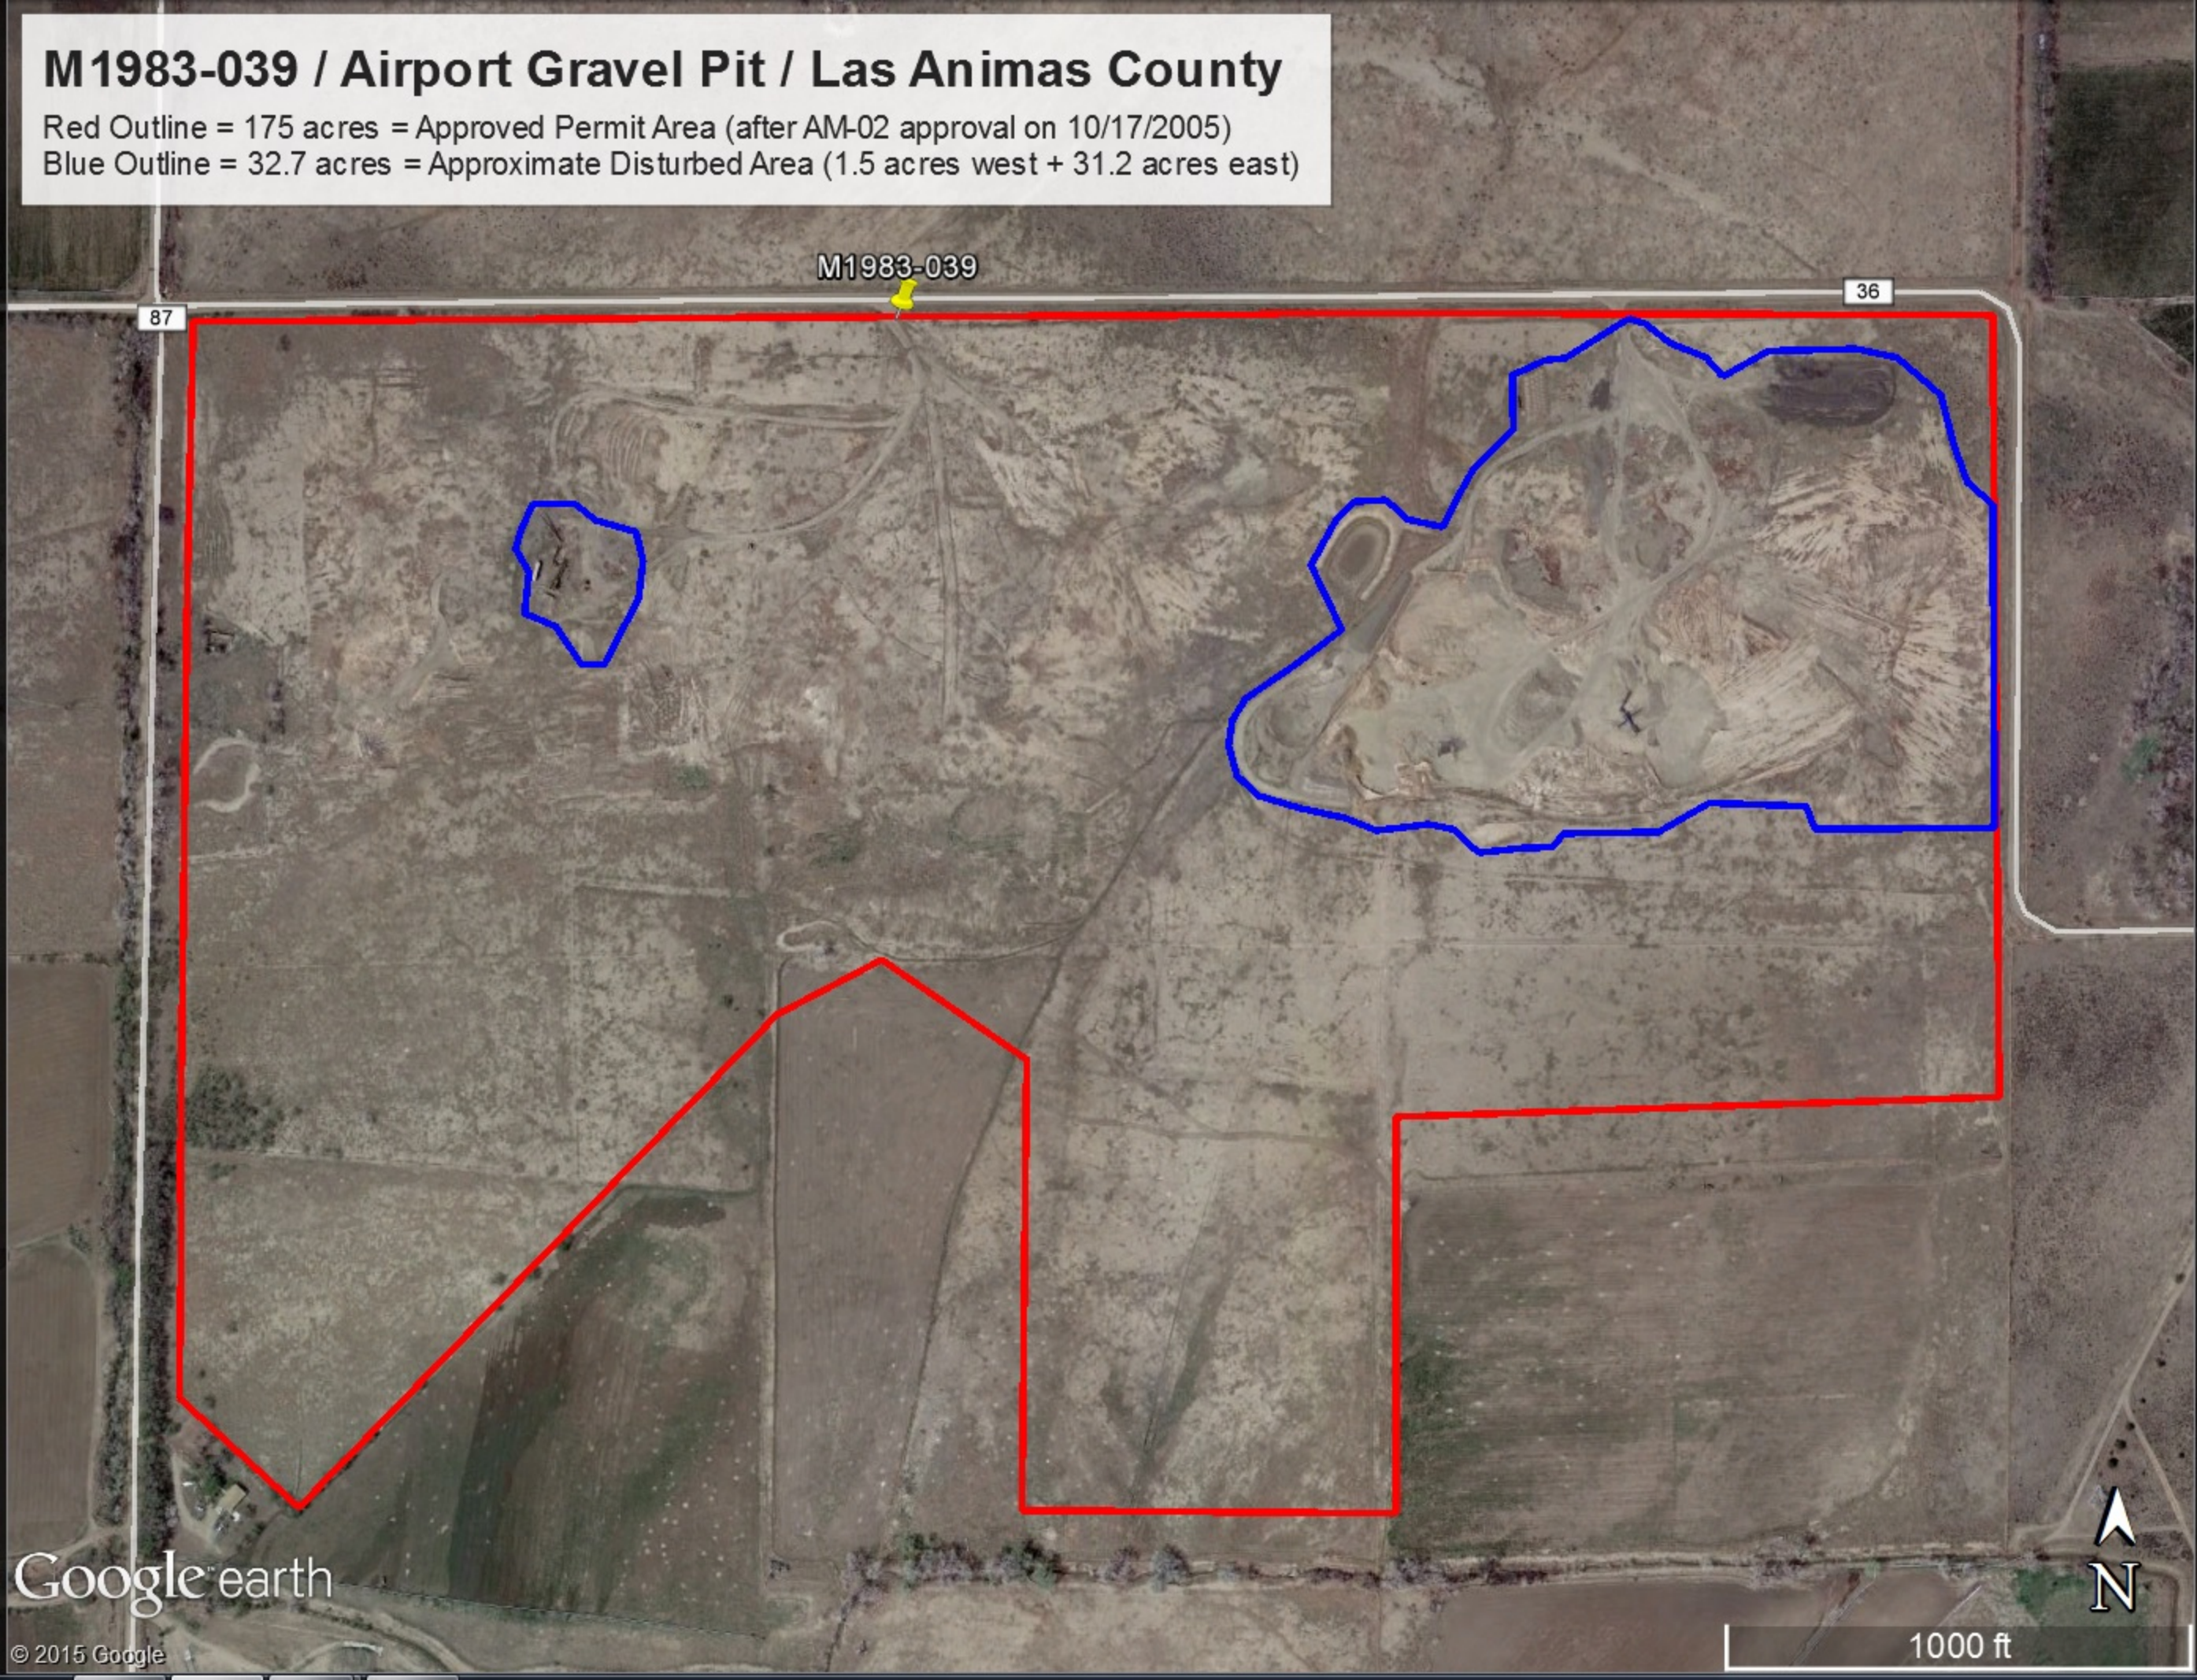
M1983-039 / Airport Gravel Pit / Las Animas County

Red Outline = 175 acres = Approved Permit Area (after AM-02 approval on 10/17/2005)

Blue Outline = 32.7 acres = Approximate Disturbed Area (1.5 acres west + 31.2 acres east)
